FAIRBANKS GOLD MINING, INC.
A wholly owned subsidiary of
Kinross Gold Corp.

Fort Knox Mine

**Reclamation, Environmental Stewardship, Arctic Grayling and
Burbot Studies, and Development of Wetlands' Habitat**

May 28, 2003

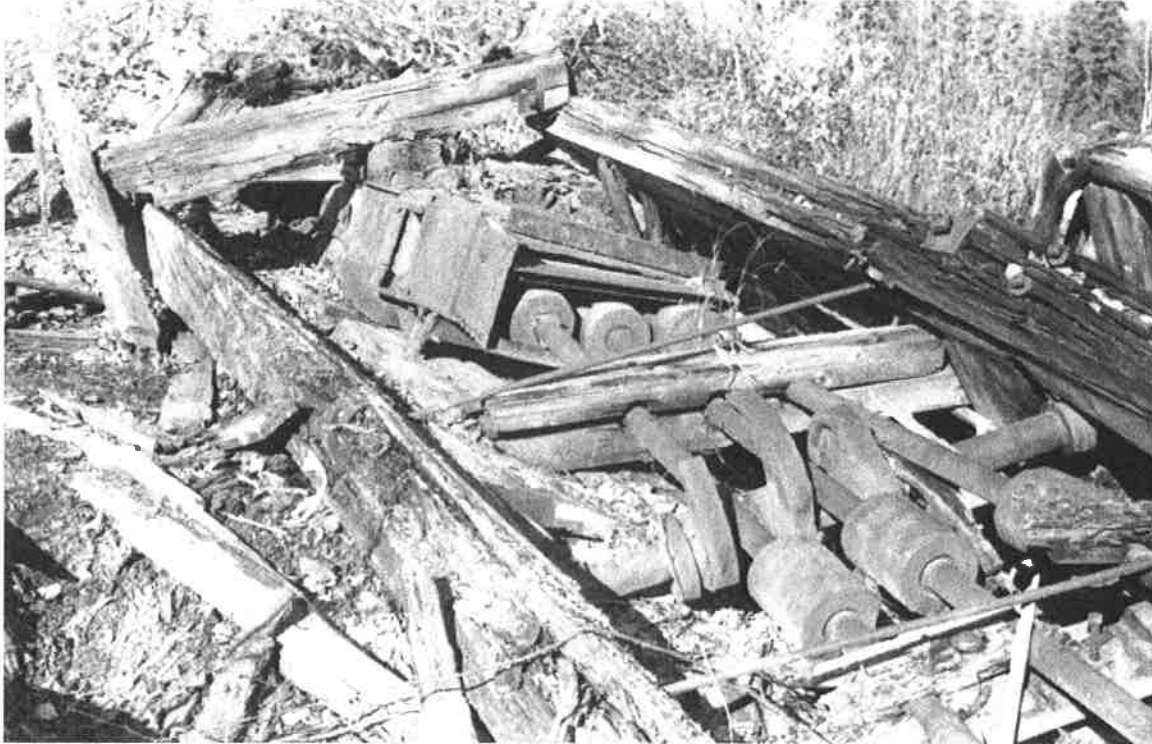
Figure 7: Remains of a three-stamp mill found on Melba Creek, 1993

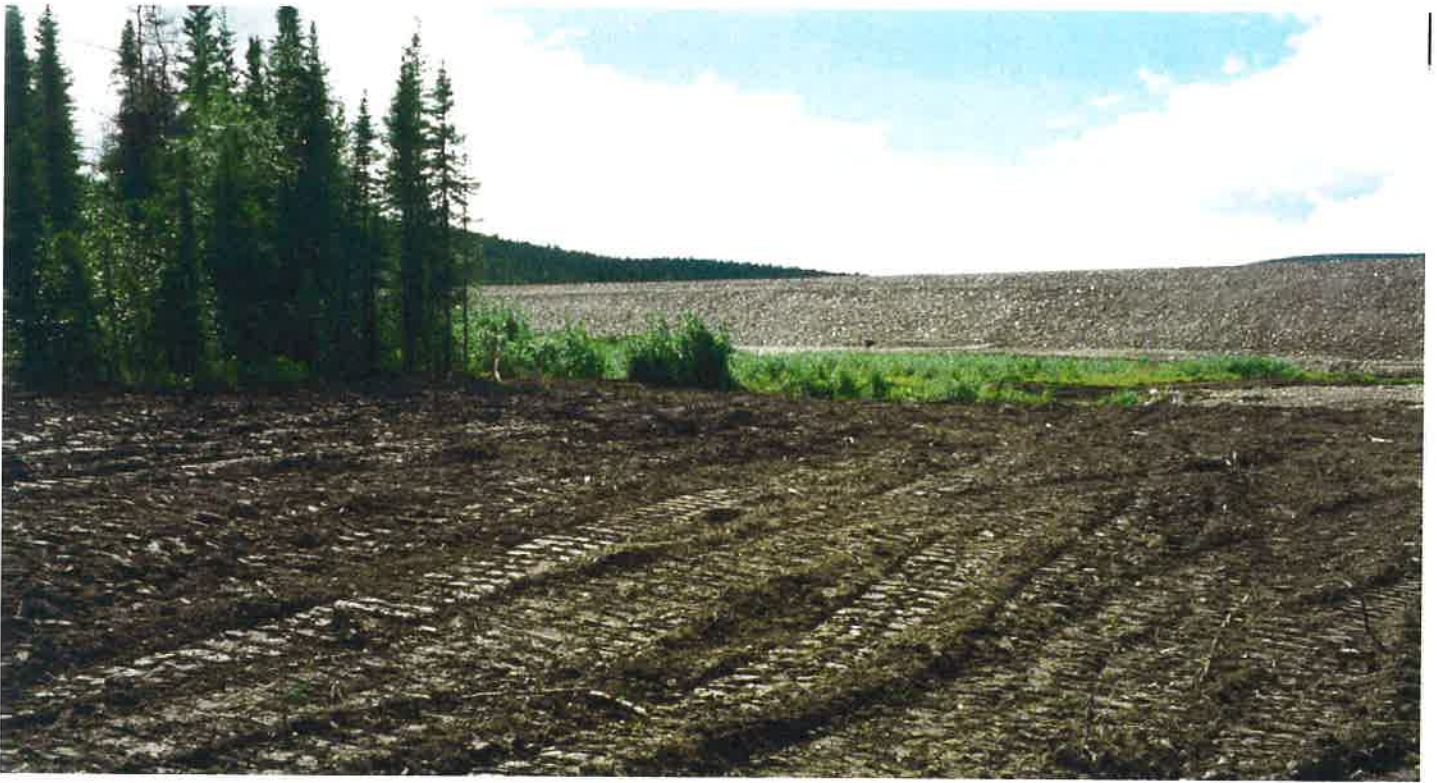
Figure 10: Below the water supply reservoir the area was recontoured and seeded after construction of the embankment, Summer 1996

Concurrent reclamation of the Fish Creek valley between the tailing dam and the water supply reservoir began following construction. Initially, most of the area was reshaped, a berm was constructed to maintain water levels in Ponds A and B, channels were constructed between the ponds in the valley, most of the area was seeded, and willow sprigging was done in selected areas.

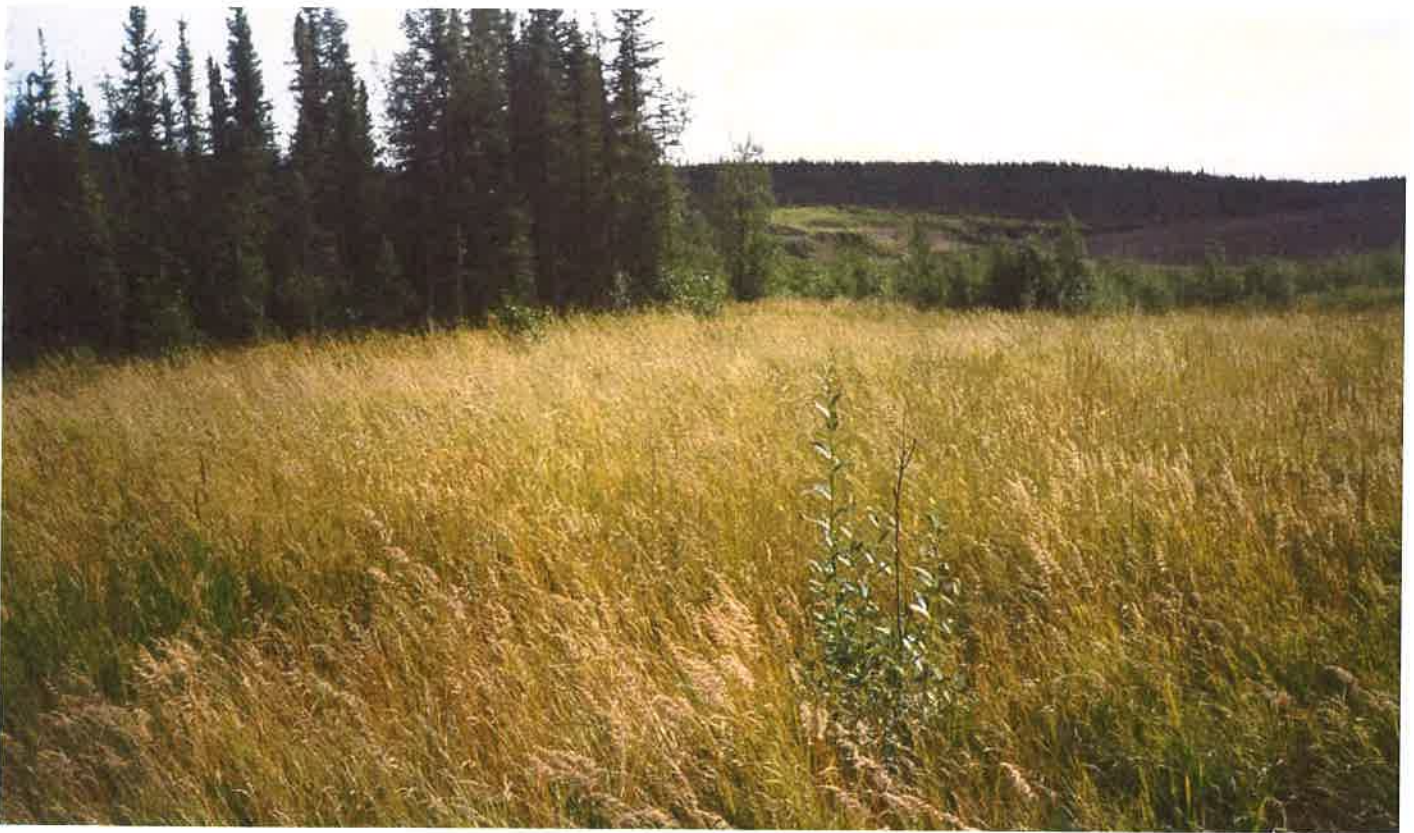
Figure 11: Two years later, the same area below the water supply reservoir embankment after being seeded with a native grass mix; natural invasion of other native species has begun, Summer 1998

Concurrent reclamation is practiced to the maximum extent possible. As soon as an area is no longer being used recontouring and reseeding takes place. A mix of native grass species: 50% Arctared Red Fescue, 20% Gruening Alpine Bluegrass, 20% Tundra Glaucous Bluegrass and 10% Nortran Tufted Hairgrass, designed in conjunction with the Alaska Department of Natural Resources- Plant Materials Center, was developed for reclamation on Fort Knox. The preferred method of planting is broadcast seeding. The recommended seeding rate is eleven pounds per acre and no mulching has been necessary. This seeding rate was reduced from the original rate purposed by the Plant Materials Center. Through experimentation, a careful balance has been achieved between the need for erosion control and soil enhancement afforded by planting grass, and a too vigorous vegetative mat that would slow down the invasion of other native species. Willow sprigging is carried out by cutting dormant branches in the spring from shrubs growing in the general area of the reclamation work. An experimental tailing soil test plot is currently planted with four different seeding rates of the native grass mix as well as four fertilizer rates in an effort to determine the best approach for future reclamation of the tailing impoundment.

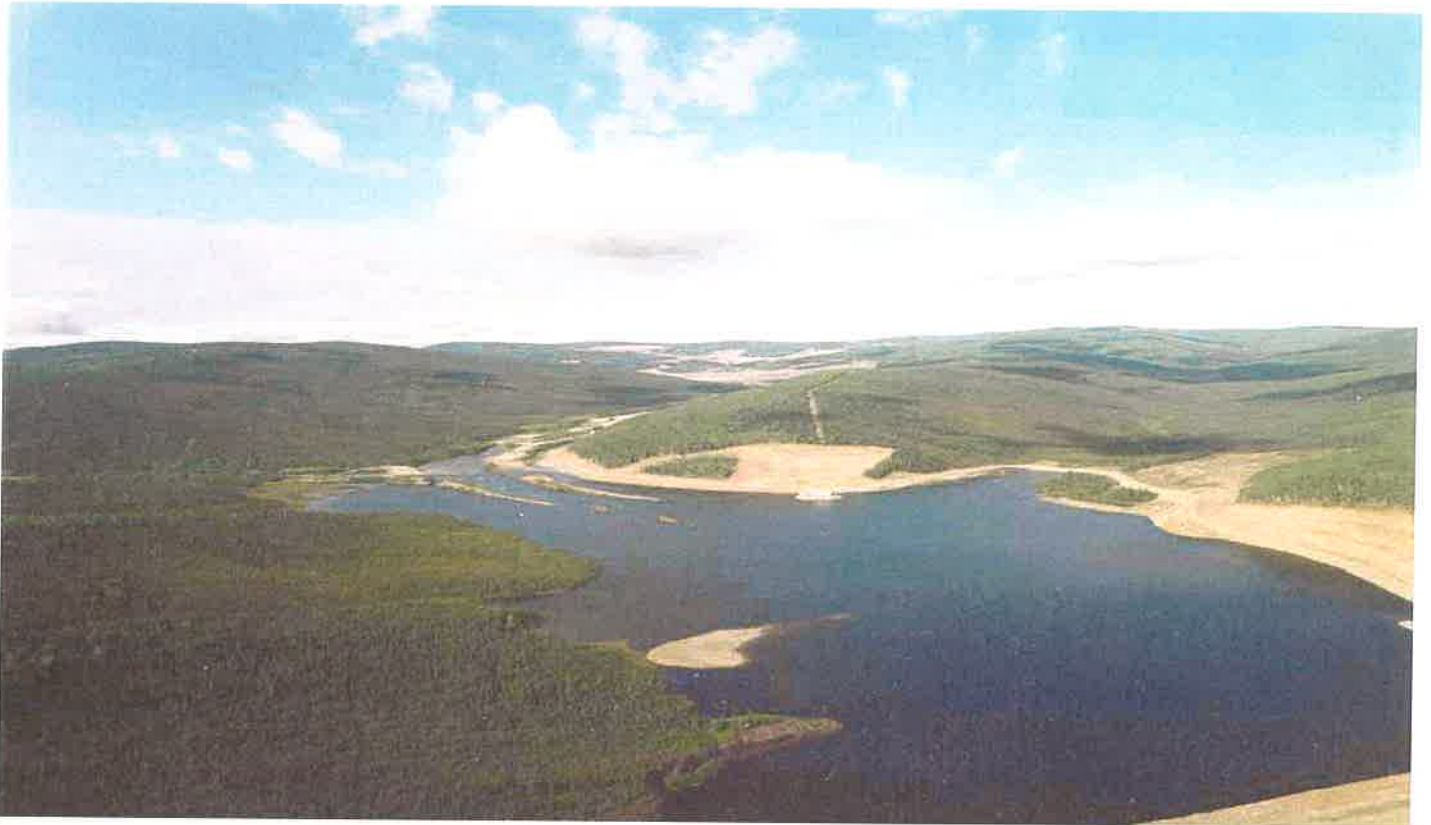
Figure 12: A view of the water supply reservoir looking upstream toward the developed wetlands; the embankment can be seen in the lower right hand corner, 1998

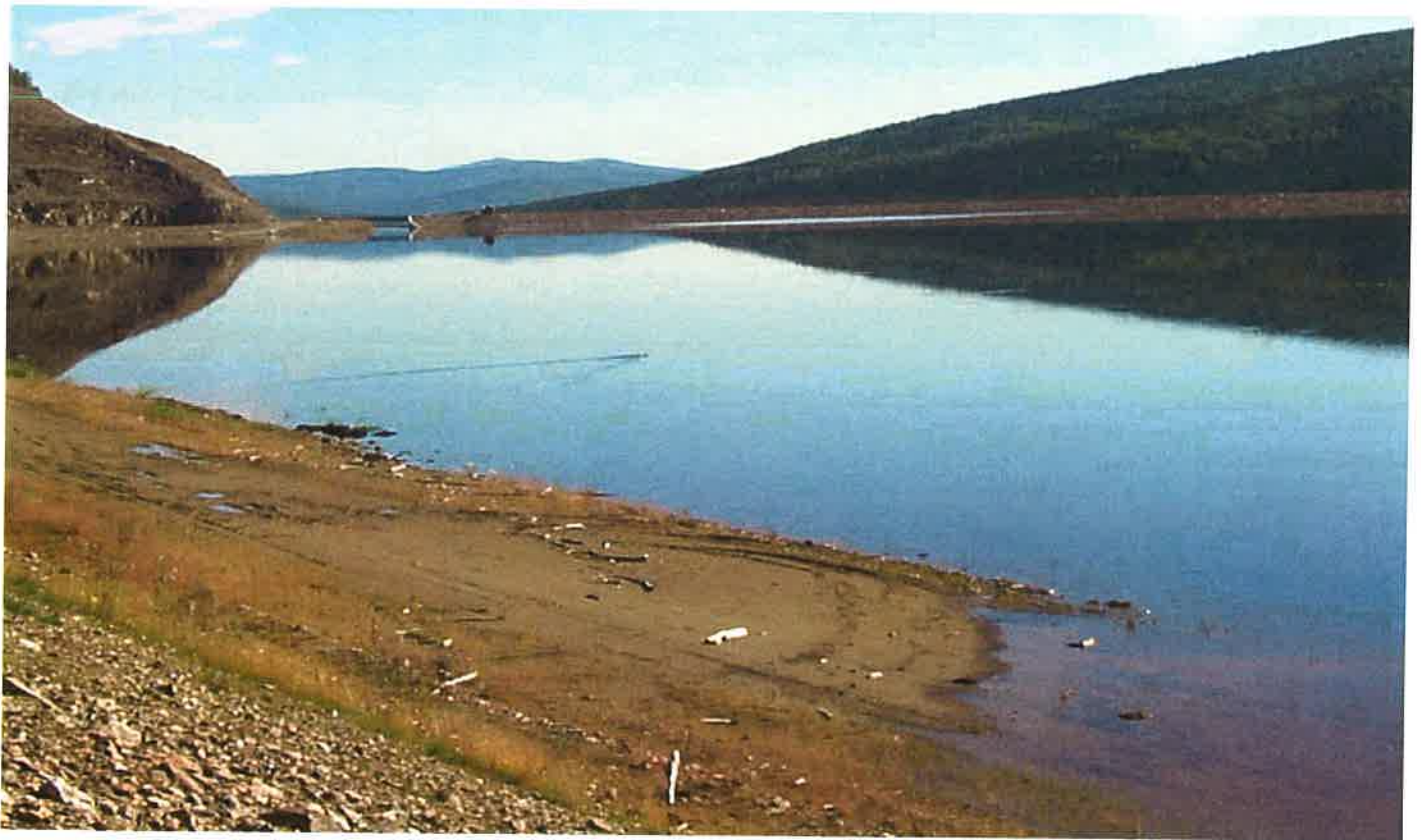
Figure 13: An upstream view of the water supply reservoir, spillway in upper left corner, 1999

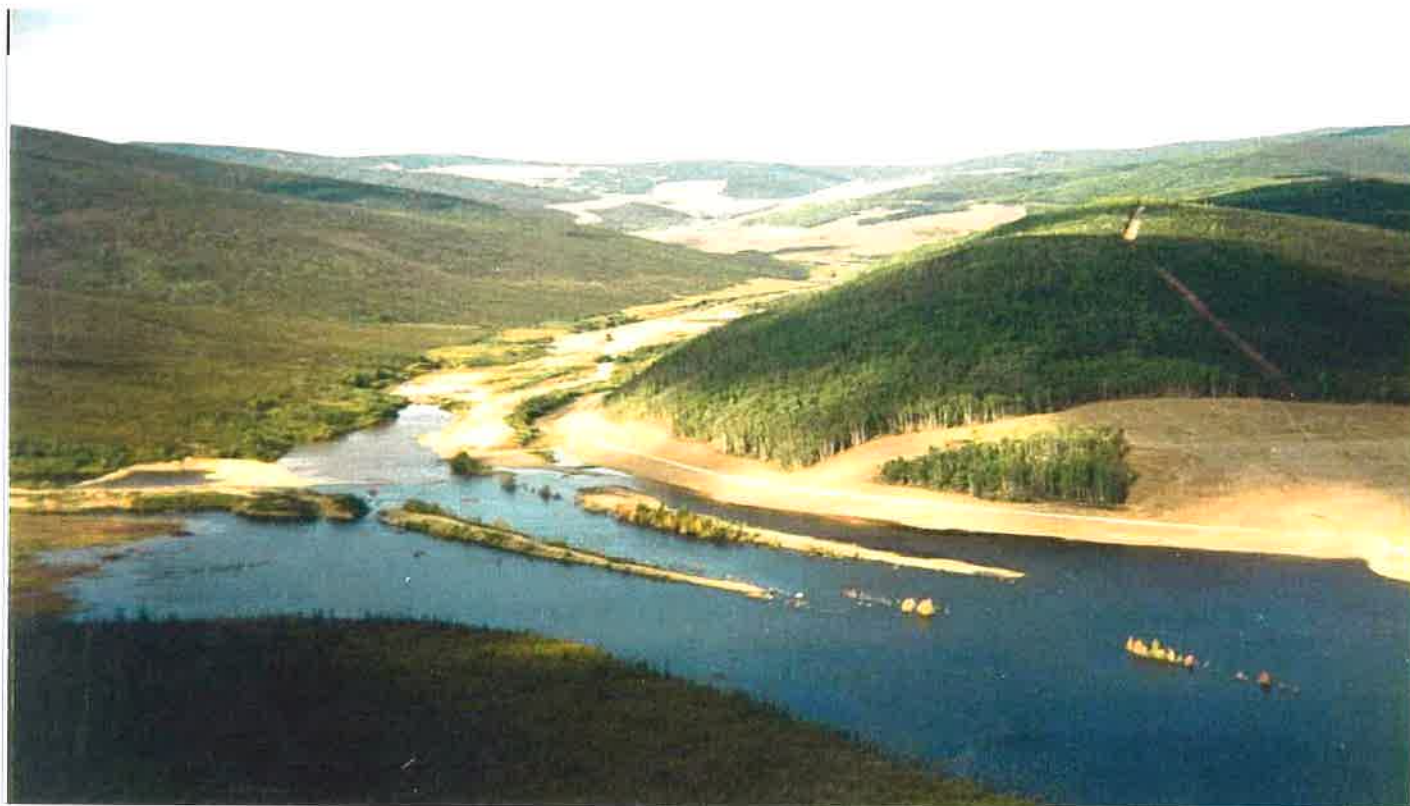
Figure 14: Upstream from the water supply reservoir flooding produced diverse, shallow shoreline habitat; the channel between the long narrow islands is Polar Bay, 1998

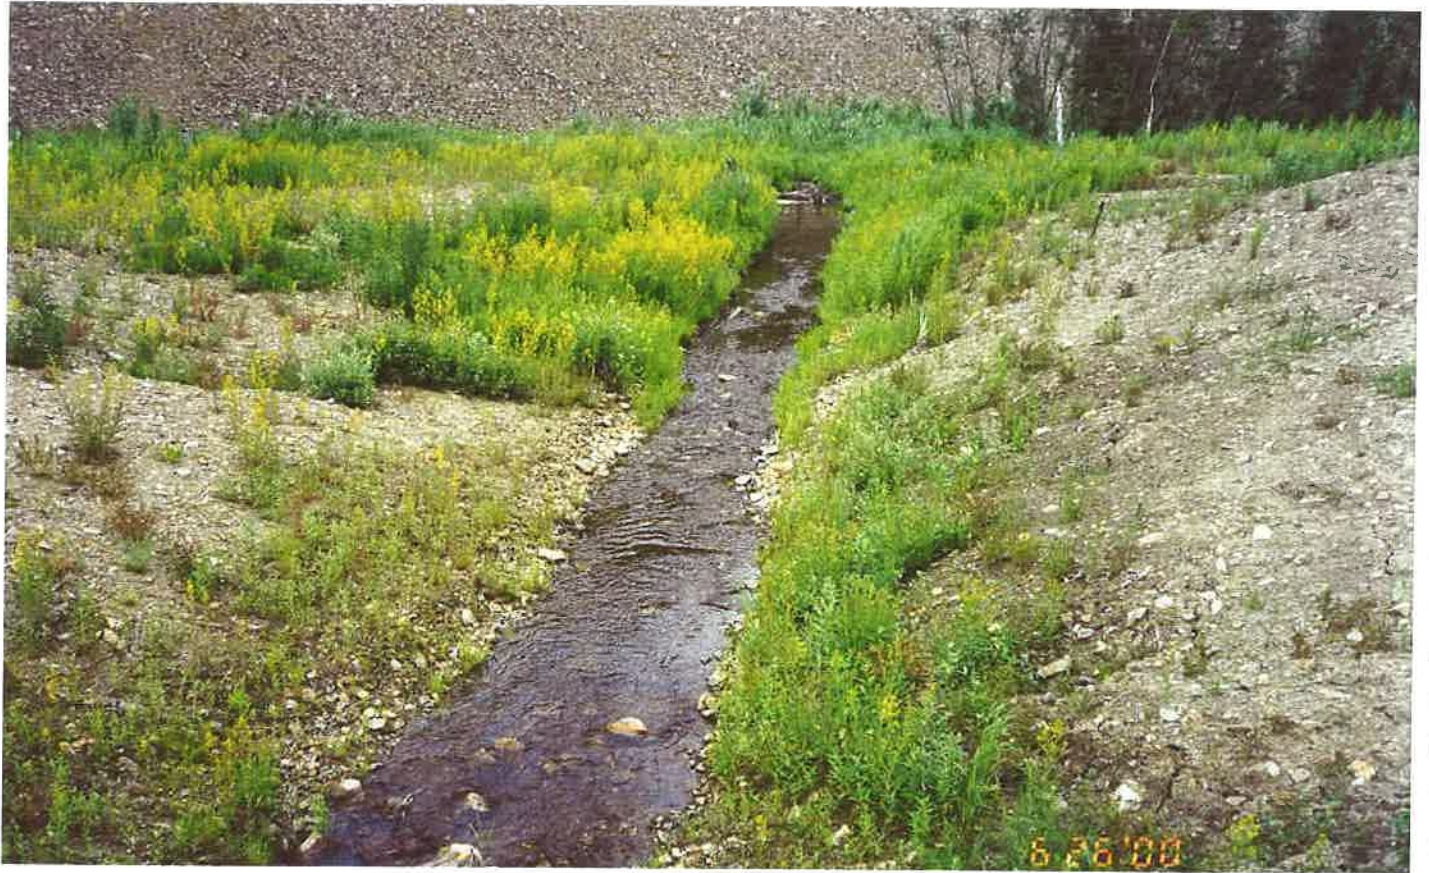
Figure 16: The shallow channel constructed to allow grayling to enter the wetlands for spawning, June 2000

In 1999, a channel was constructed to connect Ponds C, D, E, and F with the water supply reservoir. In fall 2001, work was done in Last Chance Creek in an attempt to stabilize the stream channel. In fall 2001 and 2002, additional work was done on the channel and berm separating Ponds D and E. These projects, collectively, have resulted in rapid revegetation in the valley. In addition, the channel that connects the ponds with the water supply reservoir has been used extensively by Arctic grayling for spawning each year since 1999; the wetlands have become the main source of Arctic grayling production in the valley.

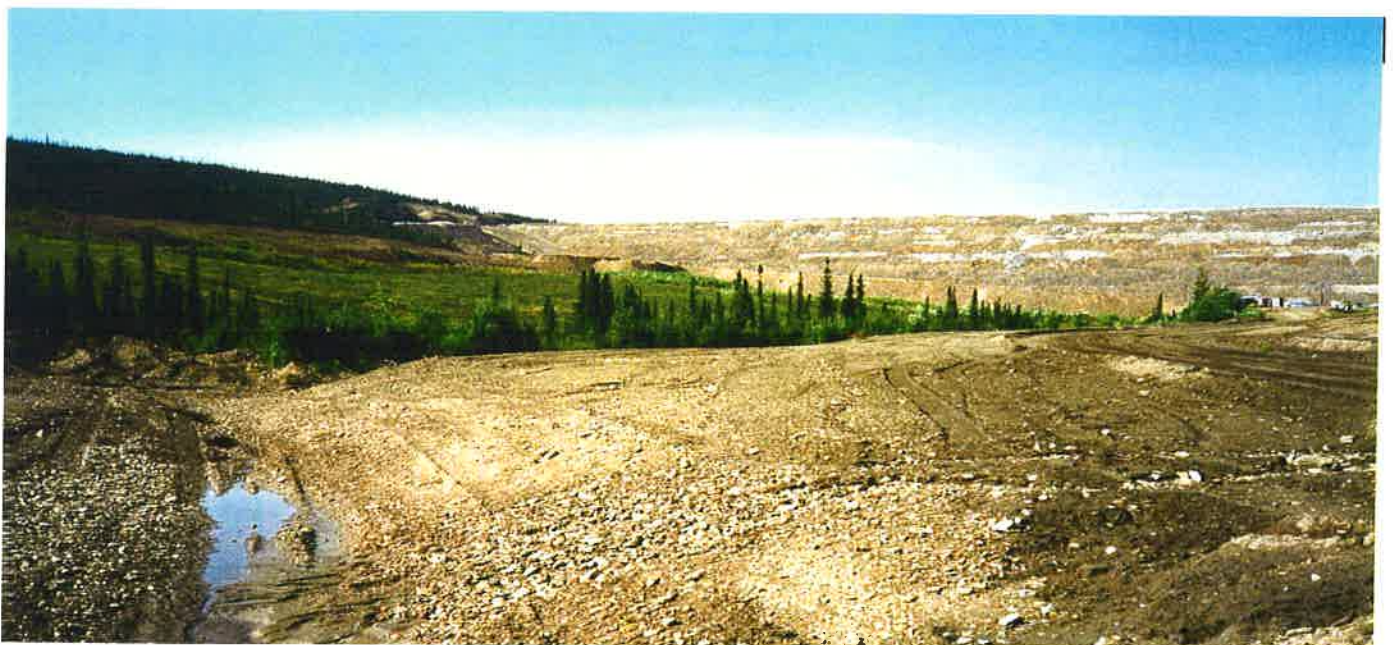
Figure 17: Looking up Fish Creek valley towards the tailing embankment, historically disturbed areas being recontoured during construction of Channel 1, Summer 1997

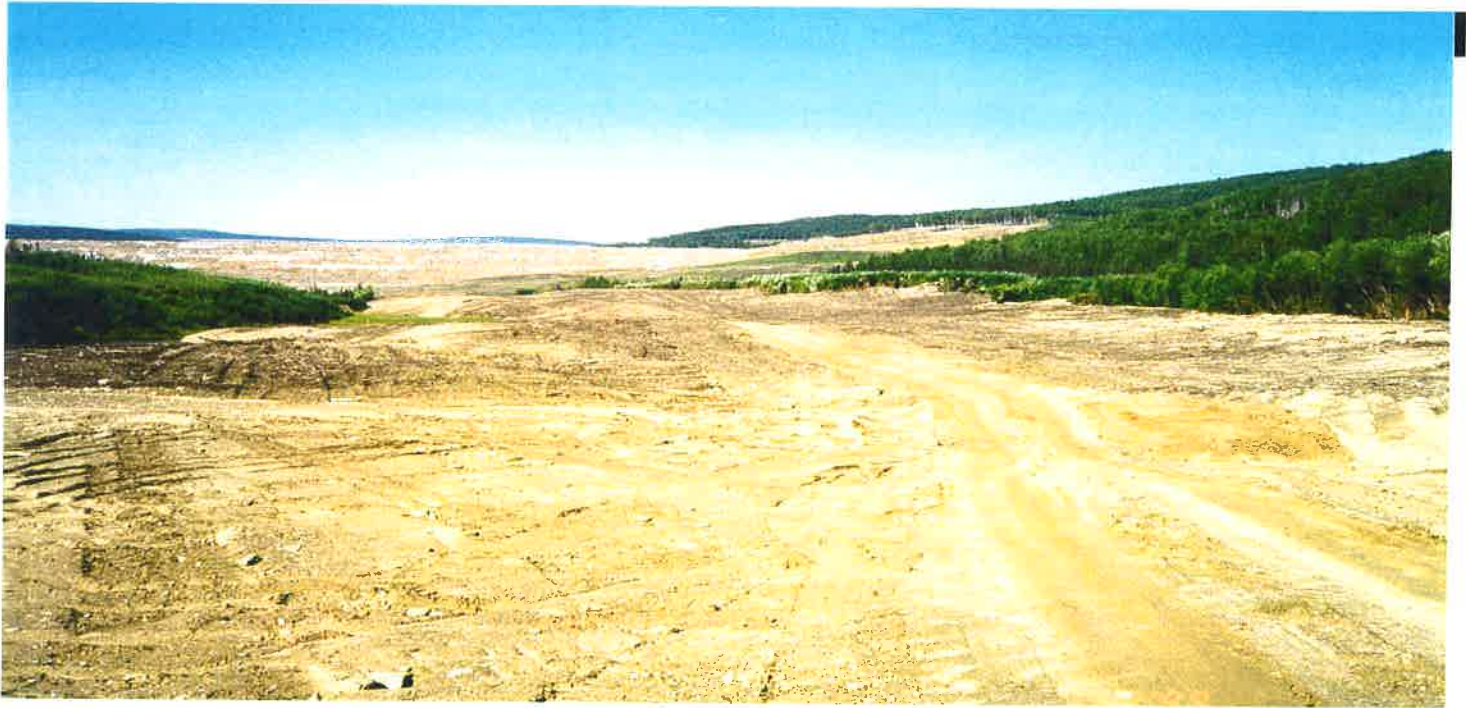
Figure 18: Another shot of recontoured historic mining disturbance with the tailing impoundment in the background, 1997

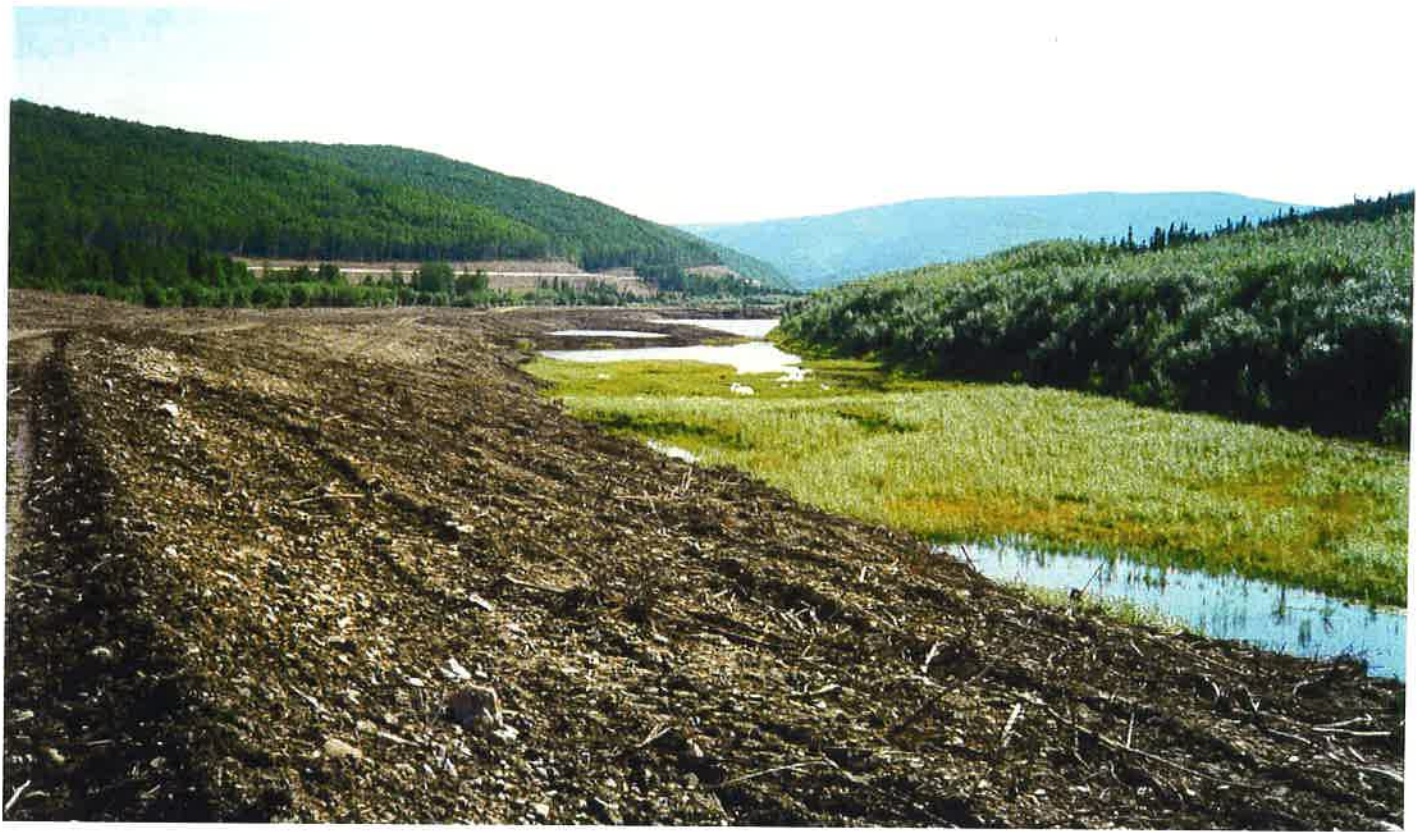
Figure 20: Steep sided pits and uneven terrain were sloped in preparation for seeding reclaimed wetlands downstream from the tailing impound, 1999

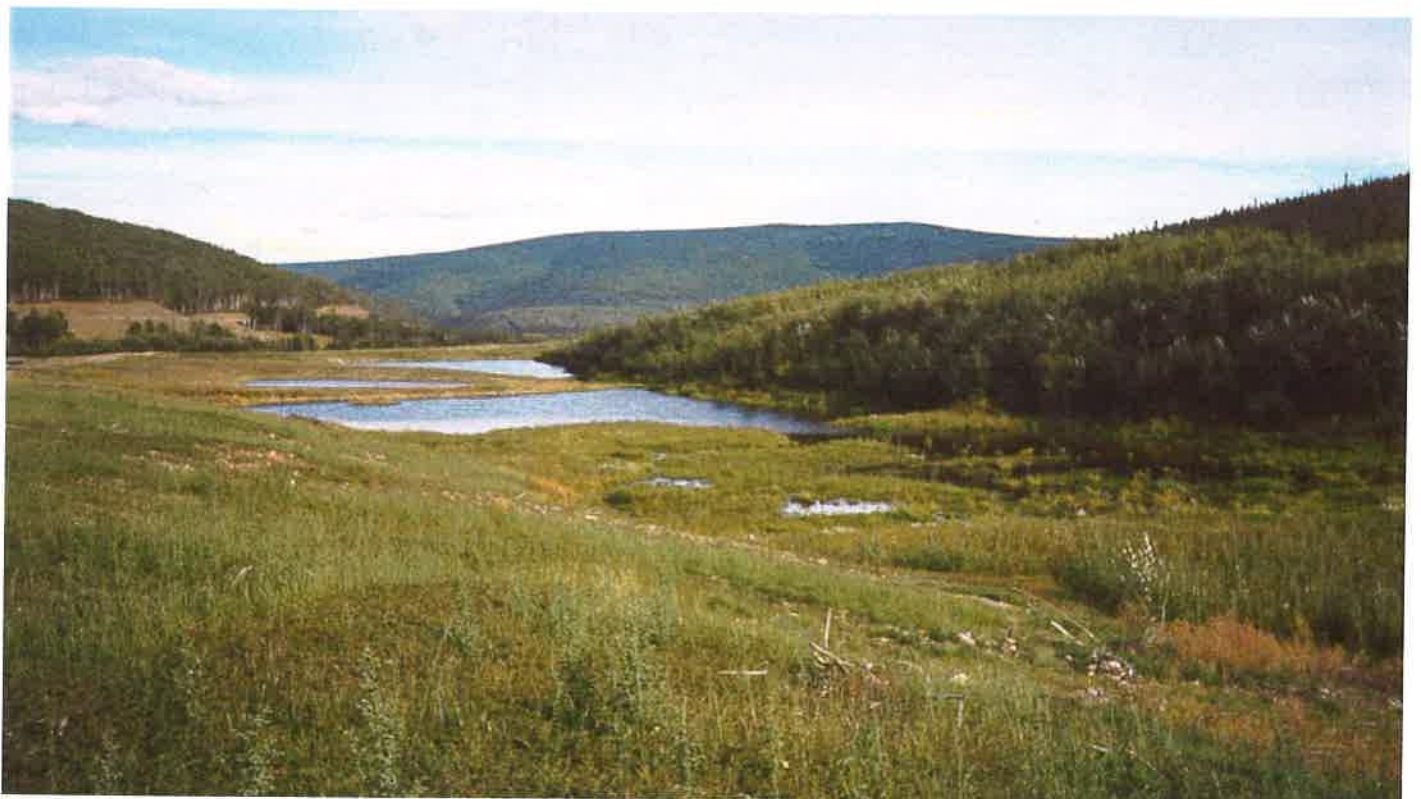
Figure 21: One year after seeding, old placer mining disturbances are unrecognizable as wetlands develop a whole new character, Summer 2000

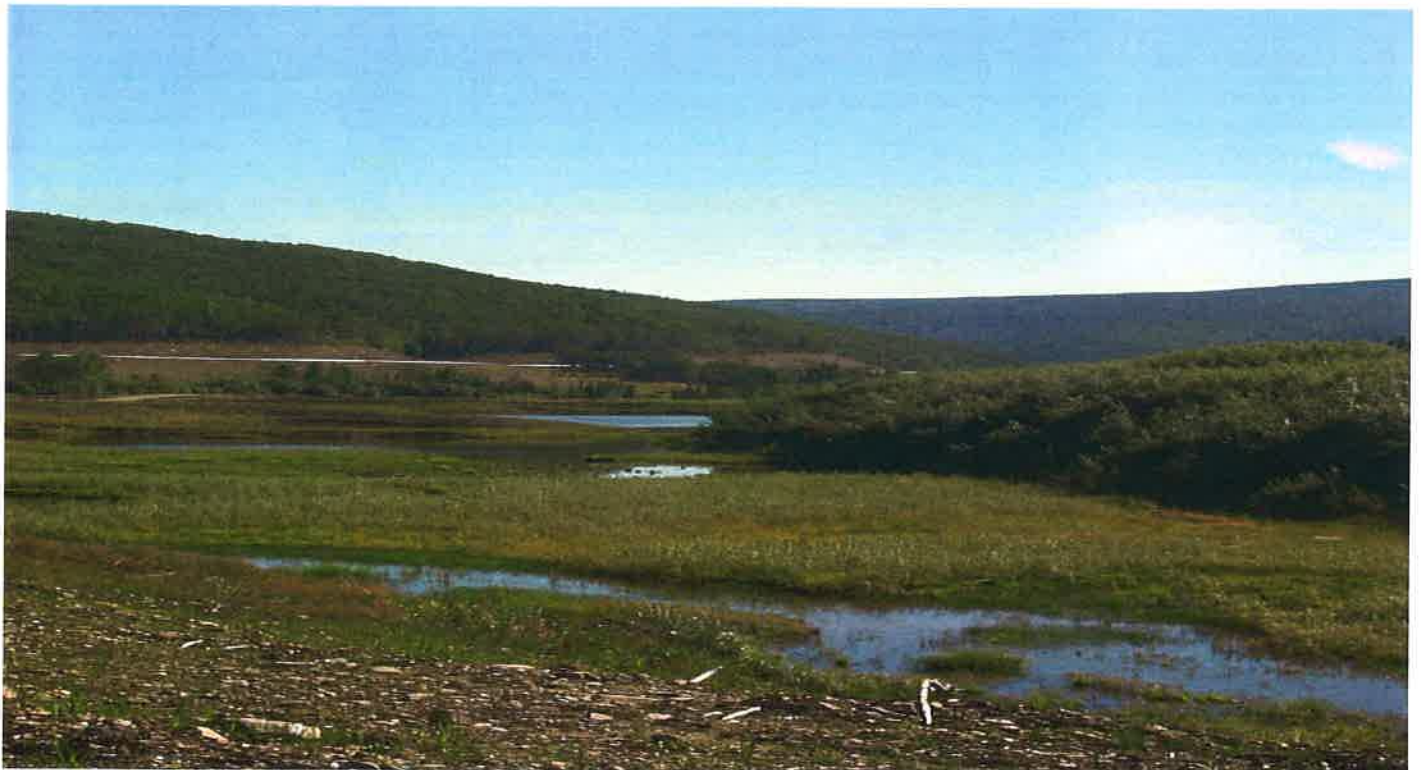
Figure 23: Recontoured and seeded to native grasses, these developed wetlands, near the tailing impoundment are becoming productive wetland habitat, mid-summer 2000

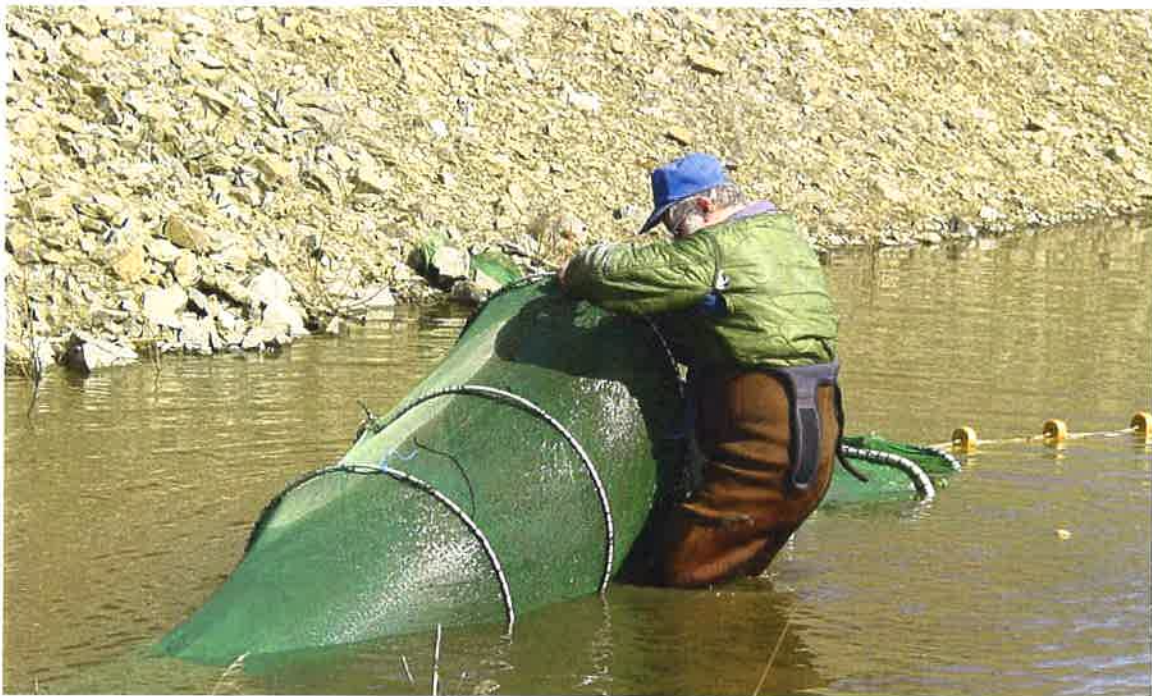
Figure 26: Al Ott, Habitat Biologist with fyke-net in the shallow end of the water supply reservoir, capturing grayling to be tagged, early spring 2003

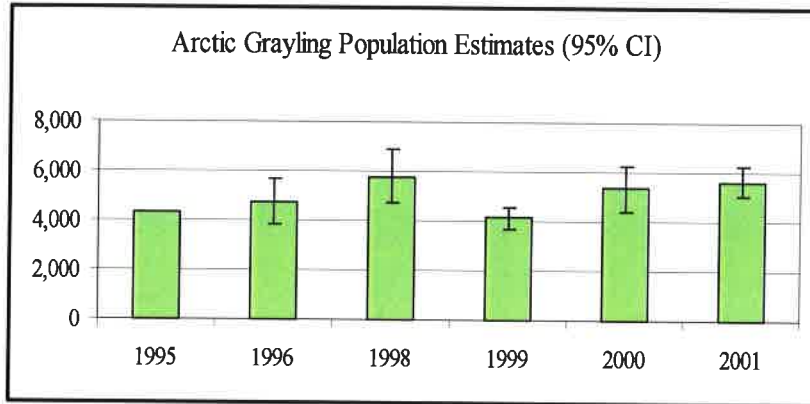
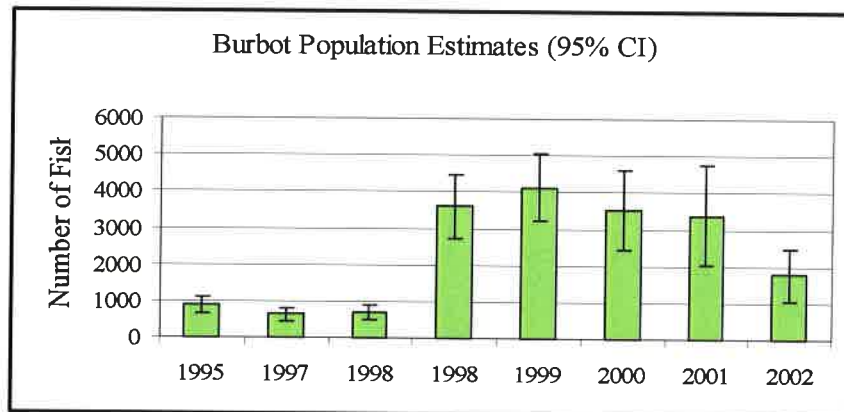
Estimates of the Arctic grayling population in the water supply reservoir at the Fort Knox Mine (1995 to 2001). Capture and recapture events were done using fyke-nets.

Estimates of the burbot population in the water supply reservoir at the Fort Knox Mine (1995 to 2002). The first 1998 estimate was in season while the second 1998 estimate is based on the 1999 recapture event when adequate recaptures of small burbot occurred making the population estimate possible.

Figure 27: These graphs show a population estimate of Arctic grayling and burbot after the building of the water supply reservoir and developed wetlands.

The goal of having a viable Arctic grayling population in the water supply reservoir and developed wetlands of between 800 and 1,600 fish >200 mm was attained in 1998, only two years after the construction of the water supply reservoir and years earlier than expected. Successful spawning and survival of age-0 Arctic grayling has been documented every year since 1999 and there is evidence of substantial recruitment to the population. The estimated population for spring 2001 for Arctic grayling >200 mm was 5,623; almost four times the original goal. Furthermore, there are now fairly large numbers of Arctic grayling leaving the water supply reservoir over the spillway – 435 Arctic grayling >200 mm were caught in spring 2002 in the stilling basin. A potential added benefit of this out migration from the Fort Knox water supply reservoir and developed wetlands is a source of recruitment of Arctic grayling to the Chena River system and fishery. The Chena River flows through Fairbanks and is used extensively by local fishermen.

The burbot population in the water supply reservoir also has increased substantially from that found prior to the water supply reservoir. The increase in burbot was not predicted based on baseline information collected. A decrease in numbers was documented in summer 2002, but the population of larger burbot (>400 mm) appears to be stable and small burbot (<200 mm) are present indicating successful spawning in the water supply reservoir. Some of these smaller burbot also are leaving the water supply reservoir.

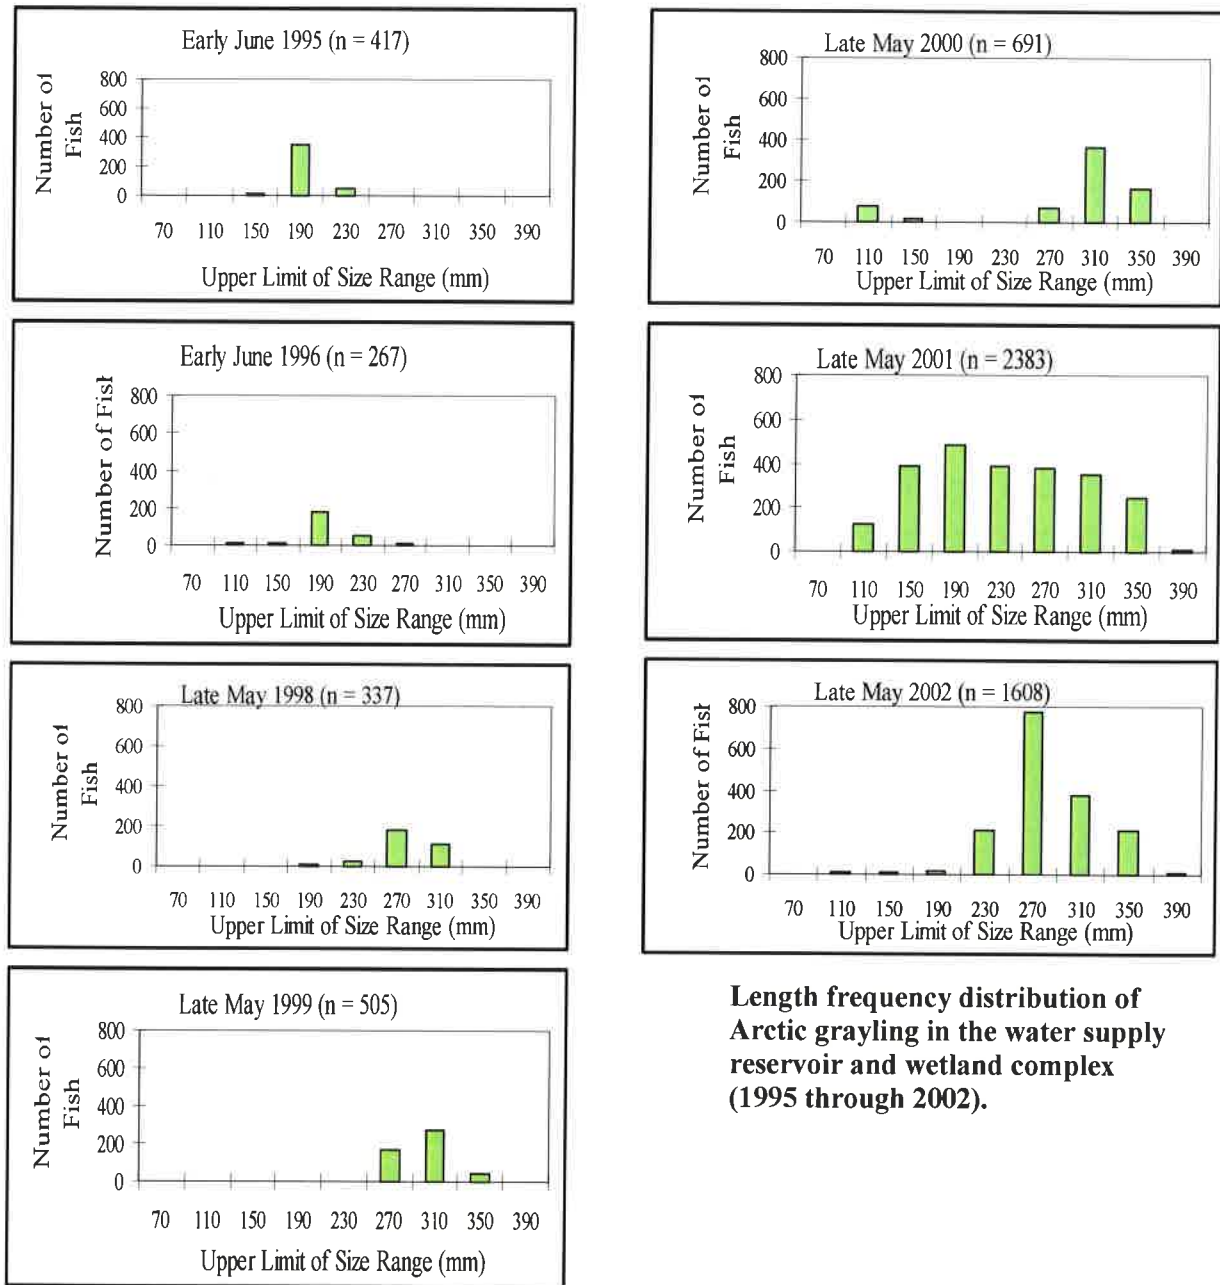
Length frequency distribution of Arctic grayling in the water supply reservoir and wetland complex (1995 through 2002).

Figure 28: These graphs depict an increase in juvenile fish, an indication of spawning success after the construction of channel #5 in 1999.

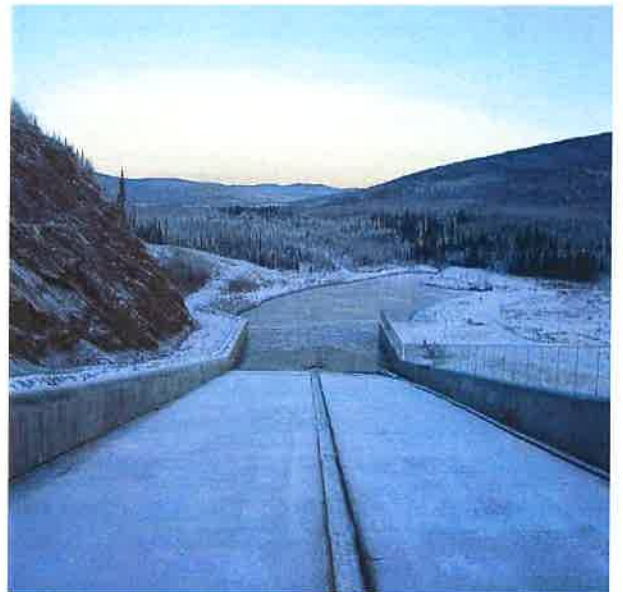
Figure 51: Water supply reservoir spillway/otter slide, in the bottom left corner of photo are faint slide marks left by playful otters, December 2002
