# Kinross True North Mine Reclamation

The Northern Latitudes Mining Reclamation Workshop addresses reclamation, remediation, and other aspects associated with the unique climate and ecosystems of northern locations as we reclaim the north. As we look at mining operations, we consider not only statutes and regulations, but also the unique conditions of the individual mine sites to determine the success of reclamation activities. Where possible, the State looks to encourage reclamation practices with the nomination for reclamation awards for those companies and individuals that exceed the minimum standards. One such award is the Interstate Mining Compact Commission (IMCC) National Reclamation Award. The State of Alaska nominated Kinross True North Mine for the State's first entry for the IMCC reclamation award. The State's nomination considered the eligibility requirement of the IMCC for active reclamation work done on the site within the 12-month period prior to the nomination as well as compliance with 11 AAC 97.200, Reclamation Performance Standards. In this respect, we reviewed the stability of the disturbed surface and the reestablishment of vegetation in accordance with the pr

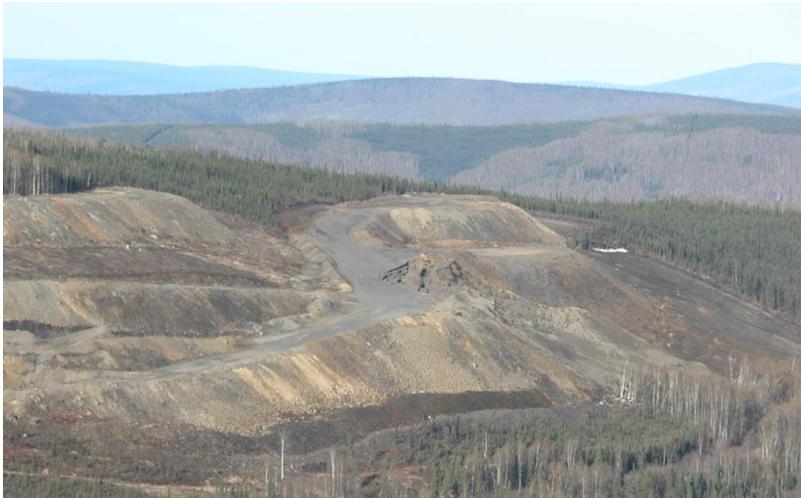
Figure 3: North Shepard Waste Rock Dump - 2005

In 2004, undecided if mining activities would continue the following year, Kinross identified 125 acres that would not be subject to further disturbance if mining activities resumed. During the summer of 2005, that identified disturbance was regraded, ripped, seeded and fertilized. This work included the North Shepard Dump, Hindenburg Dump, Zeppelin Dump, and South Shepard

Dump. The area was regraded with D10 dozers and ripped with a D8 dozer. Seed and fertilizer was applied on all reclaimed disturbance using either a broadcaster mounted on a D4 dozer or by aerial application using a fixed wing aircraft. Reclamation consisted of scarifying or ripping of the graded surface on contours that were 18" deep and spaced 18 to 24 inches apart that created a broken, roughened surface to trap moisture, reduce wind shear, and minimize surface erosion by increasing infiltration of the top surface of the soil, which in turn, created micro-habitats conducive to seed germination and development. The seed application rate and mixture was developed in collaboration with the Alaska Department of Natural Resources Division of Agriculture, Alaska Plant Material Center based on seed availability and test plots.

Subsequent to the 2005 reclamation work, a portion of the North Shepard Dump slumped in 2007 requiring additional earthwork and reseeding/fertilizing. Survey prisms were installed and the movement of the slump was monitored by tracking the survey points. The slump area encompassed approximately 7 acres. In 2010 the slump was deemed stable enough to be regraded, scarified and revegetated. The mitigation process included excavating slumped soil mass and hauling the material to Central Pit located below and backfilling along the south and west edge of the pit. The backfill material was then pushed to the south and east at a 3:1 slope for final grading. The overburden mass was excavated to a 2.5:1 or shallower slope or until undisturbed ground was encountered.

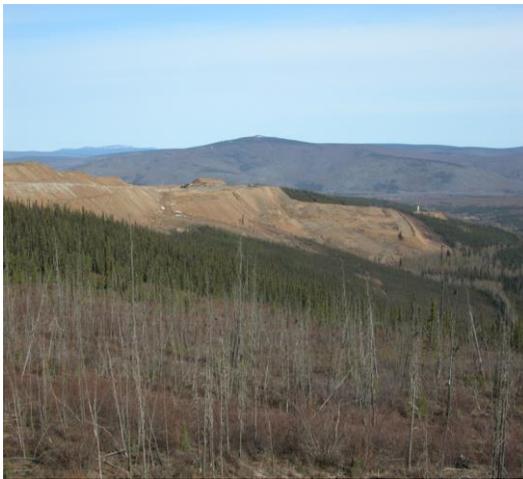
Figure 5: Louis Dump - 2005

State was notified that the company decided to cease mining operations and reclaim the True North mine site. During that year, reclamation was performed on approximately 202 acres of dumps. Louis dump was a major part of this effort encompassing 110 Acres.

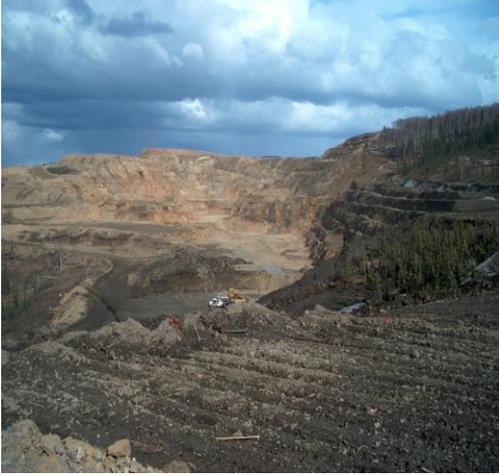
Figure 7: Central and Hindenburg Pits - 2005

Of note is the reclamation that has occurred in the pits. The State does not require reclamation of the pit; however, the pit walls do need to be in stable condition. The Central Pit was partially backfilled in 2007 to reduce surface water pooling. The Hindenburg Pit floor was graded and scarified to reduce potential runoff to the North Central Pit which enabled revegetation and a reduction in surface water flow. A diversion ditch along the southeast rim of the Central Pit and Hindenburg Pit was constructed in 2007 to divert surface storm water away from the pits.

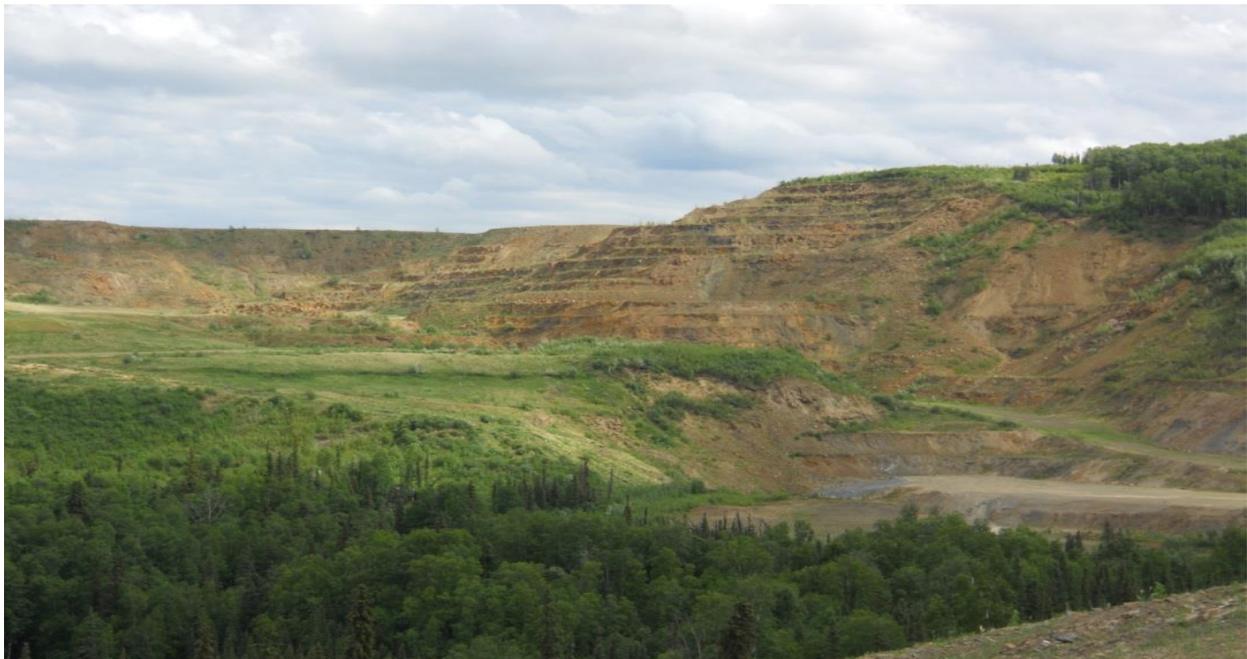
Figure 8: Central and Hindenburg Pits - 2013

Due to continued reclamation work within and around the pits and to address water flow, the Central Pit and Hindenburg Pit were regraded and scarified once again in August 2010. The Shepard Pit was reclaimed in July 2010, and again in 2013; the pit floor was scarified, seeded and fertilized. The diversion ditch above the pit was cleaned out and reconstructed to divert water away from the pits and toward the Shepard Road. The Central and Hindenburg pits received seed and fertilizer in the years 2010-2014 to promote revegetation to encourage infiltration and reduce the velocity of surface water flow. All this effort has effectively eliminated the water issues occurring in the pits.

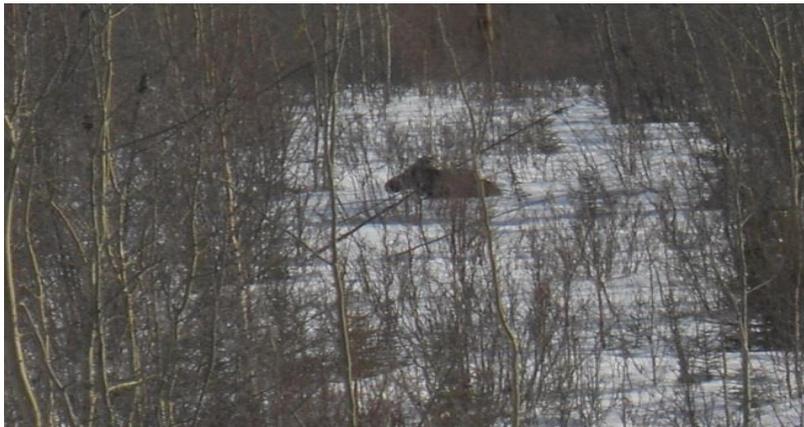
Figure 9: Moose Browse - 2014

True North provides a habitat to a large variety of Alaskan species. Moose, wolves, bear, sandhill cranes, and birds of prey have all been found at True North. Moose and wolves are found throughout most of Alaska. Moose typically live near timberline plateaus, along major rivers, and in recently burned areas. The creeks and wooded areas that are present at True North provide the dense willow strands, aspen, and birch shrubs that moose tend to enjoy. The topography at True North also offers a large, open area that wolves can utilize for hunting and roaming. Sandhill cranes and various birds of prey also enjoy the habitat that True North provides. The reclamation of the True North pit has left open cliffs. The cliffs are secluded and hard to reach so they offer a perfect location for birds to use for nesting. The creeks that are present also provide marshy, boggy areas with shallow water in which sandhill cranes enjoy nesting, feeding and rearing their young. The same pair of sandhill cranes, which mate for life, have been observed on the site since 2010. The mine site area is not short on fox. A reclamation practice was to leave larger boulders in place for visual diversification and habitat that would encourage picas and voles to inhabit as food for foxes. The picas also enjoyed some of the alder and birch seedlings that were planted at Louis Waste Rock Dump.

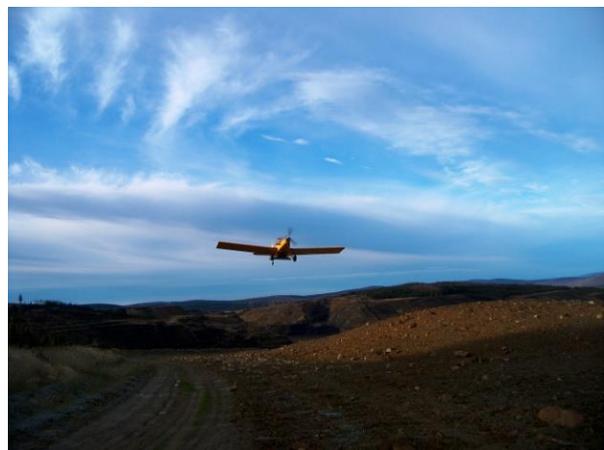
While using standard mechanical methods of reclamation, the broadcaster or hopper that was attached to the back of the D4 would often quit working due to the slope of the terrain. The oil in the hopper would drain away from the reservoir and set off the low level alarm and automatically turn off. The fertilizer application rate of 300 lbs per acre equated to 18.75 tons. The mine contacted a local pilot that had the ability to broadcast the remaining approved seed and fertilizer mixture with a fixed wing aircraft which required a relatively flat runway. After the runway was reclaimed, the mine hired a local rotary aircraft to complete the

Figure 11: Aerial Seeding via Fixed Wing Aircraft

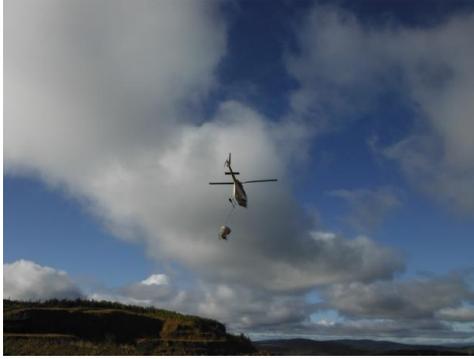
Figure 12: Aerial Seeding using Rotary Aircraft

seeding and fertilizing operation through the end of 2014. The reclamation aerial broadcasting campaign was completed in 2014.
