APPENDIX I  
PHOTOGRAPHS

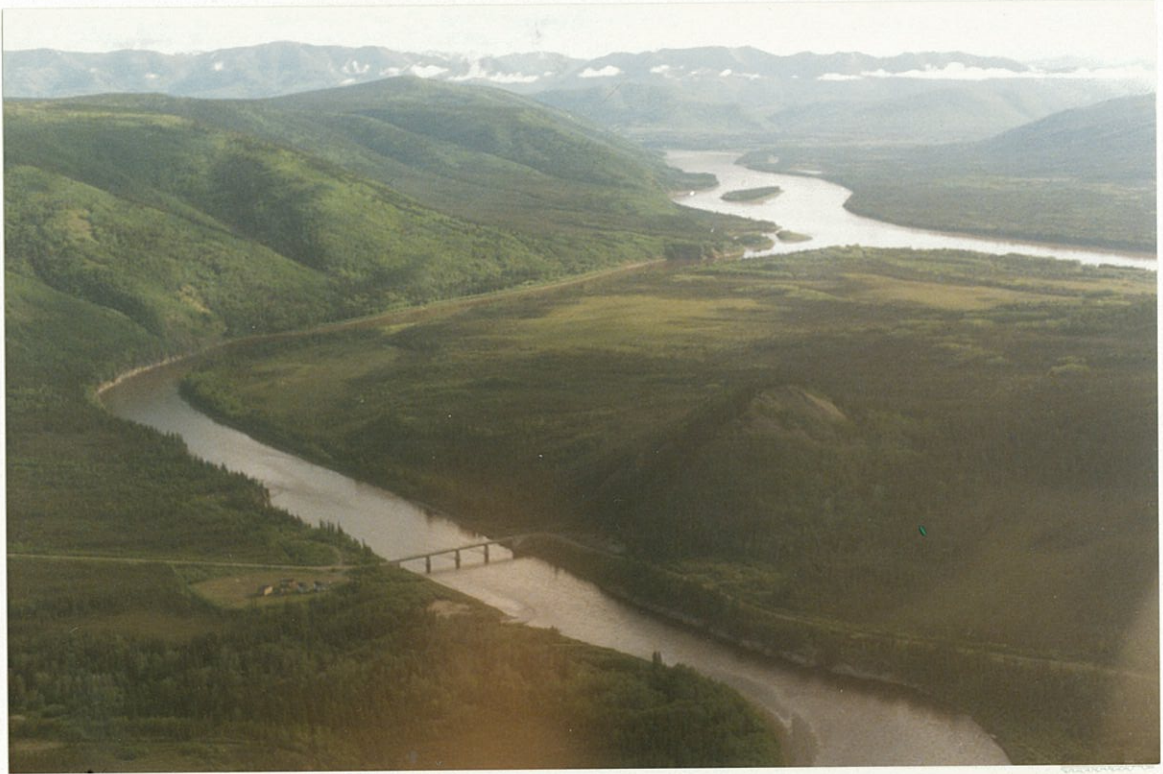
Photo 1: Forty Mile River showing confluence with Yukon River in background. Clinton Creek enters Forty Mile River just upstream of bridge. June 1985.

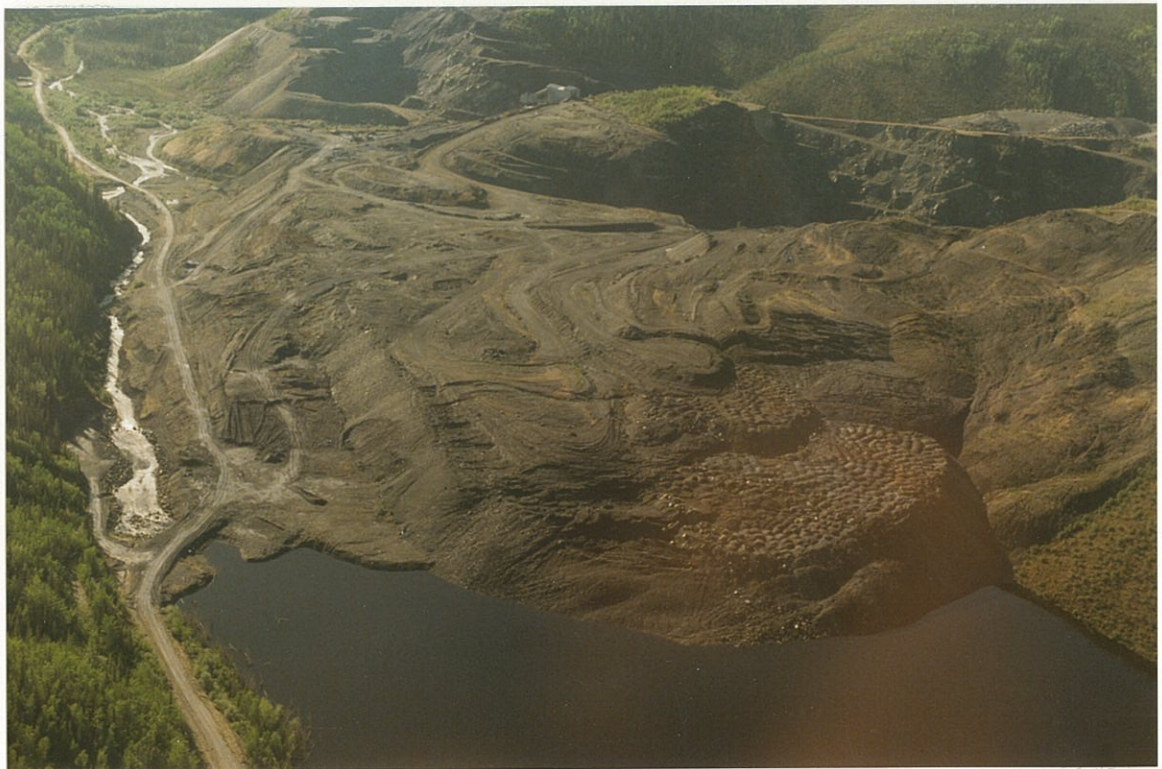
Photo 2: Clinton Creek waste dump, showing Hudgeon Lake at bottom of photo and channel of Clinton Creek over waste dump on left. June 1985.

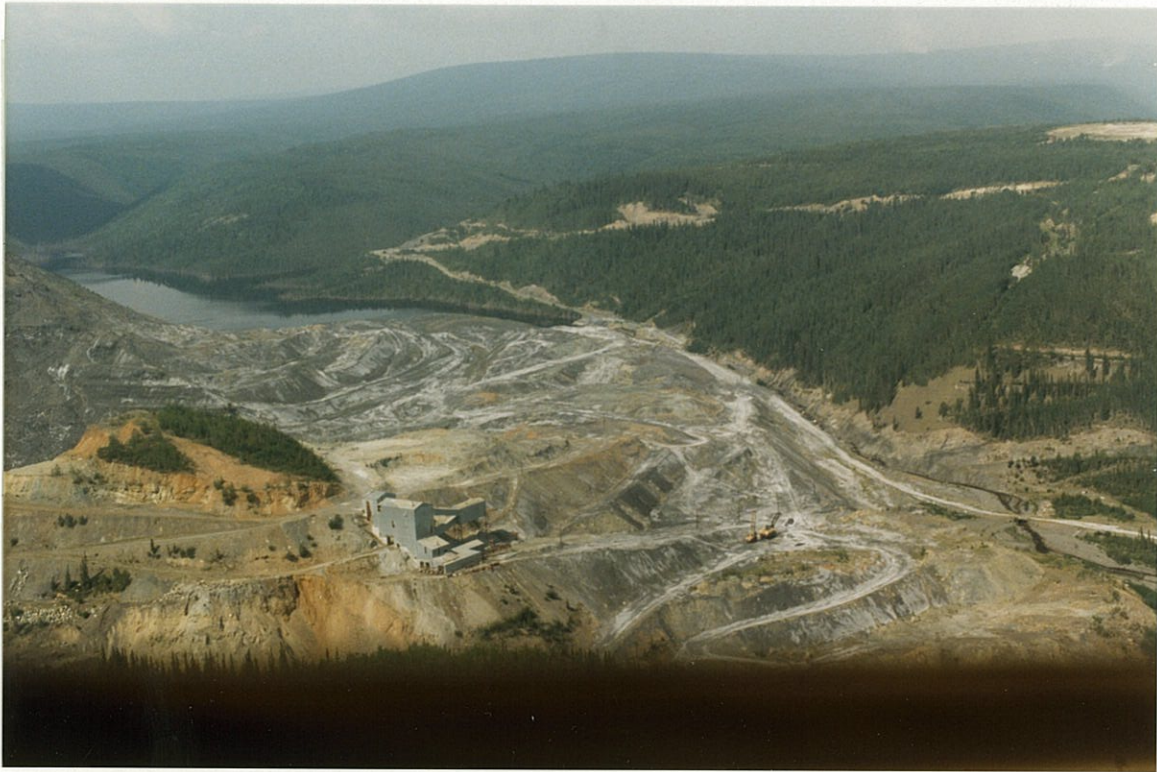
Photo 3: Clinton Creek waste dump, looking upstream toward Hudgeon Lake. Open pit is at left, crusher in foreground, and concentrator site on plateau at upper right. July 1986.

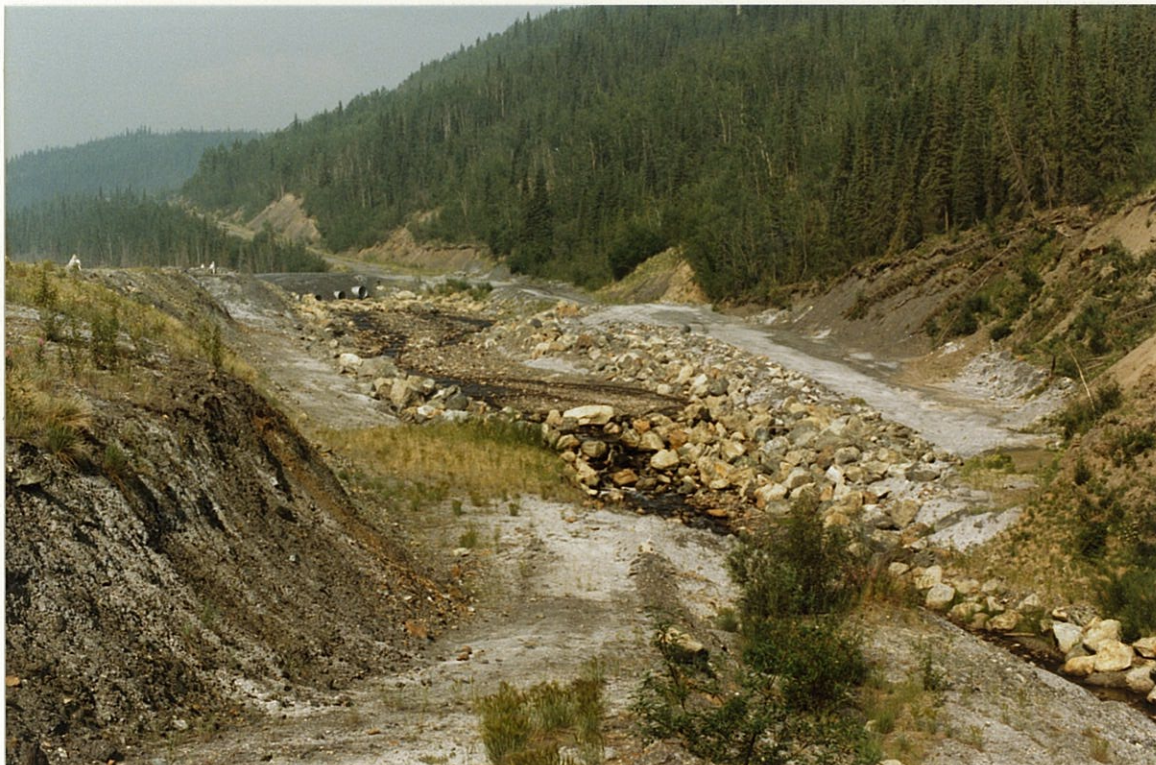
Photo 4: Rock lined section at upper end of Clinton Creek channel over waste dump. Access road culverts at upper left. July 1986.

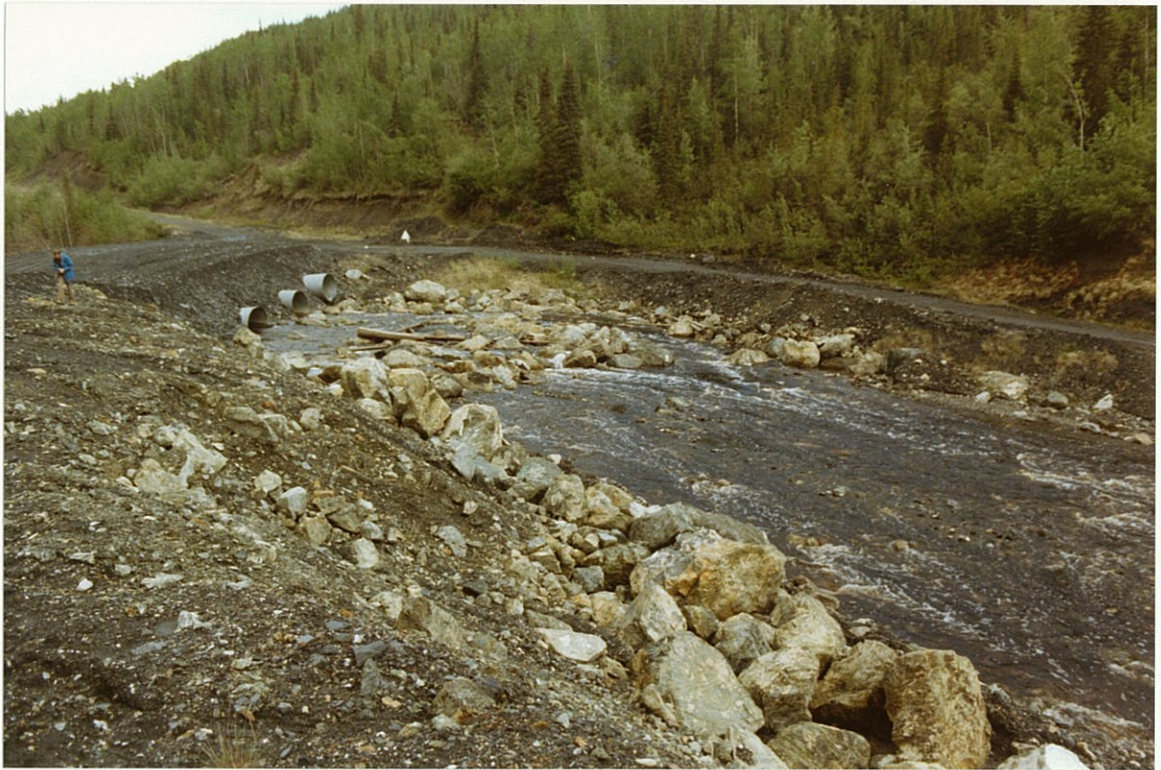
Photo 5: Access road culverts at upper end of waste dump channel. June 1985.

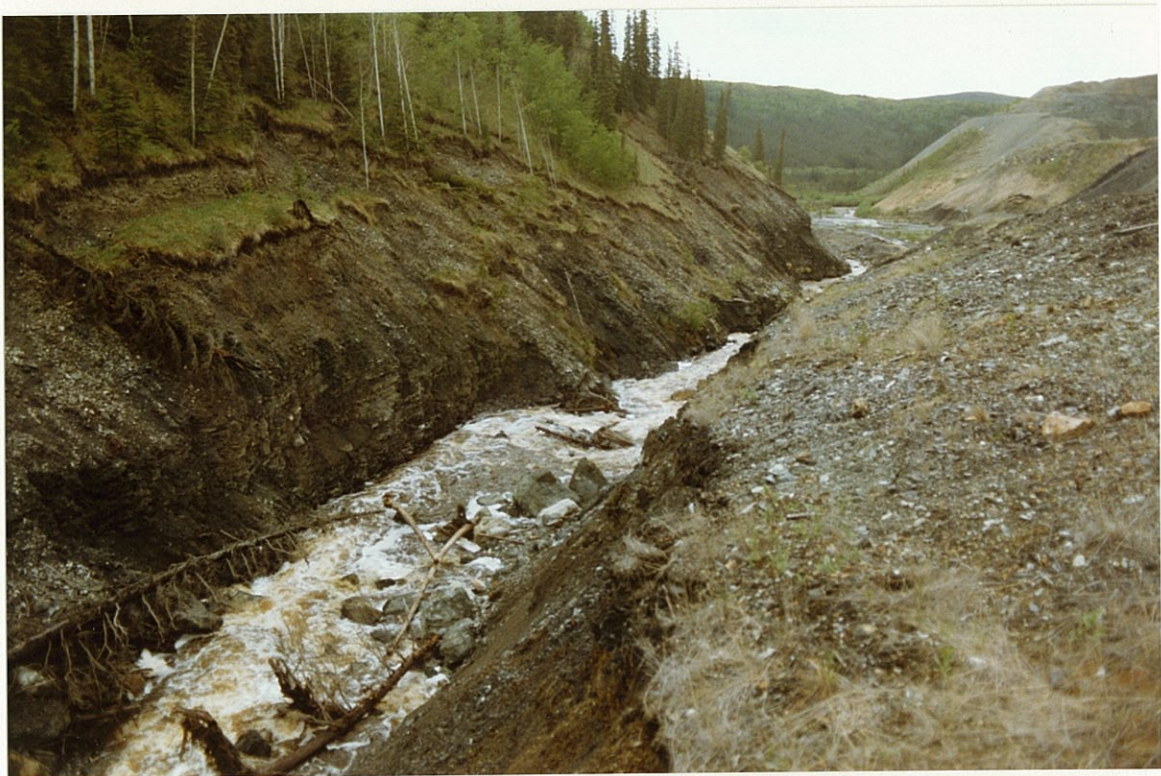
Photo 6: Waste dump channel looking downstream. Note left bank is protected by bedrock and stream bottom is armoured by large boulders from waste dump. June 1985.

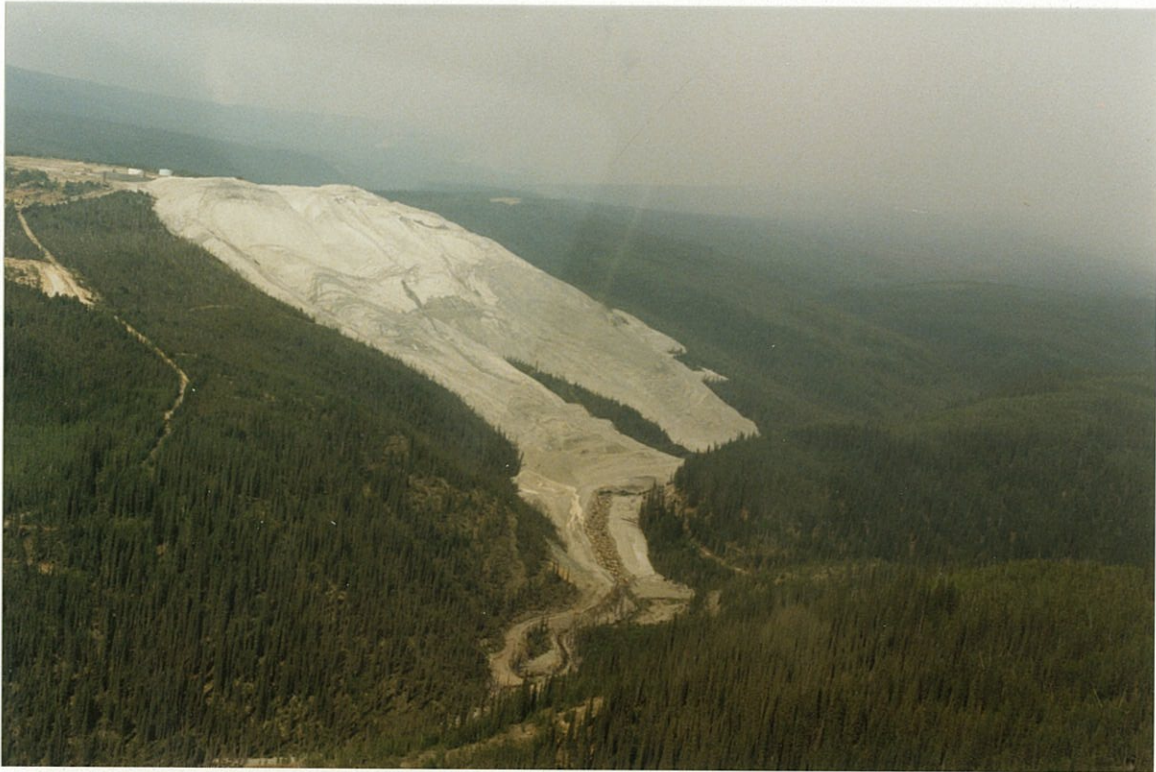
Photo 7: Wolverine Creek tailings piles looking upstream (north).  
July 1986.

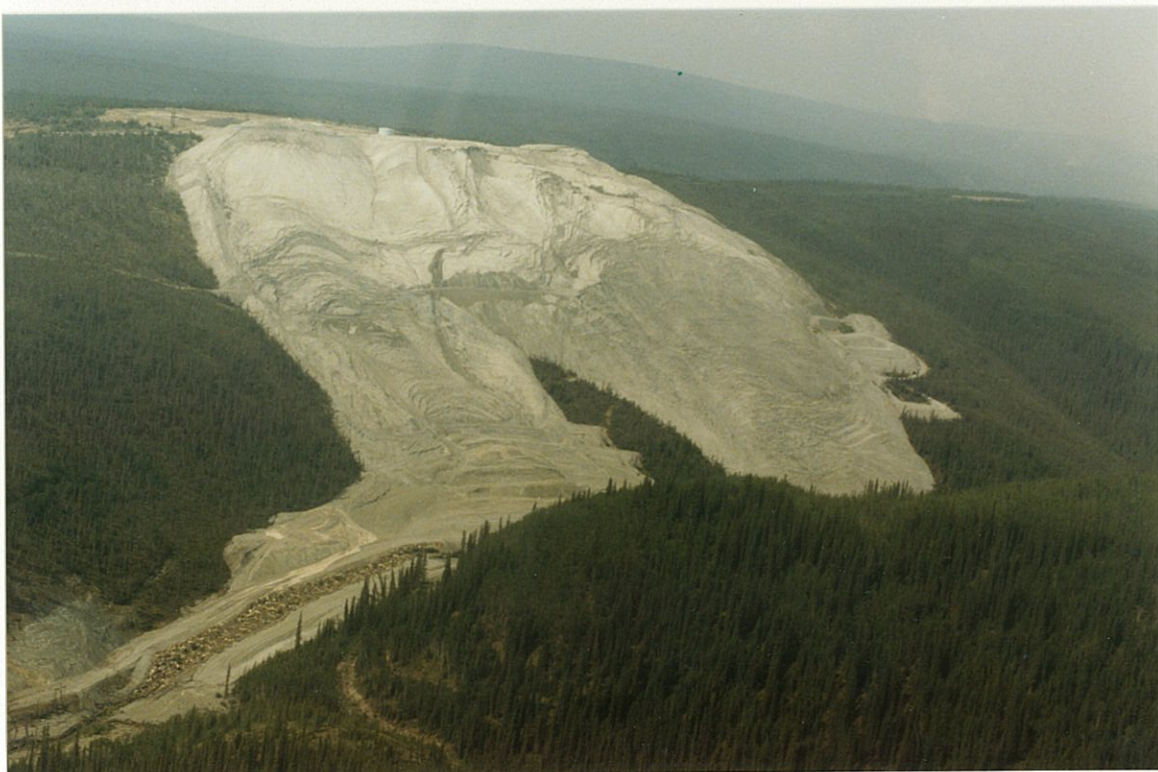
Photo 8: Wolverine Creek tailings piles looking northwest. July 1986.

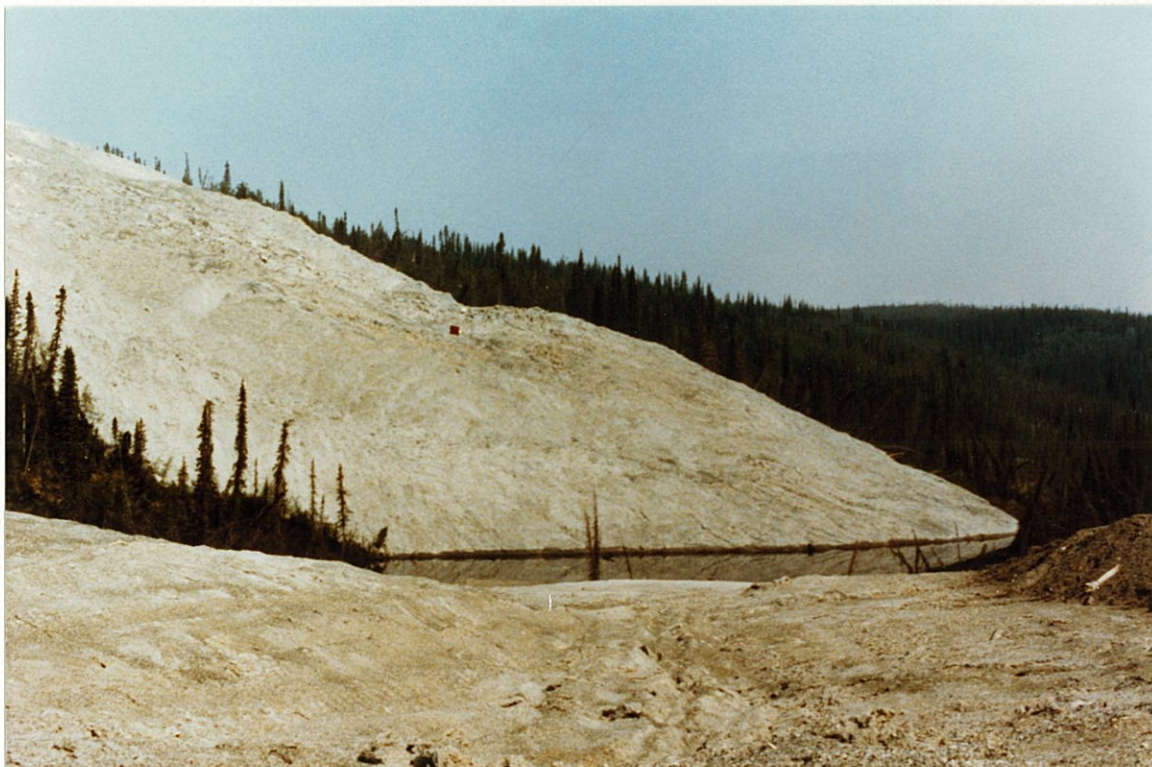
Photo 9: Toe of north tailings lobe. July 1986.

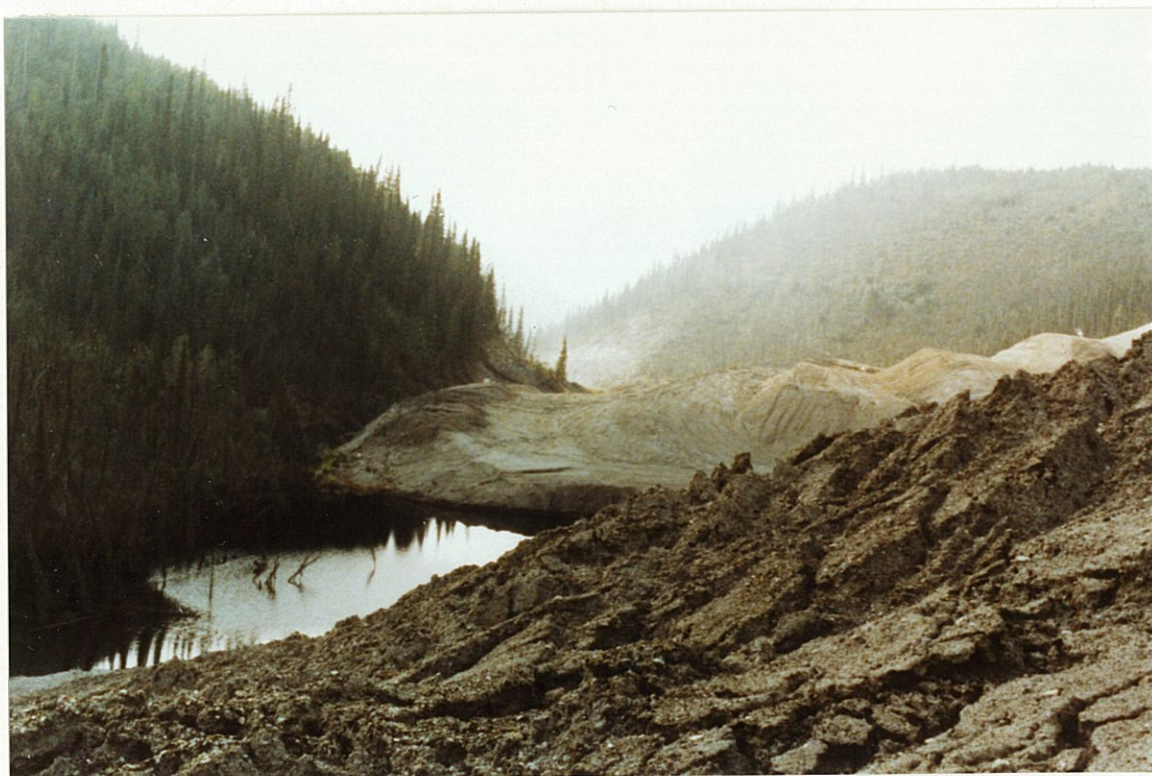
Photo 10: Toe of south tailings lobe. July 1986.
