Anvil Range Mining Complex Additional Borrow Studies 2005/06 Task 17a

Prepared for
Deloitte and Touche Inc.

On behalf of
Faro Mine Closure Planning Office

September 2006

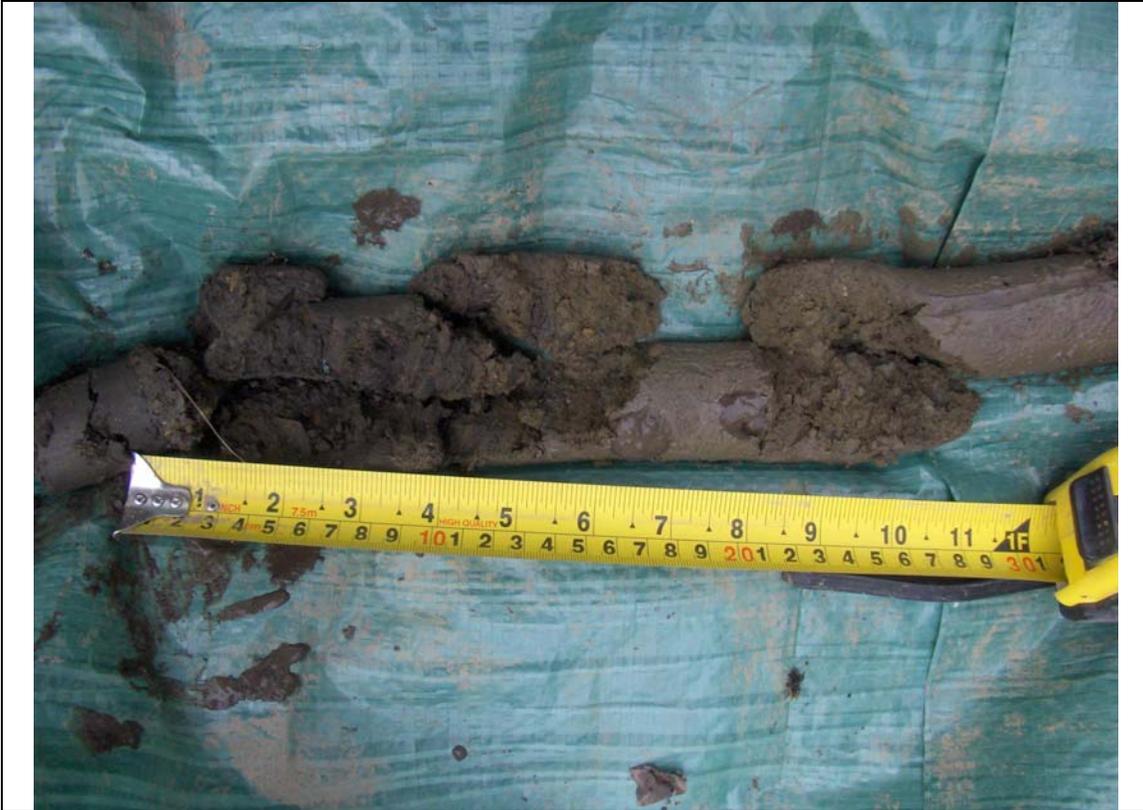
Borehole Log: B-AD-01

Interval (m)		Soil type	Soil description	Notes
From	To			
0.0	0.2	Peat	Top organic soil cover. Peat, black.	
0.2	3.1	Sandy-silty clay	Sandy-silty clay (fine to coarse sand), with fine to coarse, sub-angular to sub-rounded gravel, brown-gray, with low plasticity, damp.	Clayey till.

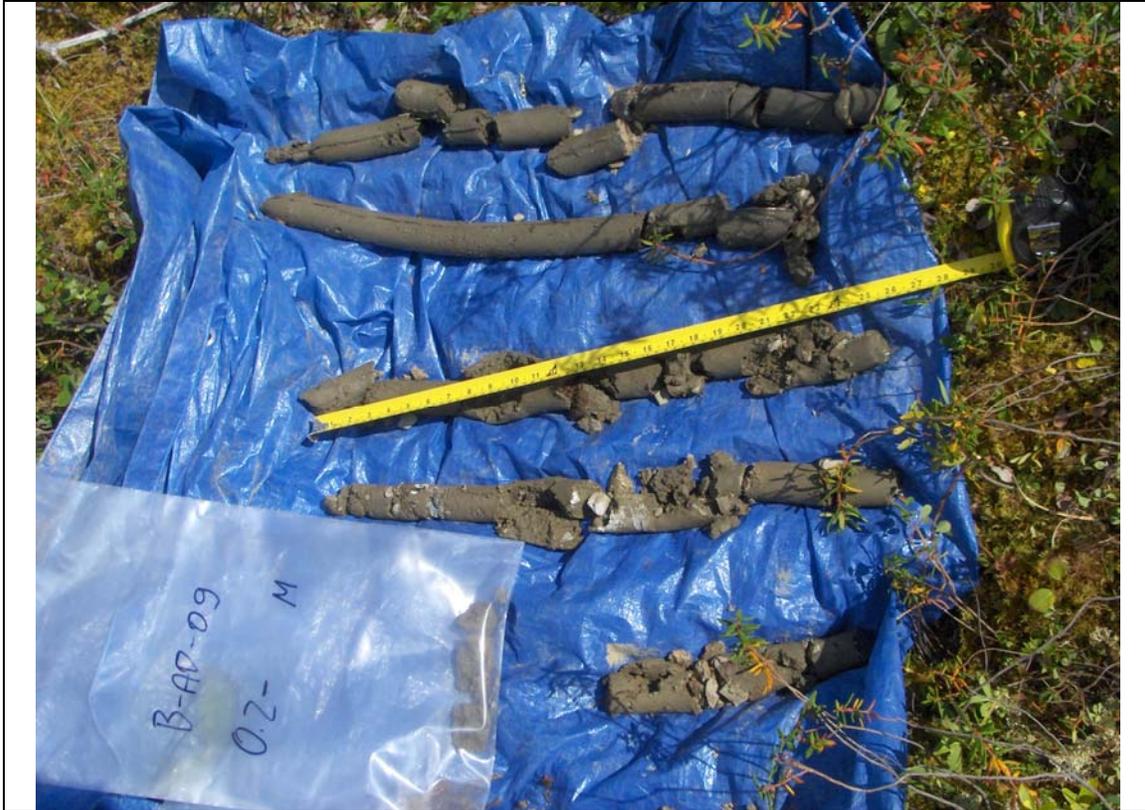
Borehole Log: B-AD-09

Interval (m)		Soil type	Soil description	Notes
From	To			
0.0	0.20	Peat+sand	Top organic soil cover. Peat, black. Fine to coarse sand from 0.15 to 0.2m.	
0.20	6.1	Sandy clayey silt	Sandy-clayey silt (fine to coarse sand), with minor fine to coarse, sub-angular to sub-rounded gravel, gray, damp, with low plasticity.	High fine-content till.

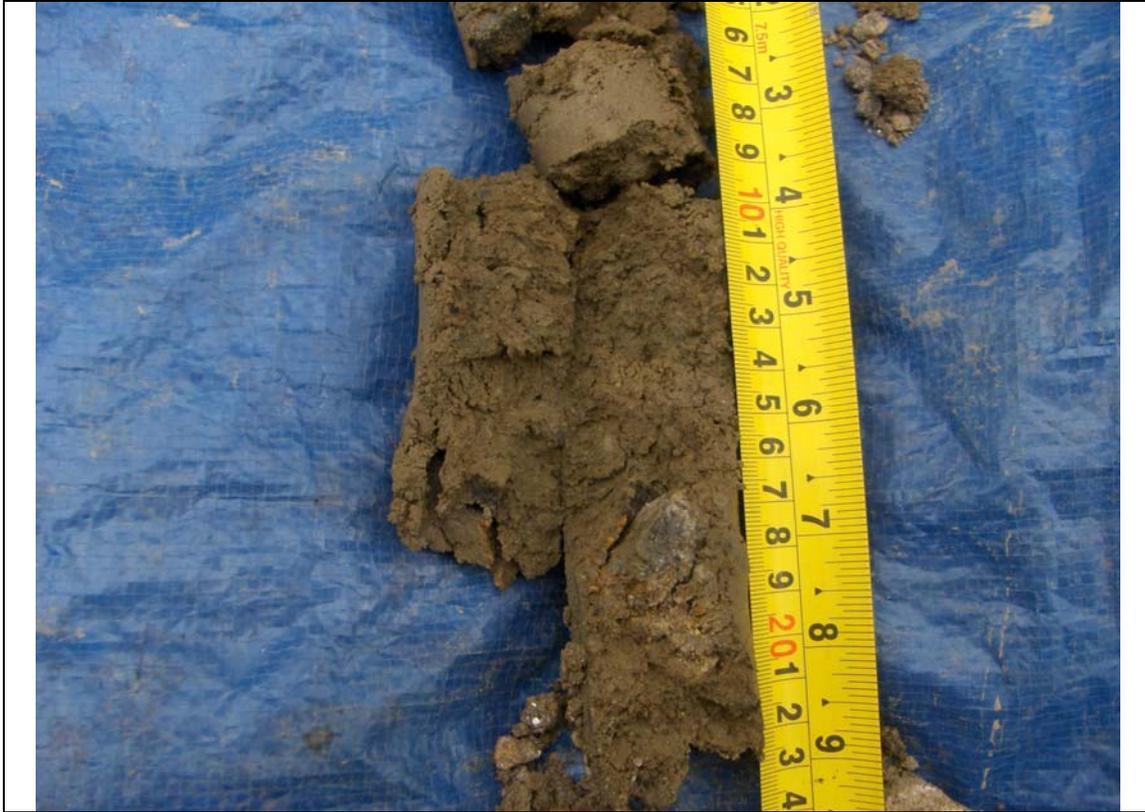
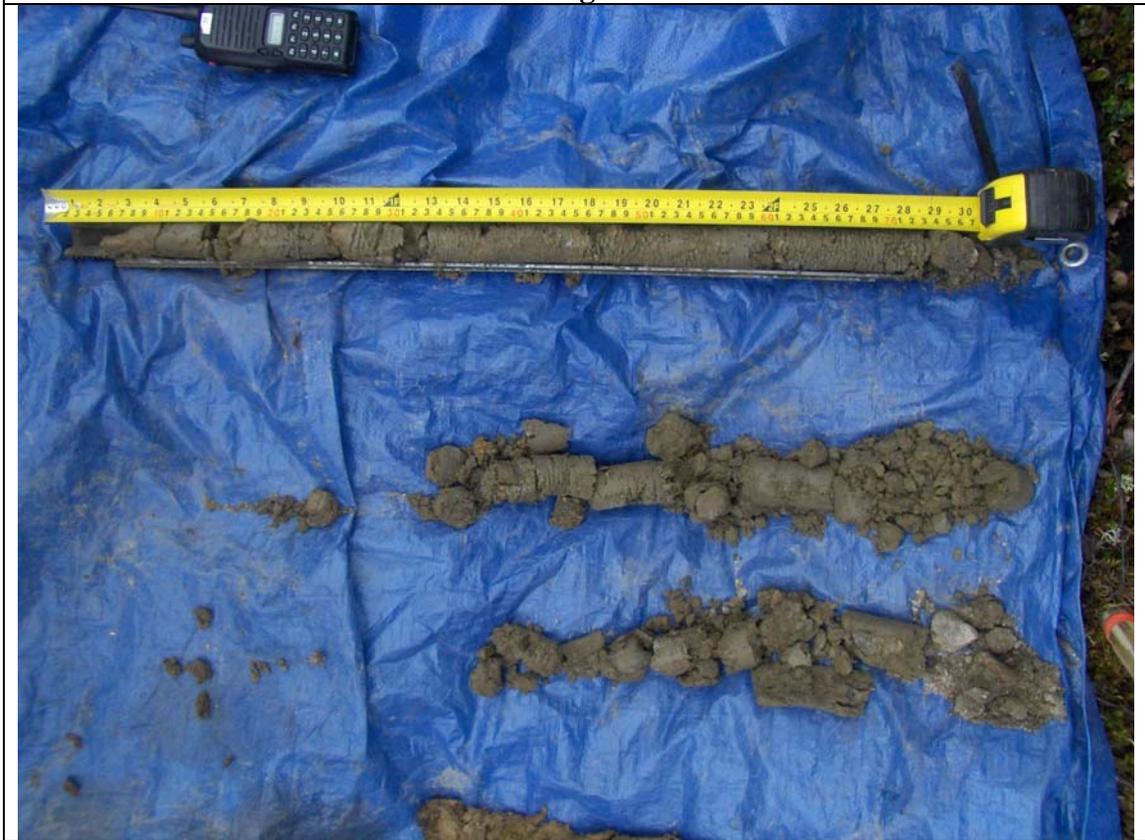
Borehole Log: B-AD-12

From	To	Soil type	Soil description	Notes
0.0	0.2	Silty sand	Silty fine to coarse sand, poorly sorted, brown, loose, damp.	
0.2	0.9	Silty-clayey sand	Silty-clayey fine to coarse sand, poorly sorted, with minor fine, sub-angular gravel, brown loose, damp.	
0.9	3.0	Silty-clayey sand	Or sandy-clayey silt (?). As above, with increased amount of fine to coarse gravel, brown-gray, damp.	Sandy till. Locally higher fines (clay) content levels.
