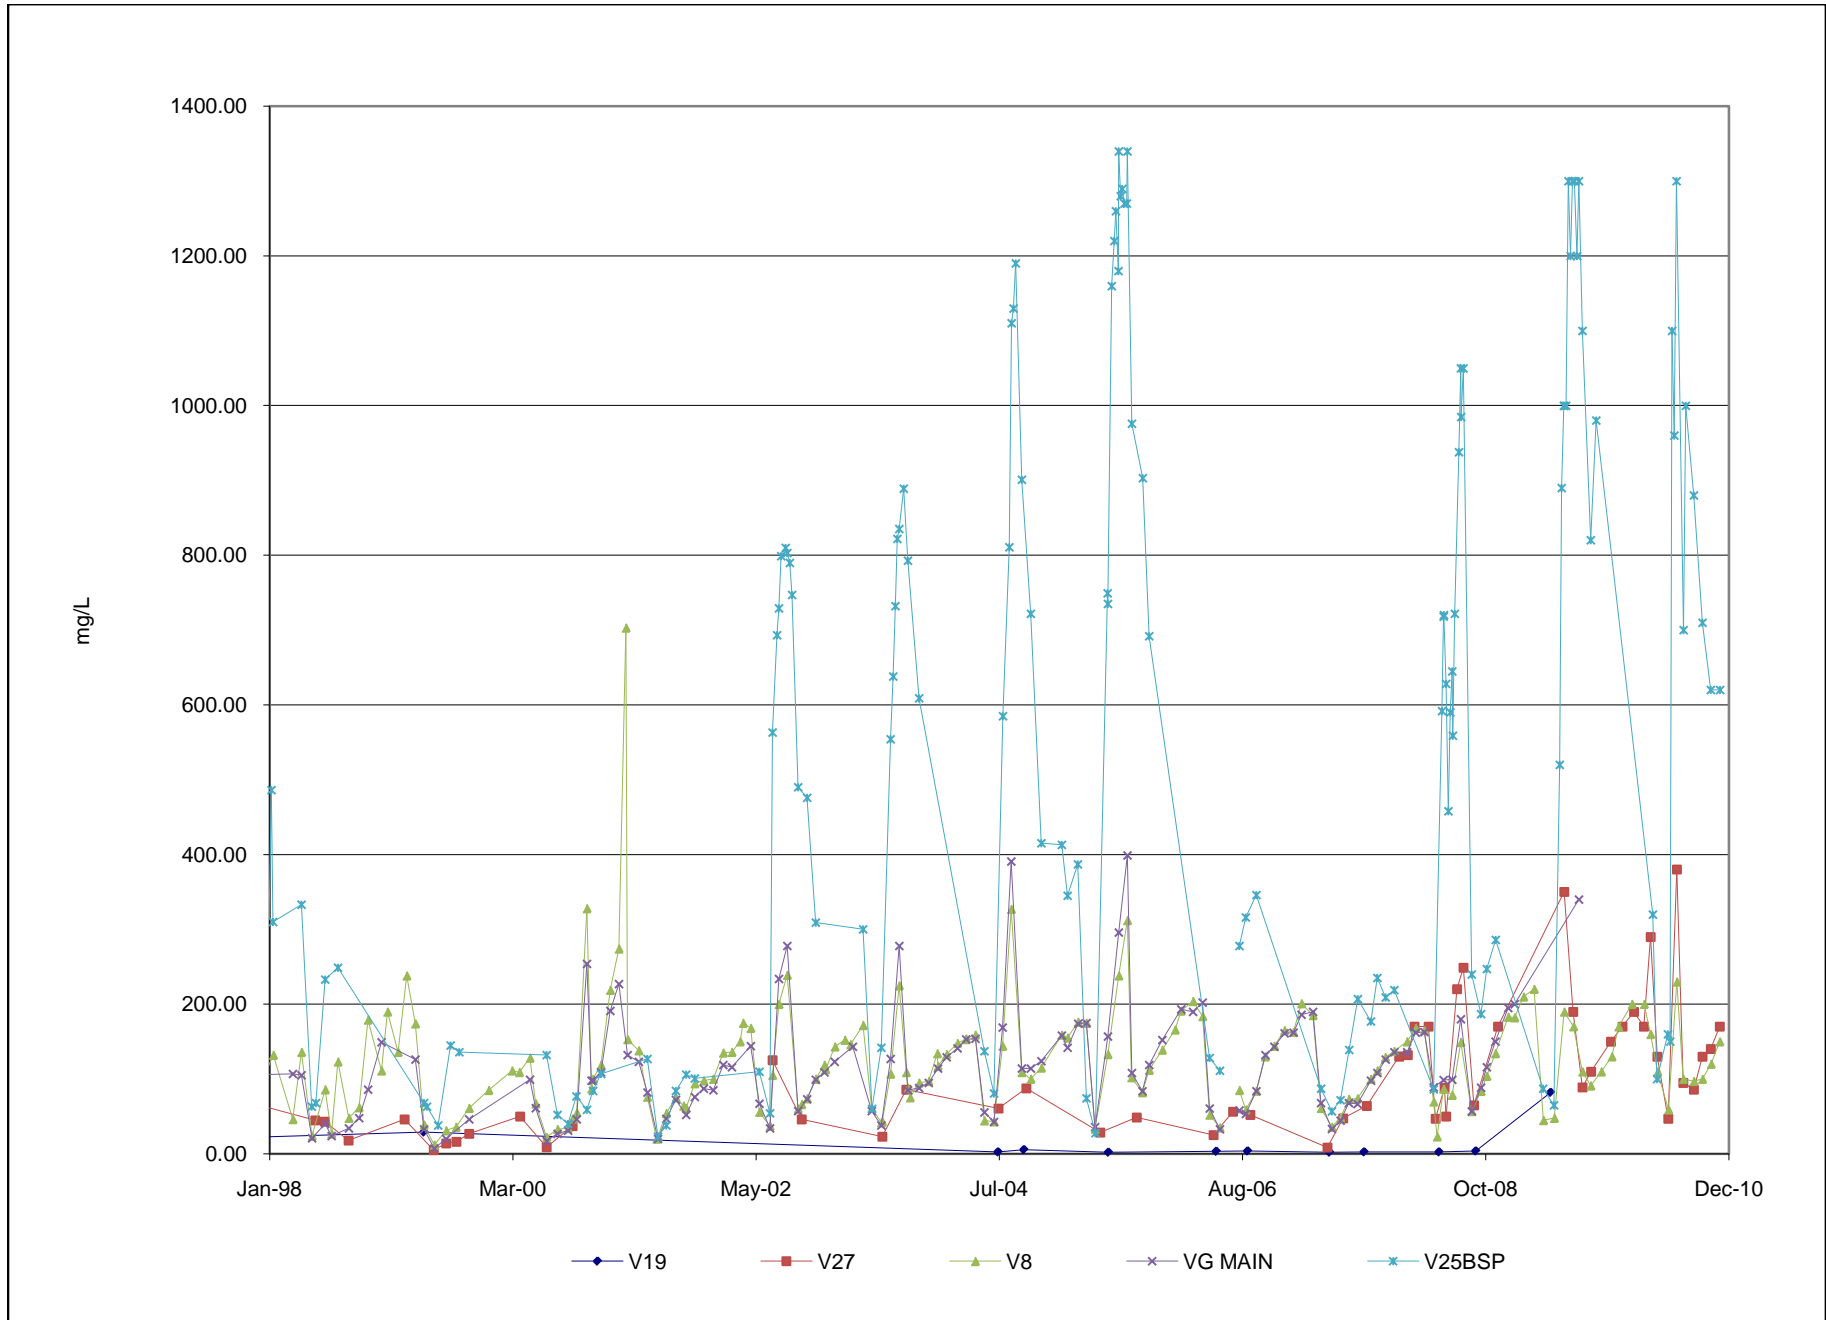
Figure 3-2: Sulphate in Vangorda Creek
(V19, V27, V8, VG Main + V2BSP) (1998-2010)

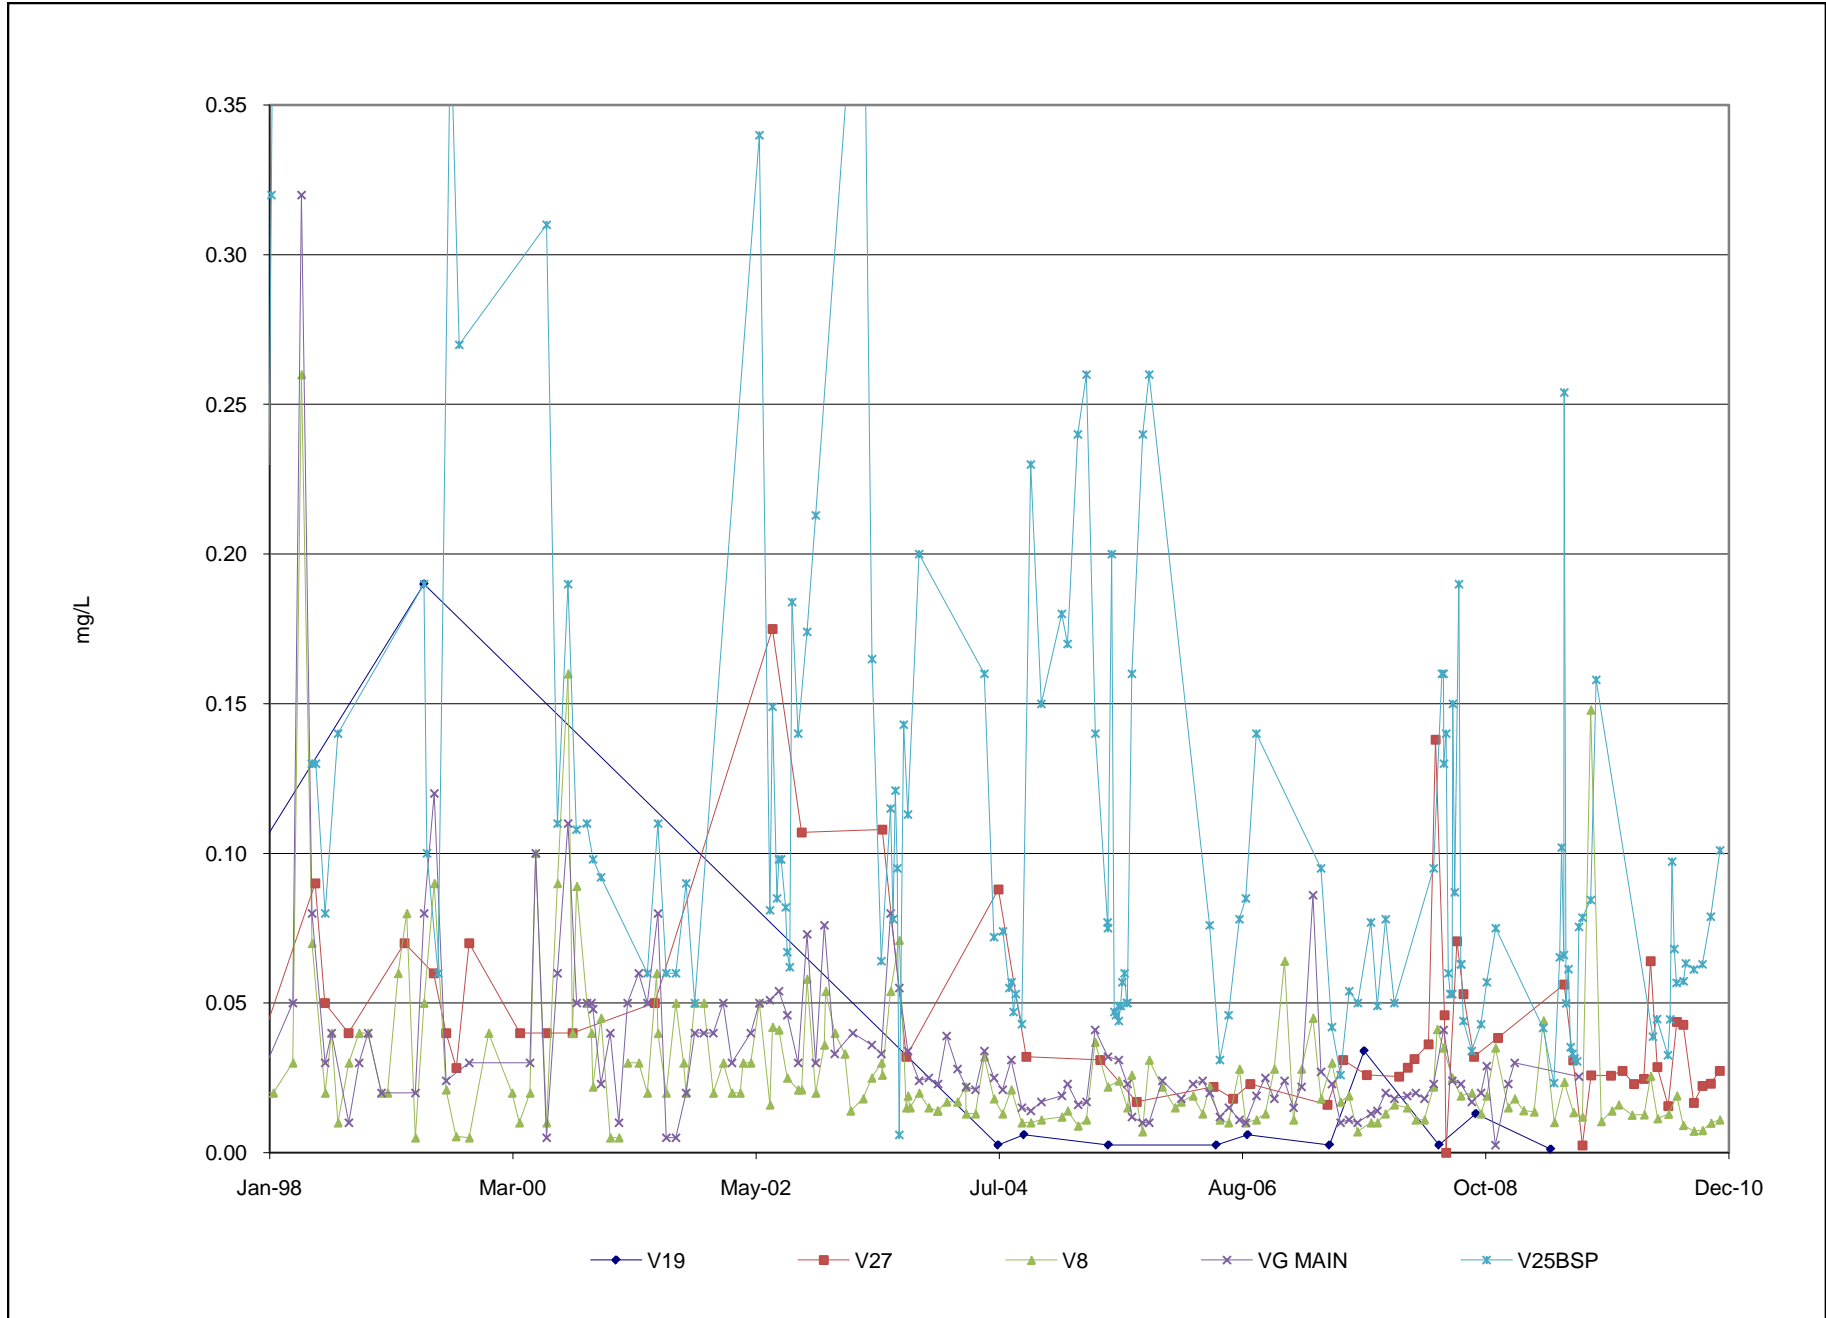
Figure 3-6: Zinc (Total) in Vangorda Creek (V19, V27, V8, VG Main + V2BSP) (1998-2010)
