**AQUATIC LIFE SAMPLING AND TESTING PROGRAM
FOR THE ANVIL RANGE MINE SITE,
ROSE AND VANGORDA CREEK WATERSHEDS,
FARO, YUKON**

Conducted: During August, 2009

**Prepared for
Type II Mines Department, YTG
And
Selkirk First Nation**

Prepared by: White Mountain Environmental Consulting, Whitehorse, Yukon
Paul Sparling and Martin Crill
March, 2012

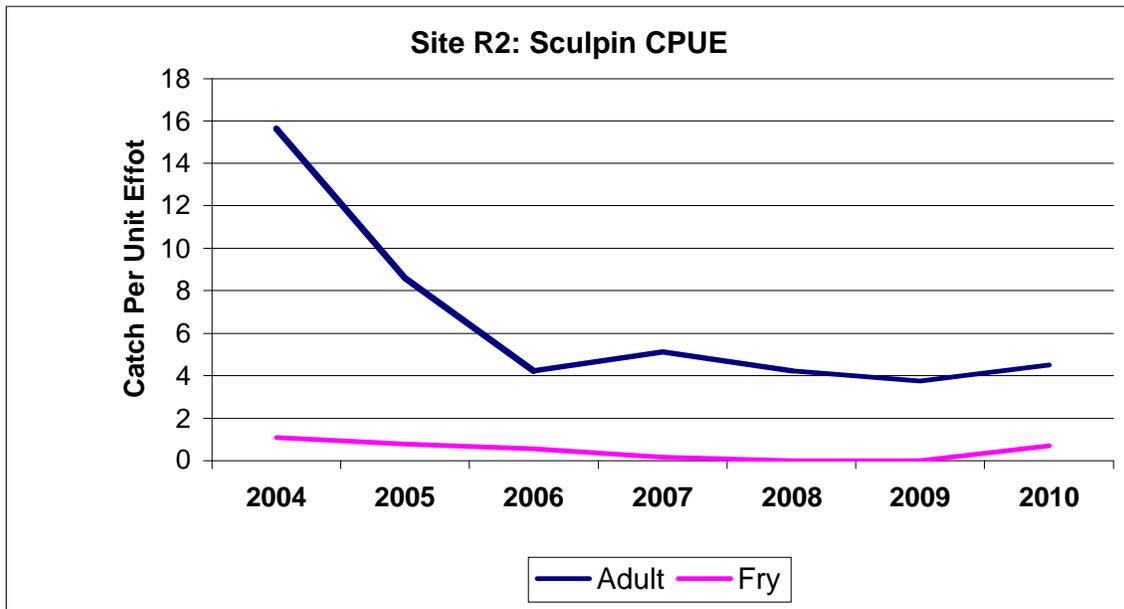
Figure 3: Sculpin catch per unit of effort (fish per 100 seconds) for electro-fishing at R2 for the seven year sample period

Electro-fishing at R2 consisted of 710 seconds of effort and was conducted through the 100 meter sample reach; the amount of time shocked typical of previous efforts. Fish recorded by electro-fishing consisted of 32 adult and 5 fry slimy sculpin and 3 burbot (Table 1). The sculpin catch was consistent with catches at this site for the past 5 years. (Figure 3).

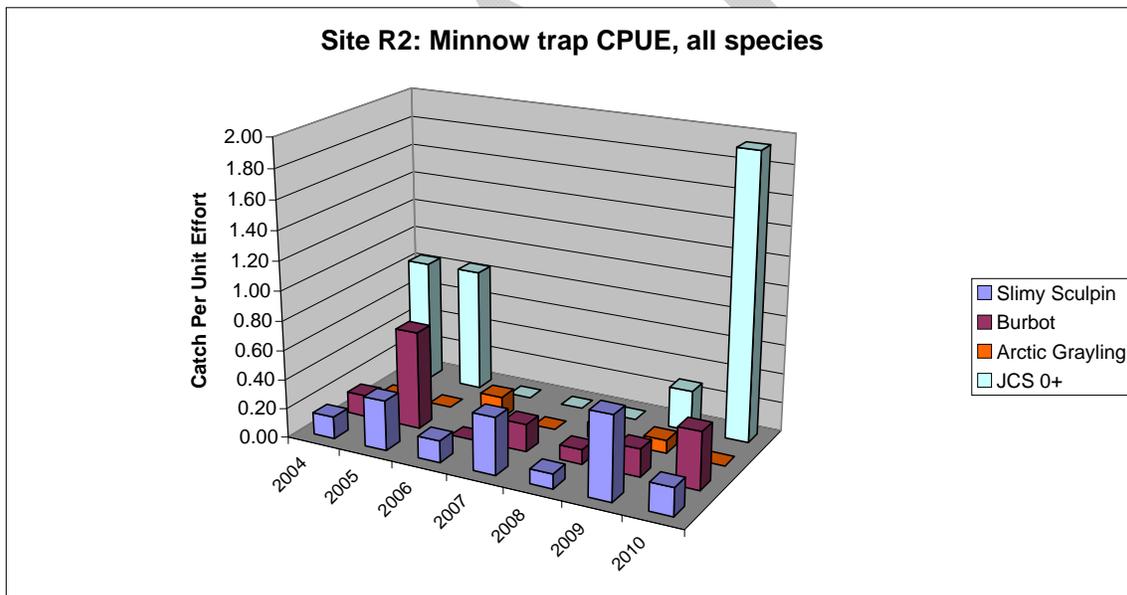
Figure 4: Multi year minnow trap data for site R2, 2010 had the greatest jcs catch of any of the years of sampling.

Minnow trapping at site R2 consisted of 8 traps set for an average soak time of 17 hours each. The total catch from the minnow trapping consisted of 1 adult slimy sculpin, 10 jcs and 2 burbot (Table 2). The minnow traps set at R2 were all set downstream of the confluence of the tailings pond channel with Rose Creek. Although sculpin catches were slightly lower than average the jcs catch was the largest jcs catch by minnow traps at this site in any of the years of sampling (Figure 4).

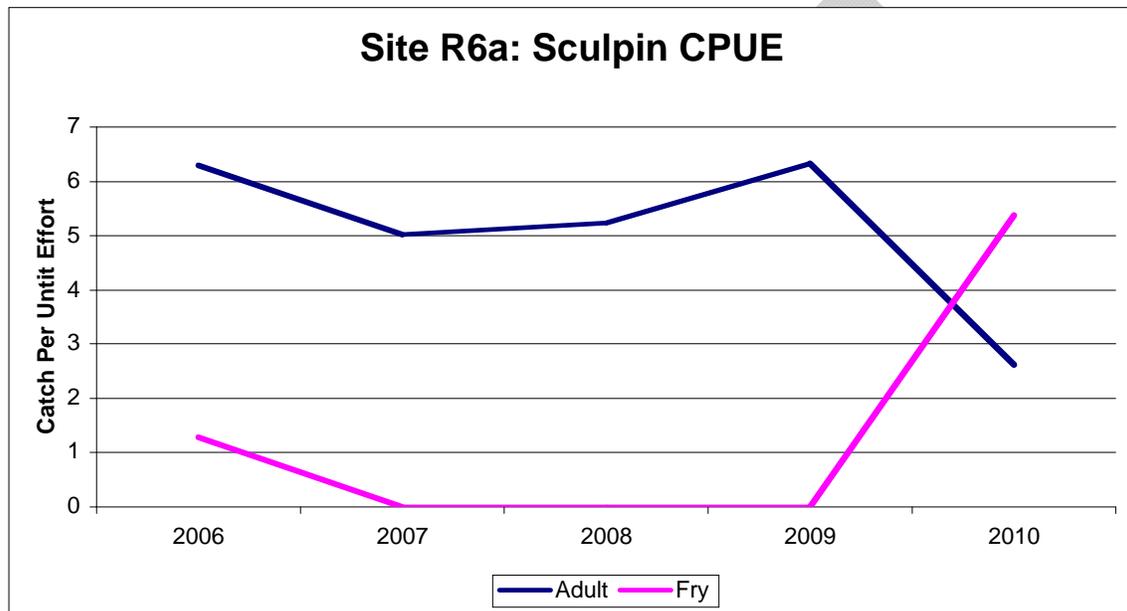
Figure 5: Sculpin catch per unit of effort (fish per 100 seconds) for electro-fishing at R6a for the entire seven year sample period.

Fishing effort was extended through the entire reach. Electro-fishing was conducted along the shoreline areas of both banks and in the shallow side flow on the right bank and covered similar areas to previous investigations. A total of 725 seconds of effort recorded 3 adult slimy sculpin and 39 fry (Table 1), this was a significant decrease in adult numbers and an increase in the number of fry recorded (Figure 5).

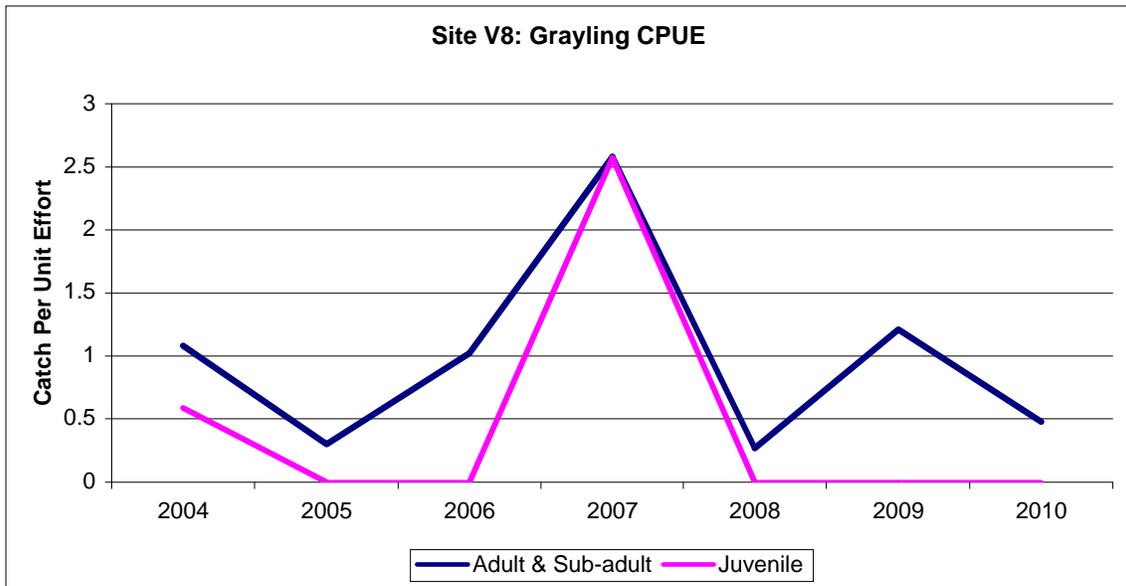
Figure 6: Grayling catch per unit of effort (fish per 100 seconds) for electro-fishing at V8 for the seven year sample period.

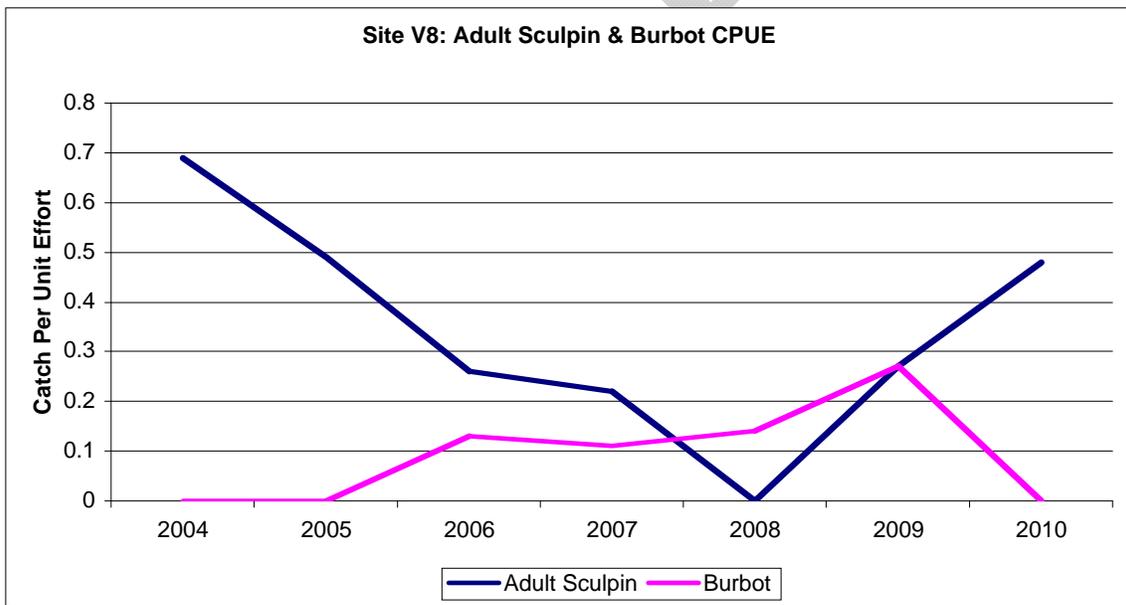
Figure 7: Sculpin and burbot catch per unit of effort (fish per 100 seconds) for electro-fishing at V8 for the seven year sample period

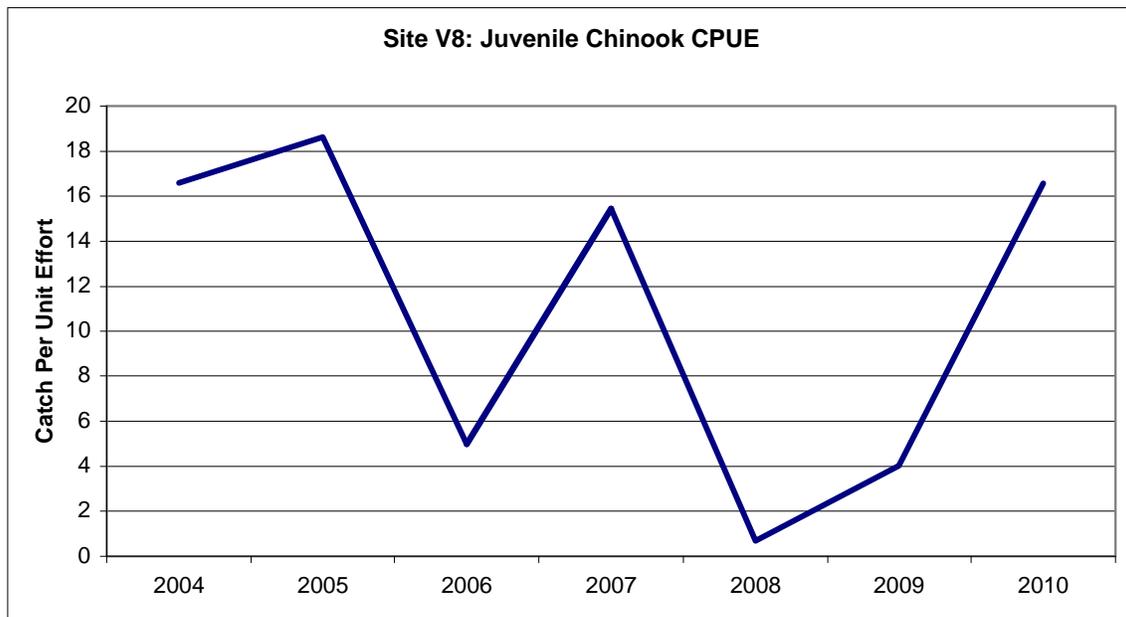
Figure 8: Sculpin catch per unit of effort (fish per 100 seconds) for electro-fishing at V8 for the seven year sample period.

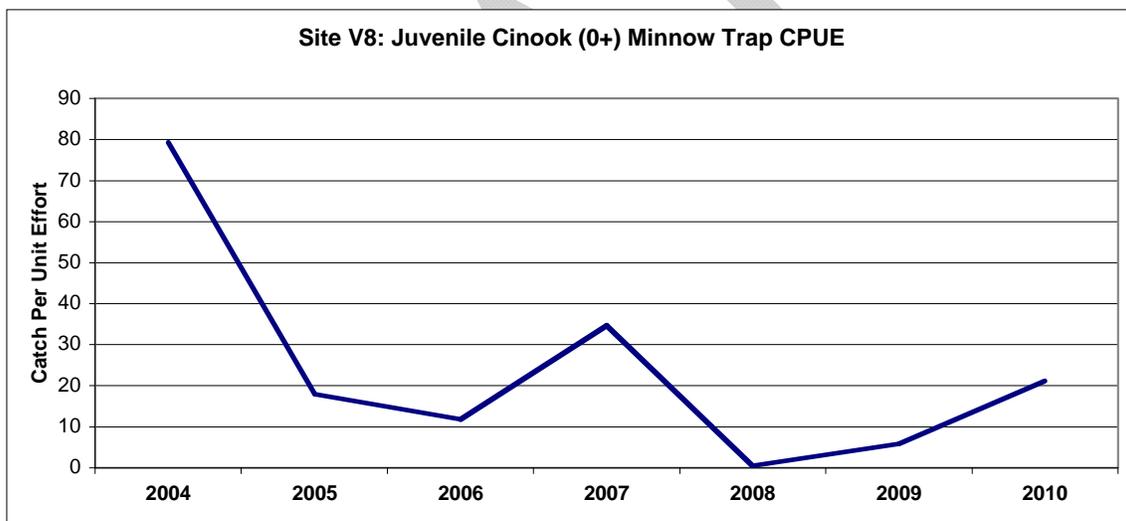
Figure 9: Minnow trap catches for site V8 on Vangorda Creek for each of the seven years of sampling.

Minnow trapping at site V8 consisted of 8 traps set for an average soak time of 19 hours each. The total catch from the minnow trapping consisted of 134 jcs, representing an increase from 2009 (Table 2). Although the jcs catches were significant they were average for the 7 years of sampling (Figure 9).

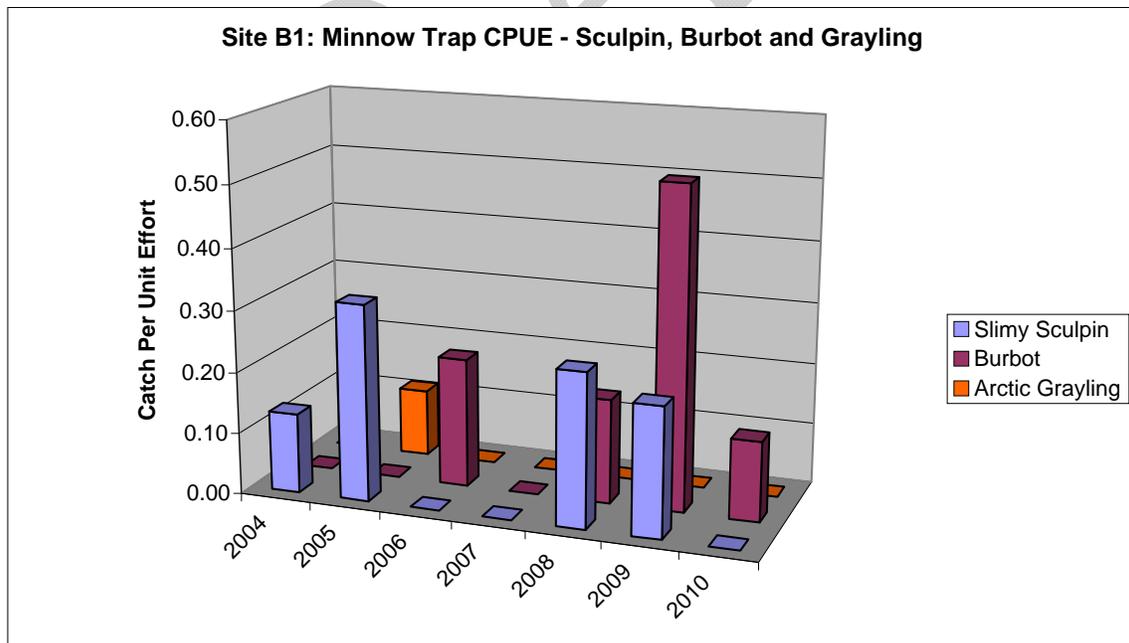
Figure 10: Multi-year minnow trap catches from Blind Creek for slimy sculpin, burbot and Arctic grayling.

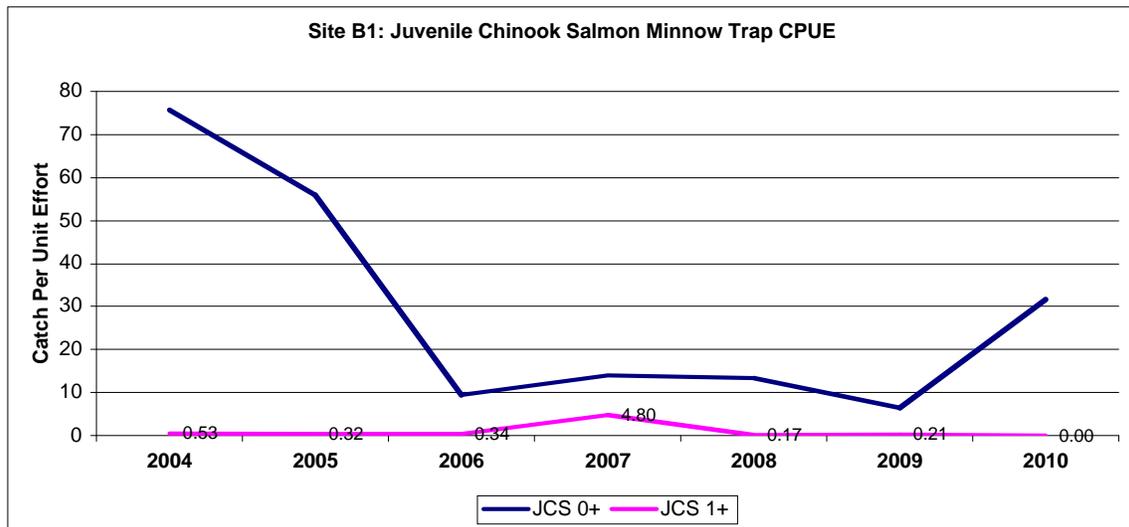
Figure 11: Multi-year minnow trap jcs catches from sets made on Blind Creek.

Extra minnow traps were set in Blind Creek to match effort extended in previous years. A total of 16 minnow traps were set in the sample reach for an average soak time of 16 hours each (Table 2). The catch consisted of 1 burbot, 150 jcs (0+) and 3 jcs (1+), which was an increase from catches in the past 4 years but not as high as in 2004 and 2005.

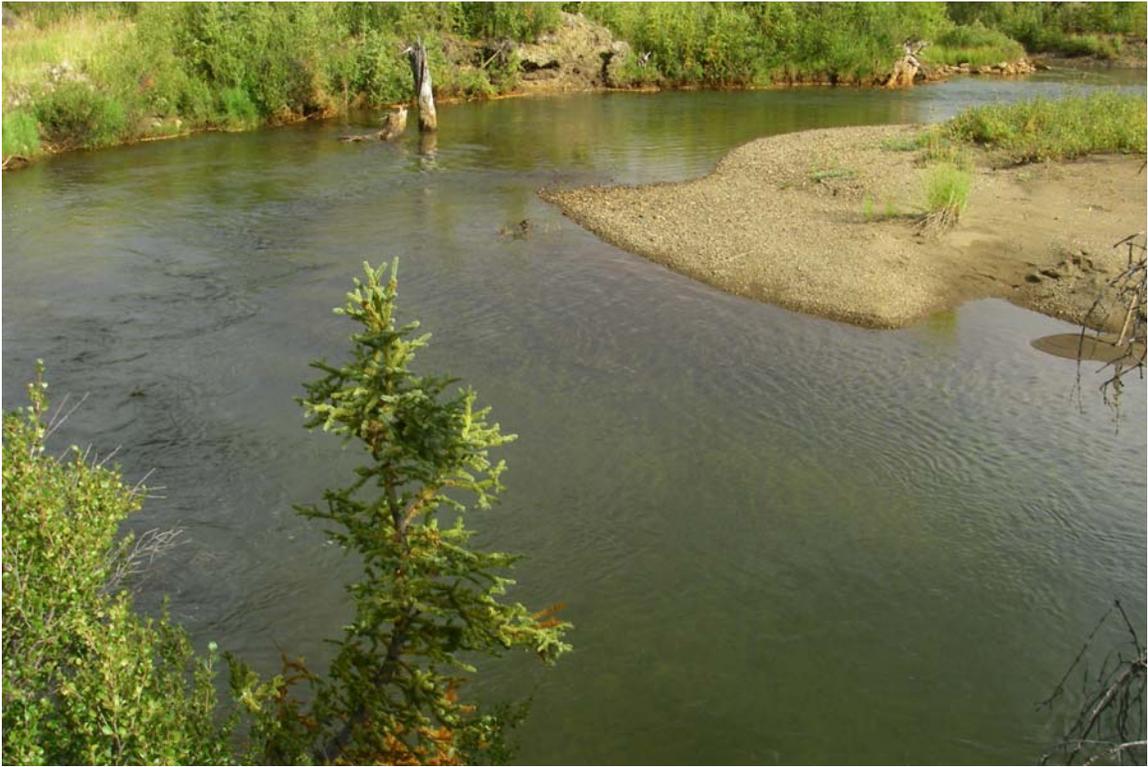
Photo 3: Rose Creek at site R2 during August of 2009. The discharge from the treatment pond can be seen in the upper right corner of the photo.

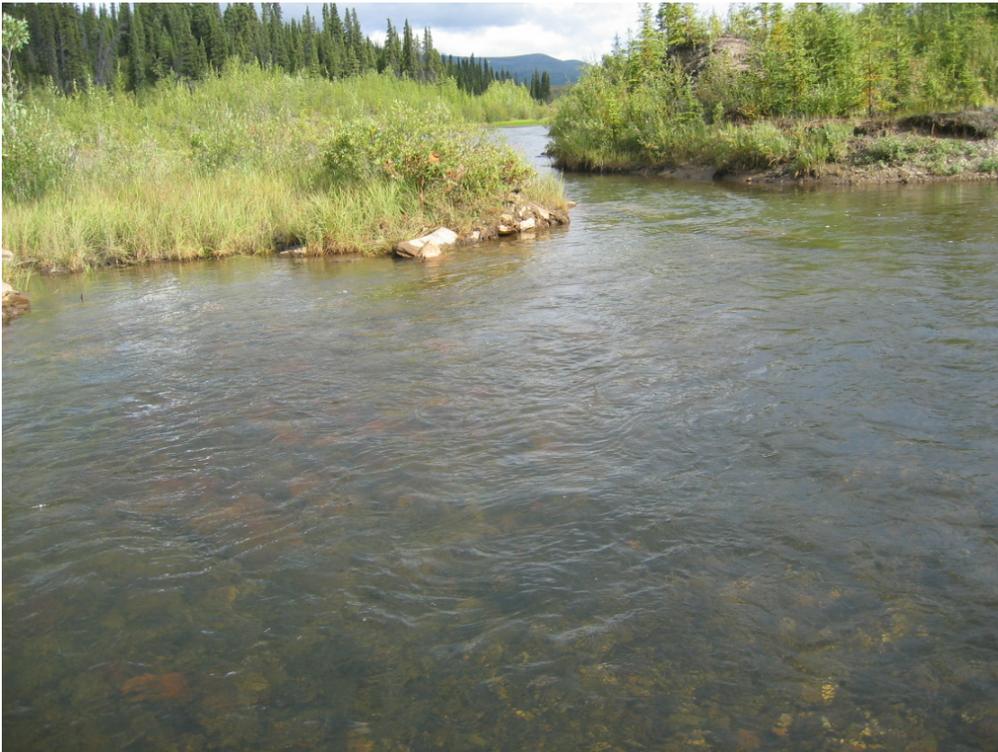
Photo 4: The tailings pond discharge channel entering Rose Creek at the upstream end of the sample reach site R2 during August, 2008. The foreground of this photo was out of the water in 2009.

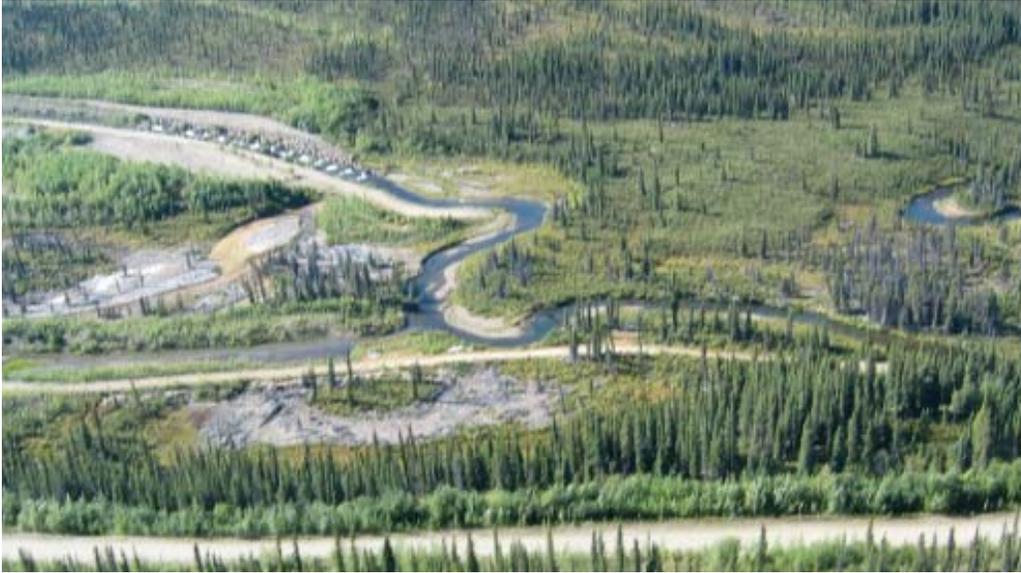
Photo 5: Site R2, Rose Creek. The downstream end of the diversion channel flows in to the photo from the right upstream of the out flow of treated water and the sample site. August 2007. The sample site begins at the outflow and continues downstream to the right margin of the photo.

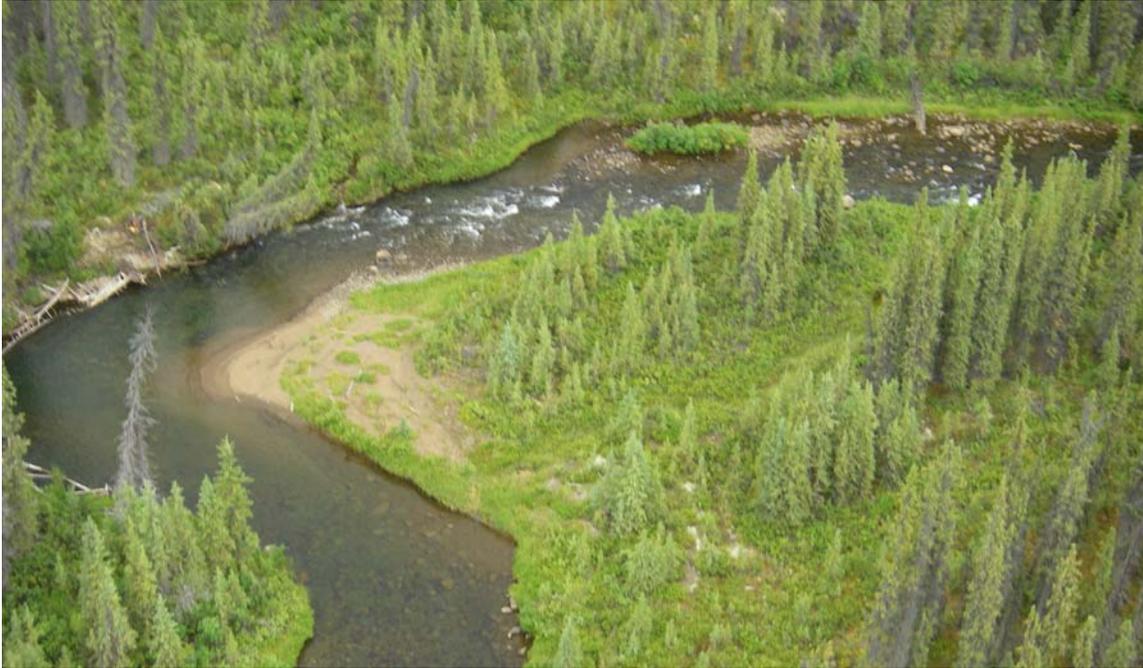
Photo 9: Anvil Creek at site R6A during August of 2009. Note the amount of exposed channel compared to the 2008 photo below.

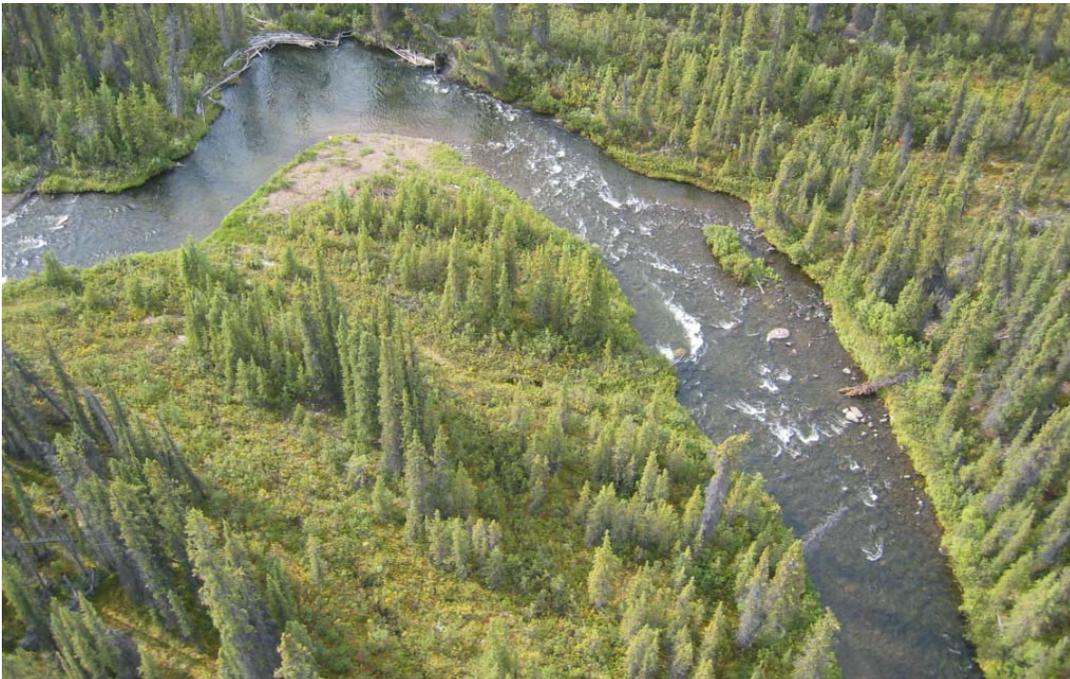
Photo 10: Reach R6a sample site, flowing right to left. August, 2008. The corner pool in the lower end of the reach is the location used to capture Arctic grayling samples.

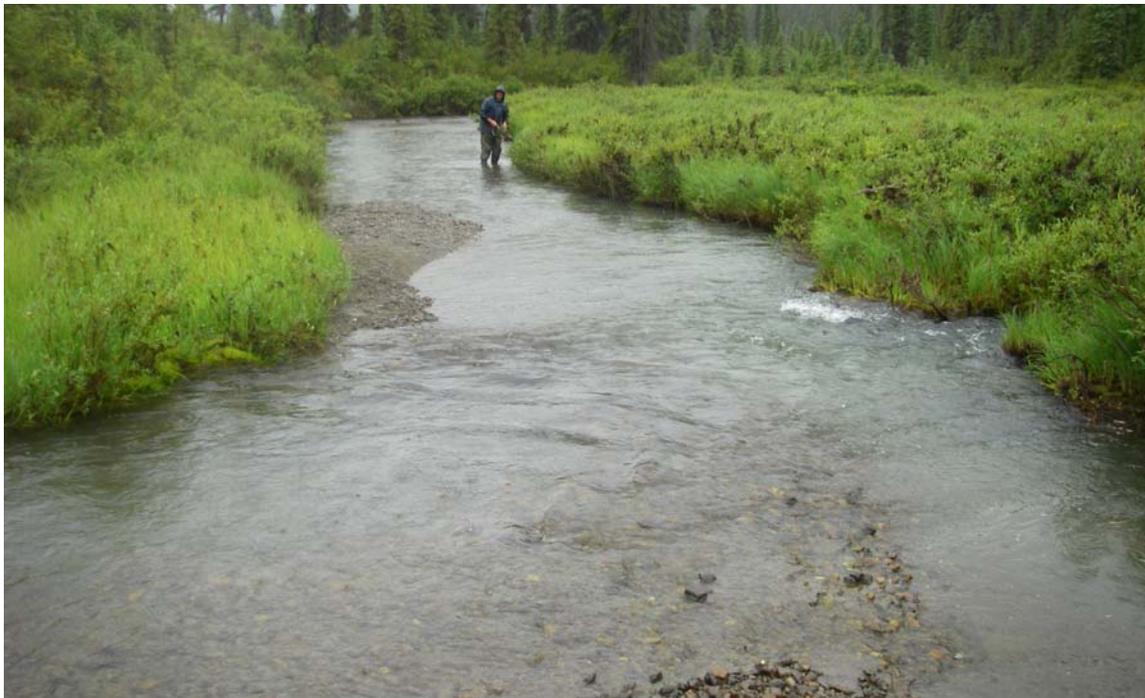
Photo 11: Lower section of sample reach at TV1 during August of 2009. The corner pool at right is 1.8 meters in depth and had numerous juvenile and sub adult Arctic grayling.

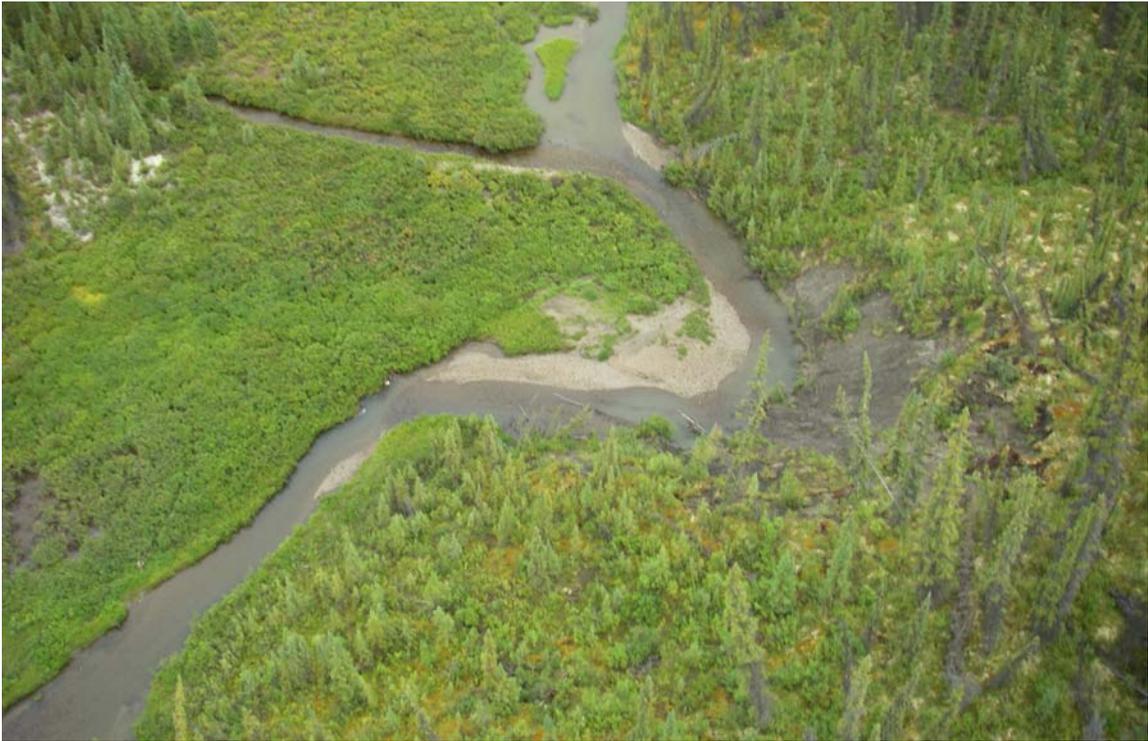
Photo 12: An aerial view of site TV1 during August of 2009. The sample reach starts just below the tributary and extends to the bottom of the photo. The point bar is an excellent helicopter landing site.

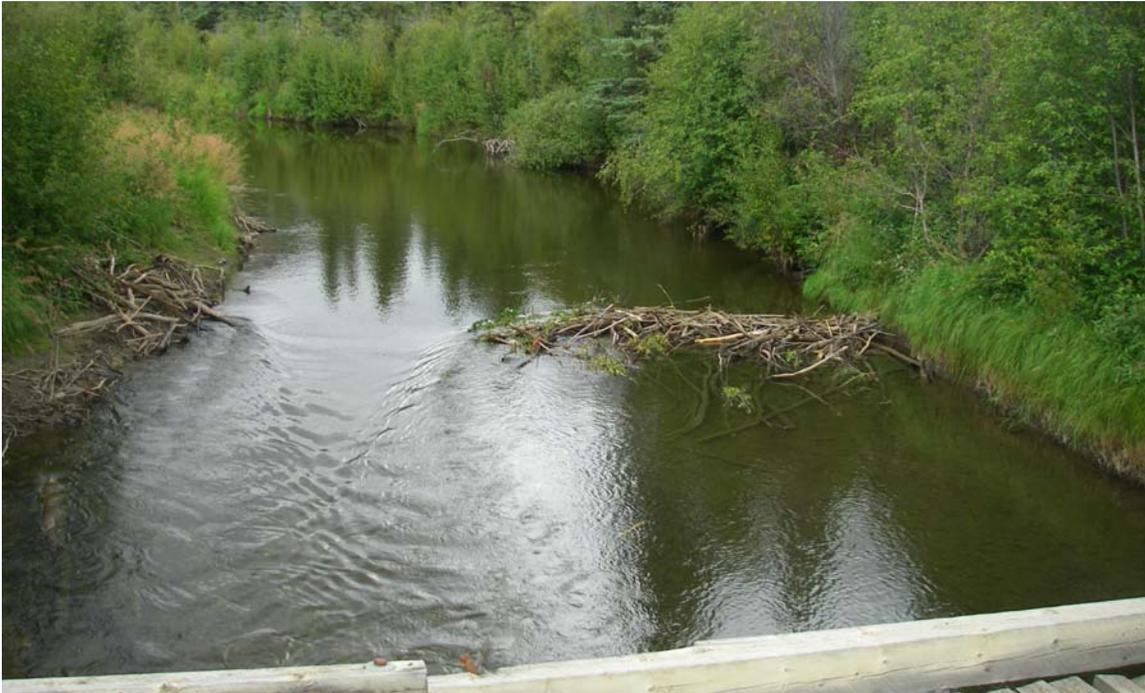
Photo 13: A small, partial beaver dam was built on Blind Creek during August of 2009. The area immediately upstream of the dam on the right side was a chinook spawning redd in previous years. Low flows in 2009 allowed the construction of the dam, in previous years the current would likely have washed the dam out.

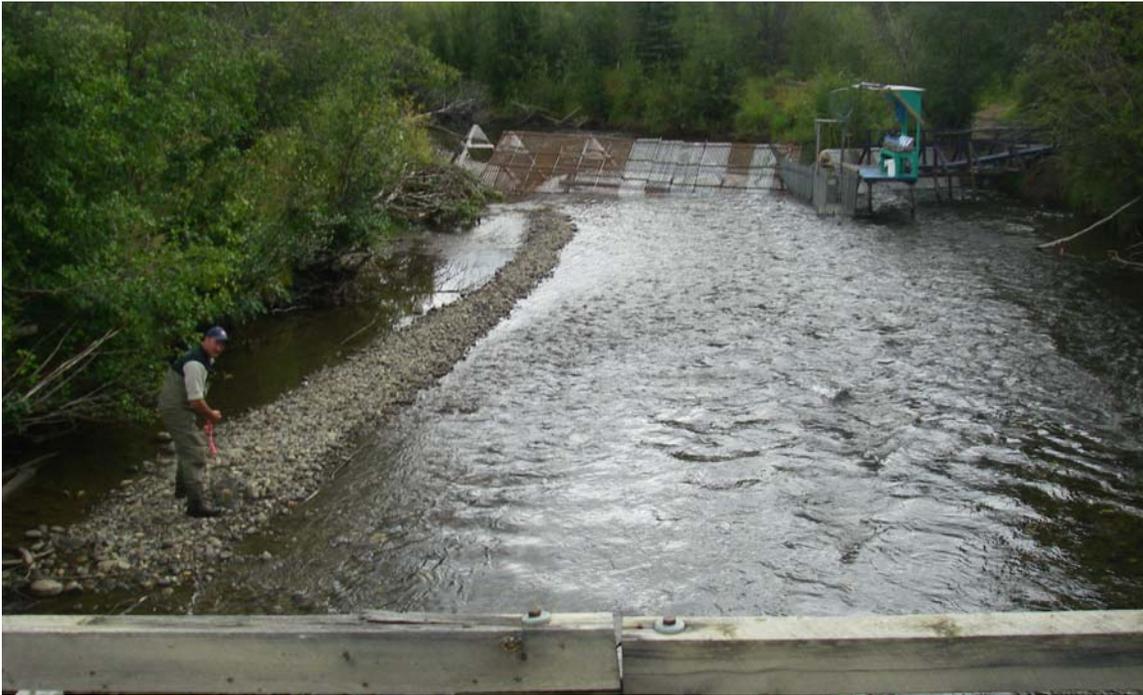
Photo 14: Collecting minnow traps in Blind Creek downstream of the bridge and upstream of the enumeration weir during August of 2009. The gravel bar Martin is standing on was created during the summer of 2009 by the beaver dam upstream of the bridge.

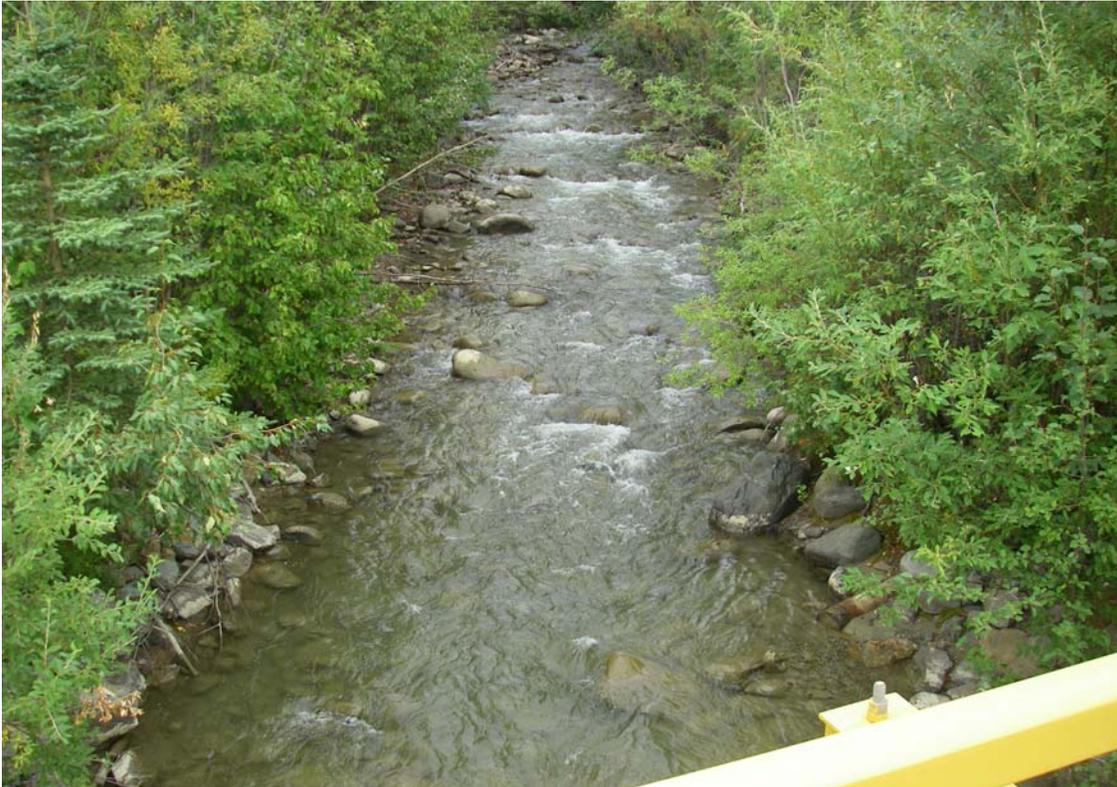
Photo 15: Vangorda Creek in 2009, low flows exposed considerable channel materials and the water was mostly clear.

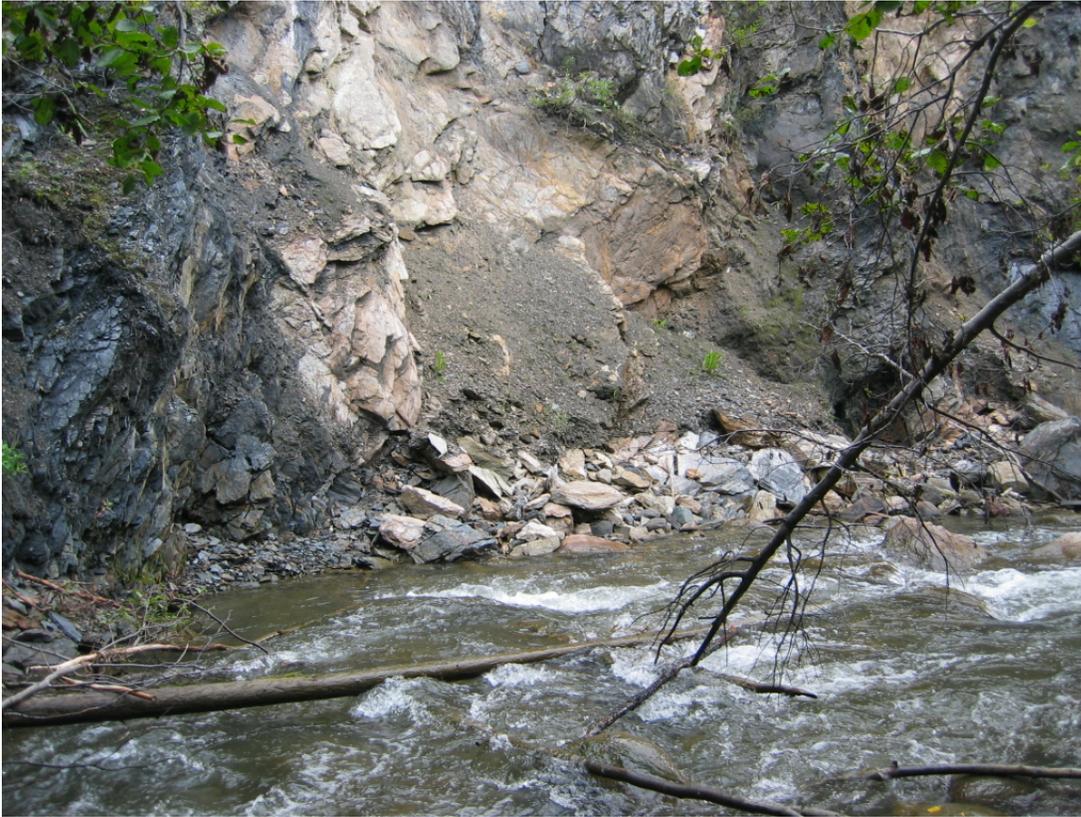
Photo 16: Rock slide at the upstream end of Vangorda Creek site V8 sample site during 2008. The materials that slid are surrounded by mineralized materials visible on the left side of the photo.

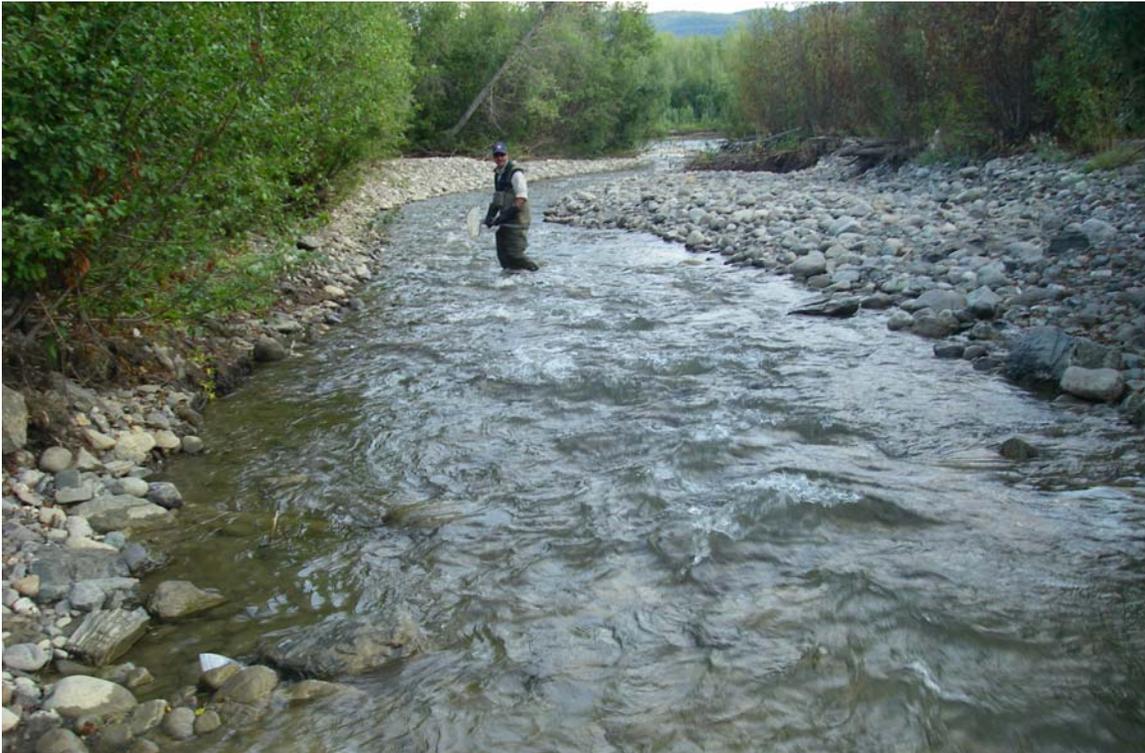
Photo 17: Lower Vangorda Creek during August of 2009. This was the lowest reach sampled for slimy sculpin and had the highest densities of sculpin on Vangorda Creek. The Pelly River is visible at the top of the photo.
