**Brown McDade Waste Rock Pile
Mount Nansen Mine Site, Yukon**

Ecological Restoration Strategy

Assessment and Abandoned Mines Branch
Energy, Mines and Resources
Government of Yukon

March 2009

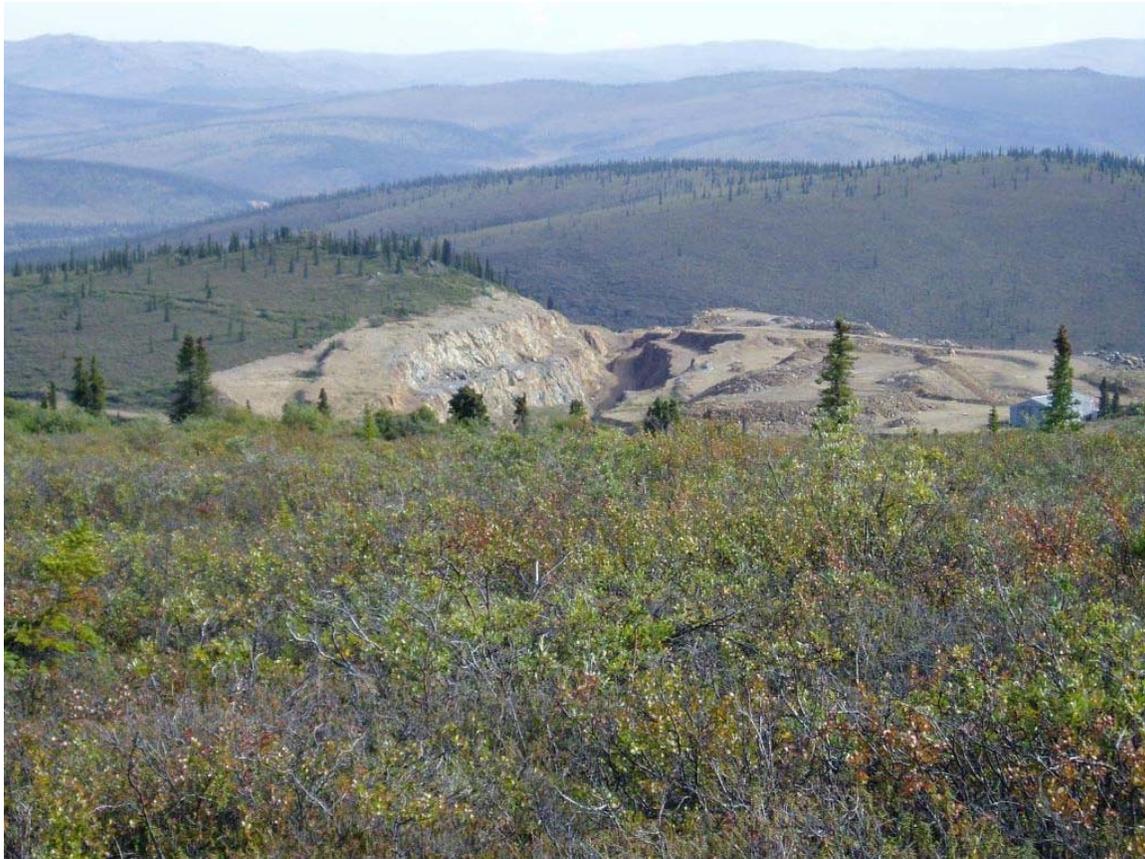
Figure 2.2 View of Mount Nansen area in vicinity of Brown McDade pit and waste rock pile, looking south (from EDI, 2007).

slopes valleys and benchlands where surficial sediments and bedrock have a thick organic or moss cover (Figure 2.2).

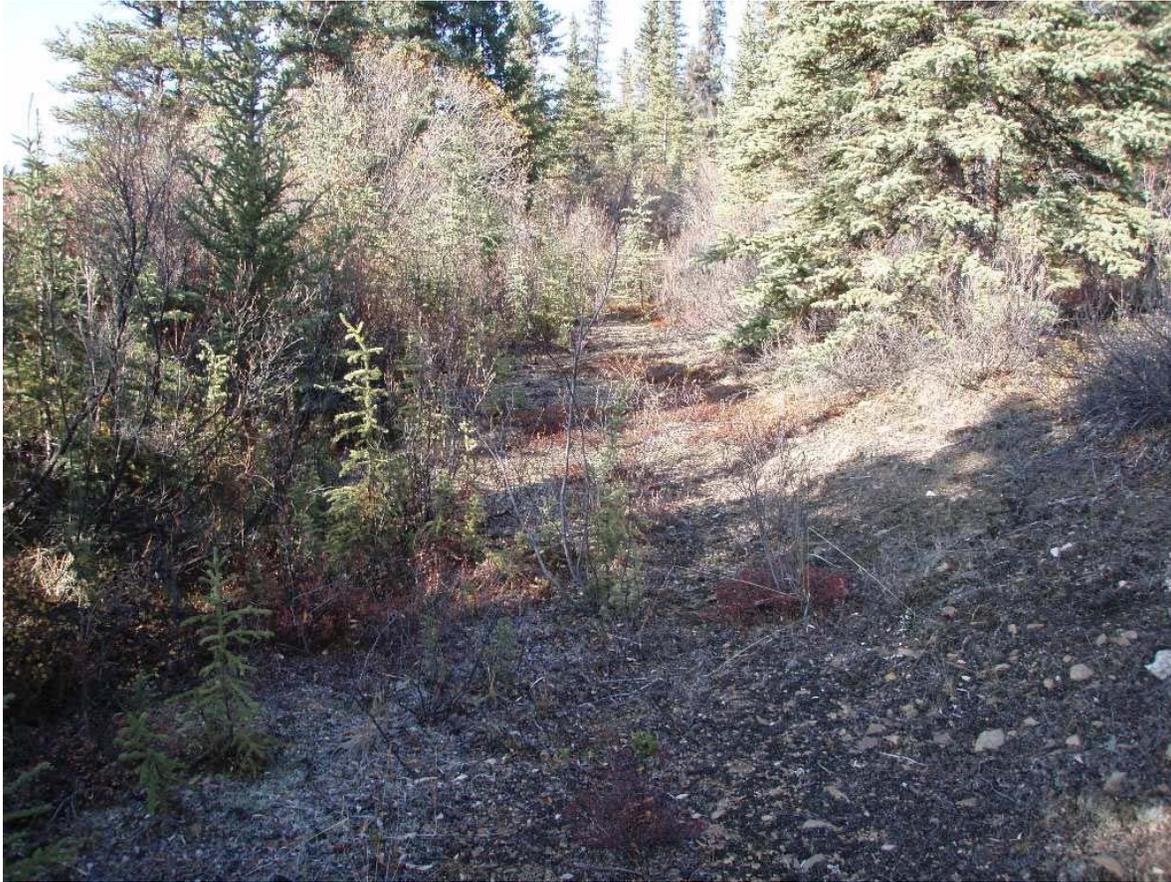
Figure 2.3 Voluntary Colonization of Old Road (circa 1950?) by Kinnikinnick, White Spruce, and Willow. A dark “biological” or cryptogamic crust is visible on the soil surface. Approximately 10 km from Mount Nansen mine site.

The local ecosystem has responded to man-made disturbances through voluntary colonization processes. Figures 2.3 and 2.4 show examples of voluntary colonization of linear disturbances approximately 50 and 30 years in age.

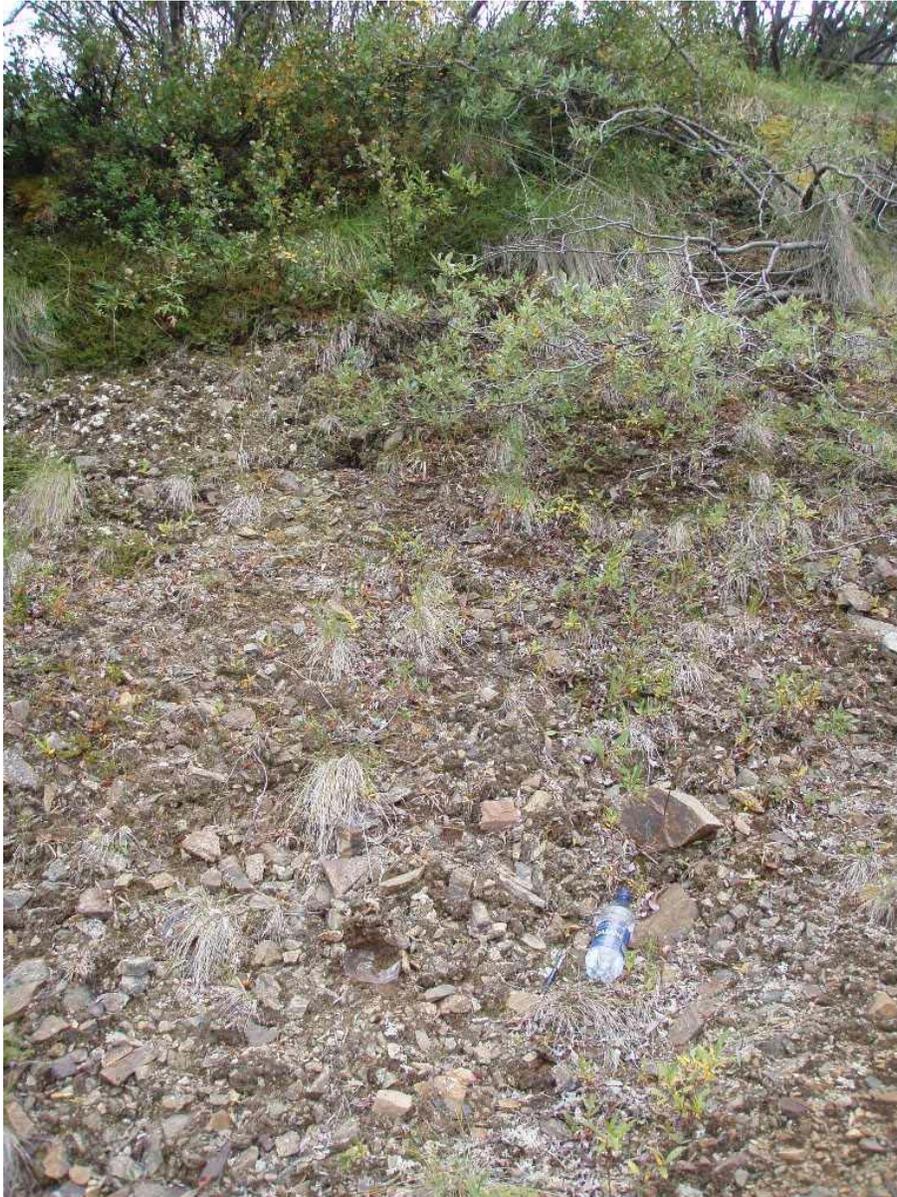
Figure 2.4 Voluntary Colonization in a 6 metre-wide old exploration trench in Heustis Zone (circa 1970?), approximately 1 km to west of Brown McDade zone. Willow is primary species, along with unidentified grass species (possibly *Festuca altaica* [Polster, pers. comm., 2008]) and occasional white spruce. Rare scrub birch, laborador tea and mossberry observed. Soil surface is darkened in some patches, potentially indicating early-stage development of a biological crust.

Although prolific in the climax vegetation community, only one local example of scrub birch colonization was observed in the disturbed areas (see Figure 2.4). Nonetheless, taking the work of Viereck, one can see that scrub birch colonization would begin at the second (meadow) successional stage. Sharman and Smyth (2002) note that once planted, scrub birch is their best growing shrub on high elevation waste rock piles in northern British Columbia. Viereck's work also indicates crowberry and potentially bilberry to be potential second stage successional species, however bilberry's affinity for more moist habitats may limit its potential as a revegetation species in the well drained waste rock environment.

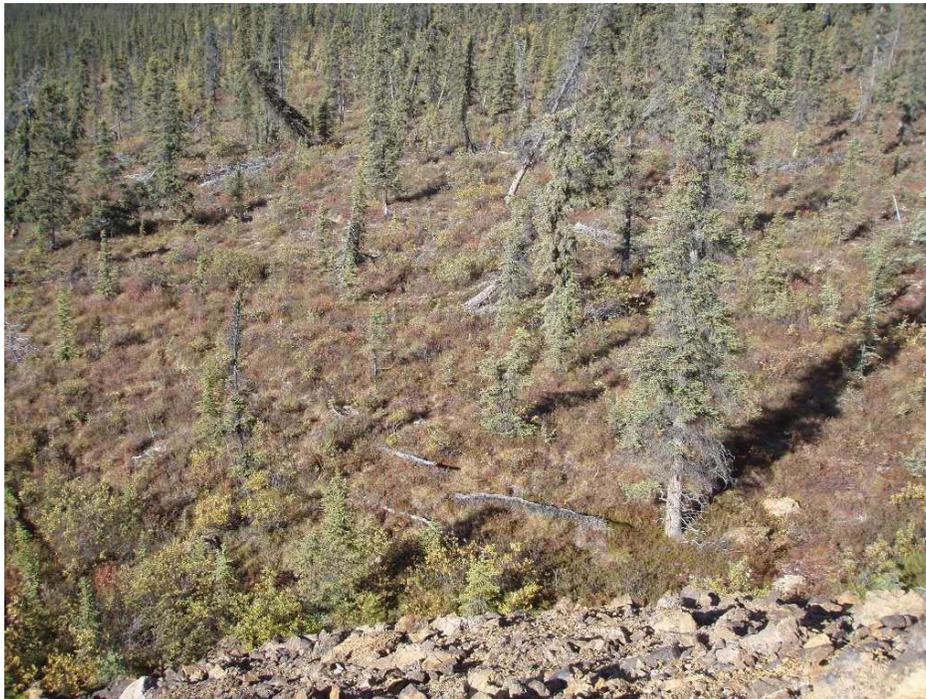
Figure 2.5 *Vegetation typical of poorly drained regime ecological reference site, SP-1.*

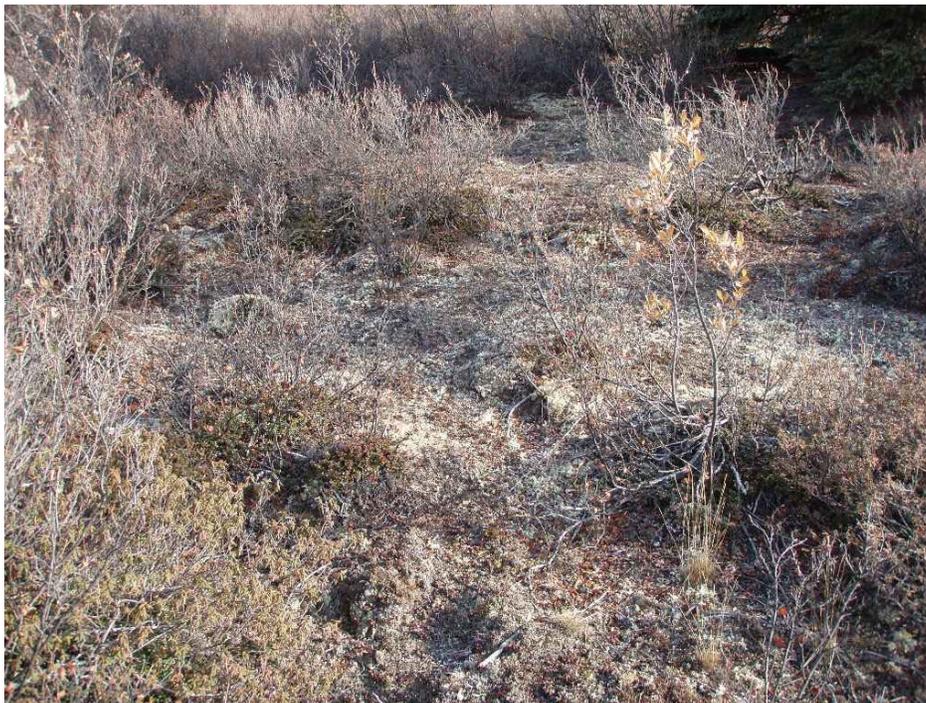
Figure 2.6 *Vegetation at well-drained regime ecological reference site, SP-2.*

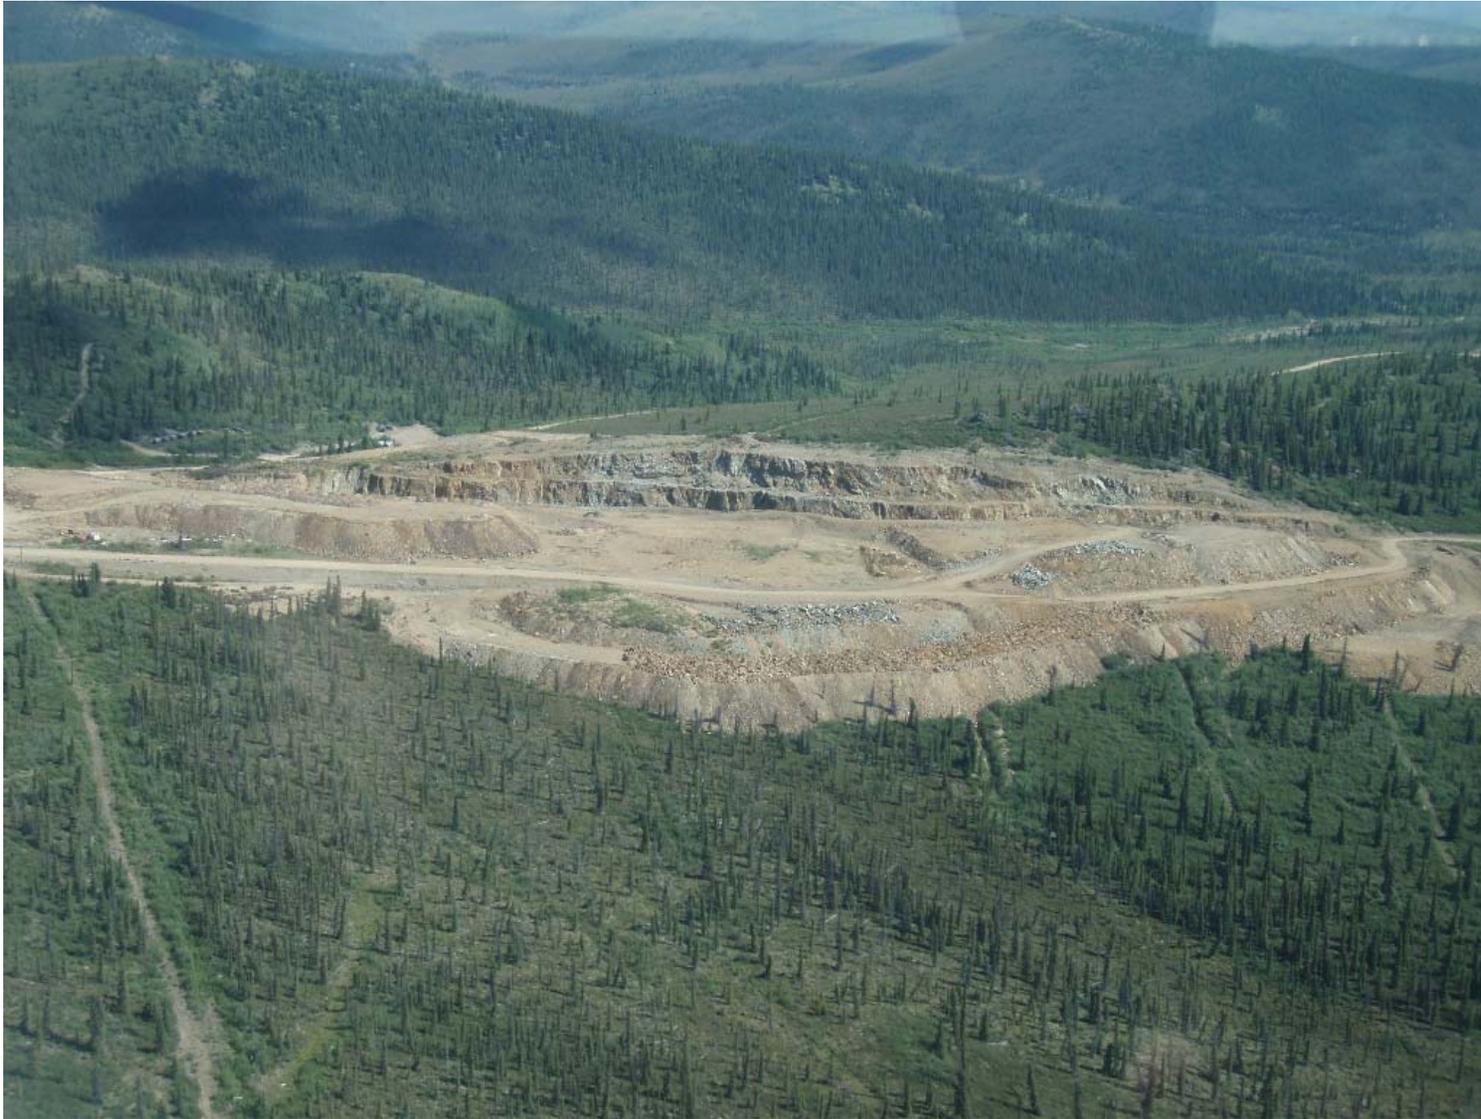
Figure 3.2 Aerial view of Brown McDade waste rock pile looking east. Pit is immediately behind waste rock area. Local natural vegetation can be seen.

Figure 3.1 shows a sketch layout of the Brown McDade Waste Rock pile; oblique aerial photos are given both on the cover of this report and in Figure 3.2. The waste pile is actually composed of several separate piles, with maximum height from original ground in the order of 10 metres. More than 85 percent of the pile is flat to slightly inclined platform areas, with the remainder being angle of repose slopes in the order of 32 degrees (shown as cross-hatched areas in Figure 3.1). Overall angle from the toe of the pile to the uppermost sections is shallow, in the order of 13 to 16 degrees.

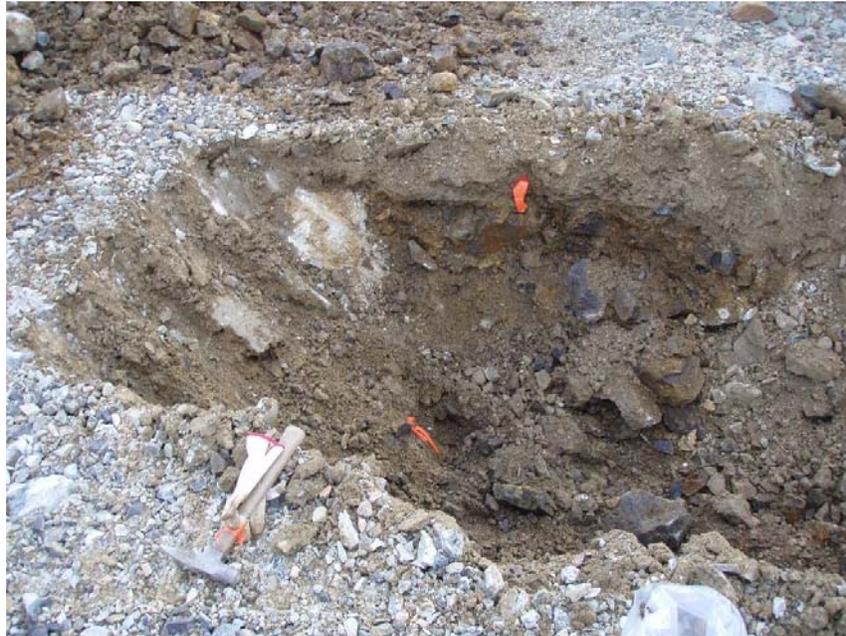
Figure 3.3 Profile in test pit TP-2, northwest sector of pile. Lower orange flagging is 1.0 m depth.

Figure 3.3 shows a wall of a 1.0 metre deep test pit excavated in the waste rock pile. Despite the obvious abundance of cobble-sized fragments, the matrix of much of the waste rock pile material is fine and “clayey-silt” in texture. The rock is well-drained and there is no evidence of saturated zones within the rock pile. The few seepage zones observed to date occur at the toe of the pile, and monitoring to date indicates they flow only sporadically.

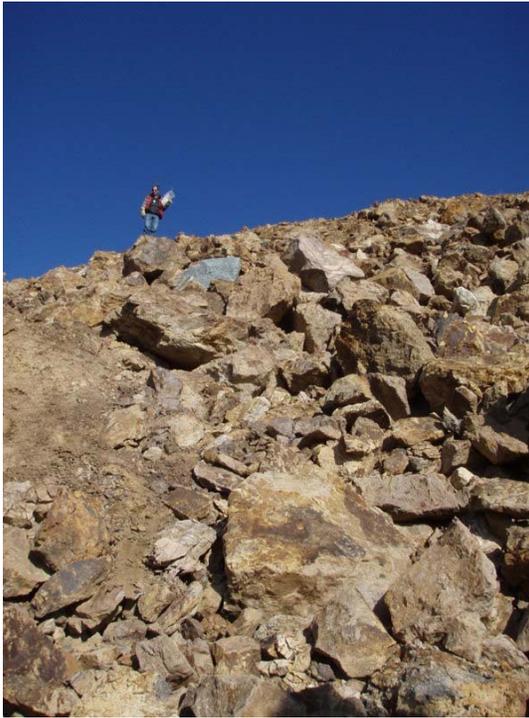
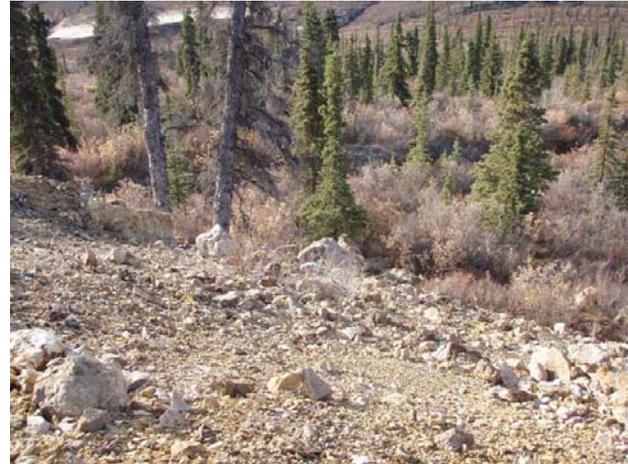
Figure 3.4 Angle of repose slopes. Right: lower west area, showing abundant coarse rock; Left: lower southwest area with relatively higher proportion of fine material (typical of most of waste rock pile).

No macro-scale surface erosion features such as rilling and gullying are observed on the Brown McDade waste rock pile platforms or slopes (Figure 3.4). Nonetheless, it is noted that the fine-grained size particles tend to form a thin and weak indurated crust in many areas of the rock pile. This armouring may be a result of a combination of: i) raindrop erosion (where the impact of raindrop entrains clay and fine silt particles leaving a cement-like crust of coarser sand-size material), ii) freeze-thaw processes (USDA, 1996) and iii) dissolution and evaporation of readily soluble salts. This crusting provides a poor substrate for seed germination, and thus negatively affects plant colonization.

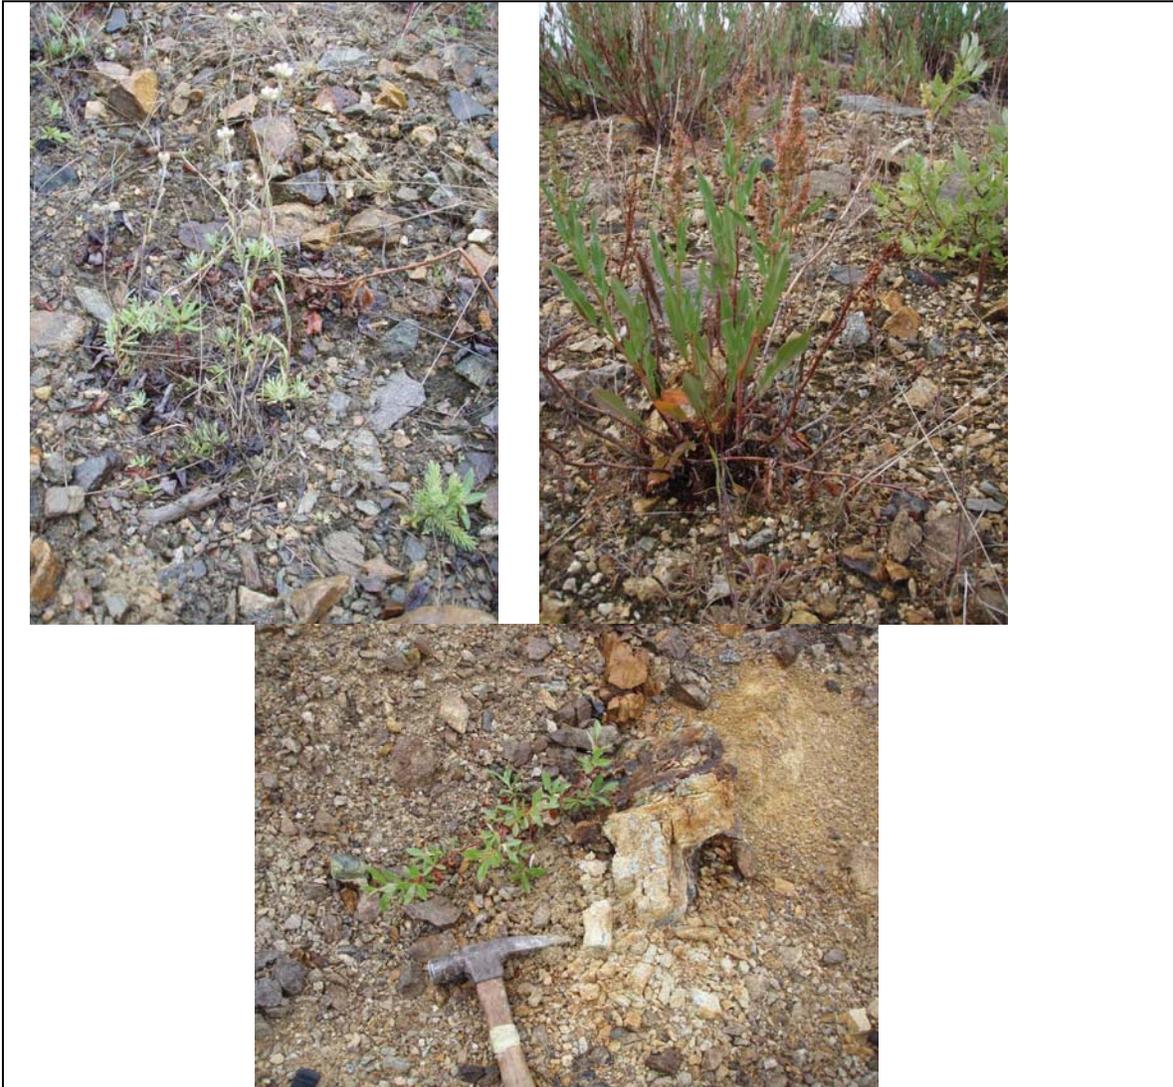
Figure 3.5 Examples of voluntary colonization in Brown McDade waste rock pile. Clockwise from top left: white spruce and showy pussytoes; dockleaf smartweed?; willow.

The following species, in order of approximate abundance of individuals, have been observed to be voluntarily colonizing the Brown McDade waste rock pile. Figure 3.5 shows photos of some of these species. Section 3.3.3 discusses potential factors that are contributing to voluntary establishment on the rock pile.

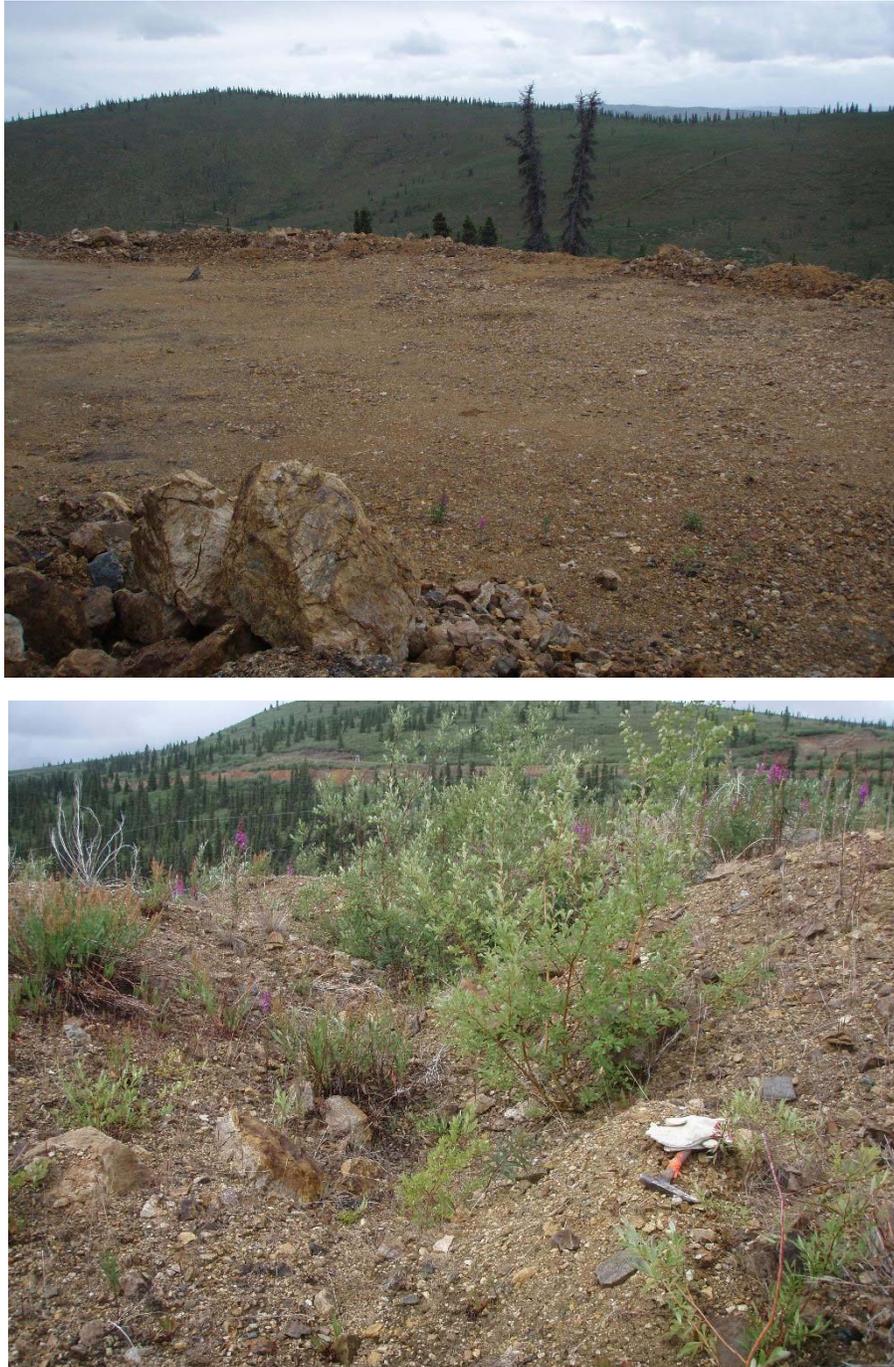
Figure 3.6 Top: platform of lower southwest pile, minimal voluntary colonization. Bottom: platform of mid west pile showing greater voluntary colonization. Potential influencing factors may be: i) soil texture and degree of compaction (lower southwest pile is coarser and shows evidence of compaction by bulldozer), and ii) hummocks on mid west pile have created micro sites to better trap moisture and seed, and provide protection from the elements.

- Highest vegetation density is found on the mid-level west pile area, where material contains a higher amount of fines, and where the pile surface is extremely hummocked (see Figure 3.6). Possibly, the favorable material texture and the creation of micro-sites are positively affecting vegetation density.
- The physical expanse of the waste pile (eg. distance from areas of natural vegetation) may be limiting the establishment of many local species with smaller seed and fragment dispersal radii such as evergreen, kinnikinnick, and crowberry.

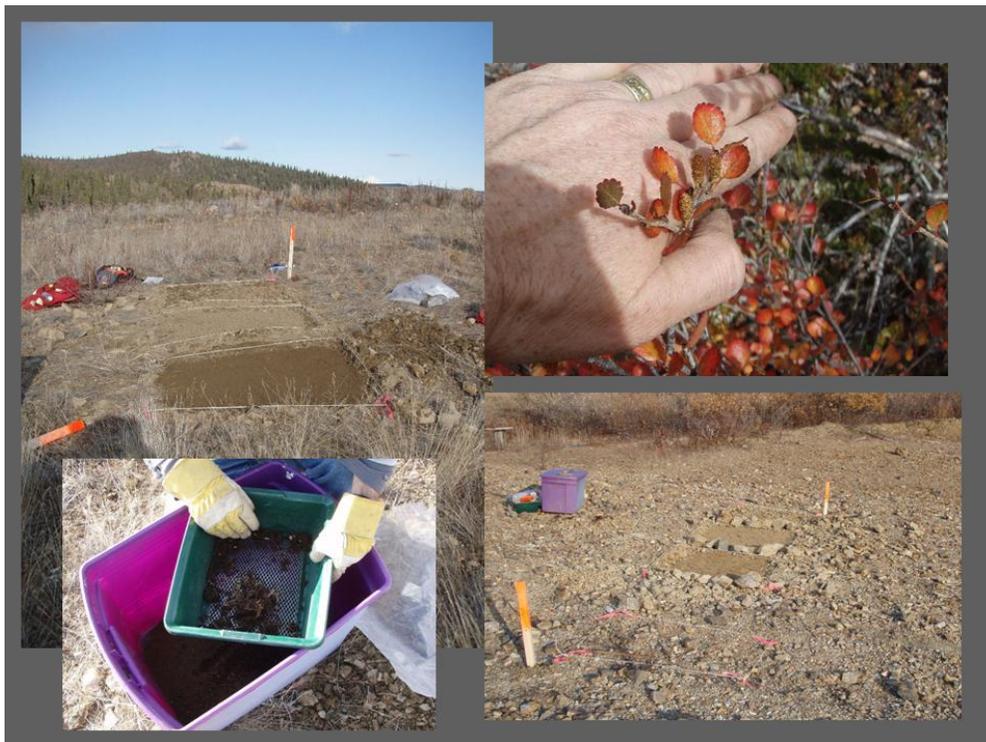
Figure 4.2 Scrub birch trials. Clockwise from upper right: i) seed-containing catkins at collection site SP-2; ii) VT-WR-02 plots on Heustis Rock pile; iii) screening organics from adjacent undisturbed site for inoculation into waste rock fines; and iv) VT-WR-01 plots on Easte Rock pile.

- Scrub Birch Germination Site Trials: as shown in photos in Figure 4.2, a small amount of scrub birch (*Betula glandulosa*) seed was collected in early September 2008. Later that month, two separate scale direct seeding trials, one on the East Pile, the other on the Heustis Rock Pile were established. The plots each measure 1 m by 1 m and are intended to test the germination of scrub birch by direct seeding on three different media: i) waste rock, scarified using hand tools, ii) scarified and screened waste rock (+3/8" fraction removed); and iii) scarified and screened waste rock inoculated with a small amount of organic soil from a nearby undisturbed site. Germination will also be tested under nursery conditions in spring 2009 using the small remaining amount of seed collected.

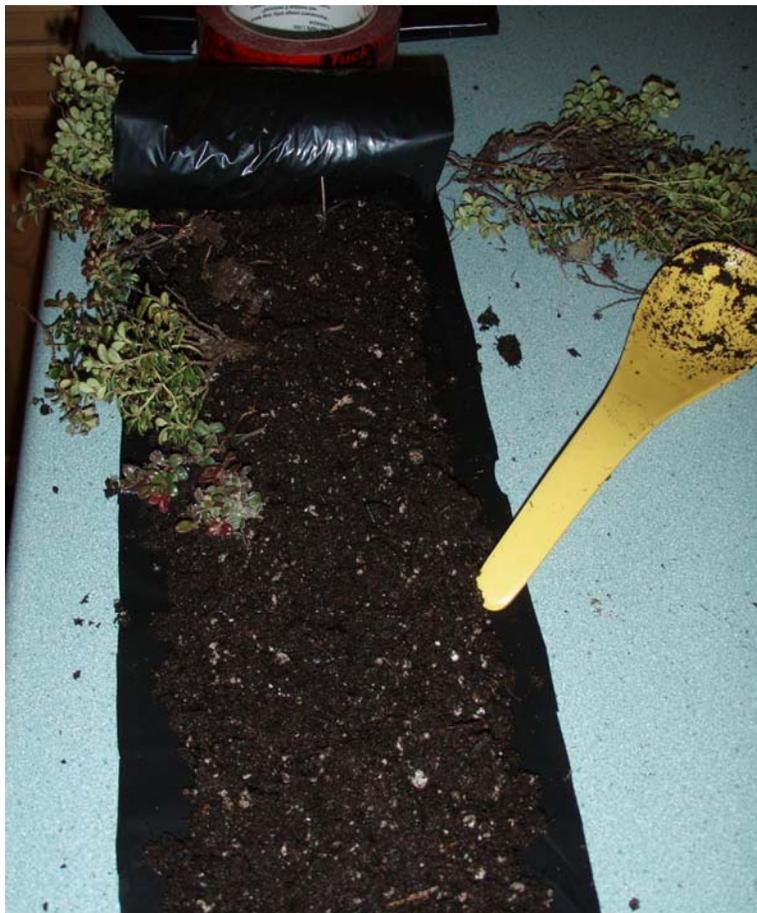
Figure 4.3 *Kinnikinnick 'roll' for overwintering stems.*
