**CLINTON CREEK CHANNEL**

**STABILIZATION (STAGE II)**

**CONSTRUCTION REPORT**

**UMA Job No. 6029 004 00**

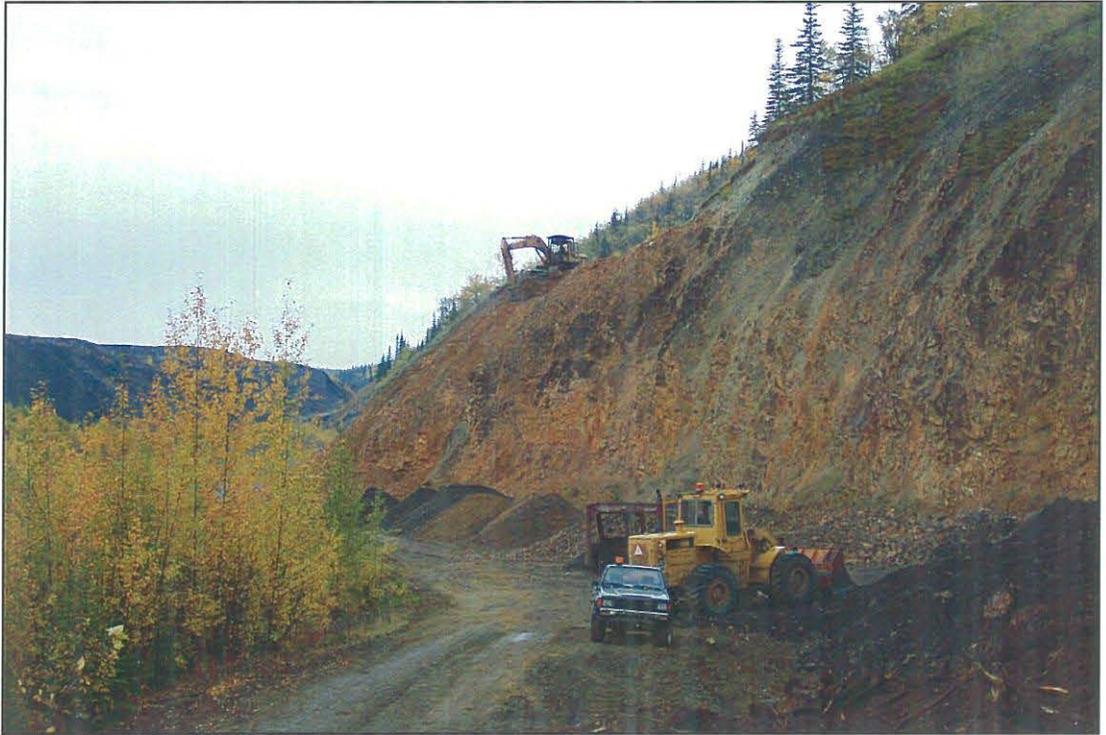
Photograph 3-1) Quarry site at Wolverine Creek.

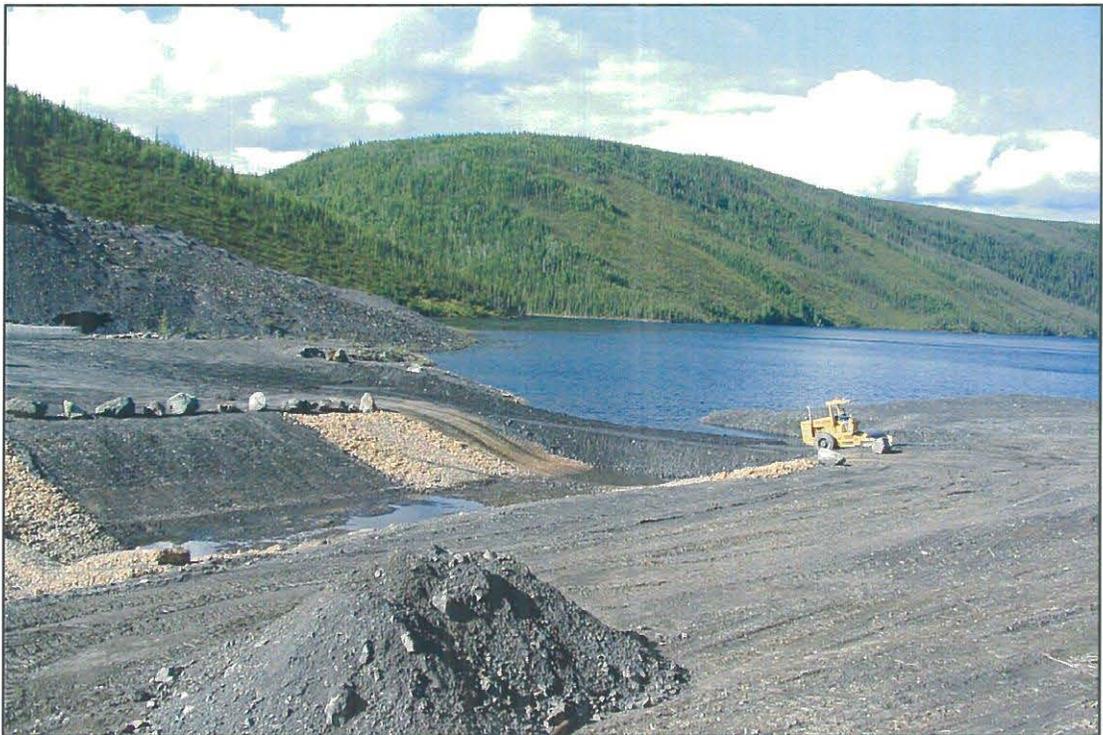
Photograph 3-2) Compacting cofferdam at lake outlet.

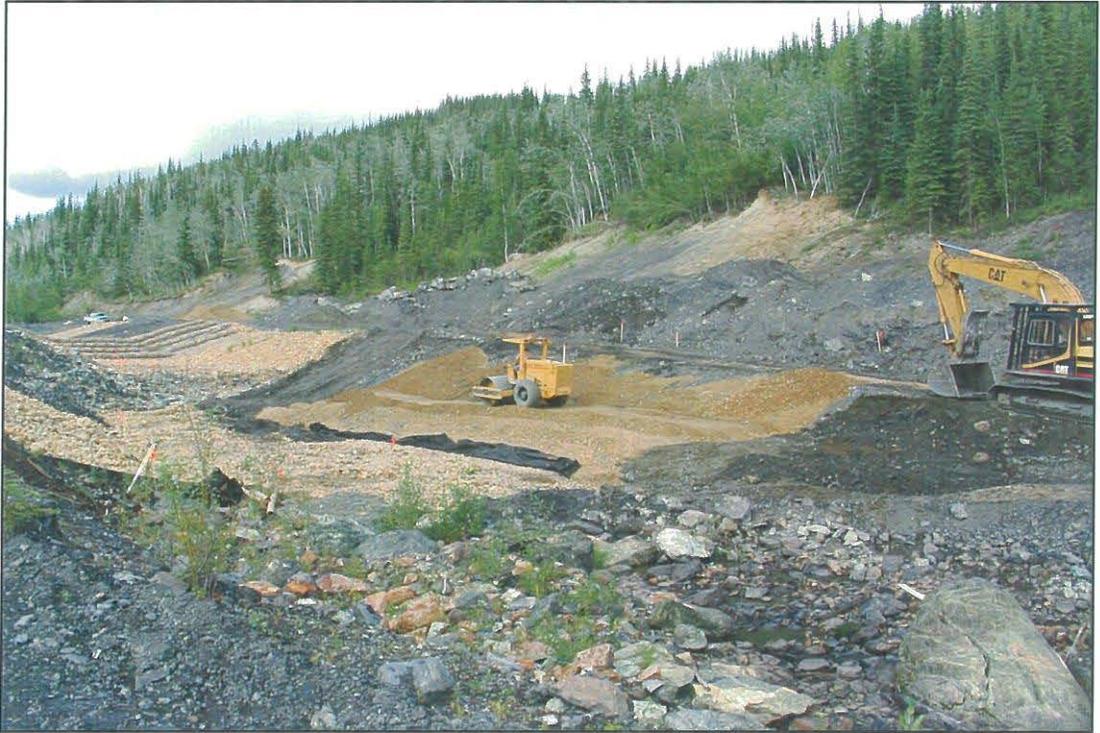
Photograph 3-3) Initial placement and compaction of foundation material.

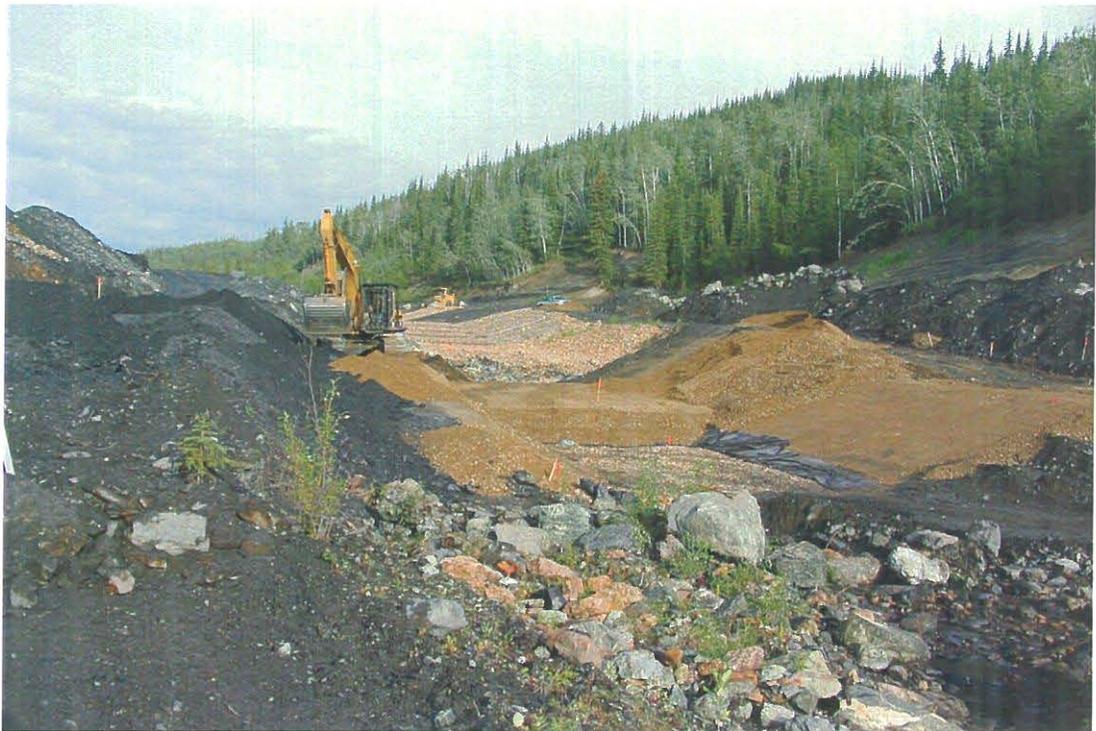
Photograph 3-4) Placement and compaction of foundation material –final stages.

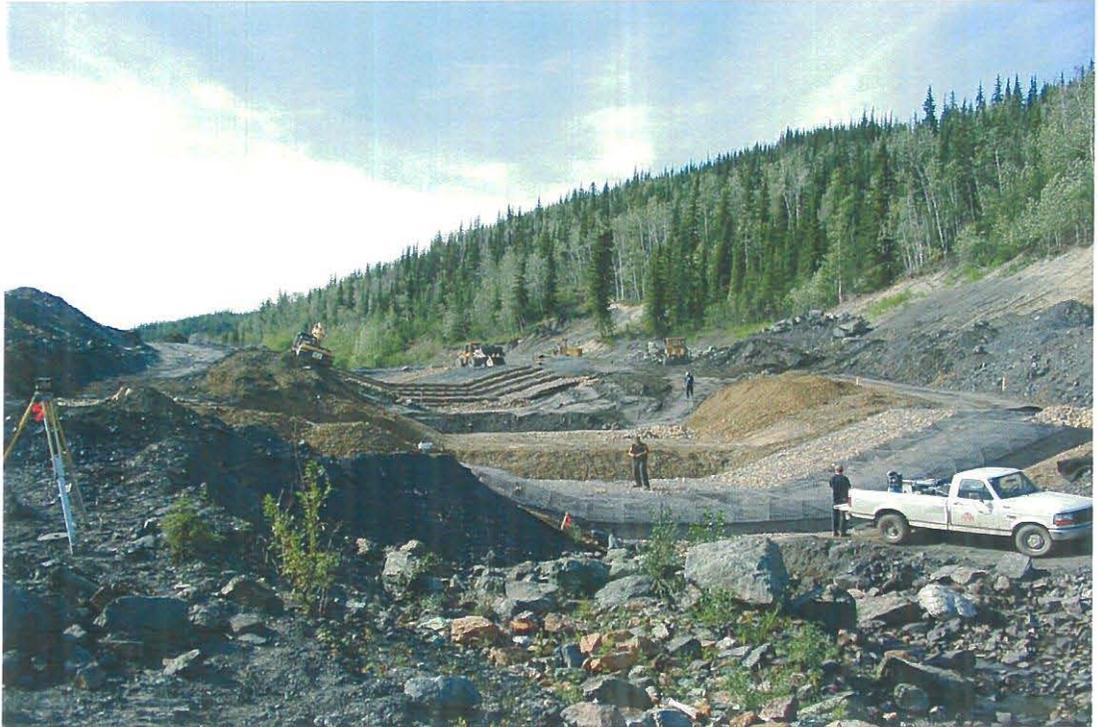
Photograph 3-5) Drop Structure 2 - Placement of gabion baskets for tier 1.

Preparation of creek channel and foundation for DS-2. Install Tiers 1 and 2 of DS-2.

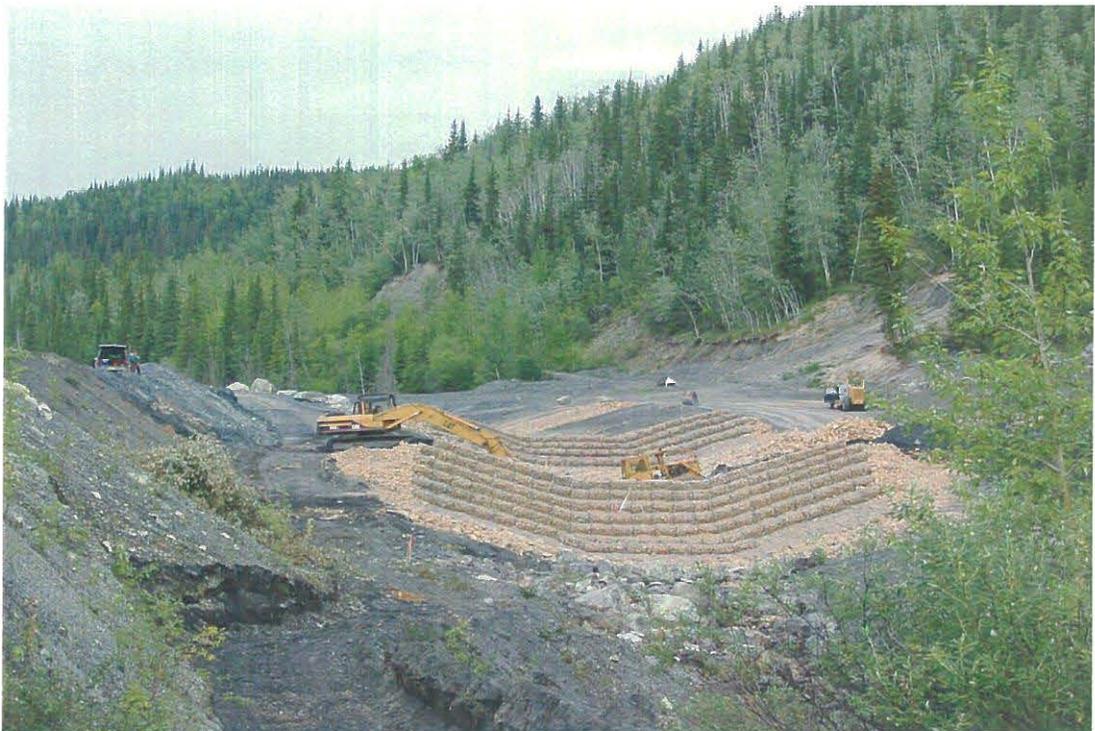
Photograph 3-6) Drop Structure 2 completed, 2.5 m tall.

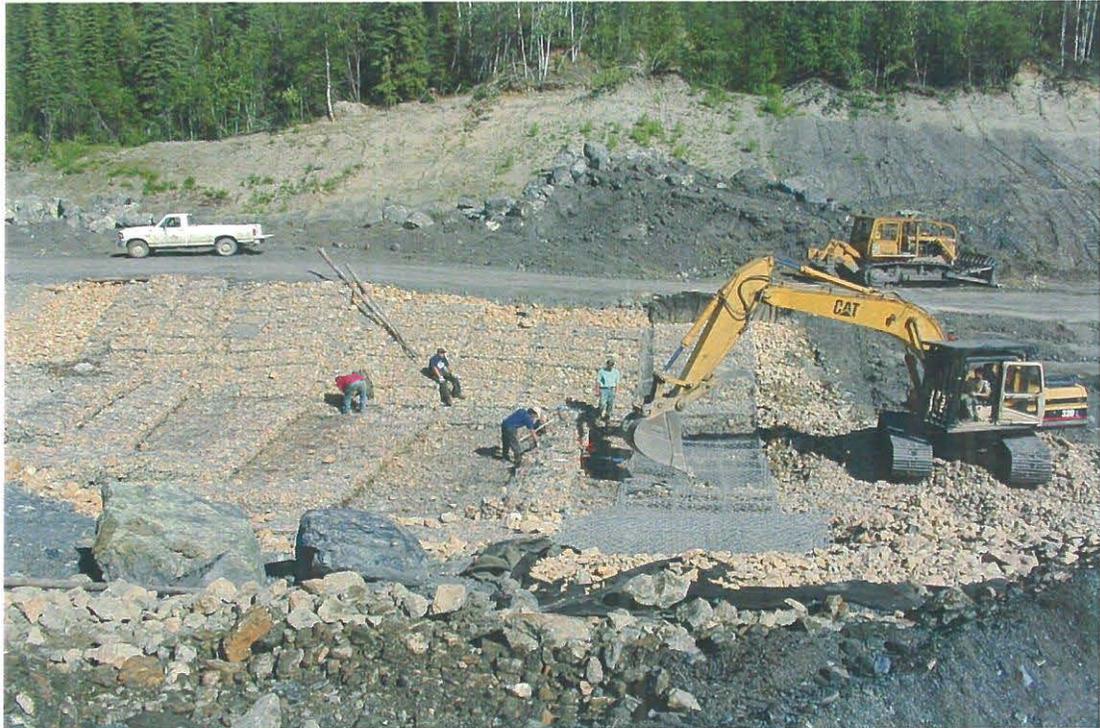
Photograph 3-7) Placing additional row of baskets at end of Drop Structure 1.

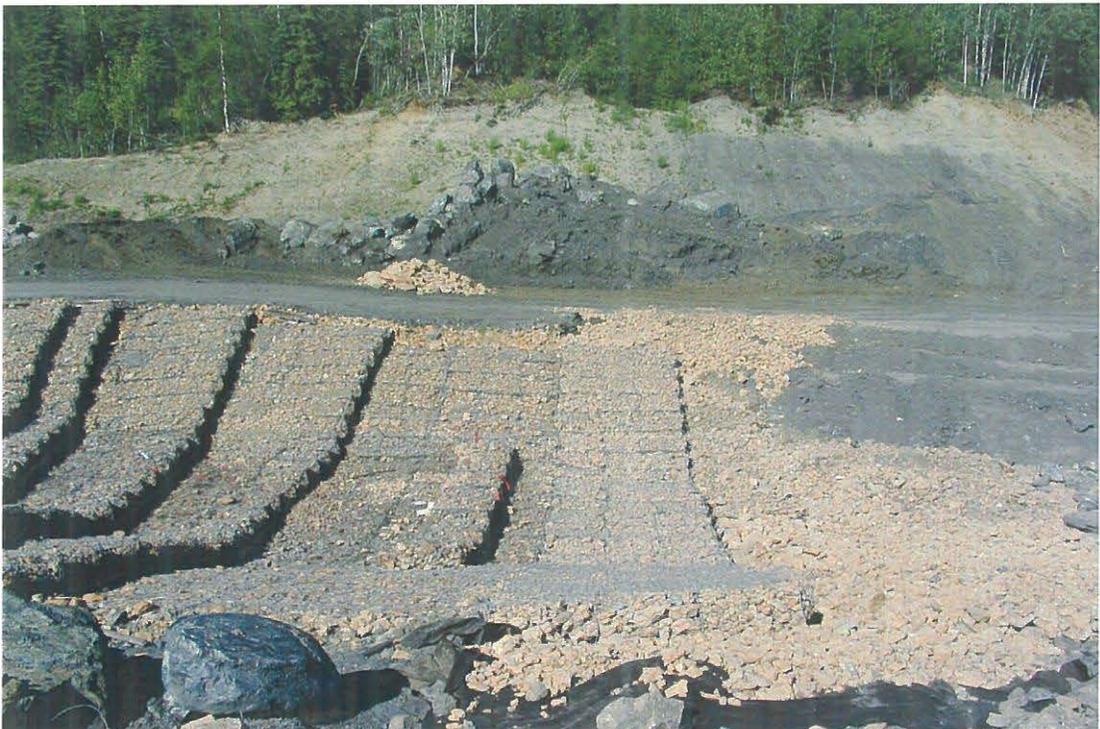
Photograph 3-8) Additional row of baskets installed at end Drop Structure 1.

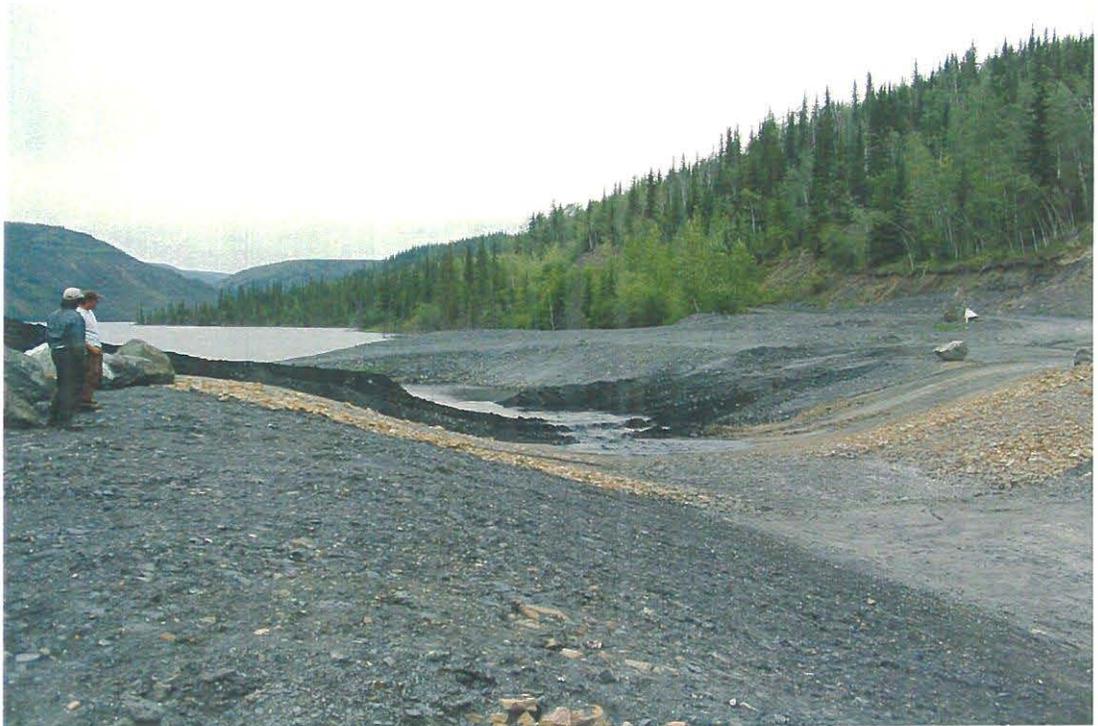
The sediment load generated during removal of the cofferdam was minimal because of the low lake level (400mm deep behind the dam) that allowed the vast majority of the cofferdam to be removed under zero flow conditions (Photograph 3-9). Water flowing through the new outlet from Hudgeon Lake began to run clear within 20 to 30 minutes of restoring the flow. The sediment load in the creek channel was also reduced by the presence of beaver dams and marsh areas downstream of the waste rock pile.

Photograph 3-9) Restoring flow from Hudgeon Lake.

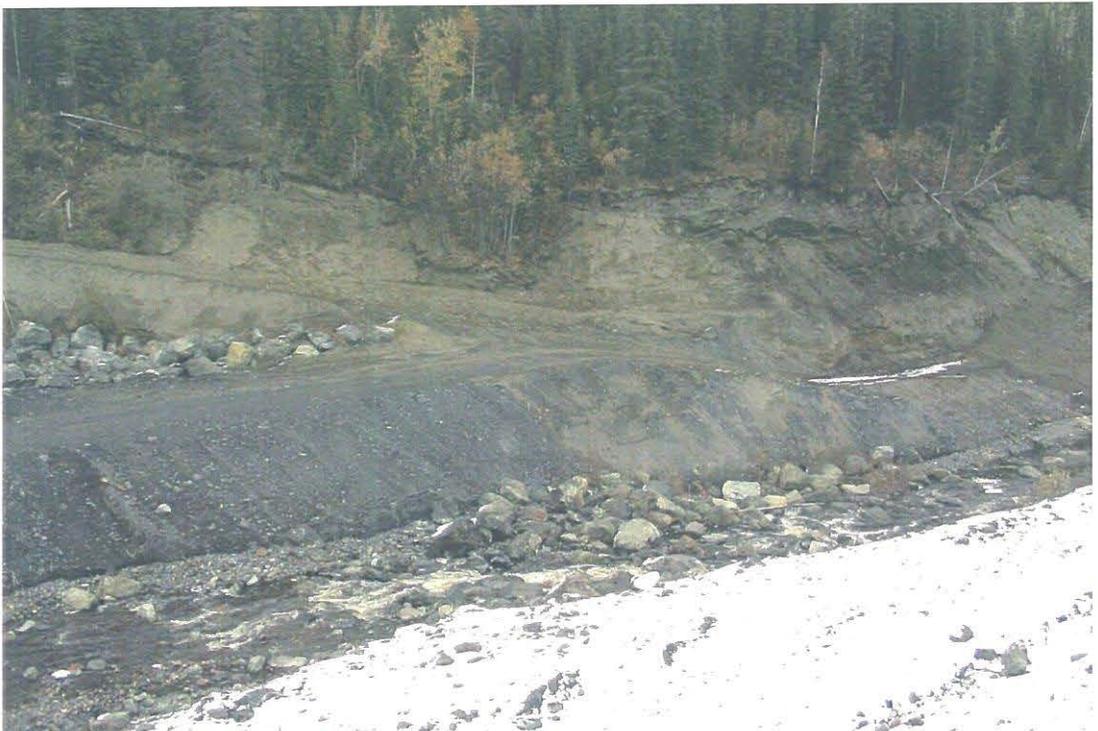
Photograph 3-10) Site preparation for Drop Structures 3 and 4.

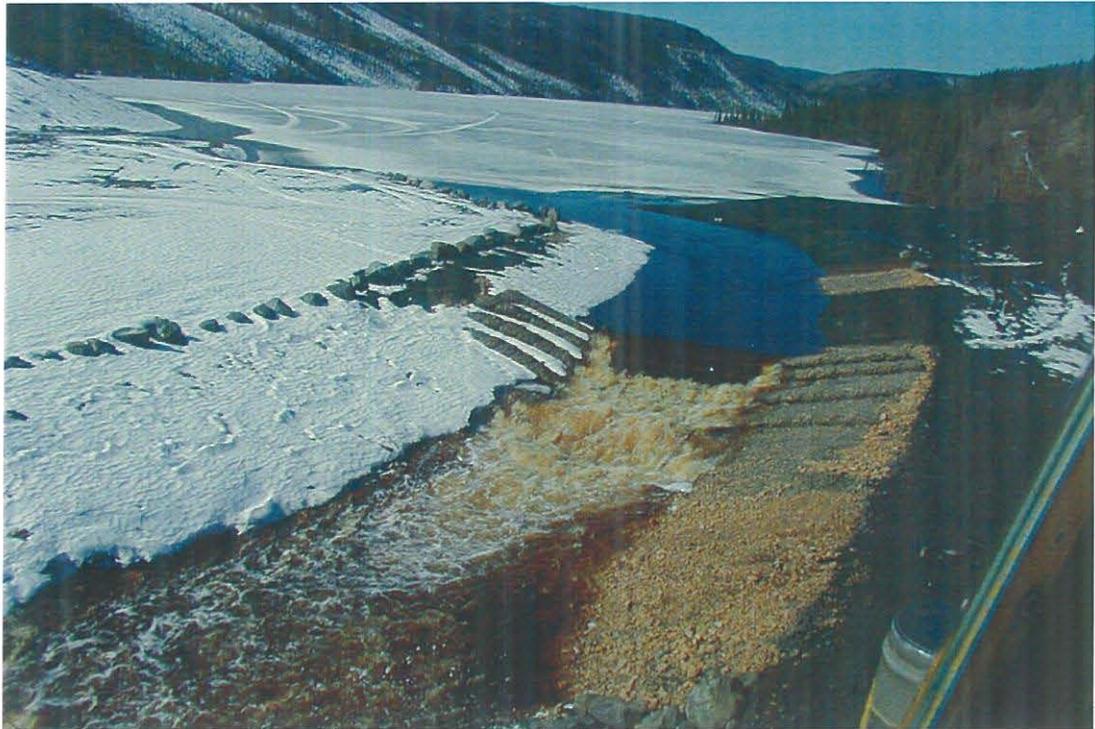
Drop Structure 1 (DS-1) performed well following the removal of the cofferdam in the fall of 2002 and there were no signs of frost heaving or ice damage during a site visit in March 2003. The higher flows experienced during the spring freshet of 2003 resulted in the formation of a scour hole in the channel riprap at the downstream end of the drop structure. Other relatively minor issues were also noted including the loss of material in some of the gabion baskets and a slight upstream rotation of the top tier of baskets.

Photograph 4-1 shows the turbulence at the downstream end of DS-1 that caused the scour hole and resulted in some erosion of foundation material under the left-hand (i.e. when facing downstream) side slope. Four baskets at the bottom of this side slope experienced some settlement (ranging from 50mm to 250mm) but the flexible nature of the baskets helped mitigate any further loss of material under the side slope (Photograph 4-2). Formation of the scour hole was a consequence of not having downstream water level control, which is now provided by DS-2. The downstream water level control provided by DS-2 is illustrated on Photograph 4-3, which was taken during the high flows in early September 2003. Note the lack of turbulence at the downstream end of DS-1. Repairs to DS-1 included the installation of an extra row of baskets at the downstream end where most of the turbulence took place (Photograph 3-7). The record drawing for DS-1 was updated to reflect this change and is included in Appendix E. This same detail was added to DS-2 as well. No signs of high turbulence or loss of material were observed at the downstream end of DS-2 during the high flows in September 2003 (Photograph 4-4).

Photograph 4-1) Turbulent flow over Drop Structure 1 on April 28, 2003.

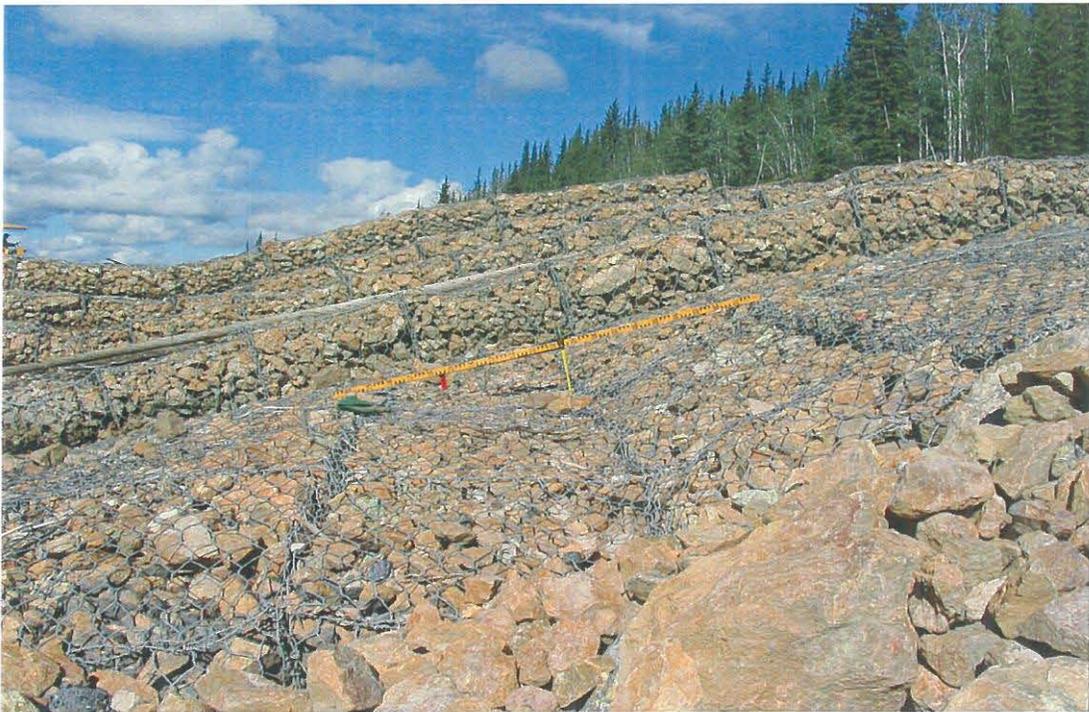
Photograph 4-2) Settlement (250mm max.) of baskets on LHS of Drop Structure 1.

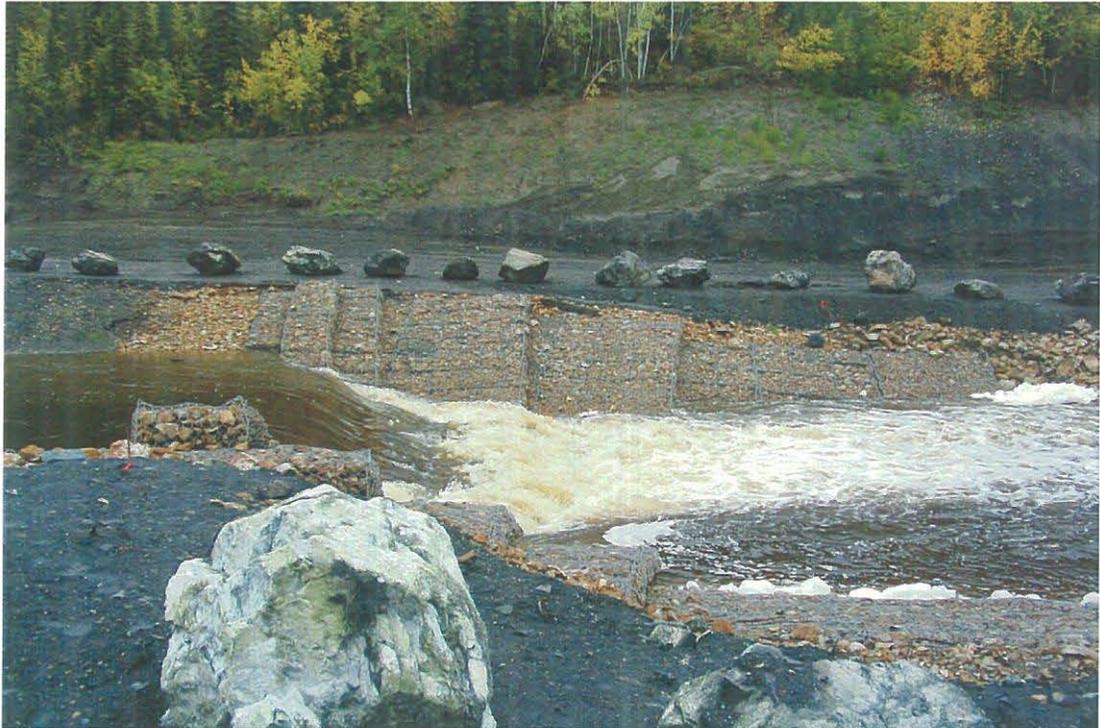
Photograph 4-3) Drop Structure 1: Turbulence confined to the gabion baskets (September 2003).

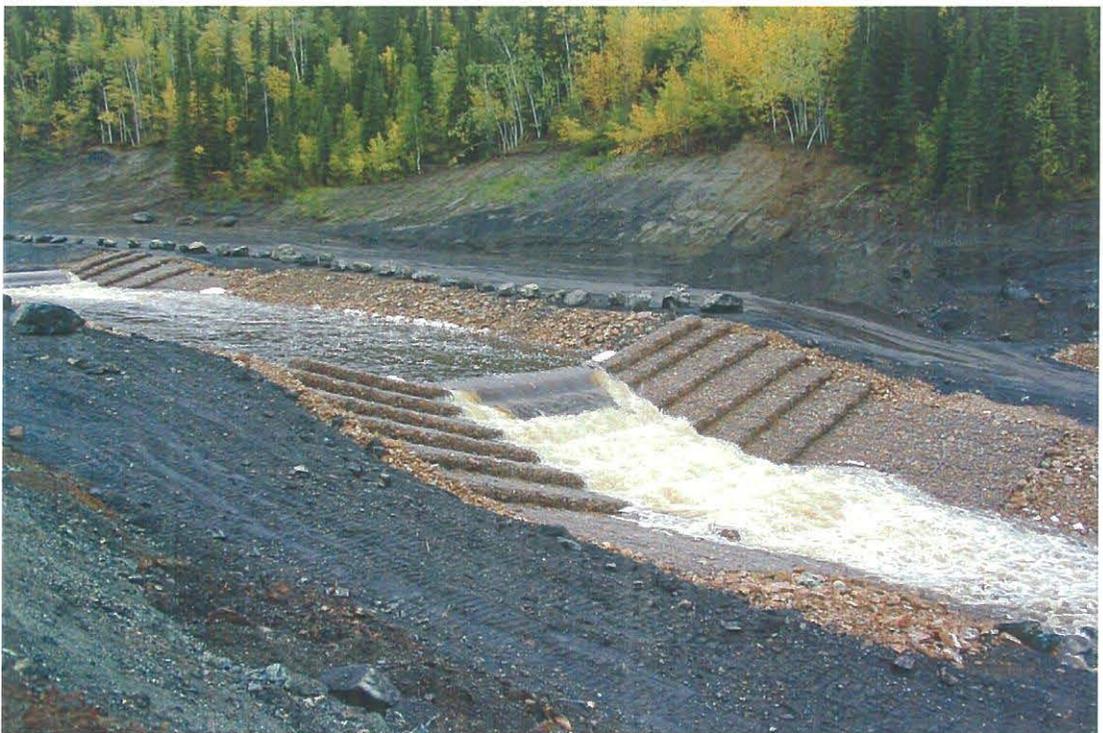
Photograph 4-4) Drop Structure 2: minimal turbulence just downstream of baskets.

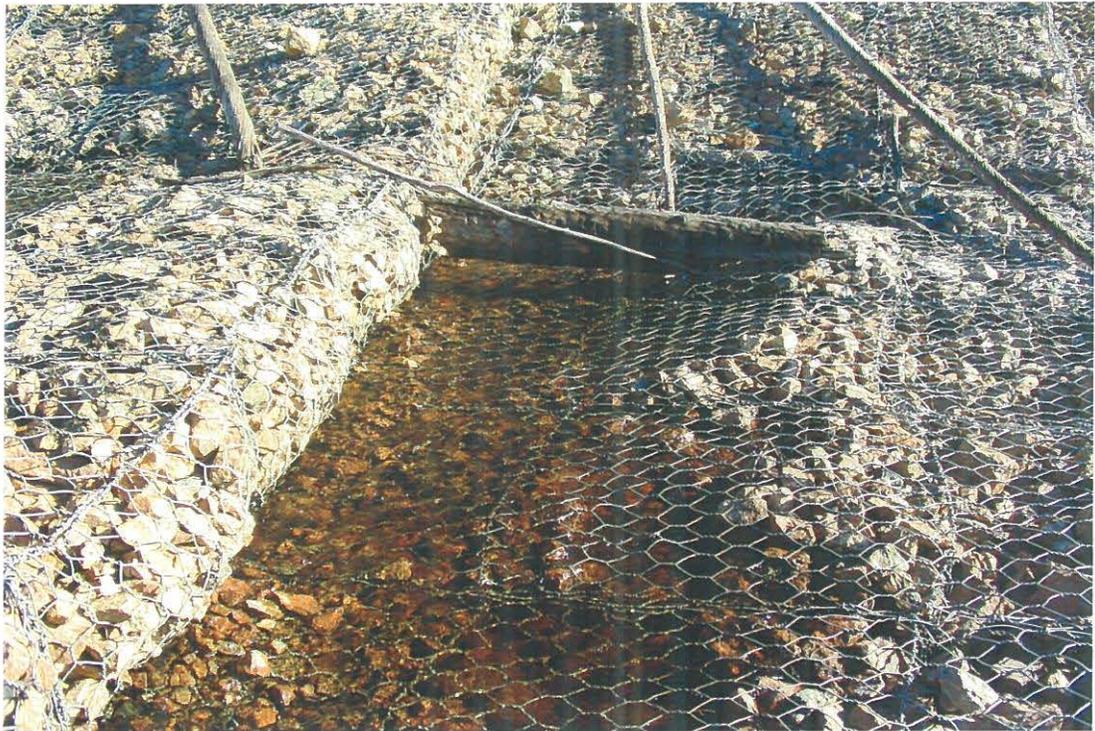
Photograph 4-5) Gabion fill rolled ahead and upward, note bulged wire mesh.

The rock for the gabion fill was selected because it was the best available material within the local area. However, over the long term the gabion fill material may be affected by freeze-thaw cycles that can break down the rock. It is not certain how resistant this rock will be to freeze-thaw cycles. There is also a possibility that ice wedges (referred to locally as ‘glaciers’) may form under the gabion baskets due to water seeping out from the waste rock pile. There were no signs of this effect observed at Drop Structure 1 in the winter of 2002/2003, although the structures could undergo heaving if the water seeping from these points begin to freeze under the gabions. Because the gabion baskets are flexible, it is not know if these effects would be detrimental to the integrity of the structure but it is anticipated that they can accommodate the movements.

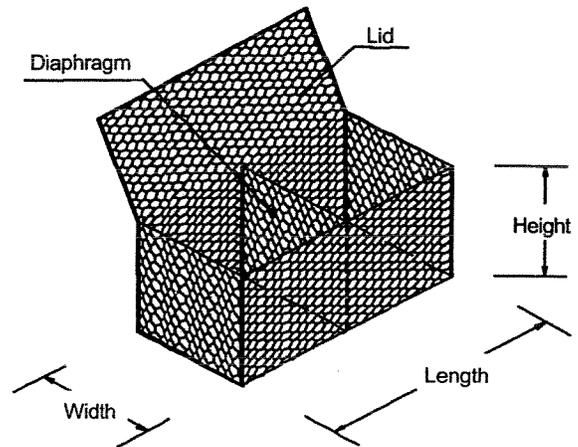
Figure 1

The gabion is divided into cells by means of diaphragms positioned at approximately 1 metre centres (Figure 1). In order to reinforce the structure, all mesh panel edges are selvaged with a wire having a greater diameter.

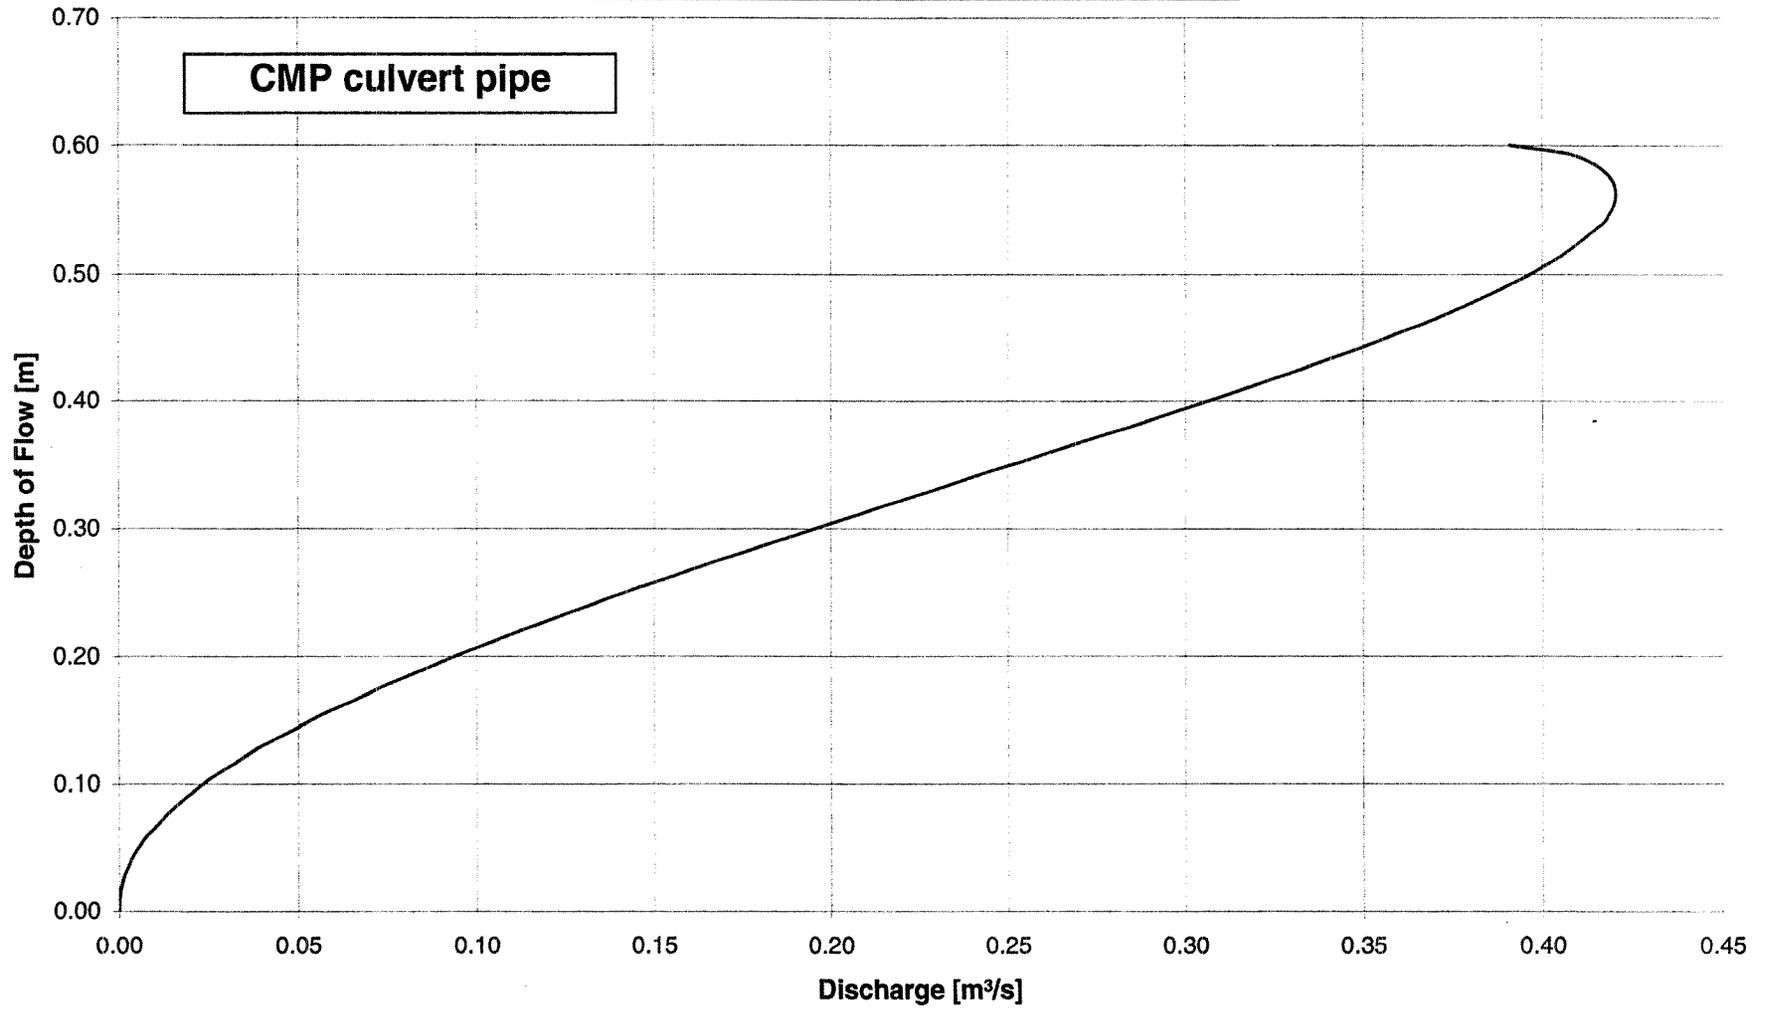
**CMP culvert pipe**

### Pipe Discharge vs. Depth

— Dia. = 600 mm, S = 0.0150 m/m and n = 0.025

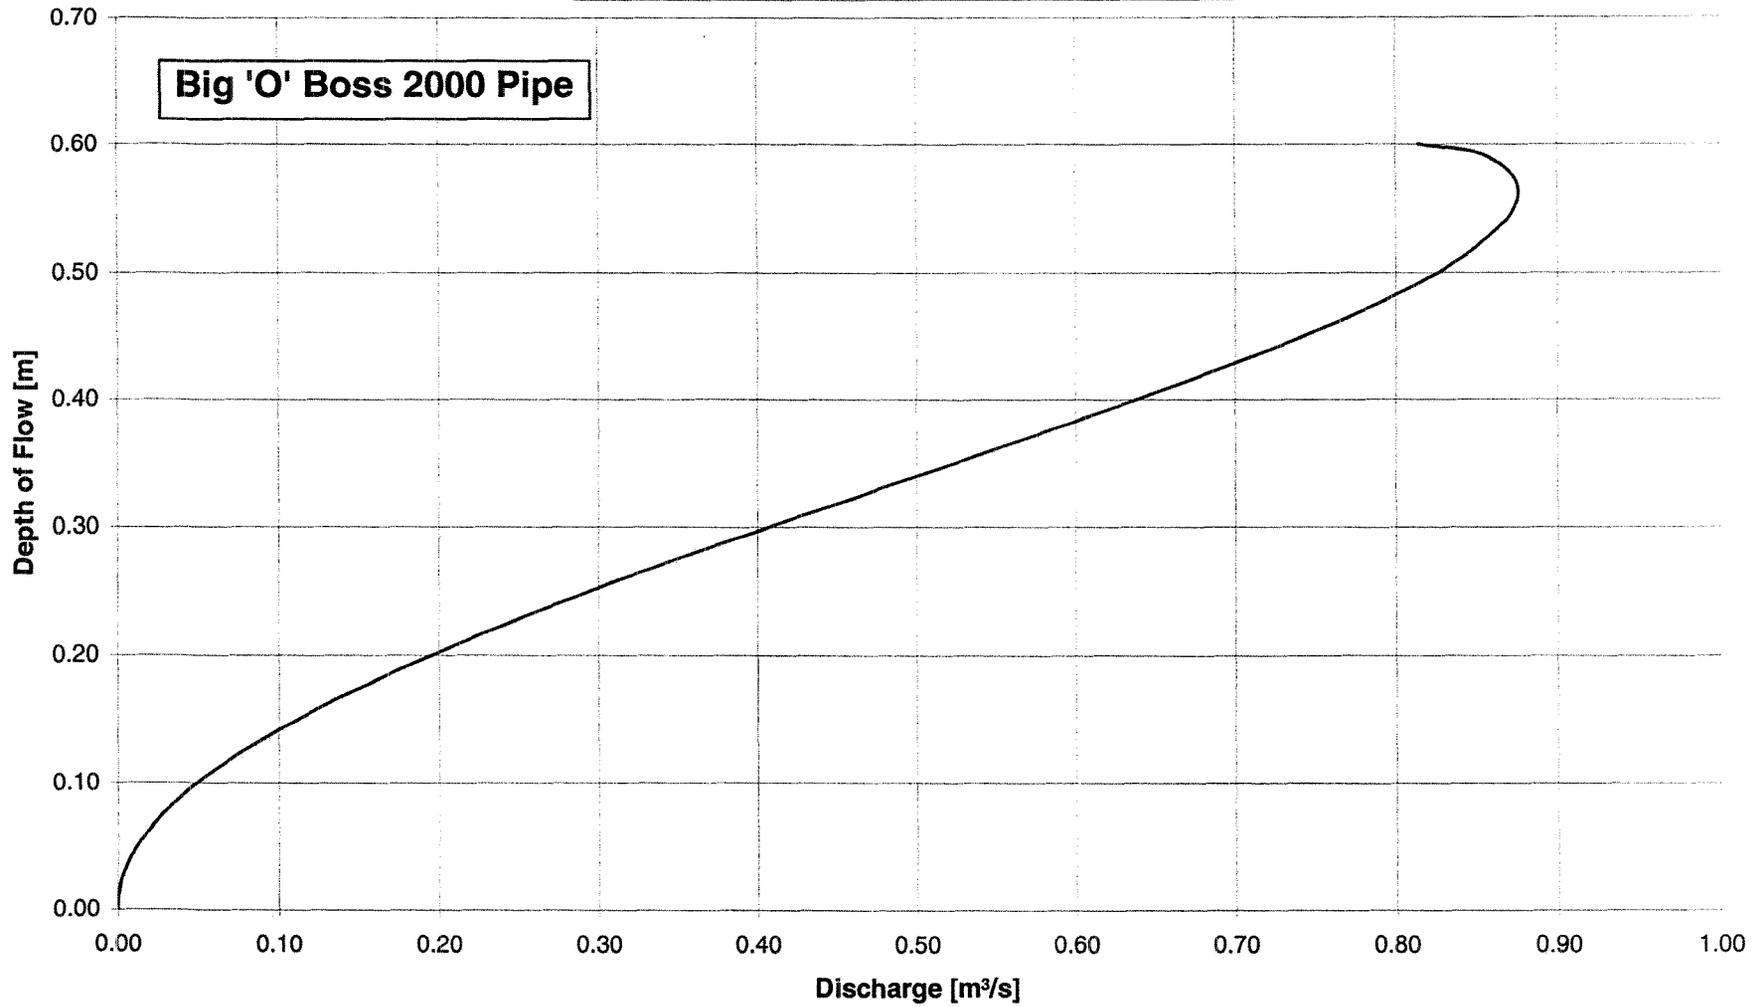
**Big 'O' Boss 2000 Pipe**

### Pipe Discharge vs. Depth

— Dia. = 600 mm, S = 0.0150 m/m and n = 0.012

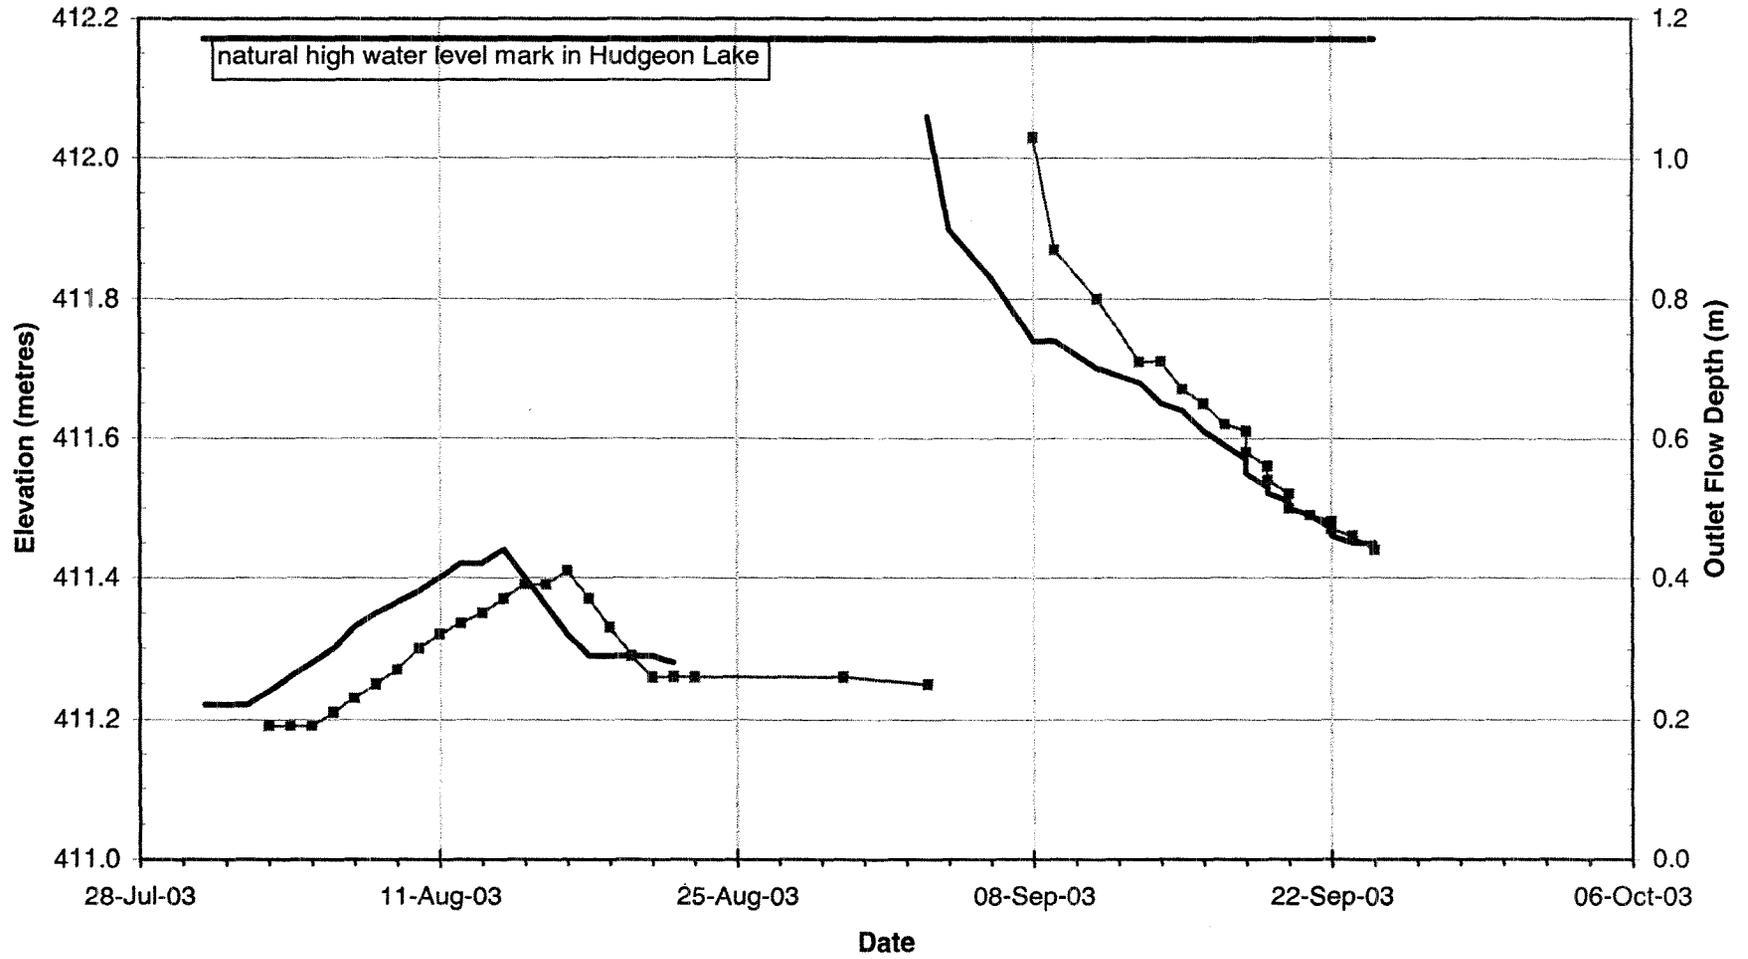
## Water Levels in Hudgeon Lake

— Lake Elev.    — High Water    — Flow Depth (outlet)

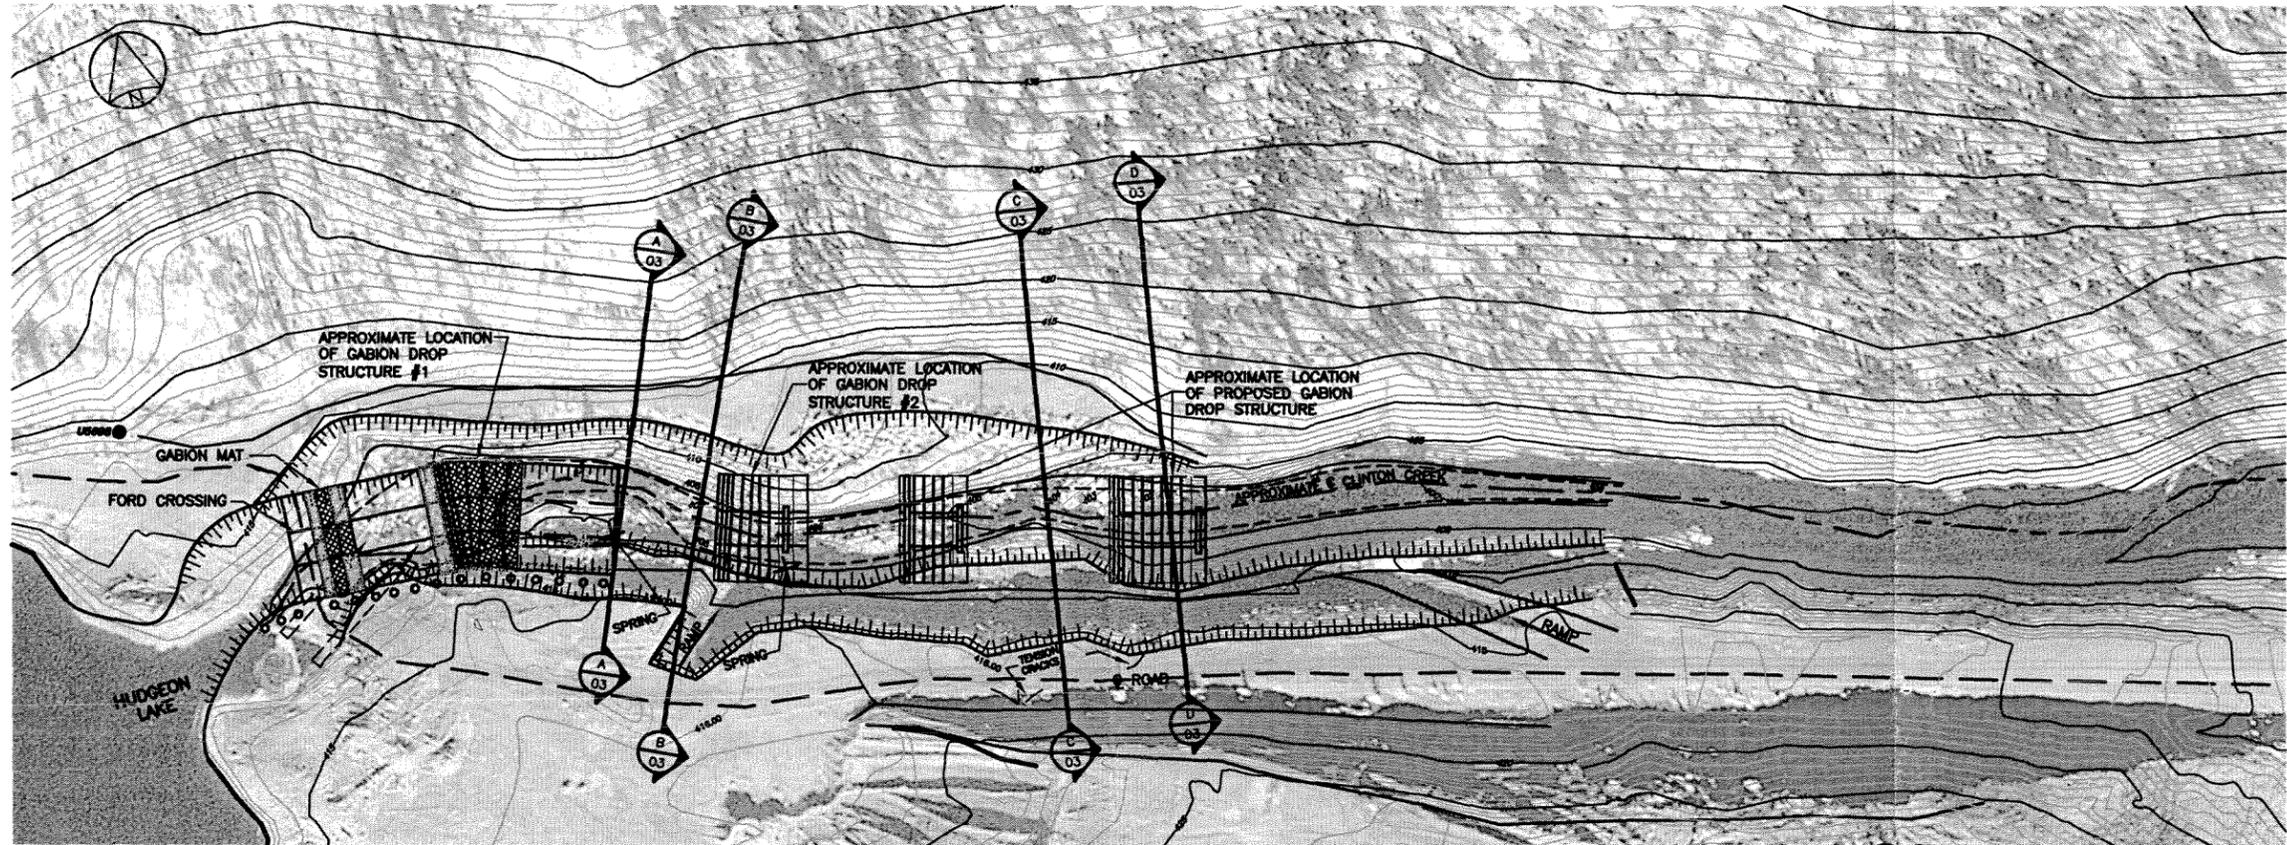
**CLINTON CREEK CHANNEL**  
SCALE 1:750

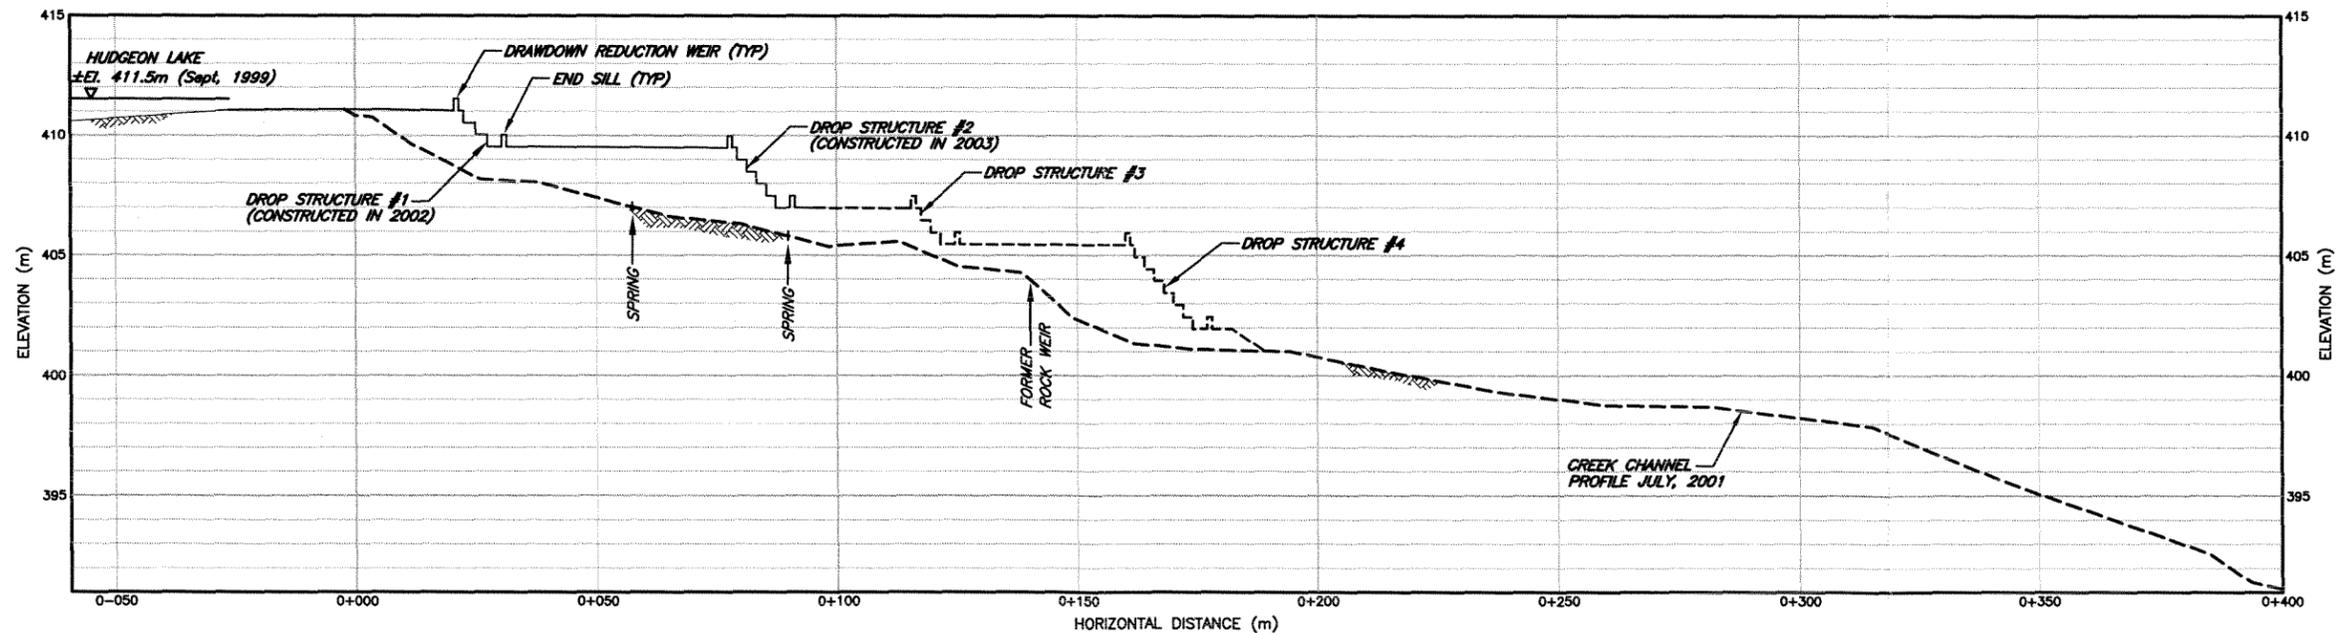
**CLINTON CREEK CHANNEL PROFILE**  
VER. SCALE 1:150  
HOR. SCALE 1:750

NOTE: FINAL LOCATION OF DROP STRUCTURES #3 AND #4 WILL BE DETERMINED DURING CONSTRUCTION.
