**CLINTON CREEK CHANNEL**

**STABILIZATION (STAGE II)**

**CONSTRUCTION REPORT**

**UMA Job No. 6029 004 00**

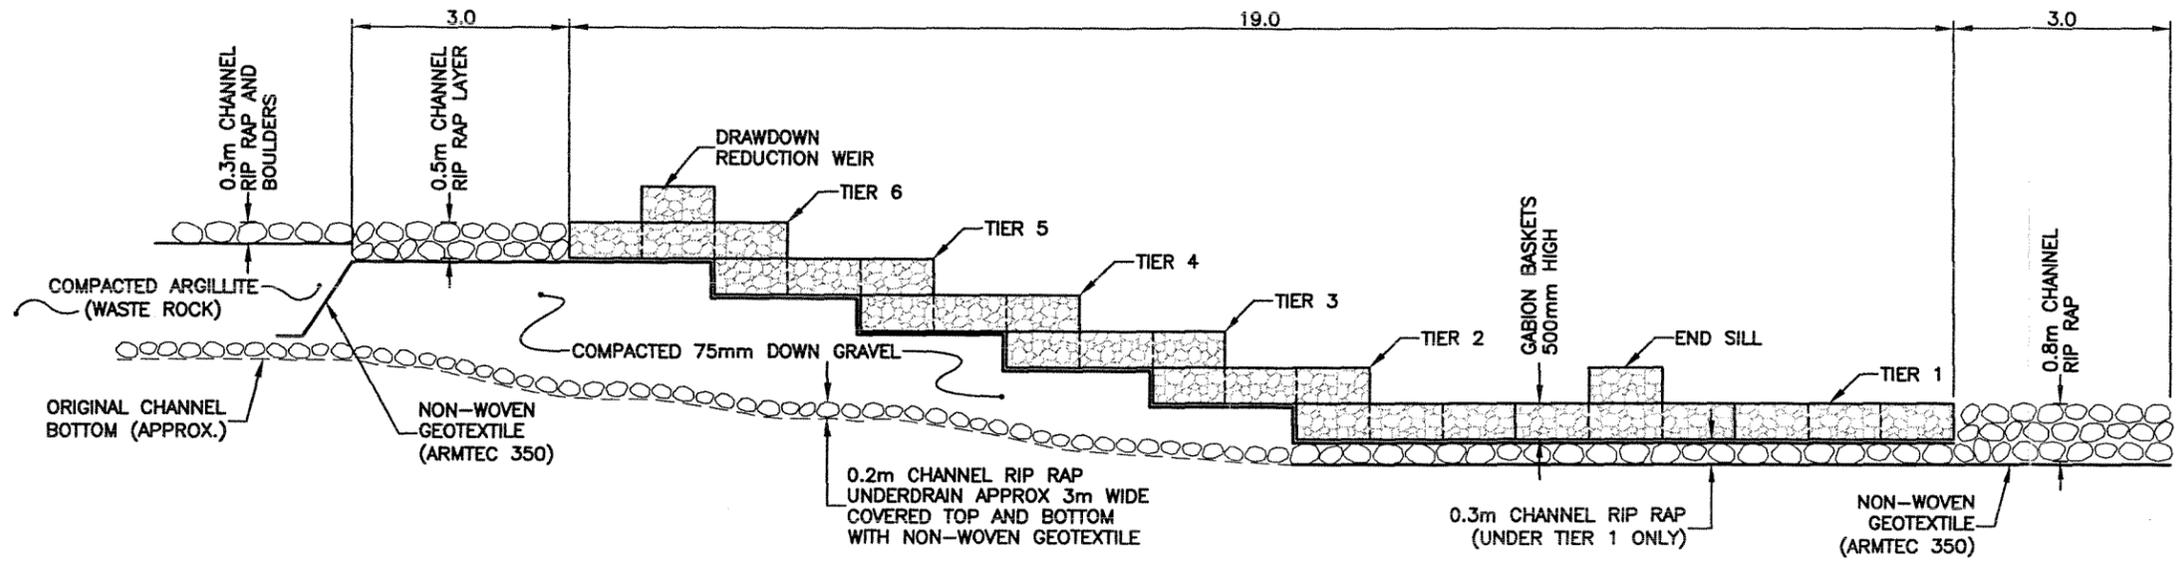
TIER	TOP OF BASKET ON $\phi$
1	406.84
2	407.48
3	408.03
4	408.52
5	409.03
6	409.60
END SILL	407.45
DRAWDOWN WEIR	410.10

**CENTERLINE PROFILE**  
1:50 A-A  
05

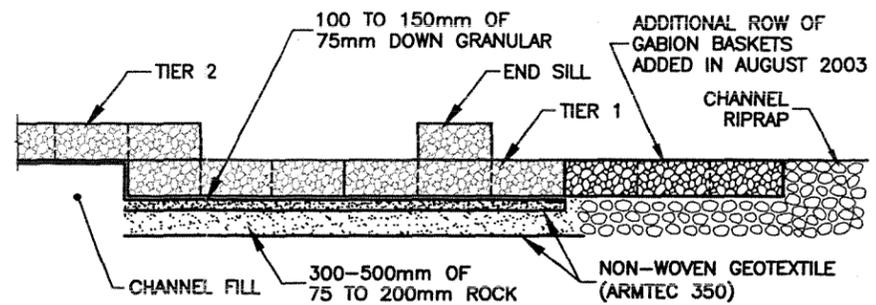
DETAIL OF BLANKET DRAIN CONSTRUCTED UNDER THE FLOOR OF TIER #1

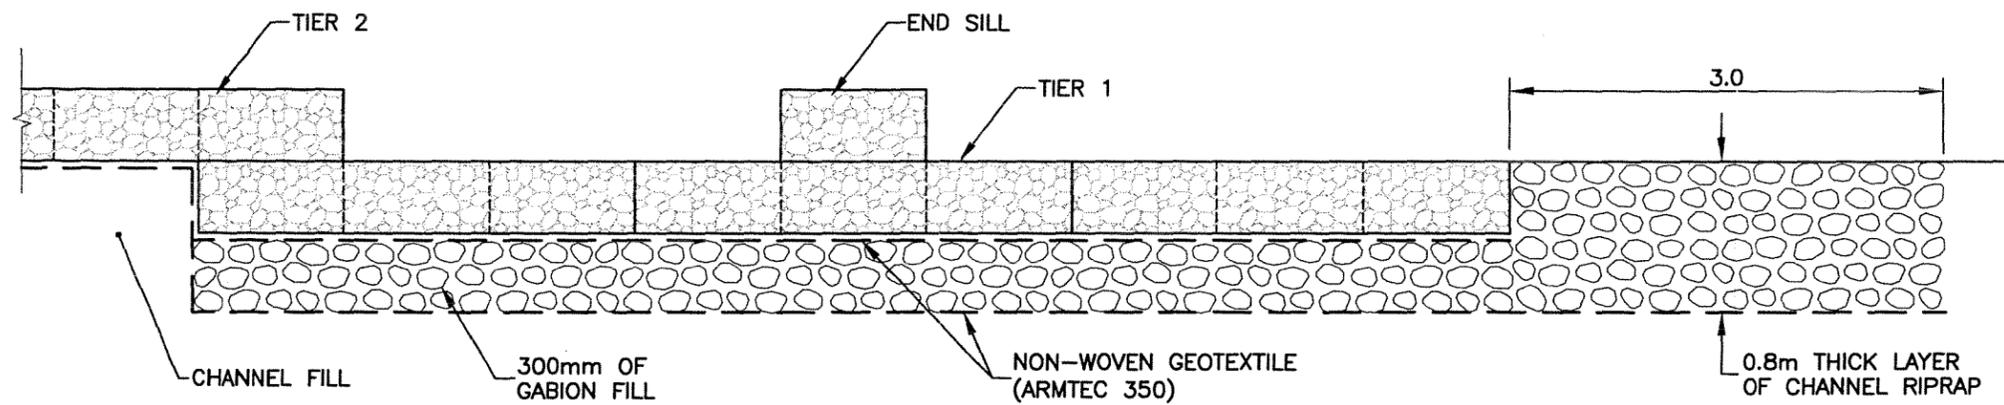
**DETAIL OF BLANKET DRAIN**
