**Clinton Creek,  
Fish Community Survey  
September, 2009**

**Prepared For  
Rachel Pugh  
Project Manager  
Assessment and Abandoned Mines Branch  
Energy, Mines and Resources  
Government of Yukon**

**PREPARED BY  
WHITE MOUNTAIN ENVIRONMENTAL CONSULTING  
PAUL SPARLING-  
P.O. Box 10140 Whitehorse,  
Yukon Y1A 7A1**

**November, 2009**

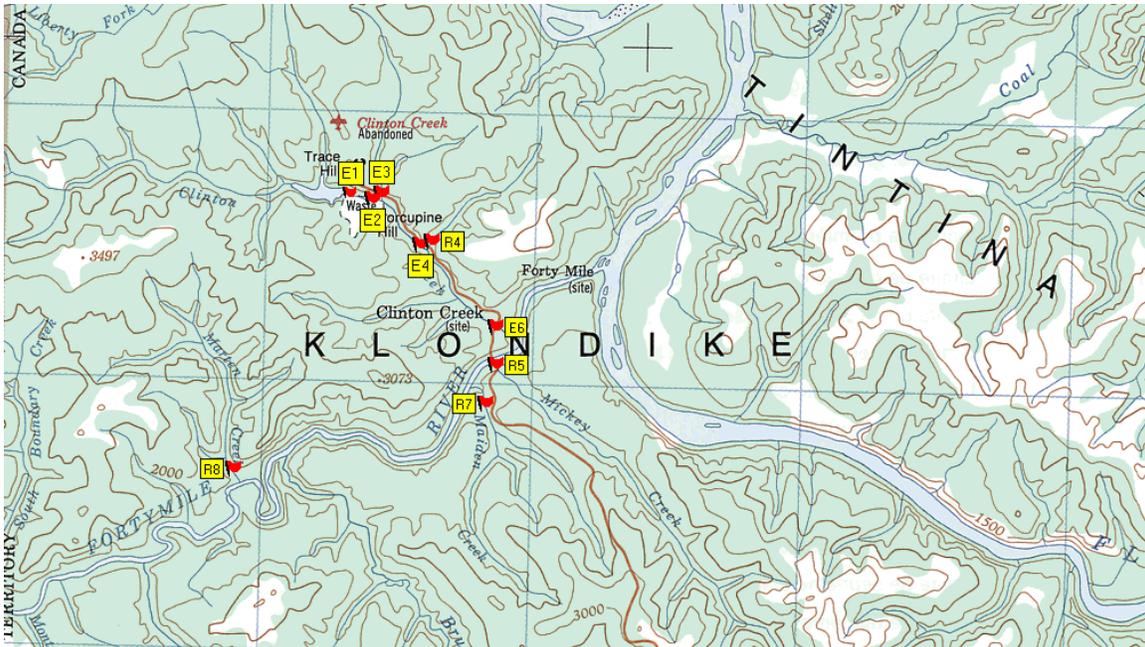
Figure 1: Map of the study area (from Topo map 116B & 116C) showing sample locations used during 2009 fisheries investigations at Clinton Creek mine site.

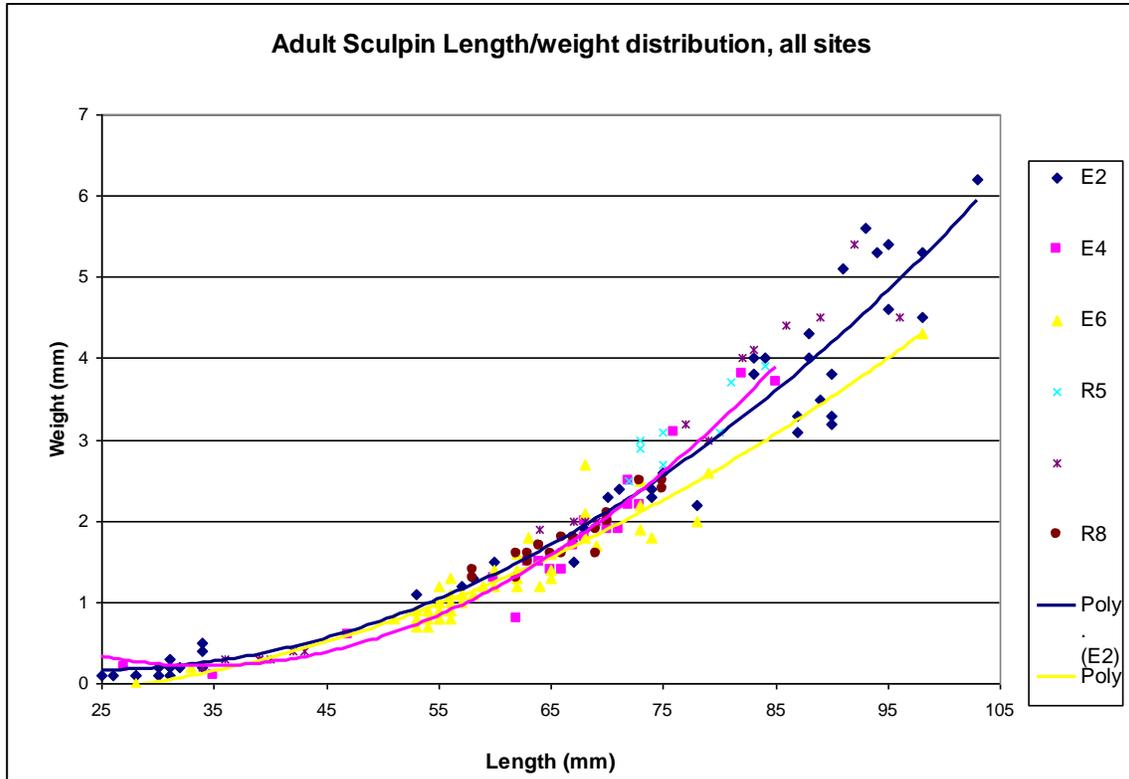
Figure 2: A comparison of slimy sculpin length weight relationships from all sites sampled during September, 2009 in the Clinton Creek area.

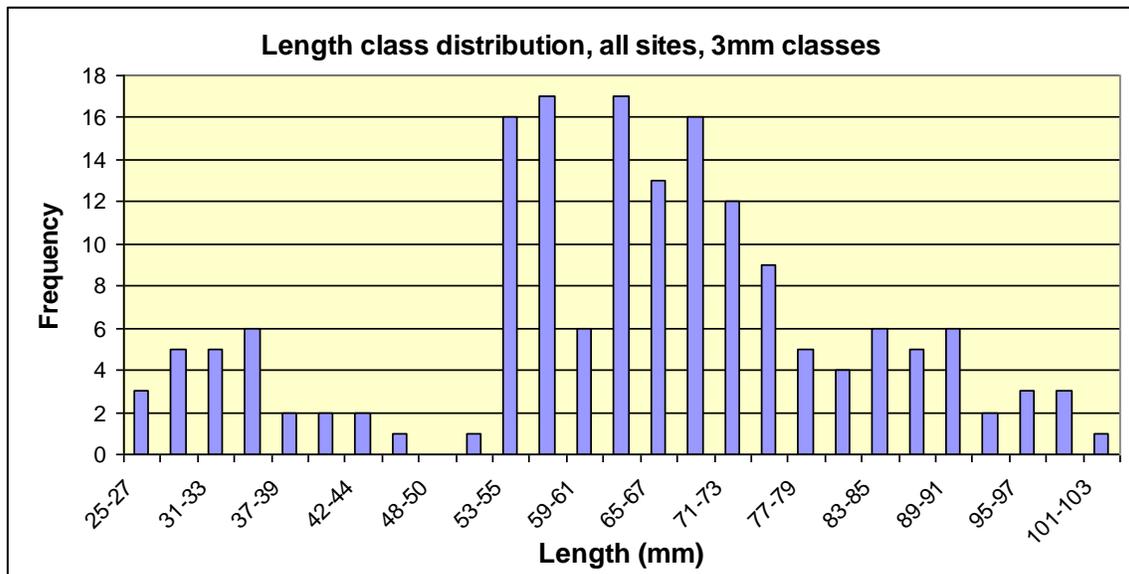
Figure 3: Combined length distribution for slimy sculpin from all areas sampled during September, 2009 in the Clinton area.

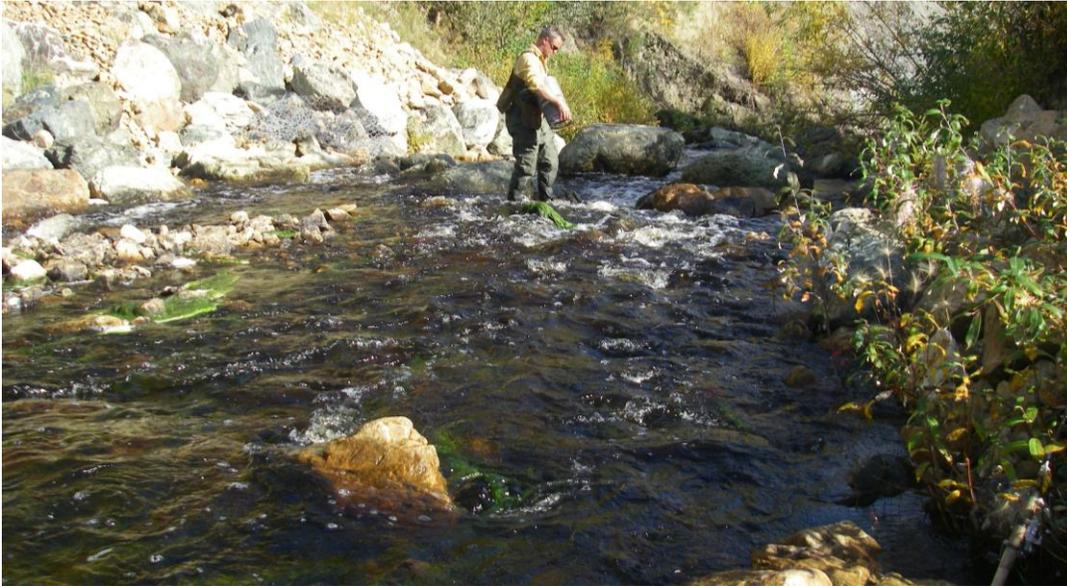
Figure 4: Clinton Creek at site E1 looking downstream from the gabions, September 8, 2009.

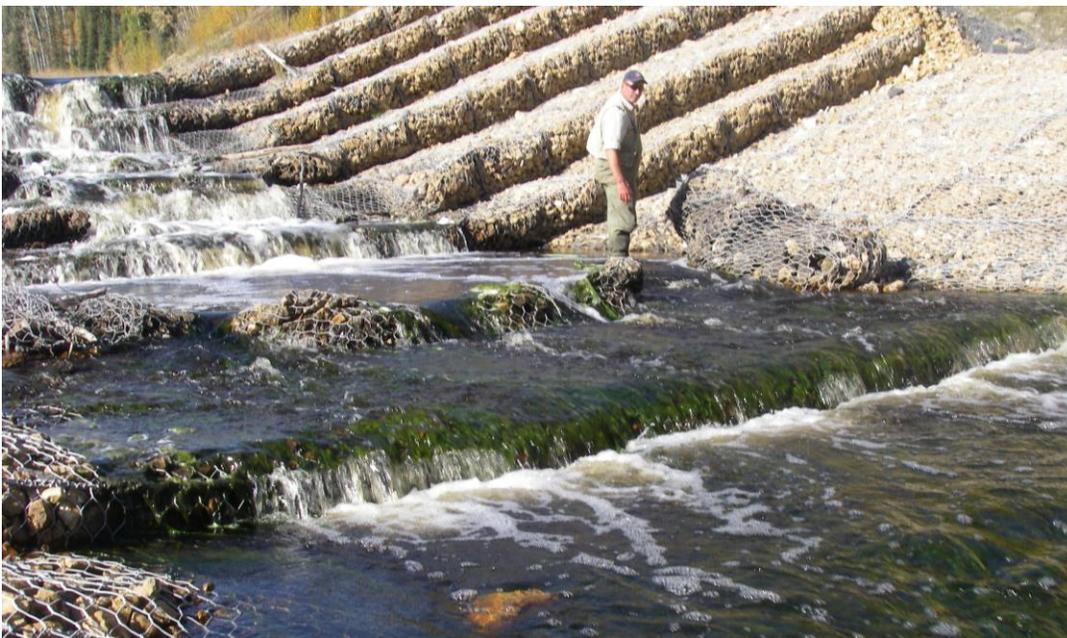
Figure 5: Clinton Creek site E1 looking upstream at the gabions, September 8. 2009. The pool the technician is standing in represents the uppermost location on Clinton Creek that fish were found.

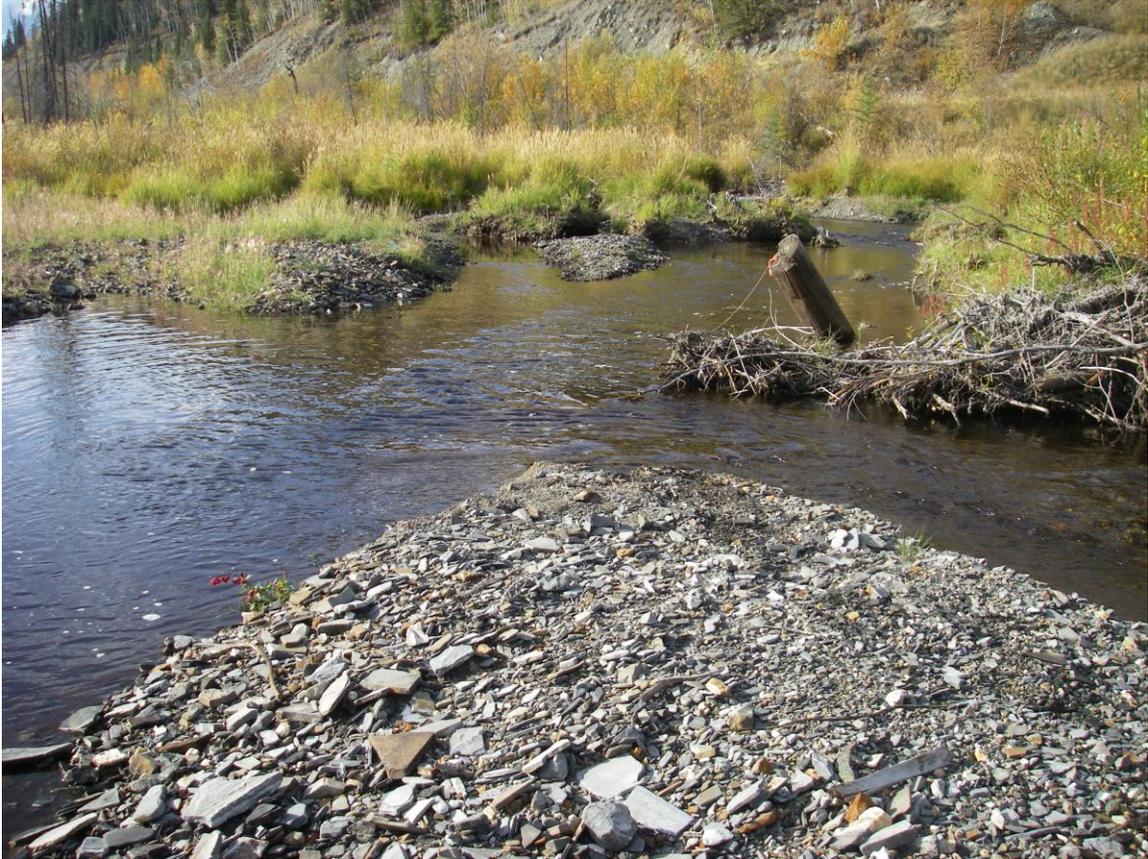
Habitats at site E2 have recently been modified by beaver activity. A large dam that held back Clinton Creek and Porcupine Creek in 2007, washed out, presumably in 2009. At the site of the old dam (approximately 50m upstream of Wolverine Creek) Clinton Creek now flows through a channel area with mid channel bars, cut banks, an attached large

Figure 6: Clinton Creek Site E2, upstream of Wolverine and Porcupine Creeks, September 9, 2009. The gravel bars are remnants of a large beaver dam that crossed Clinton Creek and contained the flow from Porcupine Creek. The dam likely washed out in spring of '09.

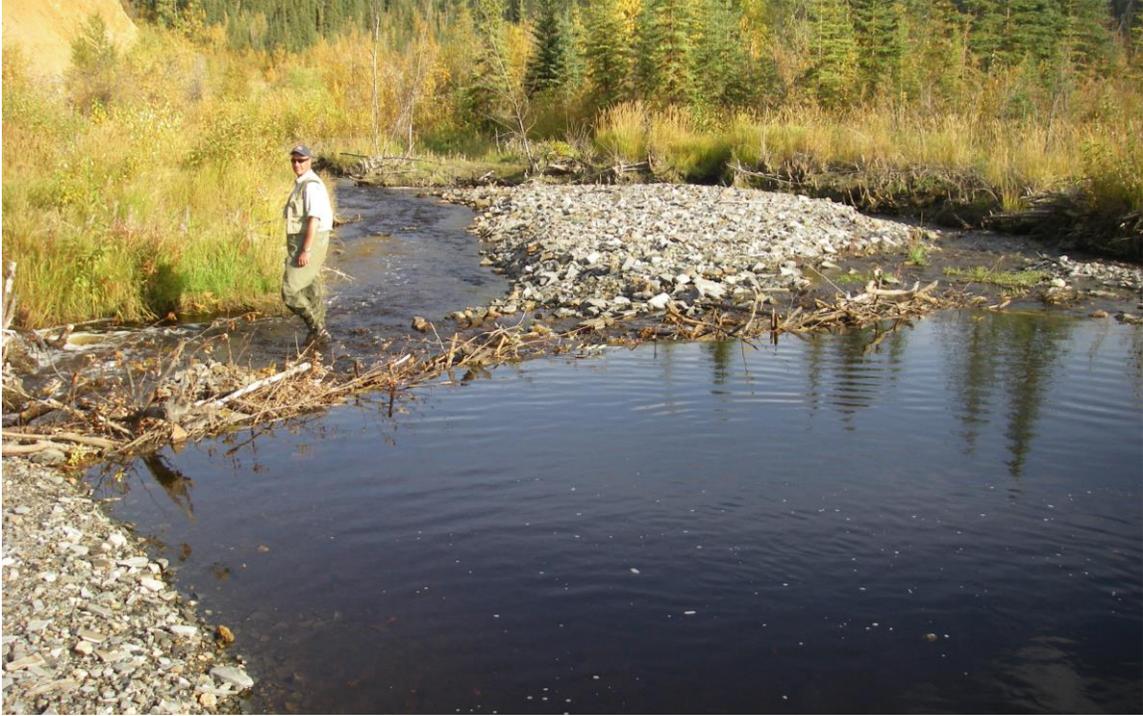
Porcupine Creek flows into Clinton Creek approximately 75 meters upstream of Wolverine Creek. At the time of investigation the creek was blocked by a beaver dam that ran parallel to Clinton Creek with a resulting pond 25 meters in diameter. Upstream of the beaver pond the flows of Porcupine Creek run through the old mining area in a poorly defined channel that often runs subsurface making it difficult to calculate the volume of water in the creek. Fish habitats are very limited upstream of the beaver pond.

Figure 7: Porcupine Creek was dammed by beavers during the summer of 2009 at the confluence with Clinton Creek. The dam shown in the photo is only a secondary dam below the main dam and not the main dam. The flowing water is Clinton Creek.

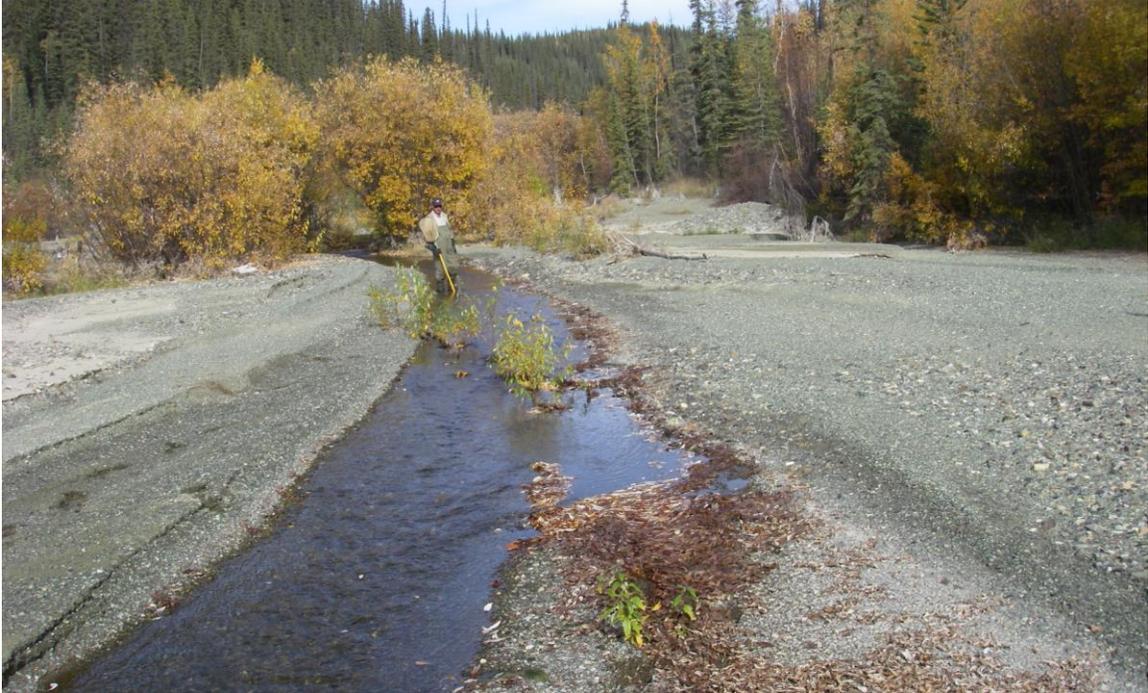
Upstream of the hanging culvert the creek is small and subject to flooding caused by the culvert. The 75m reach immediately upstream of the culverts has been flooded out on numerous occasions and has significant accumulations of fine materials (asbestos), the creek flows as a featureless glide in this reach. Small step riffles and pools caused by debris piles do occur in the wooded areas of the channel 75m upstream of the culvert.

Figure 8: Wolverine Creek immediately upstream of the road. Note the depositions of fines dropped out due to spring pooling upstream of the culverts. September 9, 2009.

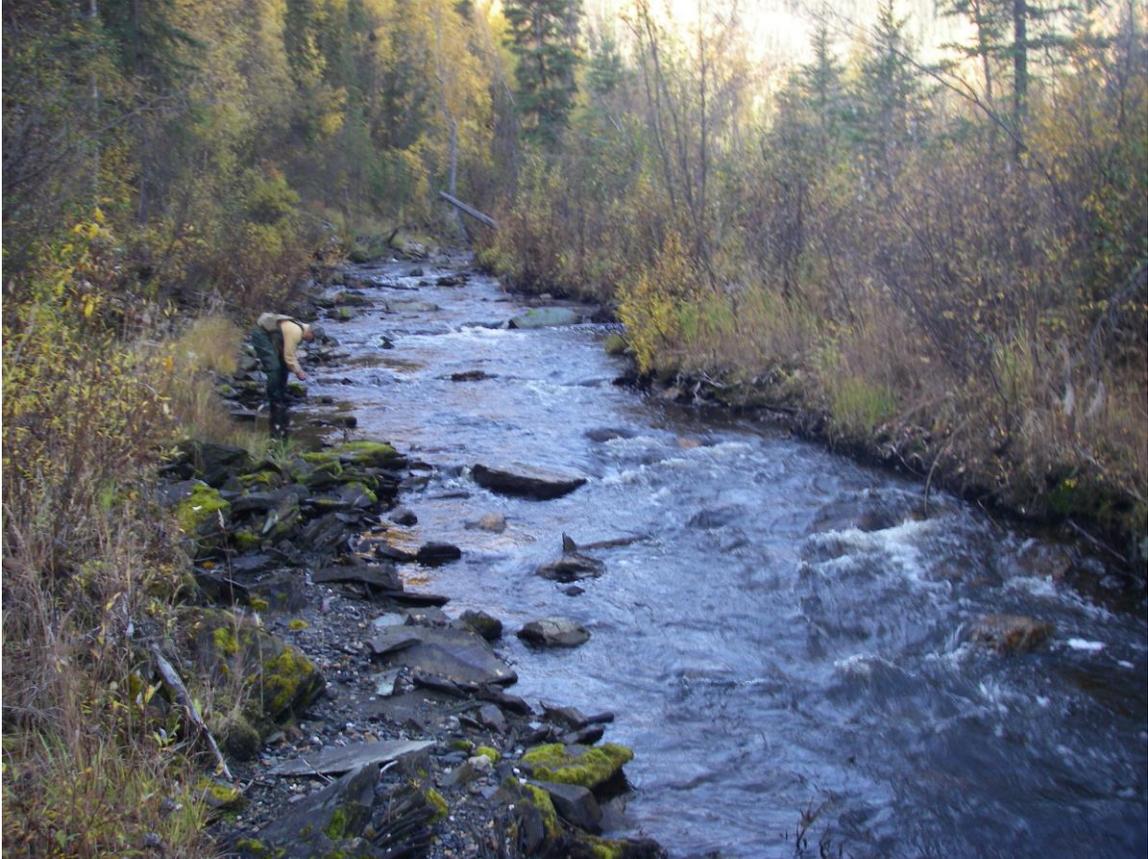
Figure 9: Clinton Creek at site E4, 100 meters upstream of the confluence with Eagle Creek, Sept 8, 2009

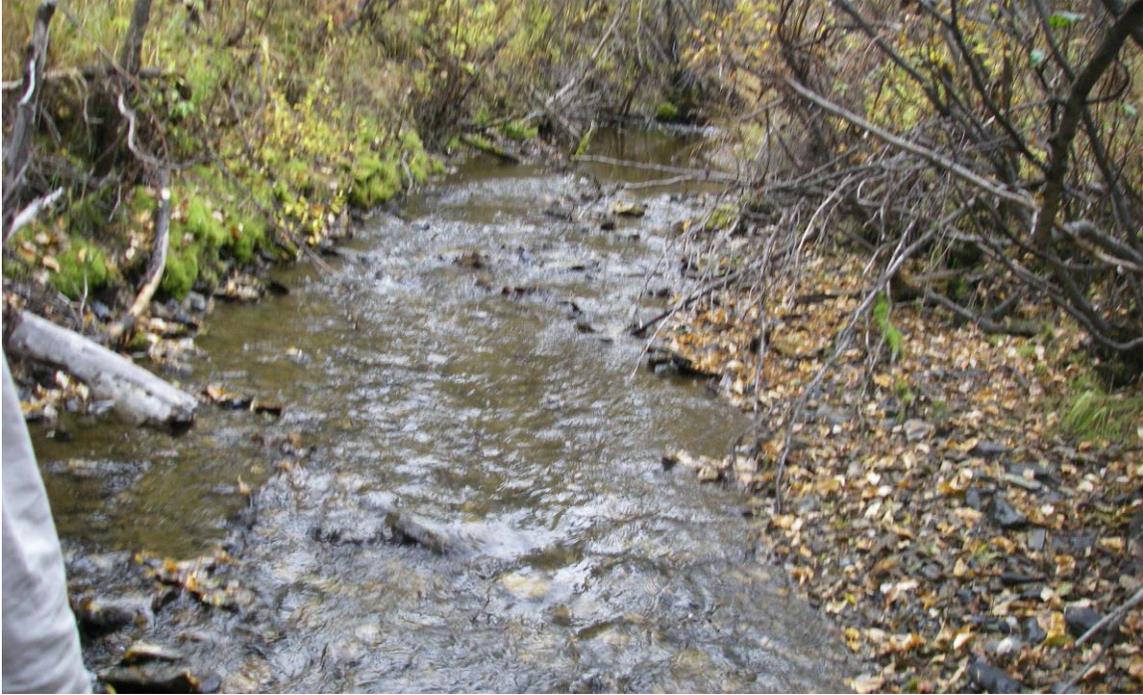
Figure 10: Eagle Creek immediately upstream of the culvert at the Clinton mine site access road, September 8, 2009.

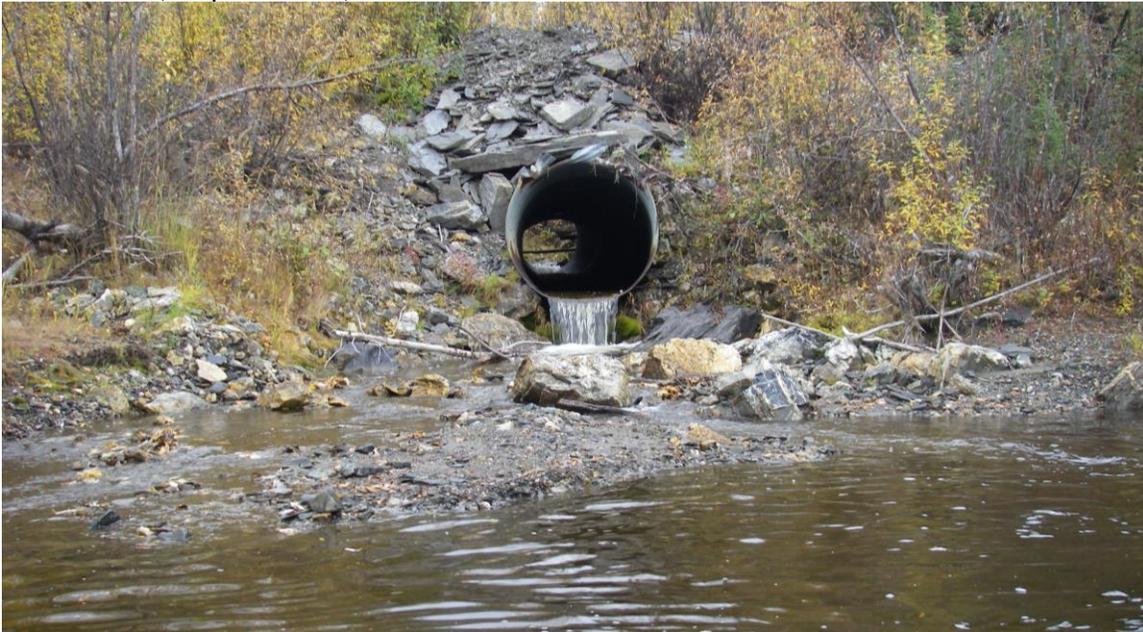
Eagle Creek is crossed by the mine site access road within 25 meters of its confluence with Clinton Creek. The culvert has a plunge of 0.5 meters on the downstream side and was a complete barrier to fish passage at the observed flow. Upstream of the culvert Eagle Creek flows in a well defined channel that is totally confined. At the time of the investigation the average wet width was 1.5 meters inside a channel of 2.5 meters that had abrupt banks rising 1.5 to 2.5 meters. The average depth was only 10 cm and the

Figure 11: Eagle Creek entering Clinton Creek through the suspended culvert. September 8, 2009.

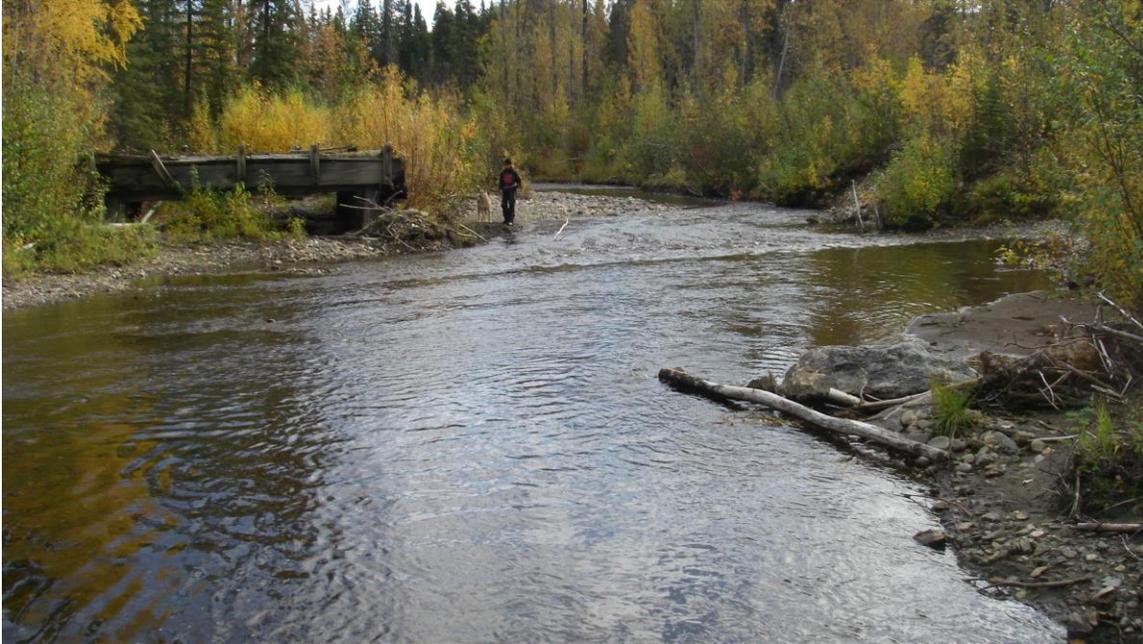
This site is located immediately upstream of the old Clinton Creek Town site road. At present the road crosses Clinton Creek as a ford, during the life of the mine there was a bridge at this location and the old abutments remain downstream of the present ford.

Figure 12: Looking downstream at Site E6, Clinton Creek at the town site ford. The ford follows the riffle line upstream of the old bridge abutments. September 10, 2009.

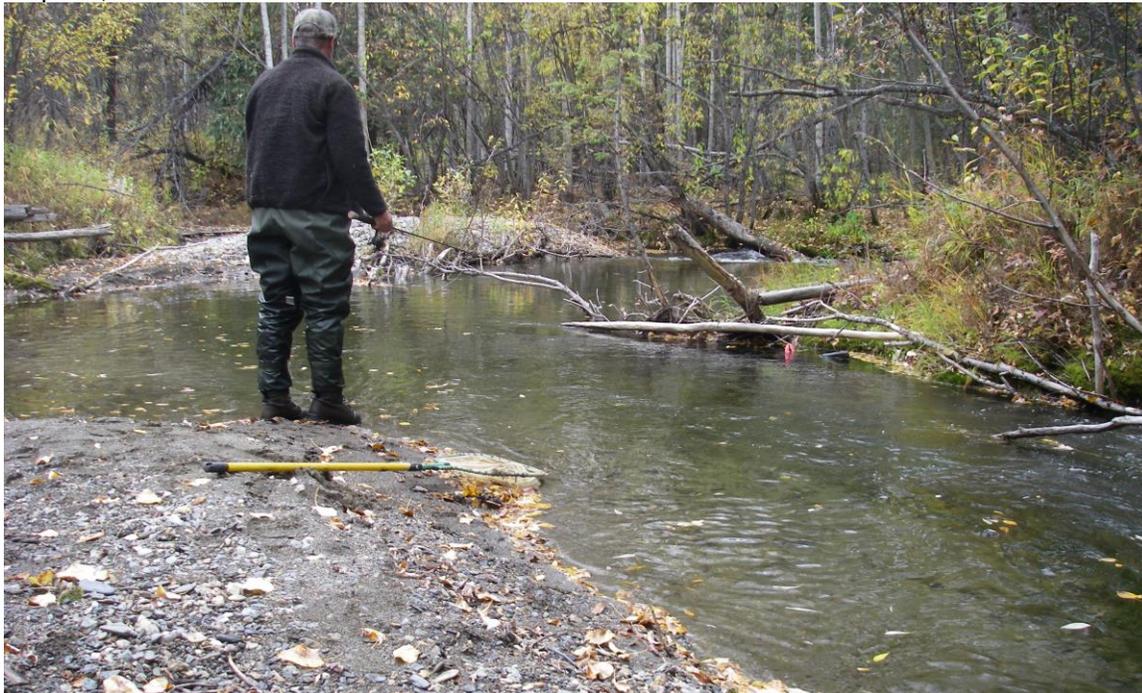
Figure 13: Mickey Creek downstream of the culvert pool. September 11, 2009.

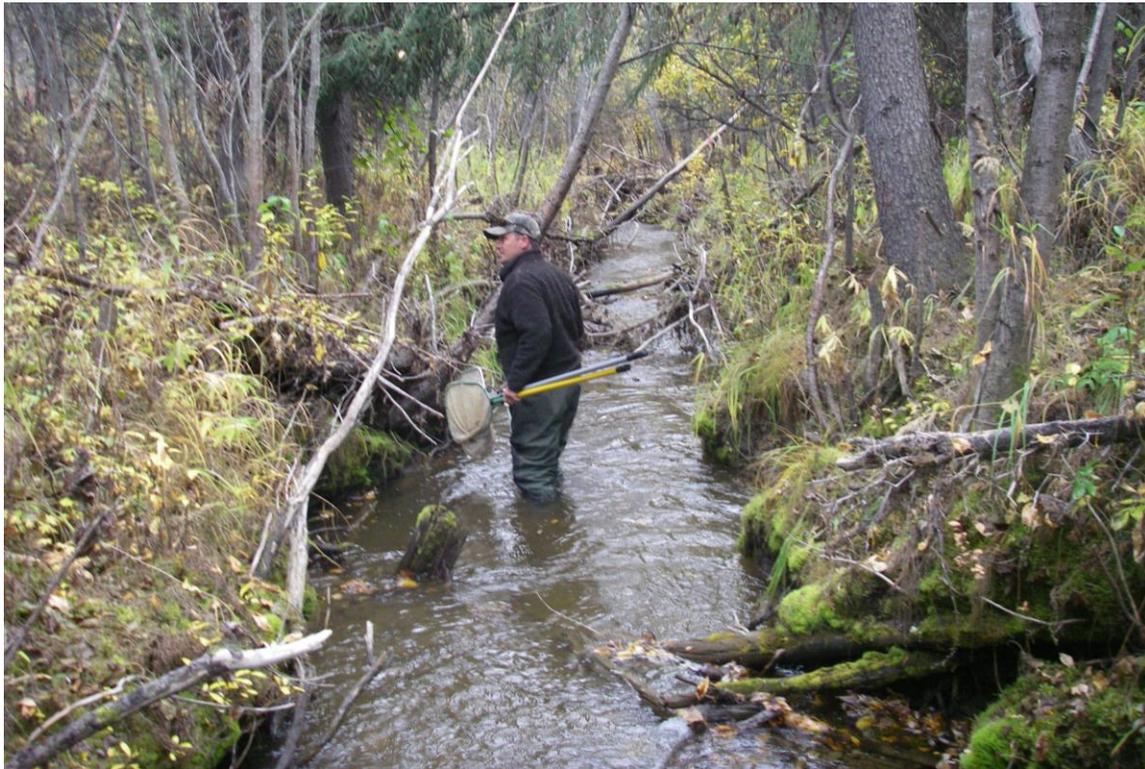
Figure 14: Maiden Creek, September 11, 2009.

A total of 685 seconds of electro-fishing time was expended on Maiden Creek and no fish were captured or observed.

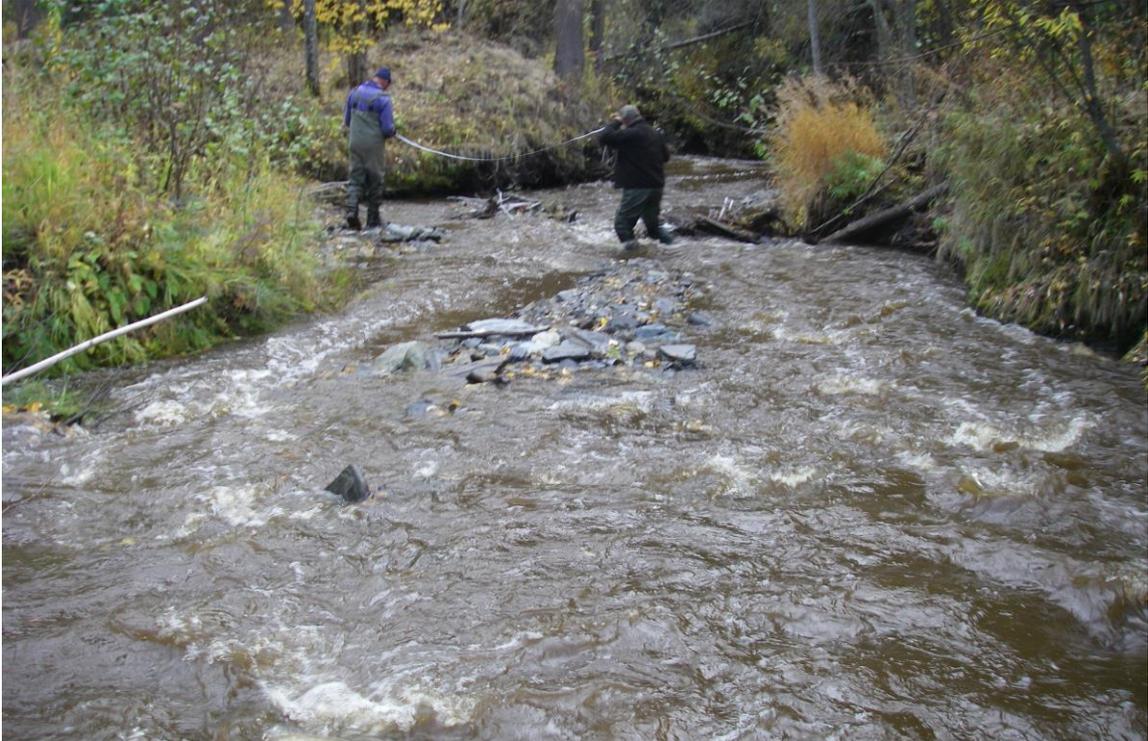
Figure 15: Sampling on Marten Creek, September 11, 2009

Date	pH	Temp (C)	Air Temp (C)	Cond (uS/cm)	Visual color
Sept 11, 09	8.01	5.2	15		Tannin stain with high silt load

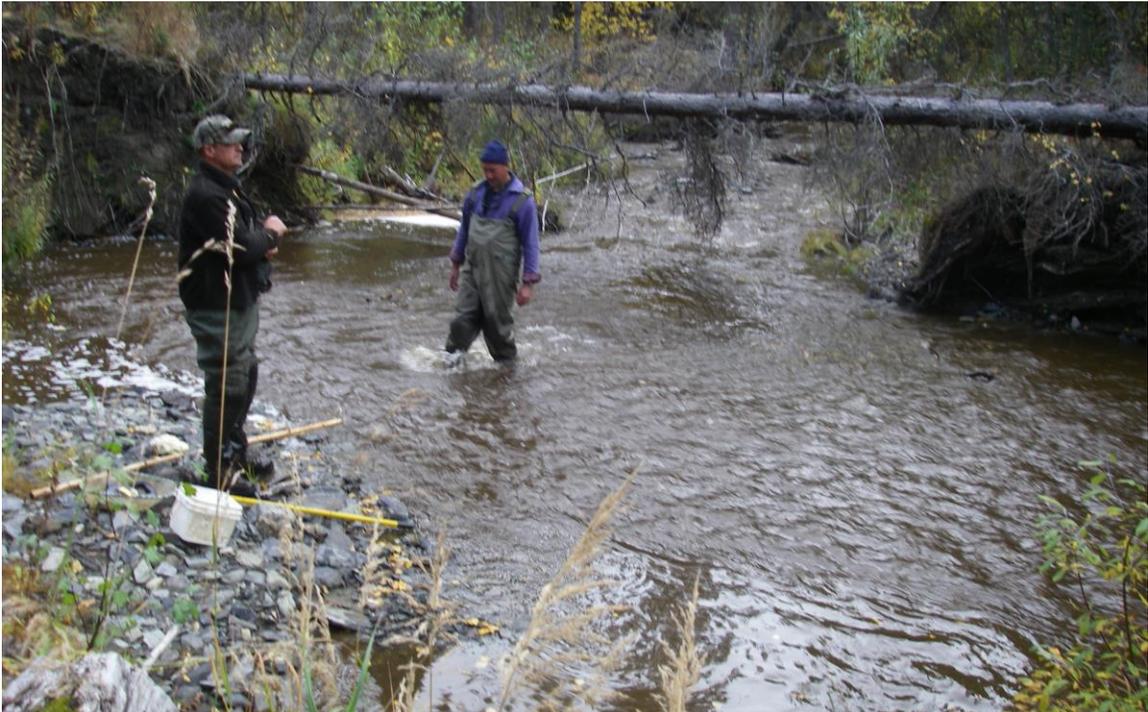
Figure 16: The largest corner pool on Marten Creek was at the edge of the placer mined area, September 11, 2009.
