CLINTON CREEK CRACK  
MONITORING

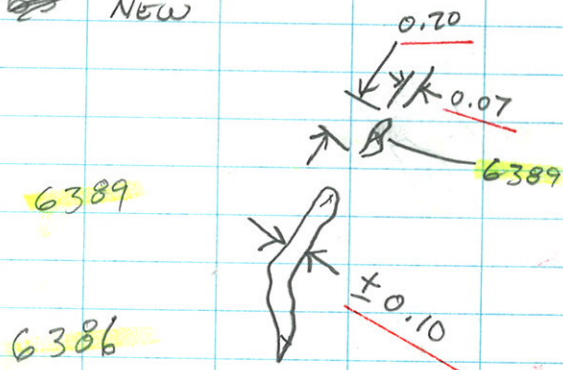
6324 TO 6385

TOP OF STEEP SLOPE

NOTES 6355 TO 6356

CRACK TIES OLD & NEW

~~NEW~~ NEW

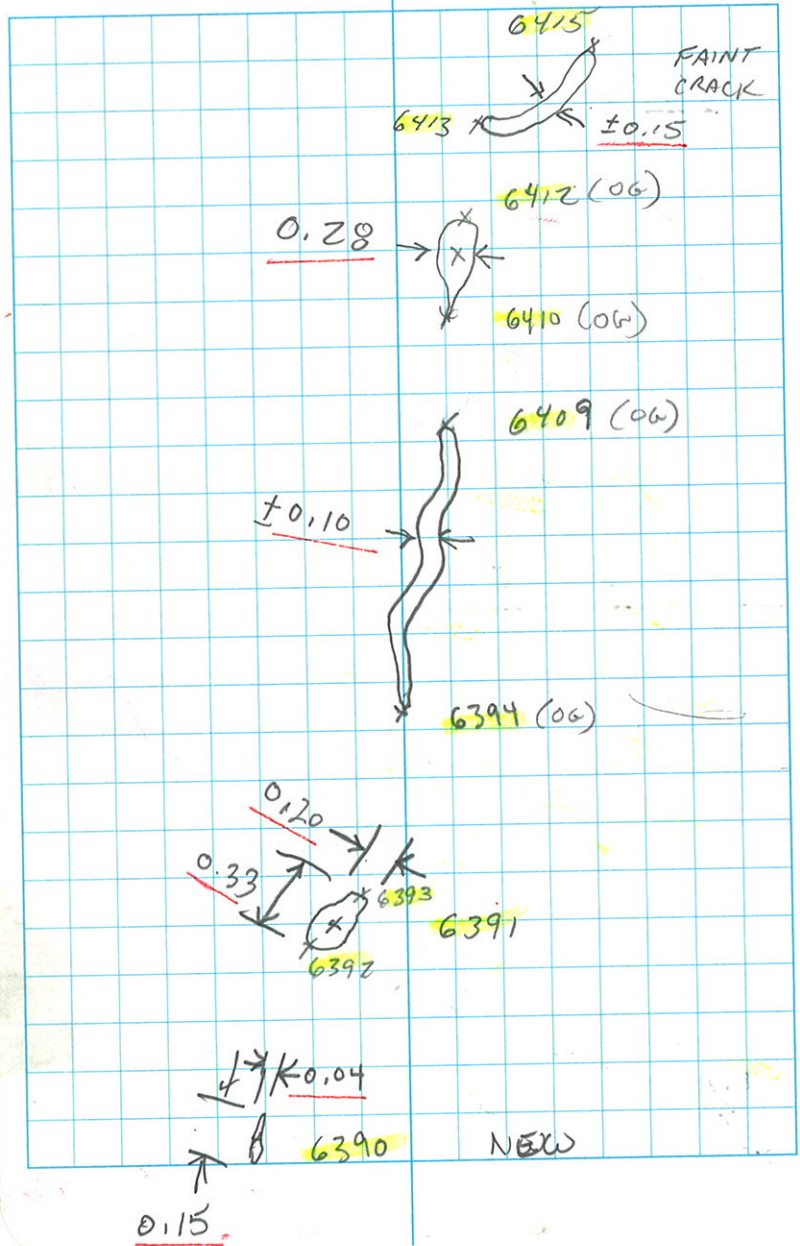
No.352

6529	→	6531		
		FAINT CRACK	<u>± 0.1</u>	WIDG
6532	→	6536	<u>± 0.06</u>	
6537	→	6541	<u>± 0.07</u>	} FAINT & NOTICE ABLE
6542	→	6546	"	
6547	→	6551	<u>± 0.15</u>	} NOTICE ABLE
6552	→	6566	<u>± 0.20</u>	
6567	→	6592	<u>± 0.12</u>	FAINT
6593	→	6595	<u>± 0.10</u>	FAINT
6596	→	6598	<u>± 0.07</u>	FAINT//Not
6599	→	6607	<u>± 0.10</u>	NOTICE ABLE
6608	→	6613	<u>± 0.10</u>	FAINT NOT.
