June 19, 2006

UMA Project No. 6029 007 00 (4.6.1.2)

Re: Former Clinton Creek Asbestos Mine – 2005 Engineering Services: Site Inspection and Monitoring Results

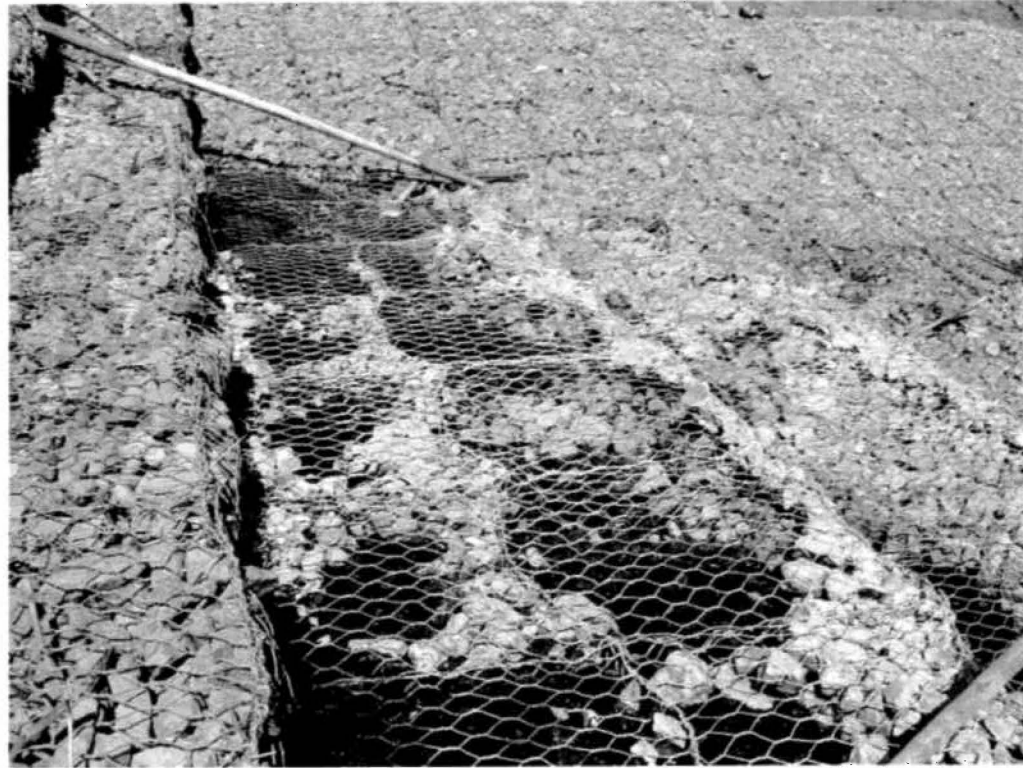
Due to the flow depth over the gabions at the time of the inspection (approximately 600 mm deep over the drawdown weirs), it was not possible to confirm the extent of the gabion fill material that was washed out of the baskets during the spring freshet event. As illustrated in Photograph 1, taken about 1 month after the site inspection, some gabion fill had been washed out of the baskets forming the floor of Drop Structures 3 and 4, constructed in 2004. Similar material loss occurred in Drop Structures 1 and 2 during the first spring freshet event that passed following each year of construction. The material loss observed in previous years was mitigated by opening the affected baskets and topping them off with 100 to 200 mm diameter gabion fill material. No noticeable material loss has since been observed in the baskets that were topped off.

Photograph 1: Erosion of gabion fill from baskets following first spring freshet event

Gabion Baskets - open and top off all gabion baskets where there is a void in the basket that is 100mm deep or greater. Top off baskets with 100 to 200 mm diameter gabion fill which is available on site. Re-attach basket lids to the basket frame with stainless steel staples.

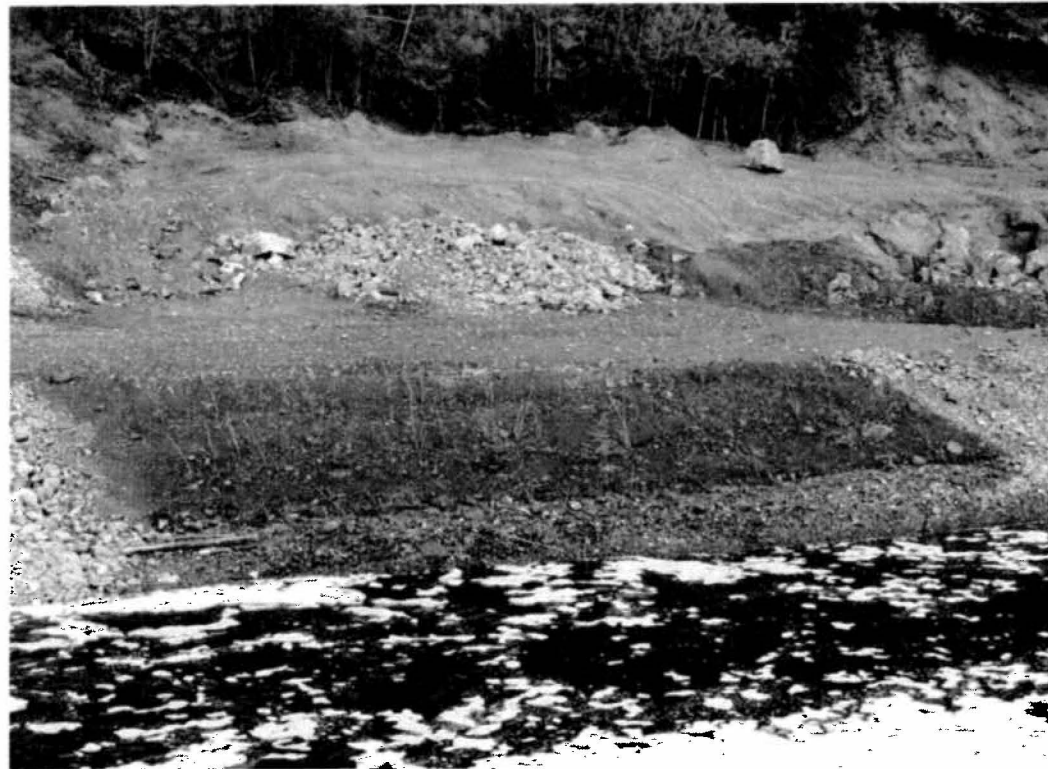
In September 2004, tree planting and grass seeding was undertaken at various areas of the former mine site. Of most concern are the willow shoots and small coniferous trees planted in the creek channel between the drop structures, as shown on Photograph 3. The channel has been designed with a very flat gradient of about 0.01 percent to reduce the flow velocity and potential for erosion of the channel between the drop structures (UMA 2003) and therefore does not to be stabilized with vegetation. In addition, the channel was designed to pass a certain creek flow and did not account for hydraulic losses resulting from trees in the channel cross-section. Removal of this vegetation is recommended.

Photograph 3: High water line from spring freshet and vegetation planted on channel slopes.

Vegetation - Remove all non-grass vegetation located within the channel cross-section.

1) vegetation (trees) planted on the channel slopes between the drop structures should be removed as they restrict flow in the channel, particularly as the trees start to grow and produce seed for new trees. The channel cross-section was not designed to include hydraulic resistance due to trees so in the event of high flows, there is a chance that the channel won't be able to handle the flow. We recommend that the trees be replanted at least 10 m away from the channel crest to permit access for maintenance when required.

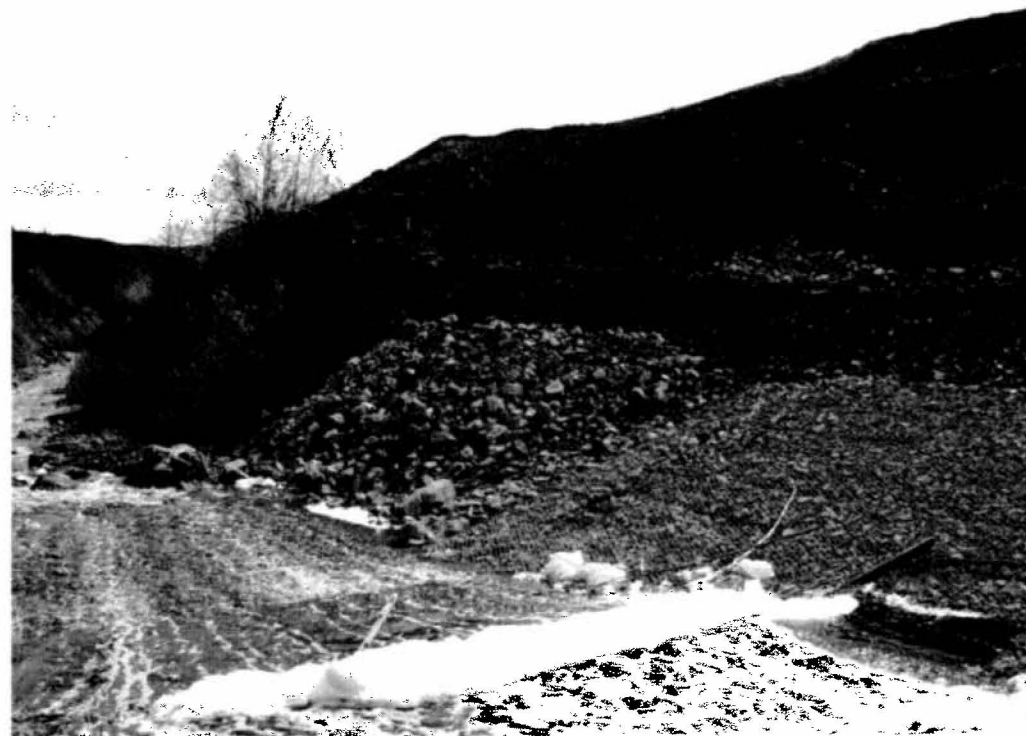
The portion of the Clinton Creek channel most susceptible to erosion is just past the downstream end of the last drop structure (Drop Structure #4) where there is a transition from the stabilized portion of the channel to the existing creek channel. As illustrated on Photograph 4, the channel transition downstream of Drop Structure 4 showed signs of some erosion on the left hand (north) side of the channel and shifting of some of the large boulders. It was anticipated that this might occur and that some maintenance work would be required in 2005 to adjust and infill the armouring after the first spring fresh. Minimal, if any, erosion occurred on the right hand side of the channel (Photograph 5).

Photograph 5: Minimal erosion on right hand side of the channel transition downstream of Drop Structure 4.

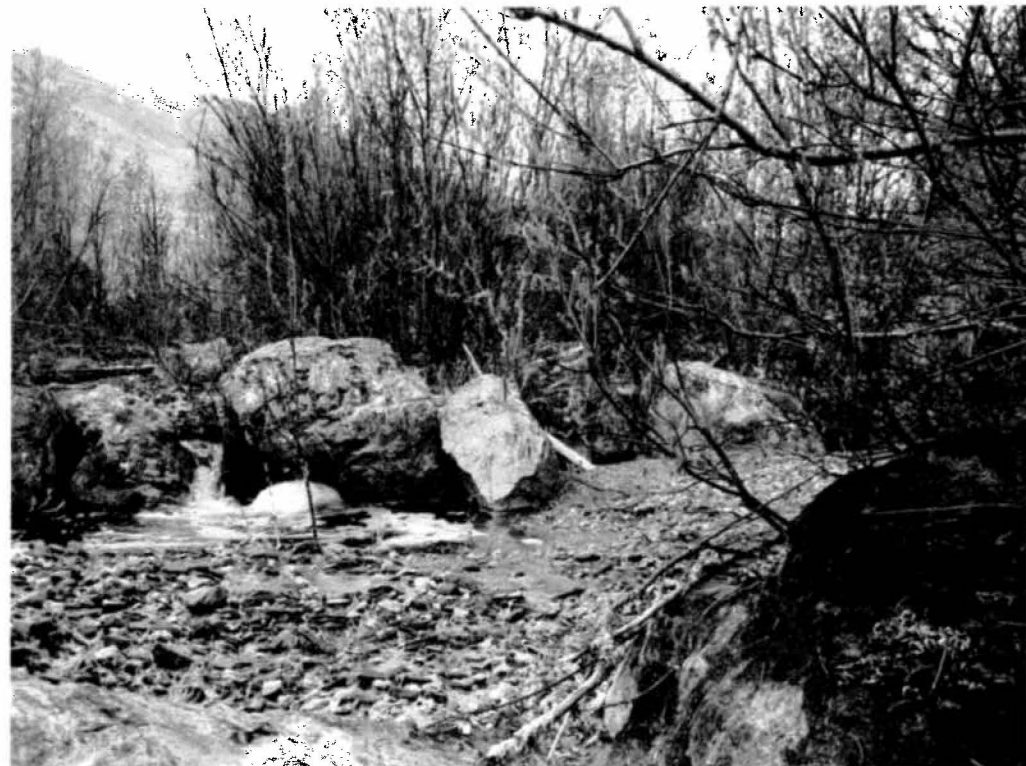
While on-site for the inspection work of the Clinton Creek channel stabilization works, the condition of the rock lined portion of Wolverine Creek, located just down stream of the south lobe of the tailings pile, was inspected and photographed. Photographs are provided on the attached Compact Disc. In general, the rock lined channel originally constructed in 1978 is functional. Some trees have grown in and around the channel (Photograph 6) and may be affecting the hydraulic capacity although there were no obvious signs that flow had overtopped the banks. No significant channel blockages were identified although there are some signs of sedimentation taking place and some shifting of boulders that form the rock lined weirs (Photograph 6).

Photograph 6: Wolverine Creek - Rock lined channel: trees growing in channel and some sedimentation occurring.

There is no immediate maintenance to be undertaken on the rock weirs pending further inspection by UMA in 2006 as part of the recommended long term performance monitoring program (UMA 2006a).

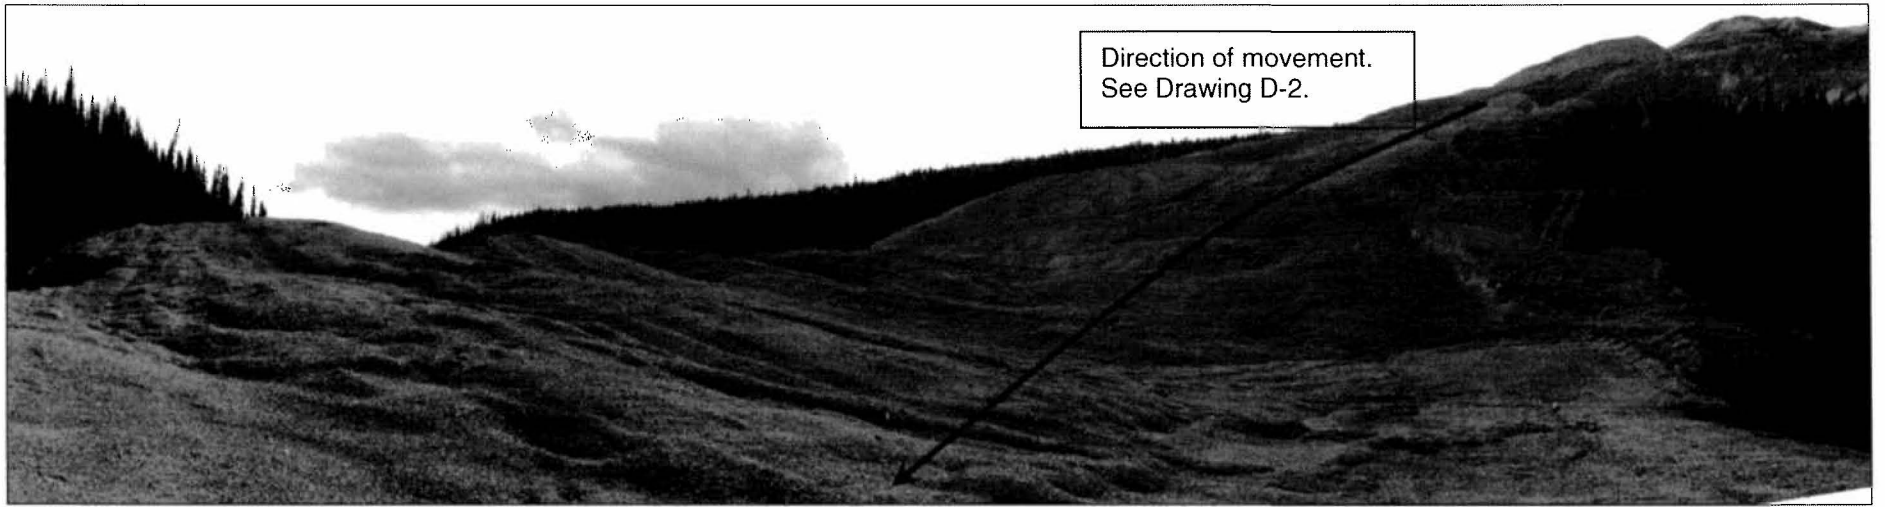
As illustrated in Photograph 7 taken from the northern edge of the lower slope area, the tailings appear to be moving in the direction of least resistance (i.e. where less tailings have mounded up) or towards the pond between the lobes. The general direction of movement of the tailings is shown on Drawing D-2, which was generated by drawing a smooth fit line along the vectors for Monitors 1084, 1485, 24A, 24B, 24D, SL-3 and 1484. The tailings in the mid slope area have a gentle curve to the north which becomes more pronounced on the lower slope area, where the height of mounded tailings is noticeably less (Photograph 7). Consistent with historical monitoring trends, the tailings in the area of Monitors 25B, SL-1 and SL-2 are generally moving eastwards towards the creek channel. Future monitoring of the additional points added in 2005 should help to interpret the movement behaviour in this area of the tailings.

Photograph 7: South Lobe of tailings pile taken facing south from the north end of the lower slope near Wolverine Creek.

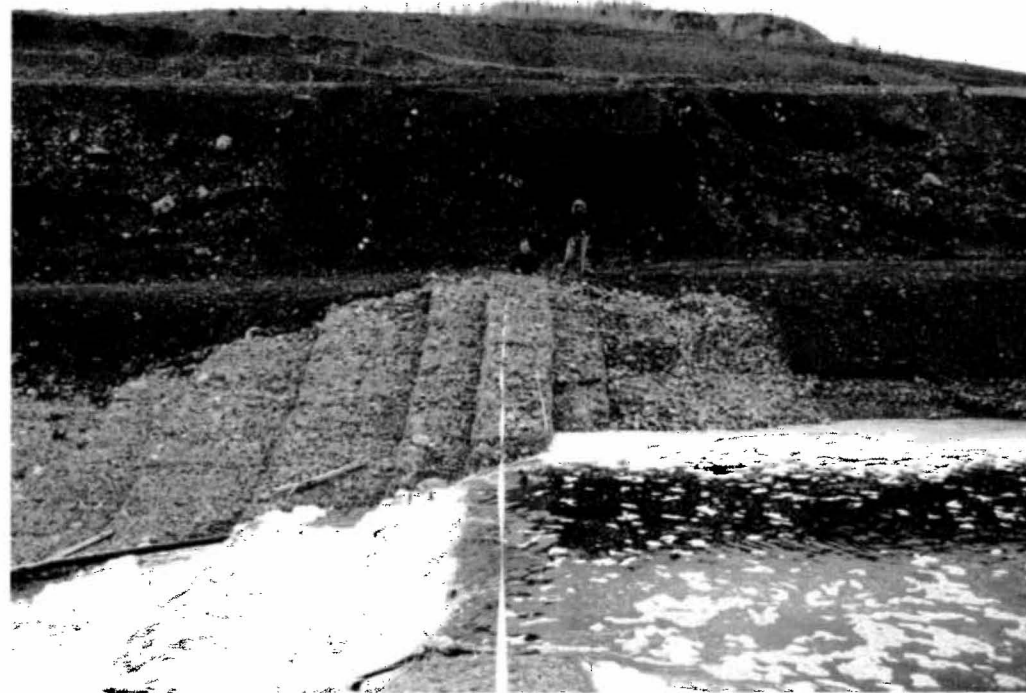
Horizontal measurements of the gabion drop structures were taken during the May 2005 site inspection and are provided in Table C-1 (Appendix C). Each drop structure was measured at the two locations shown on Drawing C-1 and illustrated on the two photographs in Appendix C. Previous (i.e. baseline) readings were only available for Measurement Location #1 on Drop Structures 1 to 3. Where no previous readings were recorded, the May 2005 measurements will serve as baseline readings for future monitoring. At Drop Structures 1 to 3, the distances measured across the drawdown weir were 1 to 12 cm shorter than those taken the previous year. The shorter distances measured may be a result of creep movements of the adjacent waste rock pile, post-construction settlement of the drop structures and/or some minor displacements resulting from the spring freshet event. Long term monitoring, including the installation of additional cross-channel reference points will assist in determining the nature of these movements and their potential impact on the integrity of the channel stabilization works (UMA 2006a).

Photograph C1: Gabion drop structure - measurement location 1 across drawdown weir.
