March 31, 2016

ISSUED FOR USE
FILE: ENG.WARC03039-01.002
Via Email: erik.pit@gov.yk.ca

Subject: Data Gap Assumption Report
Abandoned Clinton Creek Asbestos Mine Site, Yukon

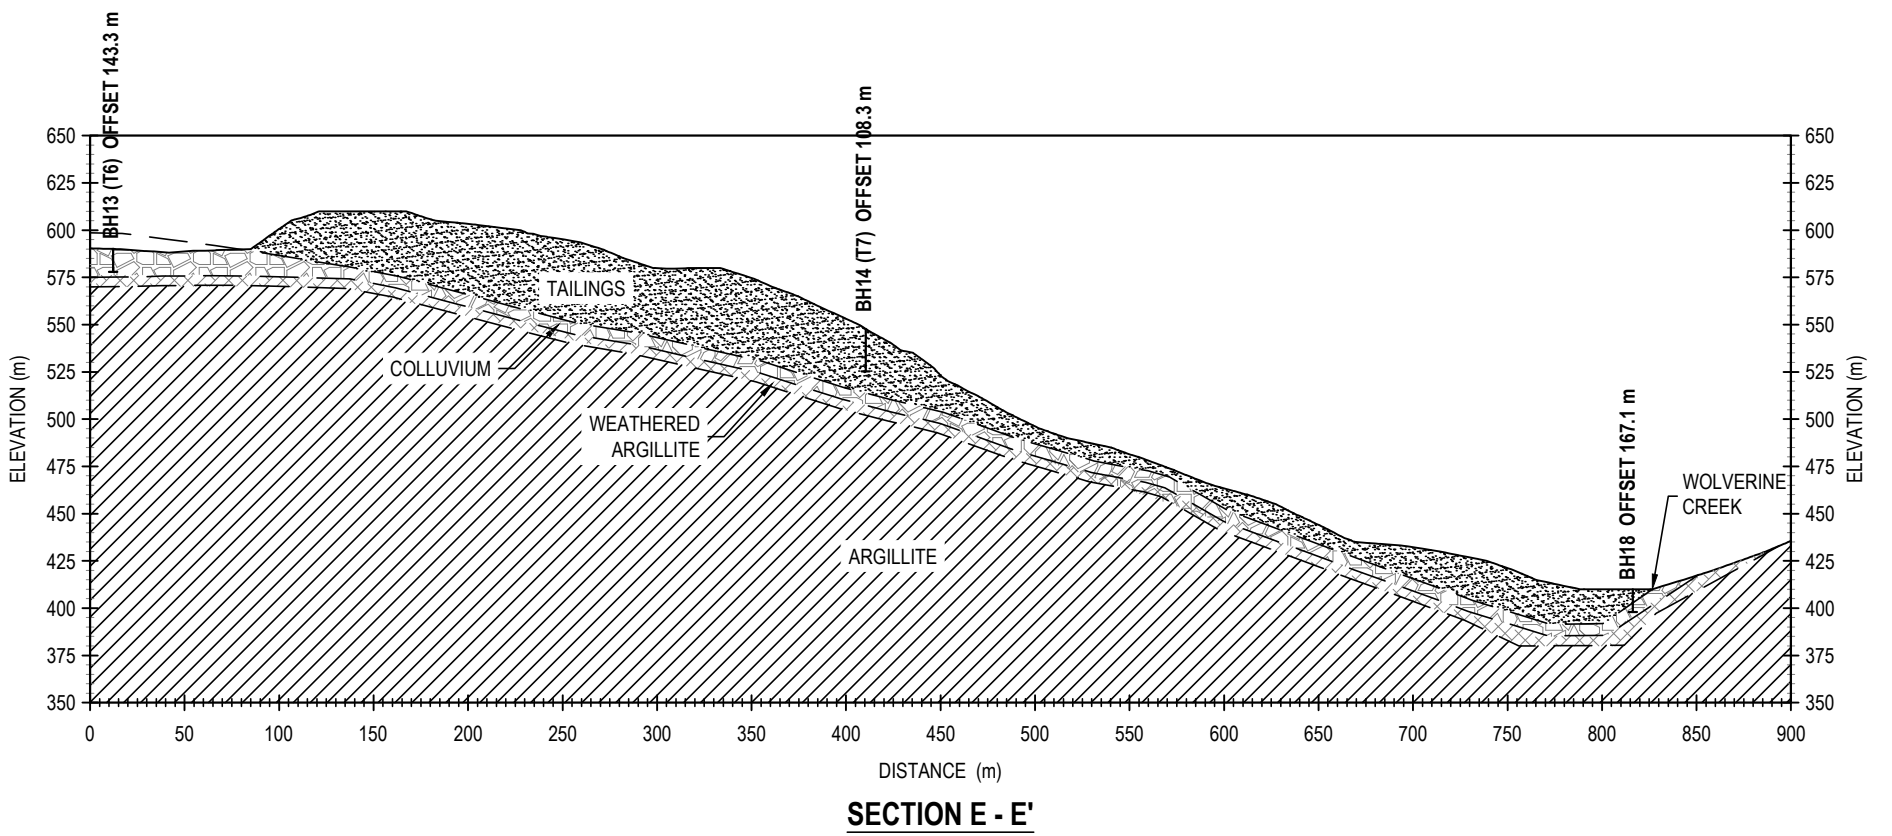
DATA GAP ASSUMPTION REPORT REPORT ABANDONED CLINTON CREEK MINE, YUKON			
TAILINGS PILE - ASSUMED SUBSURFACE CONDITIONS - SECTIONS D - E			
PROJECT NO. ENGWARC03039-01	DWN CB	CKD JTP	REV 0
OFFICE EBA-WHSE	DATE March 30, 2016		
			Figure 3

| Figure 3 | Tailings Pile – Assumed Subsurface Conditions – Sections D - E |

Although Wolverine Creek occupies the valley floor, it has no obvious floodplain except at the southern part of the valley near its confluence with Clinton Creek (Figure 4). Sections showing the assumed subsurface stratigraphy of the Wolverine tailings pile area are presented on Figure 3.

As mentioned above, the subsurface investigation completed within the Wolverine tailings pile determined that overburden thickness ranged from greater than 12 m near the top to less than 1 m near the toe. Tetra Tech EBA has assumed colluvium/alluvium overburden soils under the Wolverine tailings pile extend from the ground surface down to the assumed bedrock surface described in the previous section.
