**Subject: Type B Water Licence Application – Tailings Pond Maintenance
Ketza River Mine, Yukon**

The attached documentation is provided in support of a Type B Water Licence application on behalf of Ketza River Holdings Ltd. for the care and maintenance of an existing tailings pond at the Ketza River Mine near Ross River, Yukon.

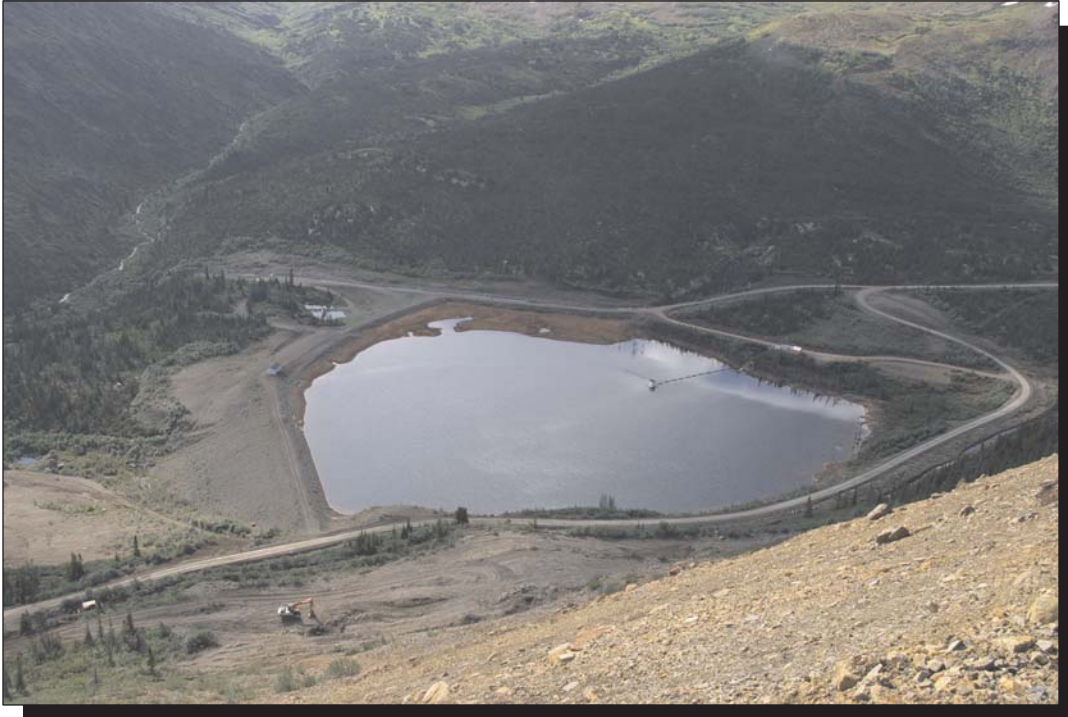
Photo 1
Overview of tailings pond. Aspect: SE. Photo taken Aug. 6, 2008

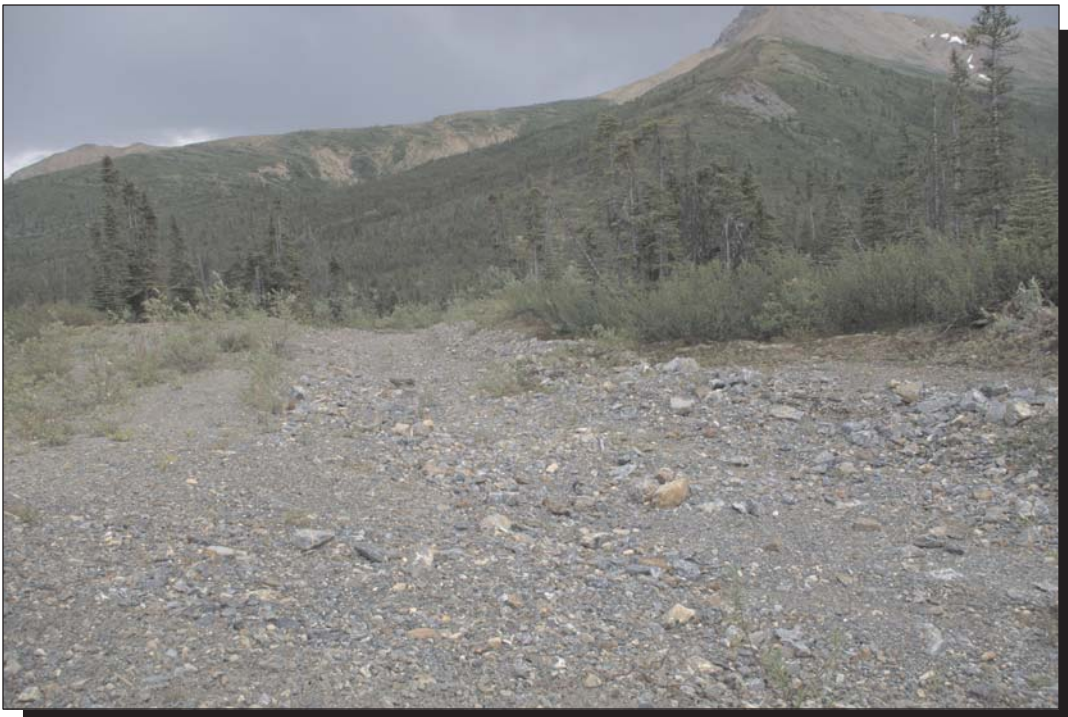
The entire crest, downstream face, and emergency spillway were visually inspected. In general, the slopes and crest of the dam are in good condition. The emergency spillway is shown in Photo 2.

Erosion of the spillway is not likely to cause instability to the structure as a whole; and the dam is considered stable in its present condition.

Photo 2
Emergency Spillway on South Dam. Aspect: E. Photo taken Aug. 6, 2008

Flow rates from Weir 5 should be collected and reviewed at least bi-weekly and piezometer/monitoring well water elevations should be collected and reviewed at least monthly, as is the current site practice. The rip-rap design should be reviewed to determine what return interval event would cause an erosion failure in the spillway. This event should be checked against the design flood event recommended by Canadian Dam Safety Guidelines for the consequence classification assigned to this structure.

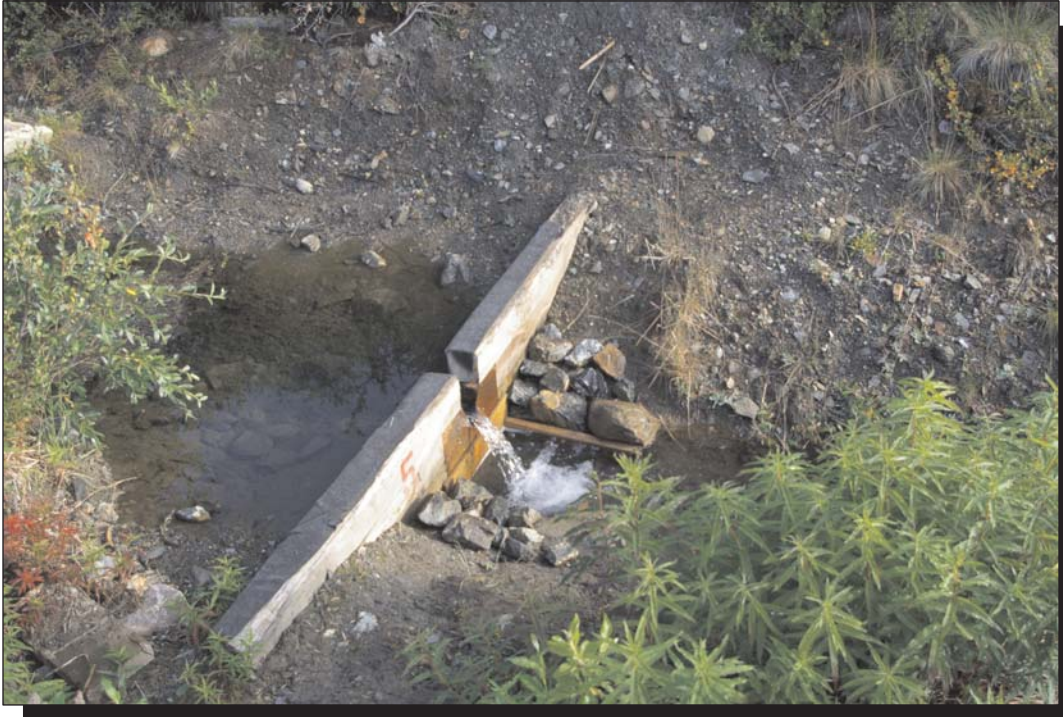
Seepage was observed along the downstream toe of the dam. The seepage has created a pond immediately downstream of the dam and upstream of a sharp-crested triangular notch weir (Weir 5) that was previously installed to monitor the seepage rate, as shown in Photo 3. The flow rate from a sharp-crested triangular notch weir can be determined using the following equation:

Photo 3
Weir 5 at South Dam. Photo taken Aug. 6, 2008

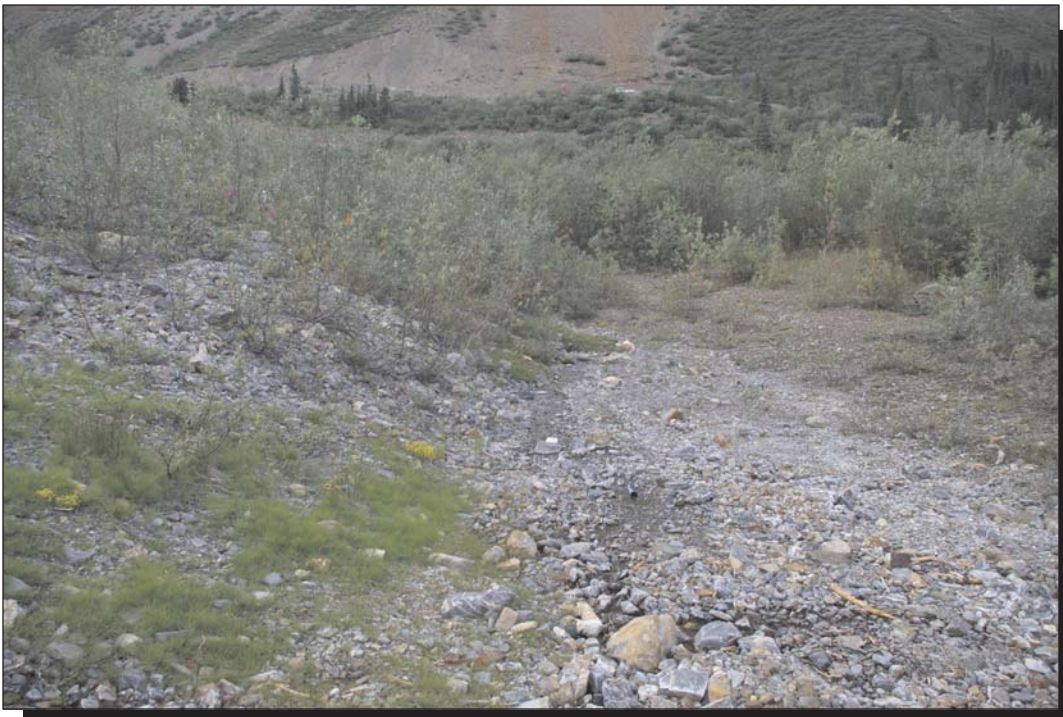
The soft area at the toe of the dam observed in 2007 was observed again during this inspection; and was approximately the same size as previously noted. In these seepage areas sand was present in areas of surfacing seepage water which could indicate some internal erosion (i.e. piping) of the fill or foundation soil. This area is shown in Photo 4 and in detail in Photo 5.

Photo 4
Soft/seepage area at toe of North Dam. Aspect: NW. Photo taken Aug. 6, 2008

A toe berm, as previously recommended and designed by EBA, should be constructed along the downstream toe of the dam to mitigate the potential for piping.

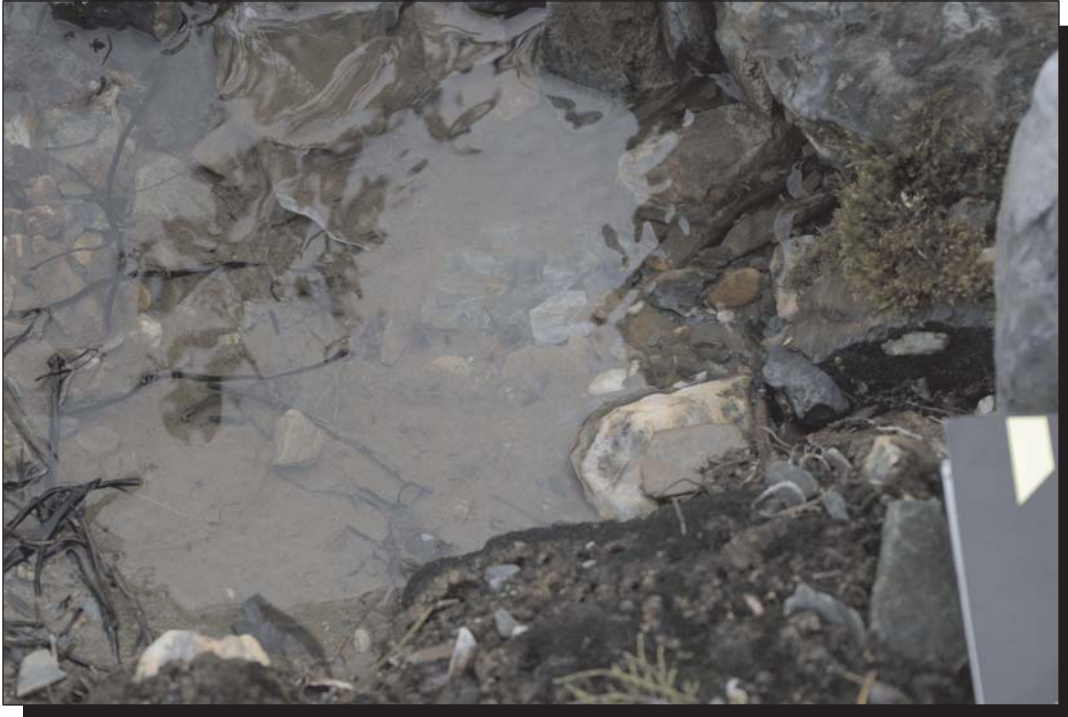
Photo 5
Sand present in seepage location at toe of North Dam. Photo taken Aug. 6, 2008

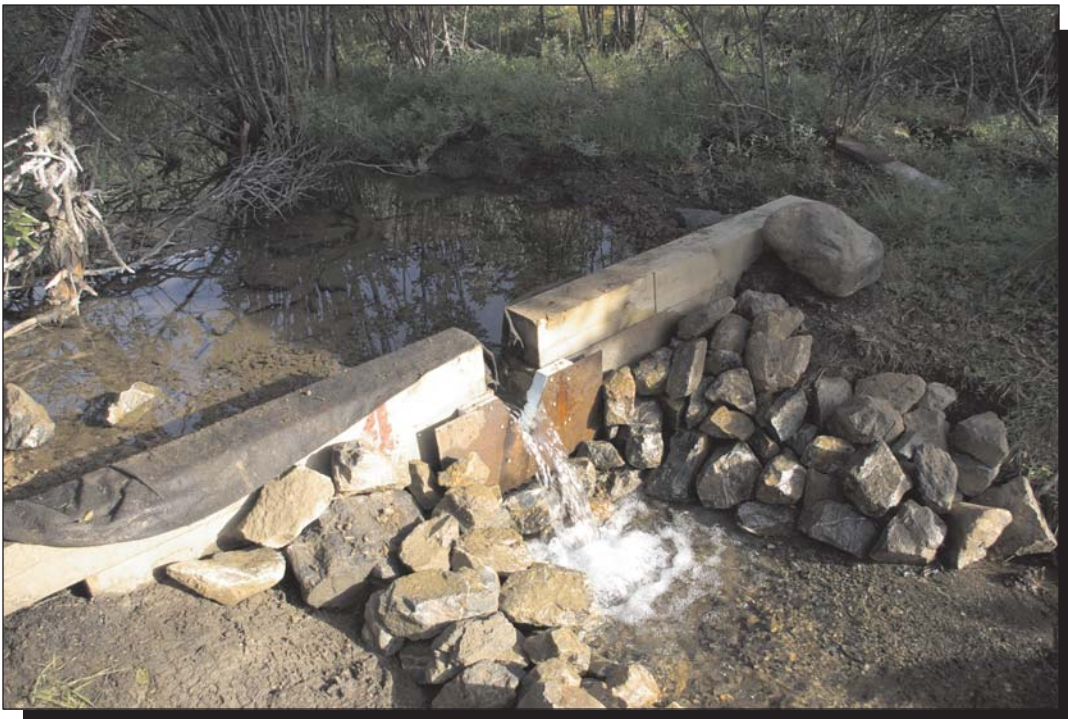
Seepage was observed along the downstream toe of the dam. The seepage has created a pond immediately downstream of the dam and upstream of a sharp-crested triangular notch weir (Weir 4) that was previously installed to monitor the seepage rate, as shown in Photo 6. The flow rate from a sharp-crested triangular notch weir can be determined using equation (1). Weir 4 had a measured notch angle of 63 degrees, which correlates to a discharge coefficient of 0.575 and a head correction of 1.1 mm. At the time of inspection the measured head 105 mm, thus the flow rate was approximately 3.1 L/s.

Photo 6
Weir 4 at North Dam. Photo taken Aug. 6, 2008

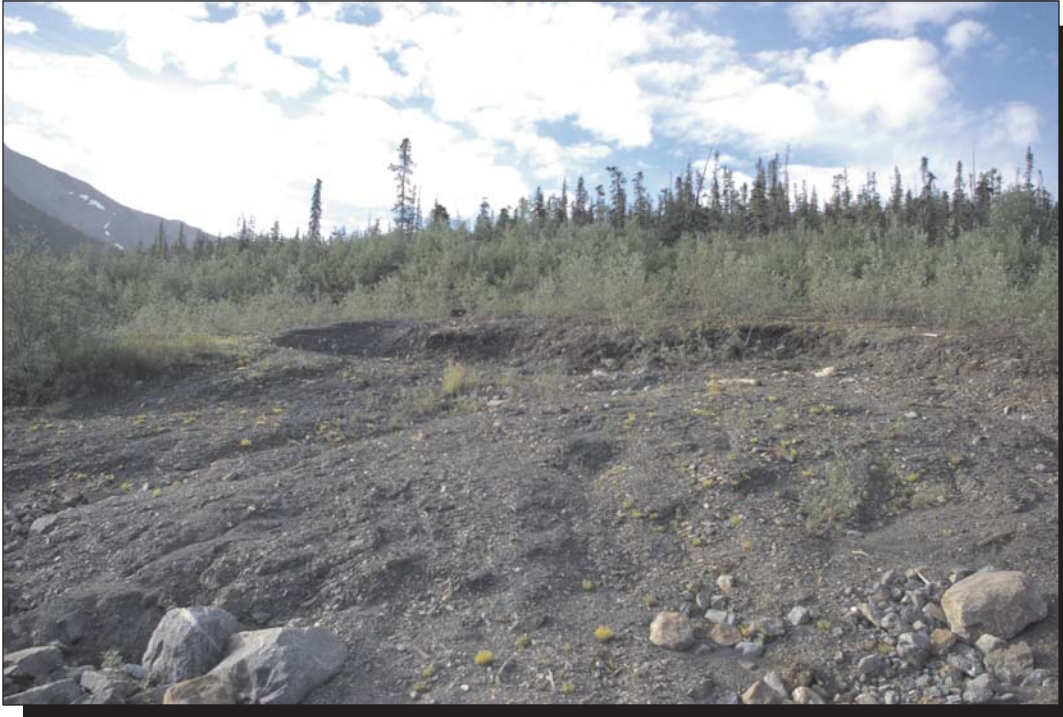
The majority of the channel and banks are in good condition with sufficiently sized rip-rap for flows observed during the inspection. EBA noted two sections of instability, the locations of which are shown in Figure 4, Photo 7 and Photo 8. Both these areas were noted in the 2007 inspection.

The first section of instability, shown in Photo 7, is near the South Tailings Dam on the south side of the channel. The area was outlined as requiring remediation during the 2007 inspection and has a history of creep and instability. It is possible that the soil conditions consist of ice-rich permafrost that is degrading, resulting in creep and slope instability.

Instability Area #1 near South Dam along Cache Creek Diversion Channel. Aspect: S. Photo taken Aug. 6, 2008

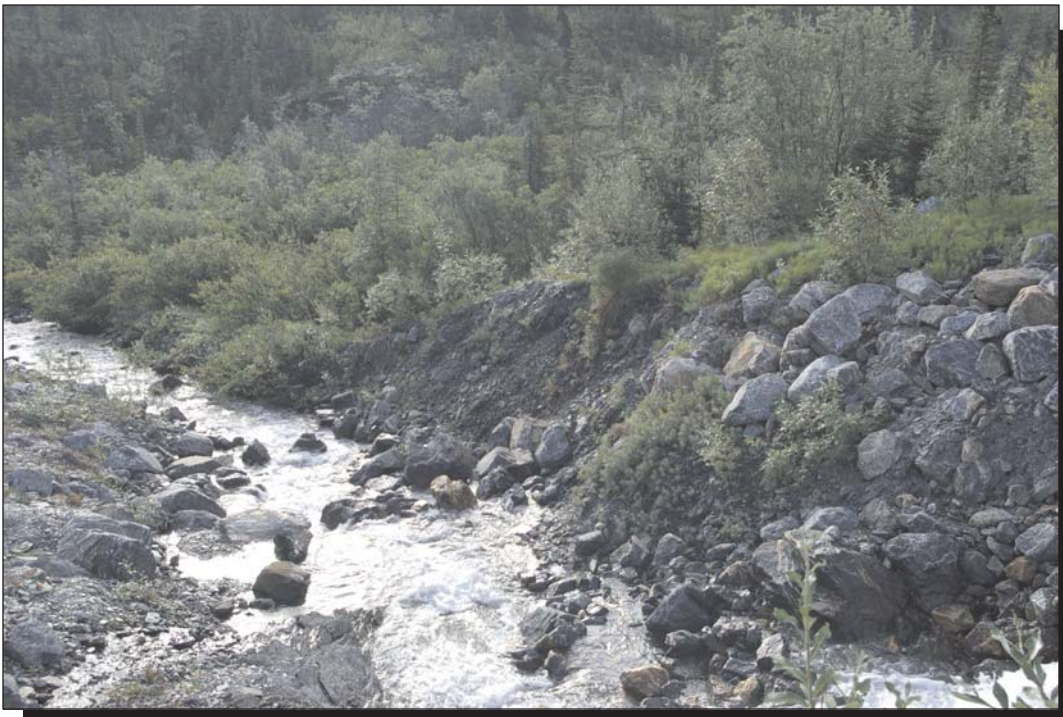
Photo 8

The second section of instability, shown in Photo 8, is near the confluence of the emergency spillway channel and is also where the South Tailings Dam seepage enters the creek diversion. The area of instability is on the south side of the channel near a bedrock outcrop. The instability seems to be caused by ongoing high water flow erosion.

Instability Area #2 at Emergency Spillway confluence along Cache Creek Diversion Channel. Aspect: NE. Photo taken Aug. 6, 2008
