To: Justin Stockwell, Lorax Environmental Services Ltd.
Cc: David Flather, Neil Mallen
From: Diane Lister
Date: October 28, 2011
RE: **Mount Nansen Closure: Synopsis of Remediation Field Work –
Lorax Proposal J987-1 / YG Contract #C00010821**

Background and Objectives

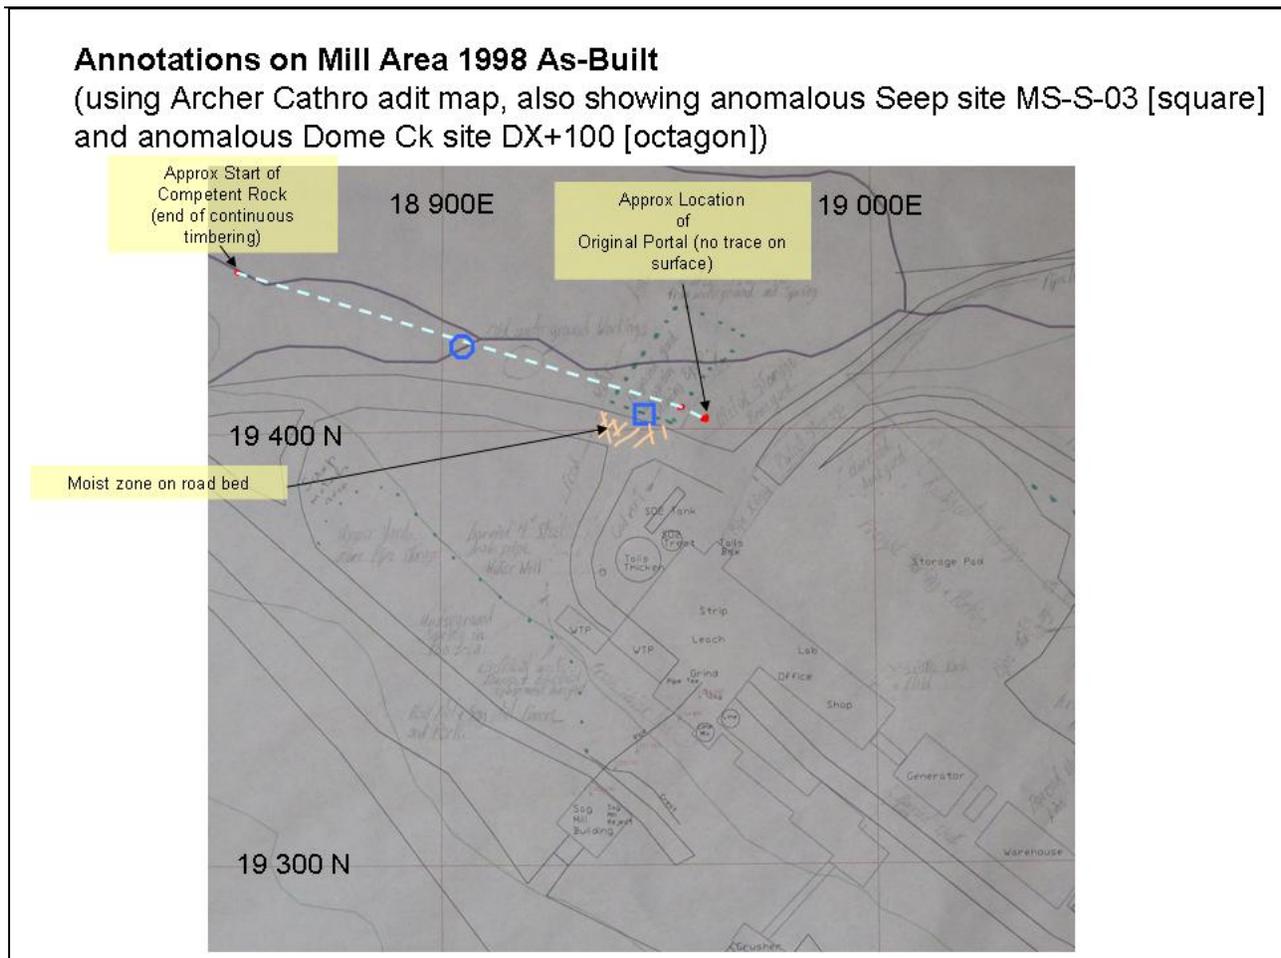
Figure 1. Approximate alignment of trace of Huestis 4100' adit based on available map information and field evidence. Coordinate system shown is that of the mine/exploration area grid.

The Heustis 4100' adit area was briefly visited on October 18, 2011. Snow was on the ground with Dome Creek flowing. Moisture was evident through the snow in the zone up-gradient of seep MS-S-03 emerging from the side of the road to the mill (Photo 4). The adit and local conditions were discussed with Tom Becker of Norwest who was on site at the time. Tom clearly recalled the presence of the adit during his early 1980's work in the area as an exploration geological field assistant. Tom recalled that the timbers at the portal were severely caved and prevented access. The use of an excavator for further investigation was discussed, and it was agreed that the existing map information, photos, and oral accounts sufficiently document the adit's historical alignment. It was also agreed that reconnaissance-level excavation would be unlikely to yield additional information, and could present risks to the main road used to access the mill and/or to Dome Creek. The approximate alignment of the adit was derived utilizing historic maps from site and field evidence (Figure 1).

2. Field investigation for mill area adit	Completed	The use of an excavator for further adit investigation was discussed with Norwest personnel on site, and it was agreed that the existing map information, photos, and oral accounts sufficiently document the adit’s historical alignment. Furthermore, reconnaissance-level excavation would be unlikely to yield additional information, and could present risks to the main road access to the mill and/or to Dome Creek.

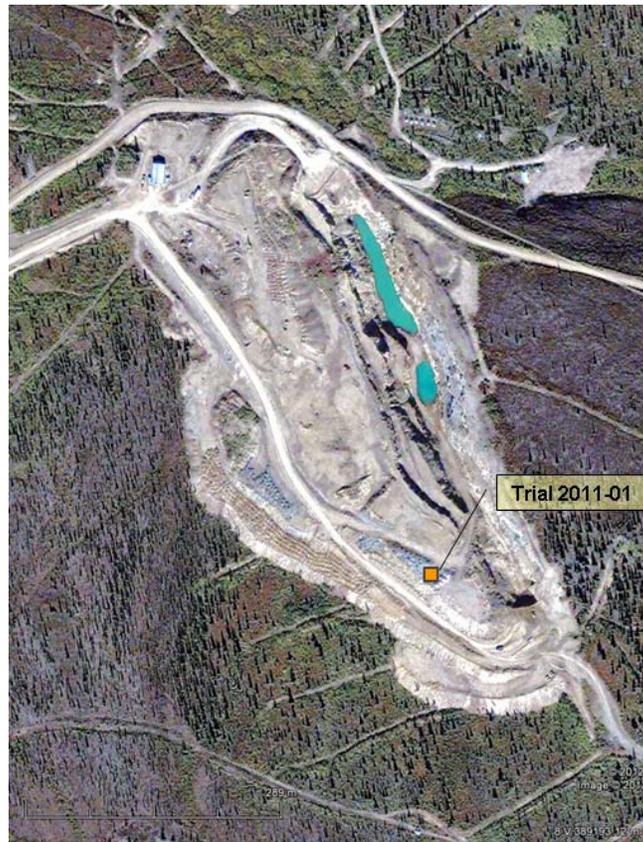
Figure 2. Location of Direct Seeding Trial 2011-01.

A direct seeding trial (2011-01) for locally collected willow and scrub birch seed was established on the waste rock pile area. The in-situ waste rock was prepared to 'rough and loose' texture using 2 hours of excavator equipment time contracted through Graceland Construction. The preparation left a highly undulating surface with some exposed boulders (Photo 2). While this approach is an obvious deviation from a smooth "track-padded" surface seen at many revegetation sites, it has recently been recognized by prominent practitioners that natural recolonization in challenging substrate and moisture conditions such as waste rock can be enhanced through use of such a 'rough and loose' approach (Polster, 2009 and Sweigard et al, 2007). This surface treatment provides sinks or traps for moisture, seeds and organic debris accumulation, and provides shelter for emerging seedlings (Photo 3). The location of trial 2011-01 is shown in Figure 2. Seeds were sown in three distinct quadrants of the re-worked area (Patches #1 through #3, shown in Photo 2). Each patch represents slightly different degrees of roughness and aspect as described in Table 3. A 20cm long flagged spike was placed in each of the four corners of the three patches. Although another potential site southeast of the mill had been earmarked for fall trials (Figure 3), safe access to the site was not possible on October 18 due to snowfall the previous evening.

Trial#	Easting (NAD 83 UTM 8V)	Northing (NAD 83 UTM 8V)	Elevation (masl)	Description
2011-01	388956	6881302	1218	Waste rock prepared to 'rough and loose' texture; 3 patches approximately 3x3m, each representing slightly different degrees of roughness and aspect. Locally collected willow and scrub birch seed dispersed in each patch.
Patch #1				Overall flat aspect with small hummocks (0.5m), in lee of large berm
Patch #2				Gentle NE aspect, least textured and most exposed of the 3 patches
Patch #3				Deepest hummocks (1-1.5m), walls relatively steep (close to angle of repose)

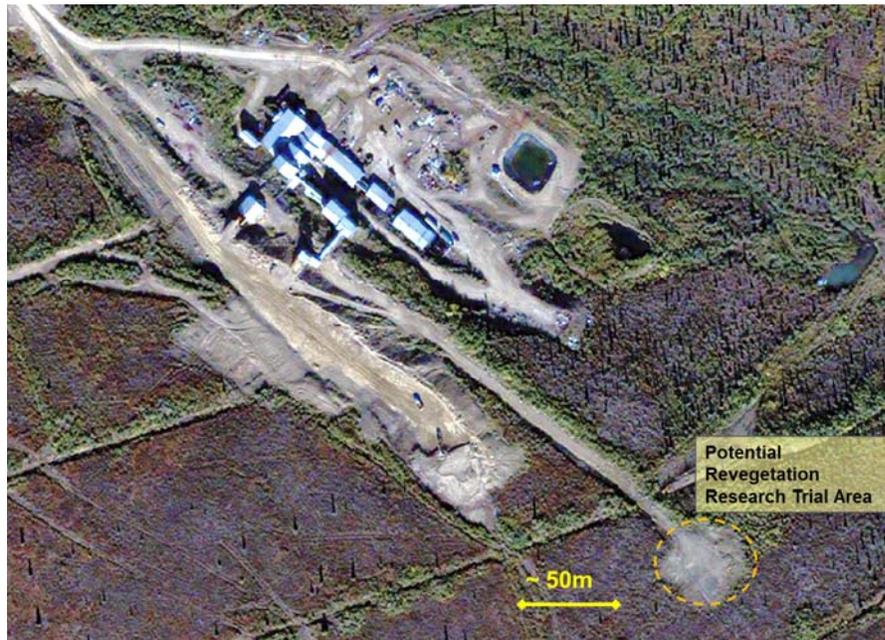
Figure 3. Location of Potential Revegetation Trial Area (not used in 2011).

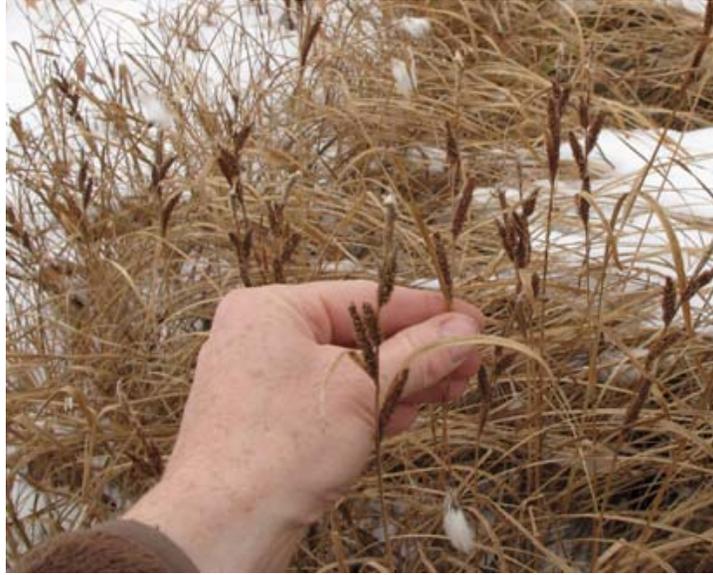
Photo 1. *Carex sp.* (sedge) seed head at lower Dome Creek at Mount Nansen road.

Minor amounts of seed of certain available species, sufficient for research trial purposes were collected while on site. Species collected include: *Betula glandulosa* (scrub birch), *Ledum L.* (Labrador/trappers tea), *Carex spp.* (sedge, Photo 1), and *Arctostaphylos uva-ursi* (kinnikinnick). Reconnaissance was carried out for ripe cones of local conifer species. However, similar to findings of September fieldwork by Altura and EDI, only open cones from 2010 were observed and it appears that there was little or no new cone production in 2011.

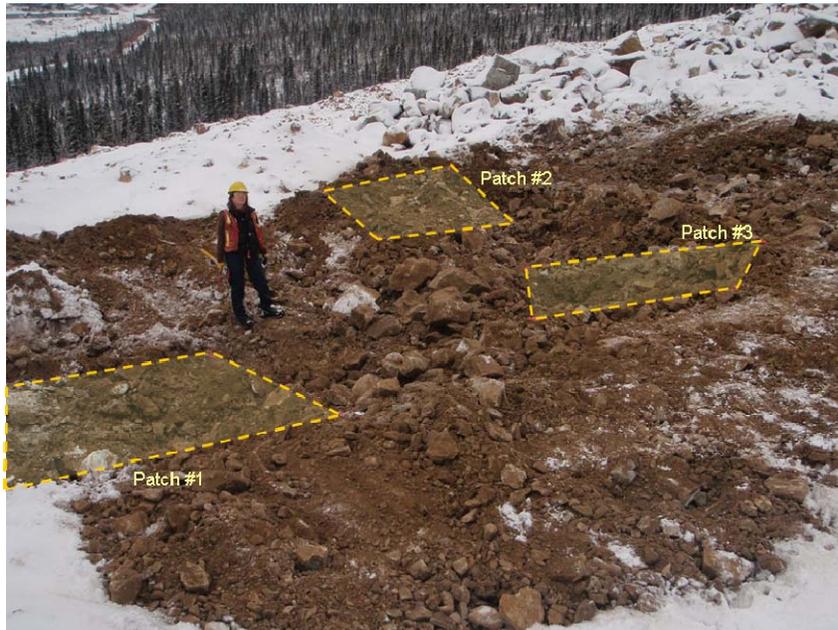
Photo 2. Revegetation trial 2011-01 on the South Pile; direct seeding of willow and birch on ‘rough and loose’ prepared waste rock surface.

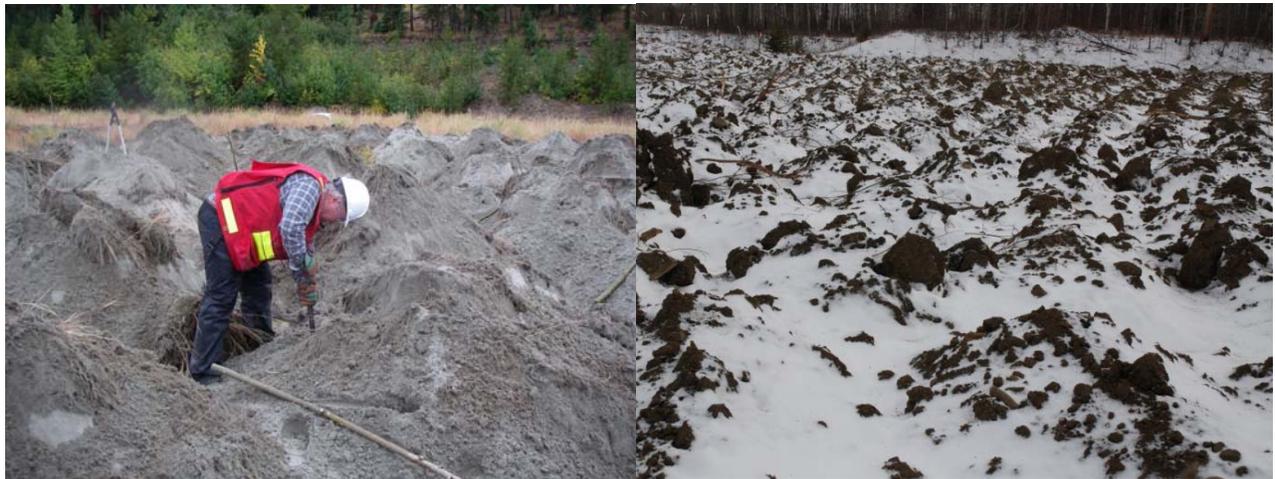
Photo 3. Examples of ‘Rough and Loose’ surface preparation at other sites. Left: tailings area in southern British Columbia (photo – Altura); Right: platform in central Alberta illustrating the ‘snow-trap’ effect in depressions (photo – Polster Environmental Services Ltd.)

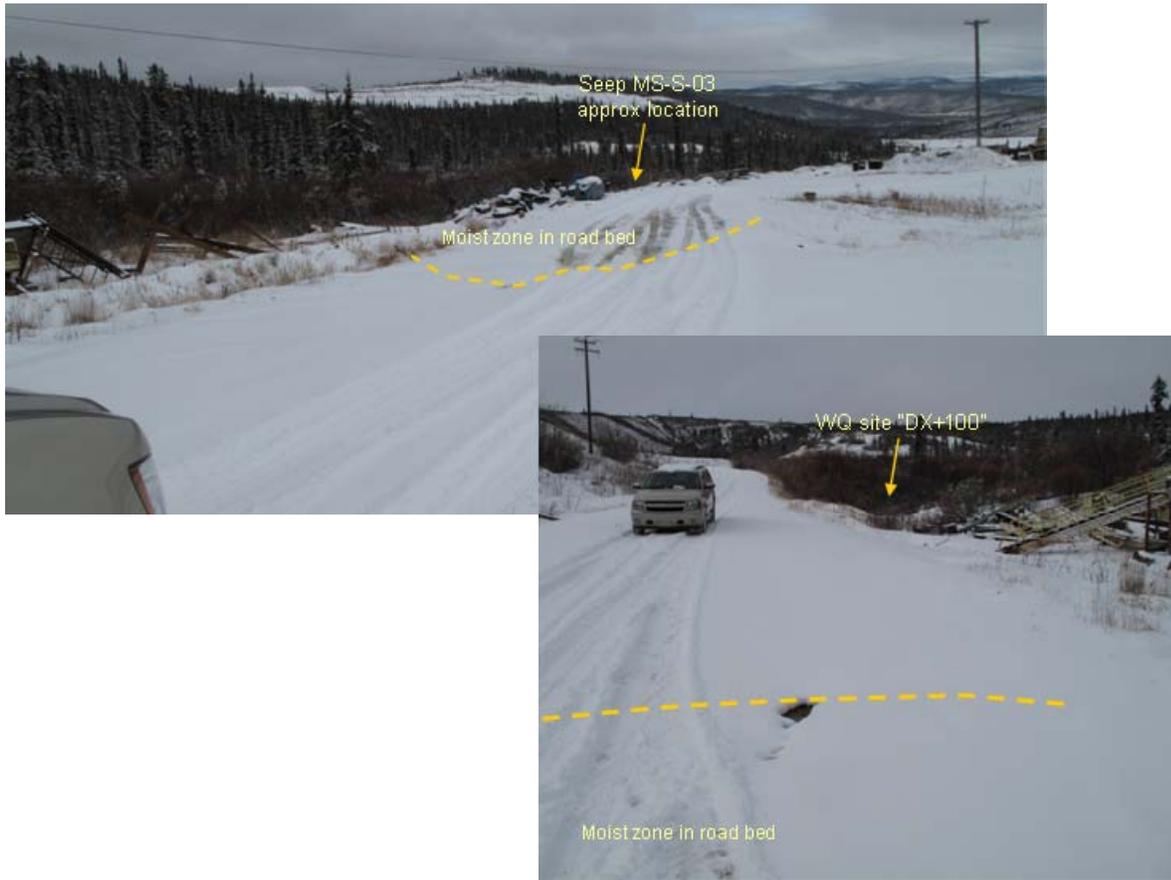
Photo 4. Moisture zone on access road to lower mill platform, October 18.
