EDI Job Number: 13-Y-0167

Re: Mount Nansen Surface Water Quality Field Memo: October 15-17, 2013

Trip Dates:	October 15-17, 2013
EDI Field Staff:	Dawn Hansen, Danny Skookum, Joel MacFabe
Tasks:	Hydrology and Water Quality

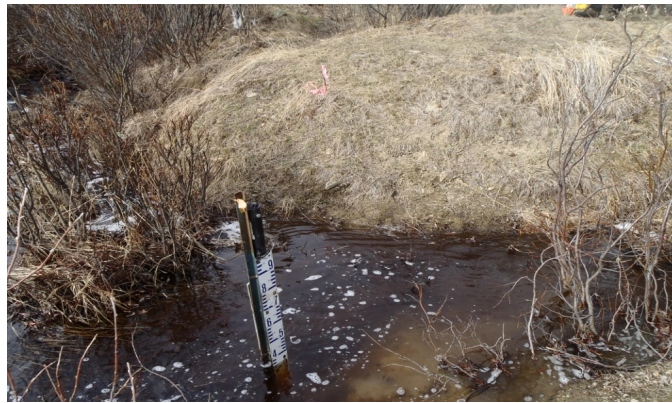
Photo 1a. H-PC-U BM2 Location 27 May, 2013.

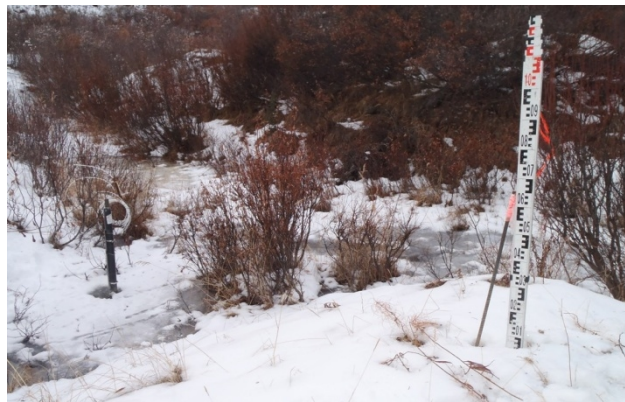
H-VC-UMN	ADV	Mid-section method used to measure discharge. Logger removed for winter season. Shore ice present along channel.
H-MN	Salt Slug	Mid-section method used to measure discharge. Logger and well casing removed for winter season. Channel partially ice and snow covered.
H-VC-R	ADV	Stream flows moderate and relatively clear. Mid-section method used to estimate discharge. Logger downloaded, winterized, and redeployed. Shore ice along entire channel section (Photo 5) and anchor ice beginning to form upstream of the culvert.
H-SEEP	Volumetric	A volumetric measurement was made at the pipe discharge. Flow rate and total volume was recorded from the flow meter. Staff gauge measurement recorded from the seepage pond pump house.
H-TP	None	Staff gauge reading recorded. Note full ice coverage at time of sampling.
H-PC-U	Salt Slug	Moderate flow at station with water continuing to be diverted around weir structure. Salt tracer was used to measure discharge. Logger and well casing were removed for the winter season. Channel snow and ice covered. Benchmark 2 was found pulled up and moved 85cm higher in elevation (photo 1, 1b).

Photo 1b H-PC-U BM2 Location 15 Oct, 2013.

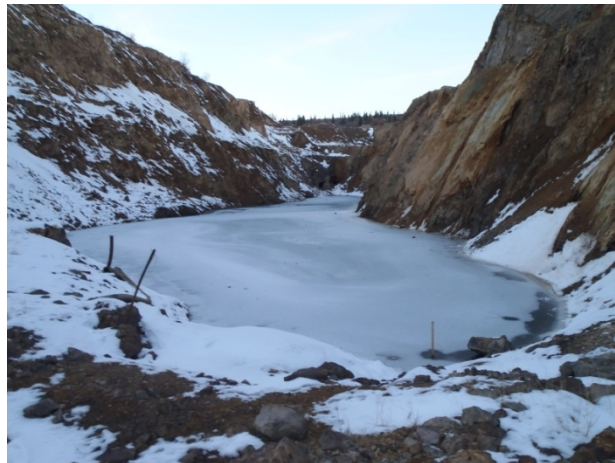
Water quality samples were collected from all monitoring sites with the exception of WQ-ADIT-SEEP due to zero flow and WQ-PIT due to thin ice conditions (Photo 2). Ice was present over most still water areas, including the tailings pond (Photo 4) and the pond at WQ-PC-U. Water levels were moderate to low at all other sites, with creek sites having some ice coverage on the margins. Table 2 summarizes the water quality sampling conditions at each site.

Site	Sampled? (Yes/No)	Notes / Explanations
WQ-PIT1	No	Thin ice covered conditions. Not safe for sampling (Photo 2).
WQ-PIT2	No	Thin ice covered conditions. Not safe for sampling (Photo 2).
WQ-PIT3	No	Thin ice covered conditions. Not safe for sampling (Photo 2).
WQ-SEEP	Yes	Conditions normal for this time of year.
WQ-TP	Yes	Conditions normal for this time of year. Ice covering 8 cm (Photo 4).
WQ-DC-DX	Yes	Water levels were moderate.
WQ-DC-DX+105	Yes	Water levels were moderate.
WQ-DC-D1b	Yes	Water levels were moderate.
WQ-DC-U1	Yes	Water levels were moderate.
WQ-DC-U2	Yes	Water levels were moderate.
WQ-DC-U	Yes	Water levels were moderate.
WQ-DC-R	Yes	Water levels were moderate.
WQ-VC-REF	Yes	Site conditions normal for time of year.
WQ-VC-U	Yes	Site conditions normal for time of year.
WQ-BC	Yes	Site conditions normal for time of year.
WQ-VC-DBC	Yes	Site conditions normal for time of year.
WQ-VC-UMN	Yes	Site conditions normal for time of year.

Photo 2. WQ-PIT thin ice conditions.

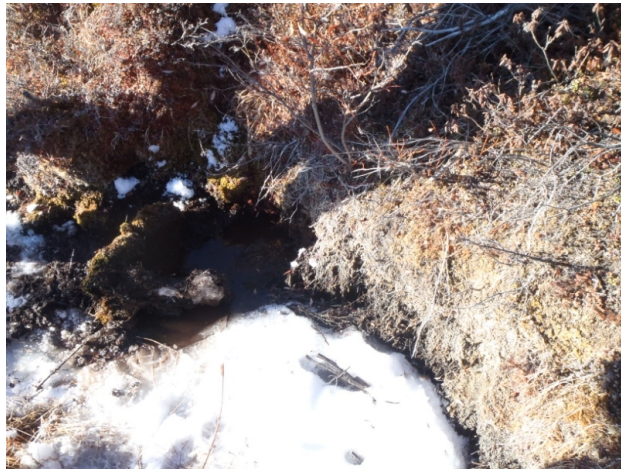
Photo 3. Dome East Slope Seep 01 (WQ-DESS-01), site requested by AAM for one time sample event.

<p>Any changes to project scope (i.e. additional sites sampled):</p>	<p>One water quality site (WQ-DESS-01) outside of the Scope of Work was sampled upon request from AAM. Erik Pit directed crew to the site which lies along the power line road along the east slope of the Dome Creek Valley (Field GPS Coordinates 08V 0388628, 6881160). Location, photos and the regular suite of samples were taken (Photo 3). See comments below for budget implications and addition comments.</p>
<p>Any alterations to sample scheduling:</p>	<p>No alterations to monitoring trip schedule.</p>
<p>Any events resulting in changes to budget:</p>	<p>The addition of the one-time water sample at the site noted above, required some additional time and expense, including 2.25 hrs of additional person hours plus the analysis of the extra sample set. This will be noted on the October invoice for budget tracking purposes.</p>
<p>Additional Comments:</p>	<p>Crews noticed that Benchmark 2 at H-PC-U had been moved by someone else prior to October field visit.</p> <p>The WQ-DESS-01 site sampled this trip at the request of AAM, is a site that has been sampled in previous years (2009-2011) and was originally established by Altura Environmental Consulting.</p>

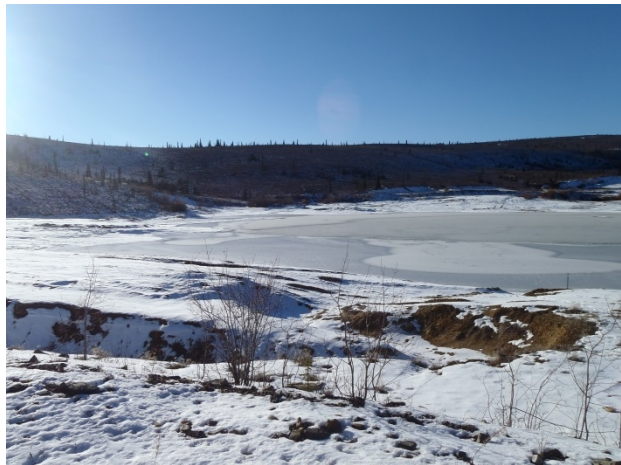
Photo 4. WQ-TP showing ice coverage over entire pond.

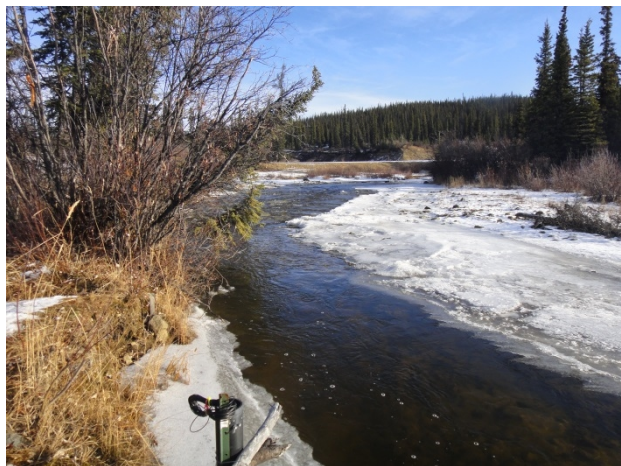
Photo 5. H-VC-R (looking upstream) station showing ice on margins.

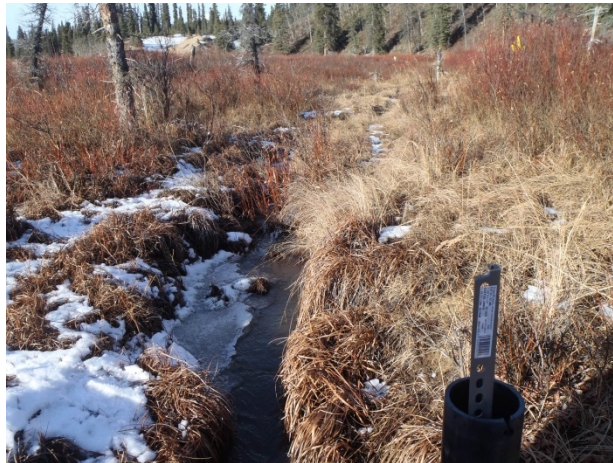
Station	Hydrometric Measurement Type	Notes & Comments
H-DC-R	Salt Slug	Water level moderate. Salt tracer used to estimate stream discharge. Logger and well casing removed for the winter season. Shore ice along some creek margins (Photo 6).
H-VC-REF	ADV	Flow levels moderate and water clear. Area-velocity method used to estimate discharge. Logger removed for winter season. Shore and anchor ice along length of channel.
H-VC-U	ADV	Water levels are moderate. Discharge measurement completed using the mid-section method. Logger winterized and redeployed. Minimal ice observed in channel section.
H-BC	Salt Slug	Water levels moderate and water very clear. Channel is ice covered with overflow taking place. Salt tracer used to measure discharge. Logger removed for winter season.
H-VC-DBC	ADV	Water level moderate. Stream water is clear with some silt accumulation. Mid-section method used to measure discharge. Logger downloaded, winterized, and redeployed. Minimal ice observed in channel section.

Photo 6. H-DC-R (looking upstream) station showing ice on margins and light snow on banks.
