**NORTH FORK ROCK DRAIN**

**GEOTECHNICAL  
EVALUATION**

**DRAFT REPORT**

PROJECT NO.: 0257-023-03  
DATE: NOVEMBER 22, 2004

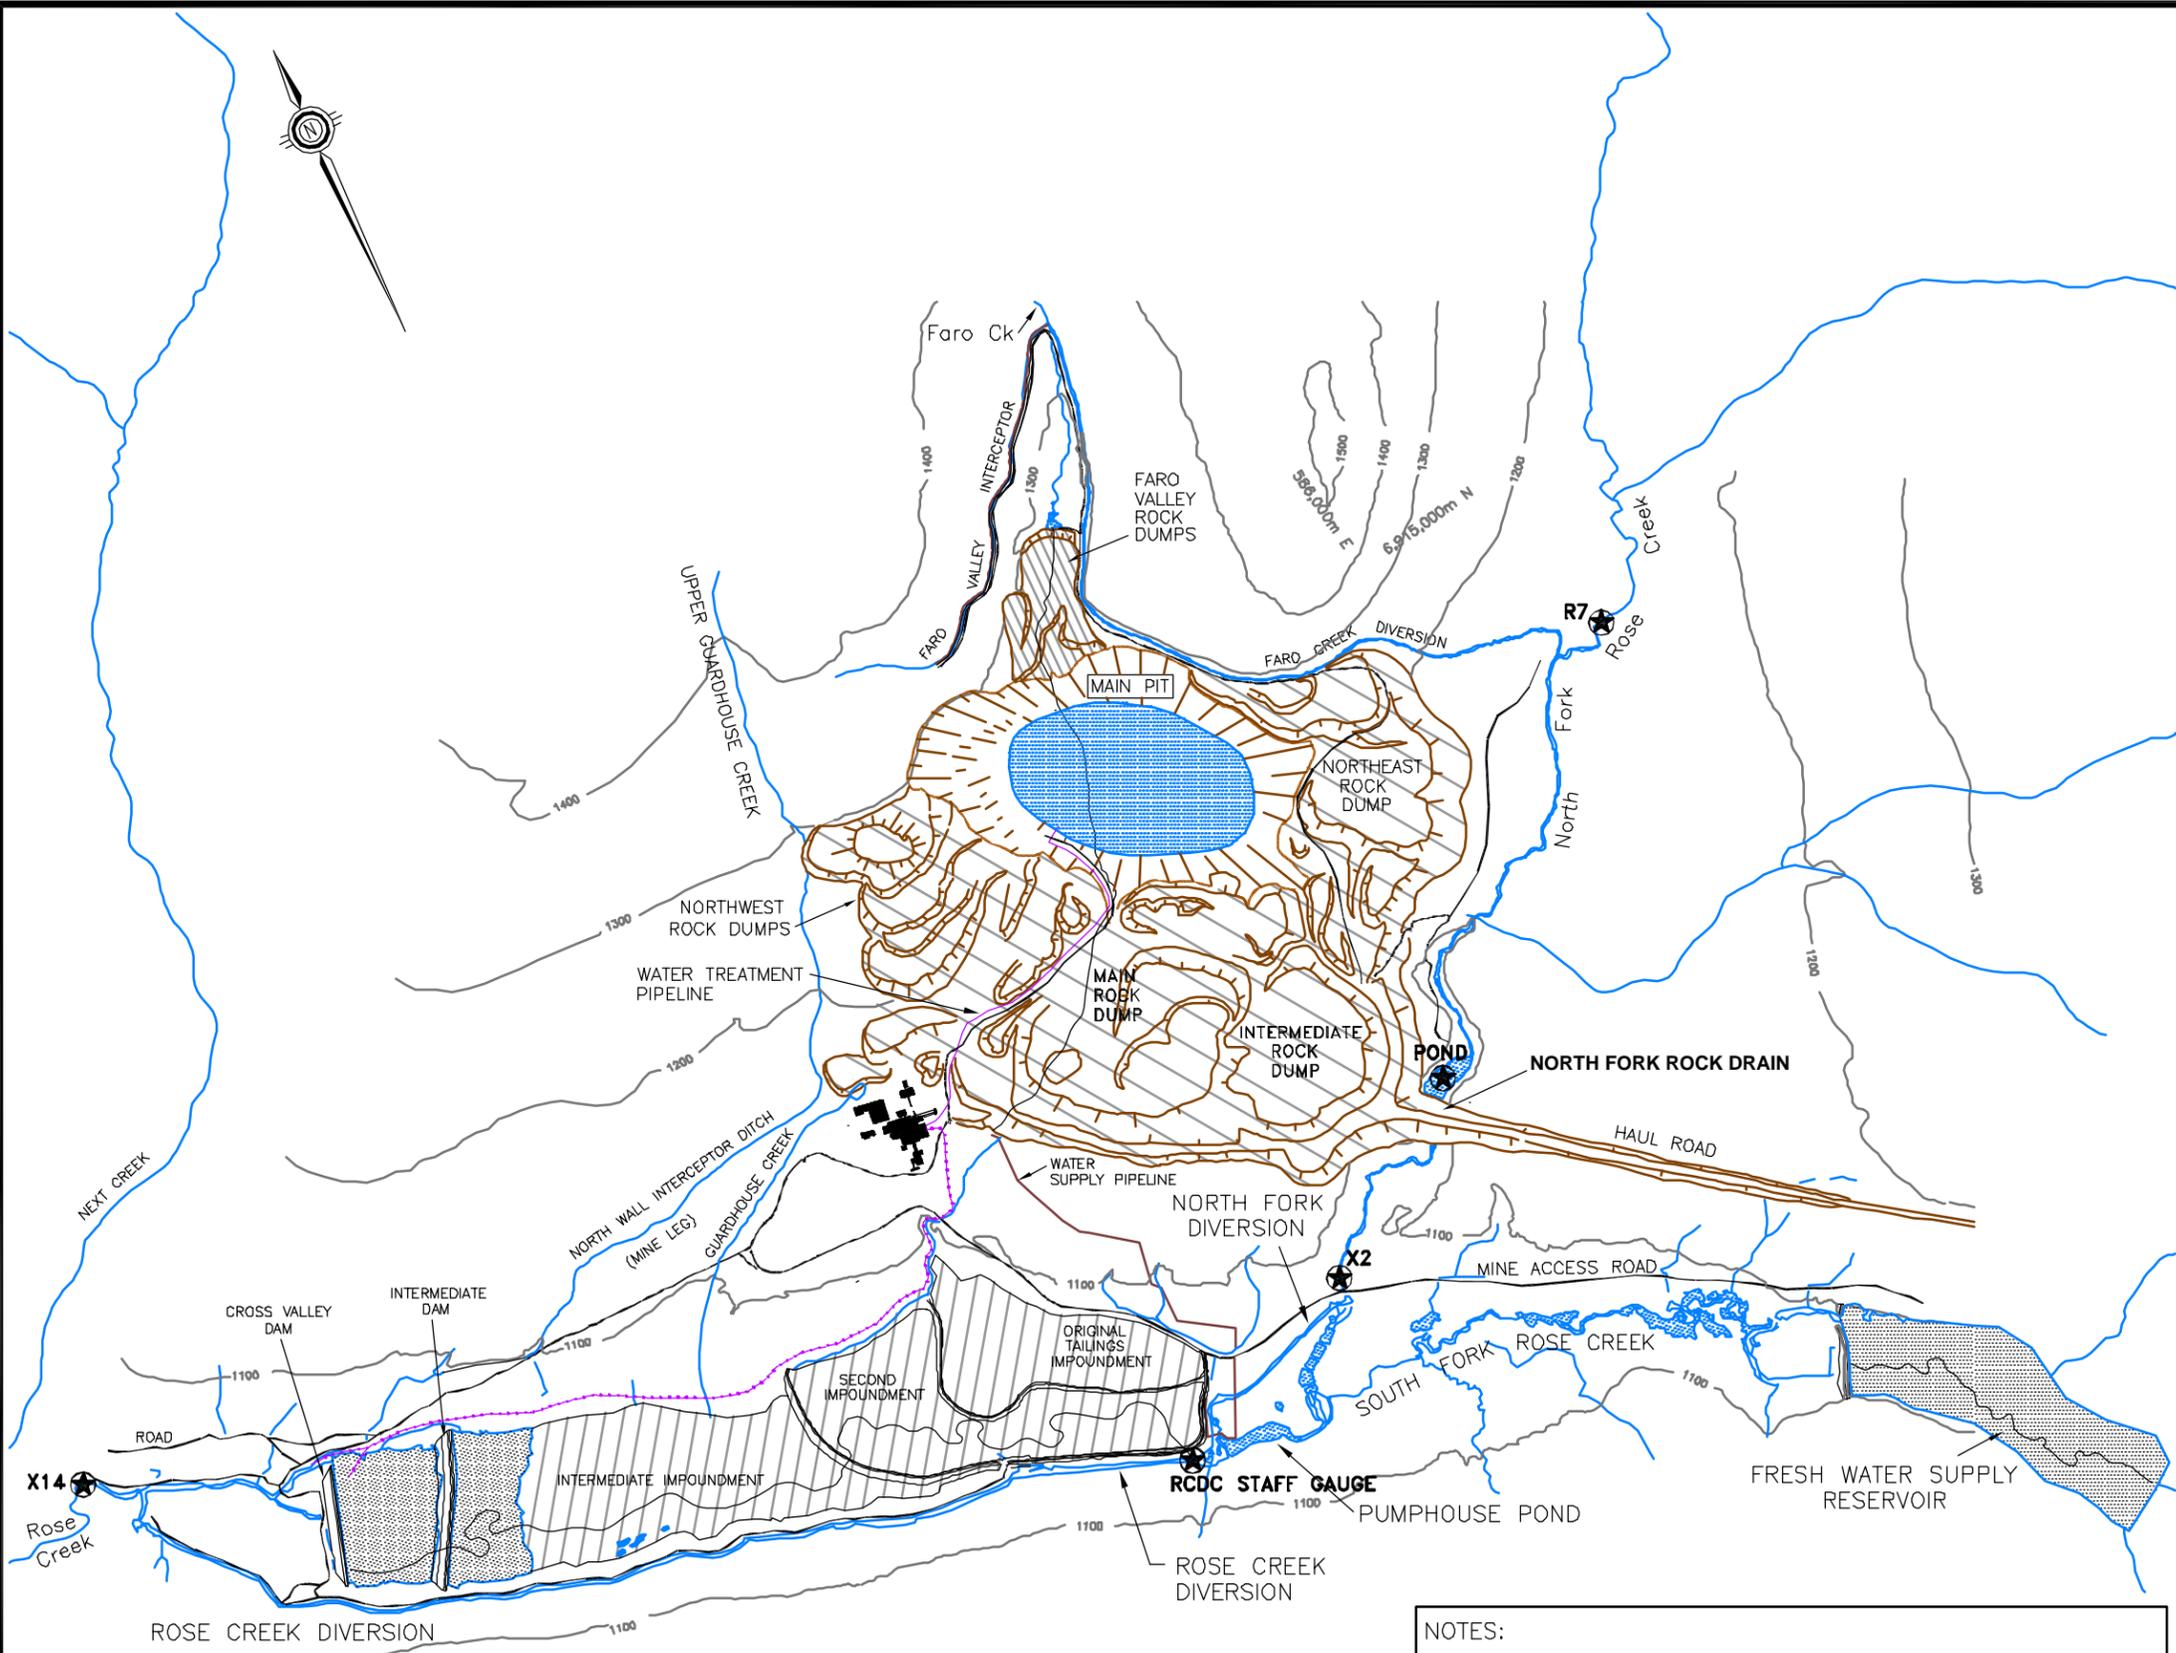
PROJECT	NORTH FORK ROCK DRAIN EVALUATION	
TITLE	1986 DESIGN PLAN AND SECTION	
PROJECT No.	DWG No.	REV.
0257-023-03	3	0

1. The drain is to be constructed from calc-silicate rock. The remainder of the haul road could be constructed of schistose rock.
2. The design flood for this structure was the 100 year return period flood, 70 m<sup>3</sup>/s.
3. The width of the drain was to be 70 m, centered on the pre-existing creek channel. That is, the portion constructed from calc-silicate rock.
4. The construction of the NFRD was to be accomplished by end-dumping the rock from the final road elevation, the final height was noted to be approximately 55 m. This method would result in natural sorting of the rock, with the largest rocks being at the base of the road and the fine material near the top.

5. The assumed slope of the upstream and downstream faces of the drain was  $37^\circ$ , the angle of repose for the calc-silicate rock.
6. For prediction purposes, the design considered that the drain would consist of the lower 3.6 m of the causeway. The grain size was assumed to be 0.3 m, given the likely maximum particle size and an allowance for particle breakage due to the overlying weight of the rock fill.

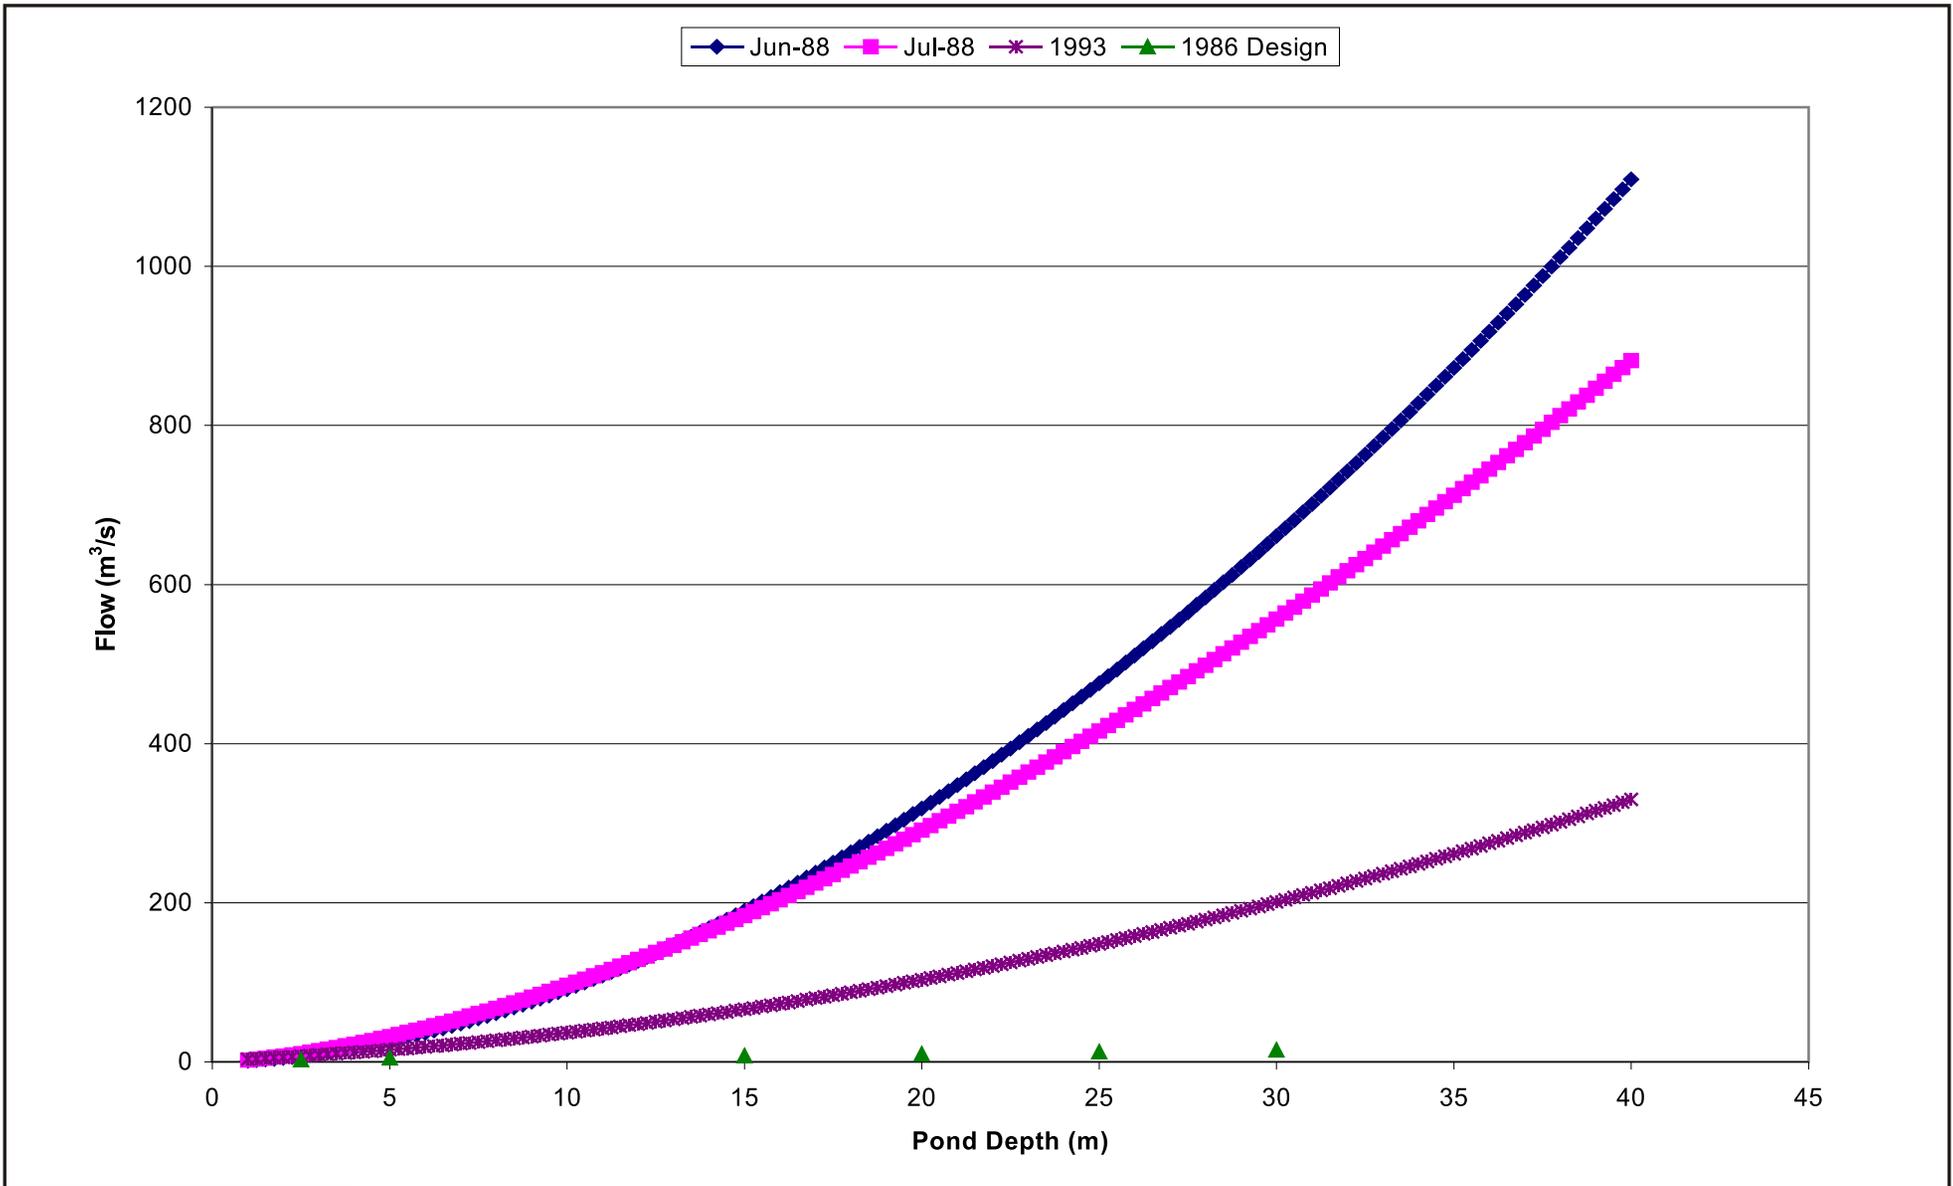
PROJECT No. 0257-023-03	DWG. No. 5	REV. 0

A comparison between the four pond level-flow through relationships is shown in Figures 5 and 6. The plot in Figure 6 shows the comparisons below a pond level of 6 m. As seen in this figure, the initial design estimates (1986) were significantly lower than actual measurements. Comparison of these relationships in the low pond depth region (Figure 6) reveals that all of the relationships are relatively close. It must be noted that the largest pond depth measured at this time was about 4 m.

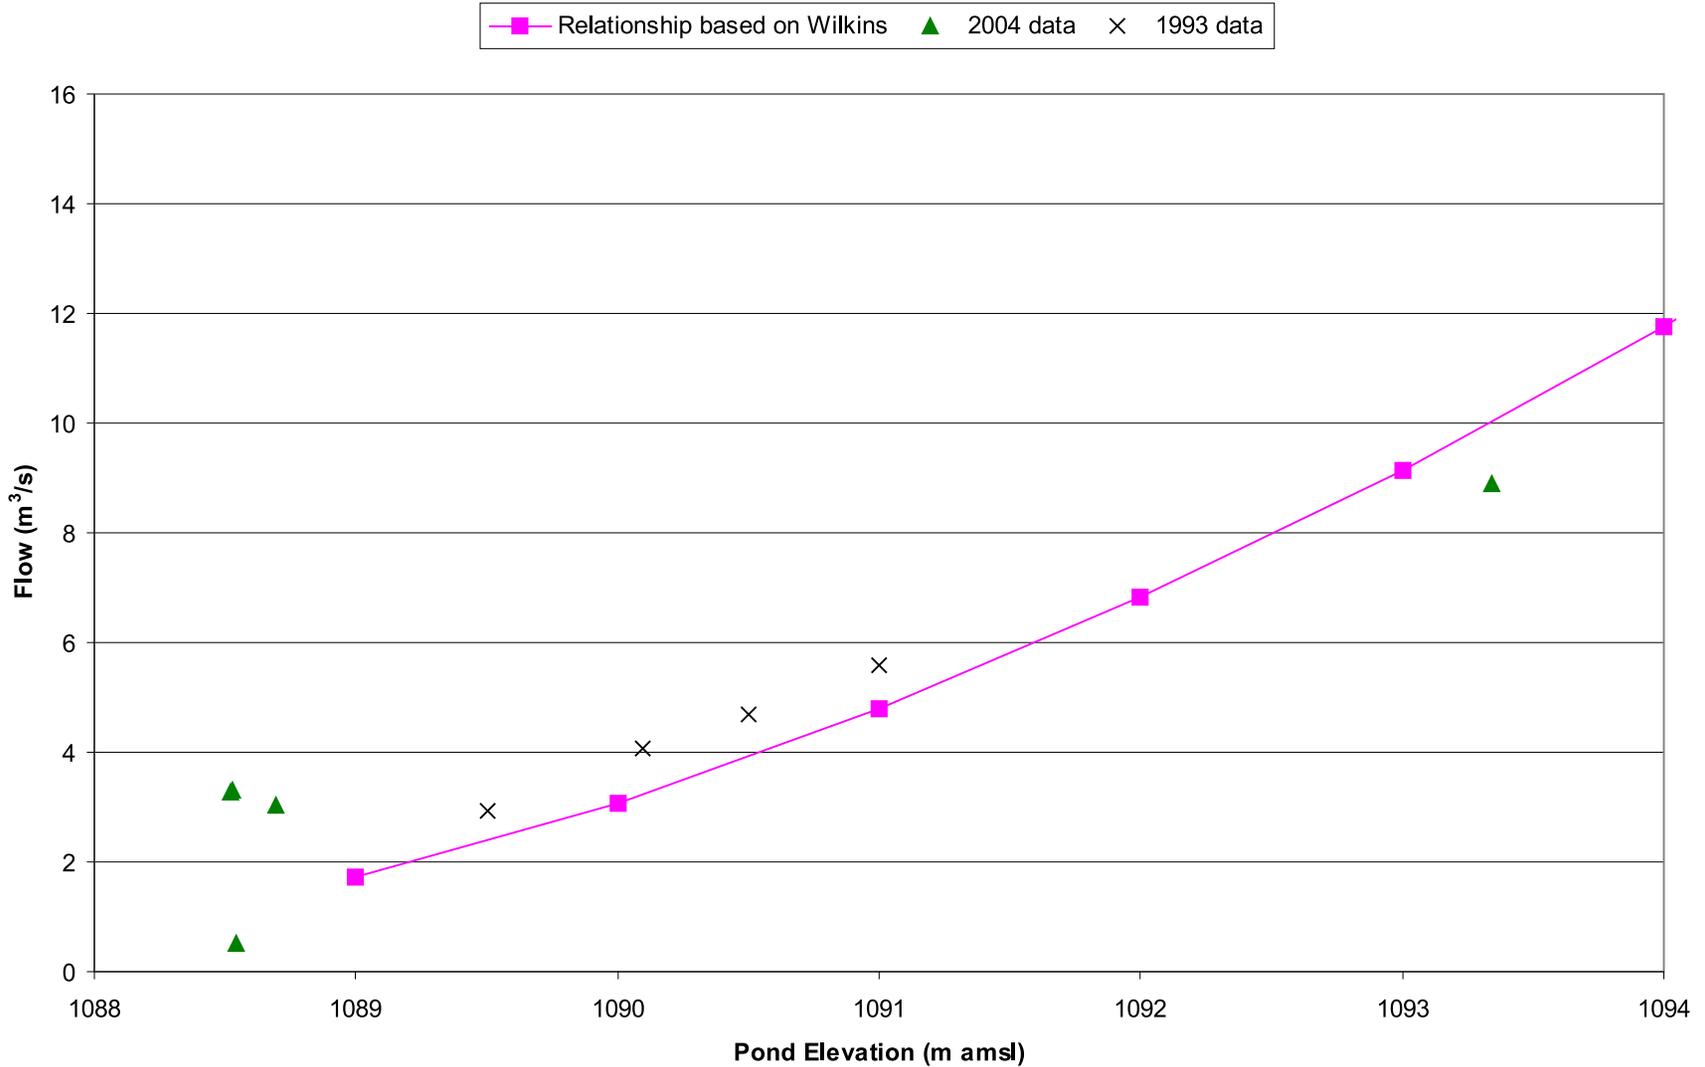
DWG. No.  
8

The relationship between pond elevation and flow through the drain is plotted in Figure 8 along with data collected in 2004 and 1993. The pond elevation data plotted from 1993 is based on a rough estimate of the elevation of the sensor, which was developed by comparing the low pond water levels measured in 1991 to those measured in 2004. Given the limited data collected in 2004, due to data-logger failures, and the rough correlation to the 1993 data set, this equation describing the relationship between pond elevation and flow should be considered as tentative. Additional pond elevation data should be collected in 2005 along with a careful program of flow measurement to confirm the relationship. A comparison between the relationship for pond elevation and flow developed in 1993 and 2004 is shown in Figure 9. Again, the 1993 curve was modified to pond elevations based on the comparison of low pond levels in the summer and fall.

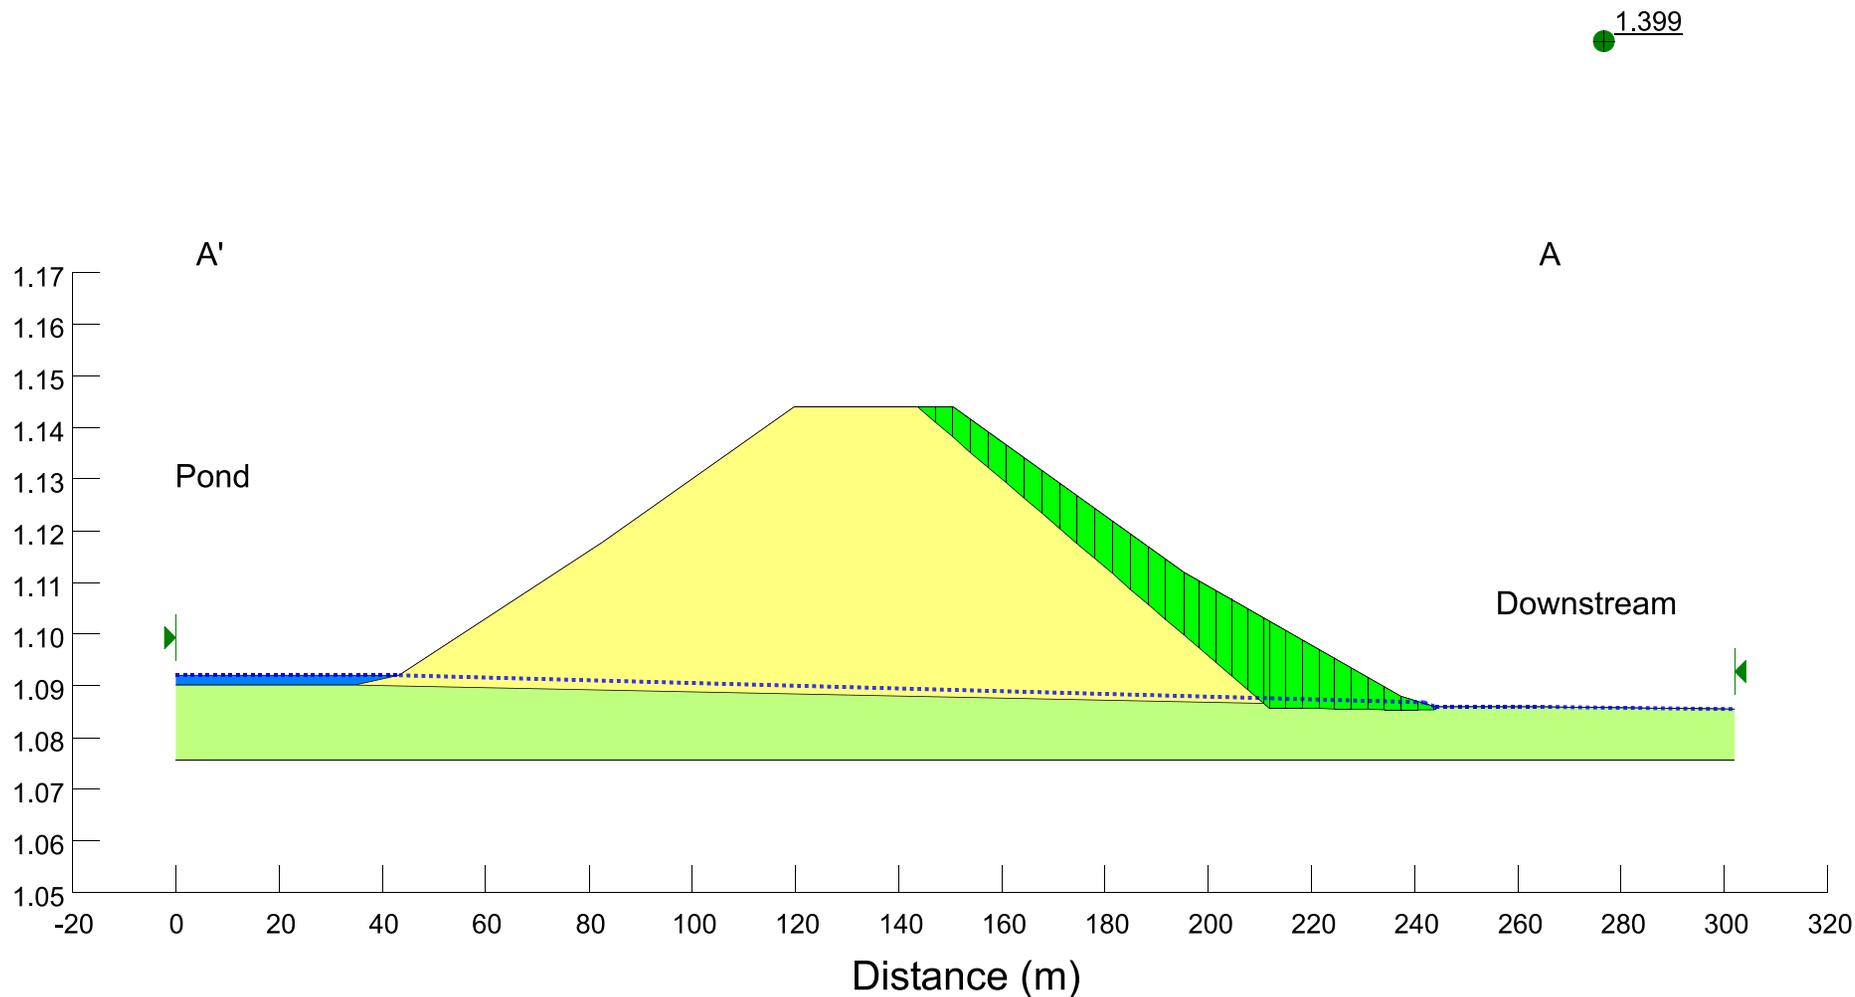
PROJECT No. 0257-023-03	DWG. No. 10	REV. 0

During construction of the NFRD the measured angle of repose was 37°. The current condition of the NFRD is shown on Figure 10. The pond side of the NFRD has an angle of 34°. The upper and lower portions of the downstream side of the NFRD are at 35° and 29°, respectively. Typical ranges for angle of repose for a rock dump constructed of clean rock ranges between 35° and 40° (BCMWRPRC 1991).

Limit equilibrium analysis was performed for a variety of pond conditions and assumed downstream exit water elevations. Shown in Figure 10 is the analysis using typical winter and summer pond levels. It should be noted that the failure surface shown in this figure is one of a family of failure surfaces that were analyzed, with the failure surface indicated being the one with the minimum factor of safety. The analysis shown in Figure 10 is based on measured pond elevation and measured water exit elevation on October 5, 2004, which were considered to be typical of summer/fall/winter conditions. Shown on Figure 11 is the result for the analysis of pond elevation and water exit elevation on May 27, 2004, which was near the peak of the 2004 spring freshet.

The NFRD was constructed as a dumped fill structure at the angle of repose. Given that the upstream side and the upper portion of the downstream side of the structure are currently near the angle of repose, any significant earthquake acceleration will move these slope faces to a failure condition. A pseudo-static stability analysis was performed for the NFRD to determine the stability with respect to larger deep seated failures, like those shown in Figure 10 and 11.

The soil properties listed in Table 6 were used along with the typical pond levels, as shown in Figure 10. Results of the factor of safety versus the applied acceleration (% g) are plotted in Figure 12. These results indicate that the structure will “fail”, that is a calculated factor of safety less than one, during an earthquake that produces acceleration greater than about 0.27g.

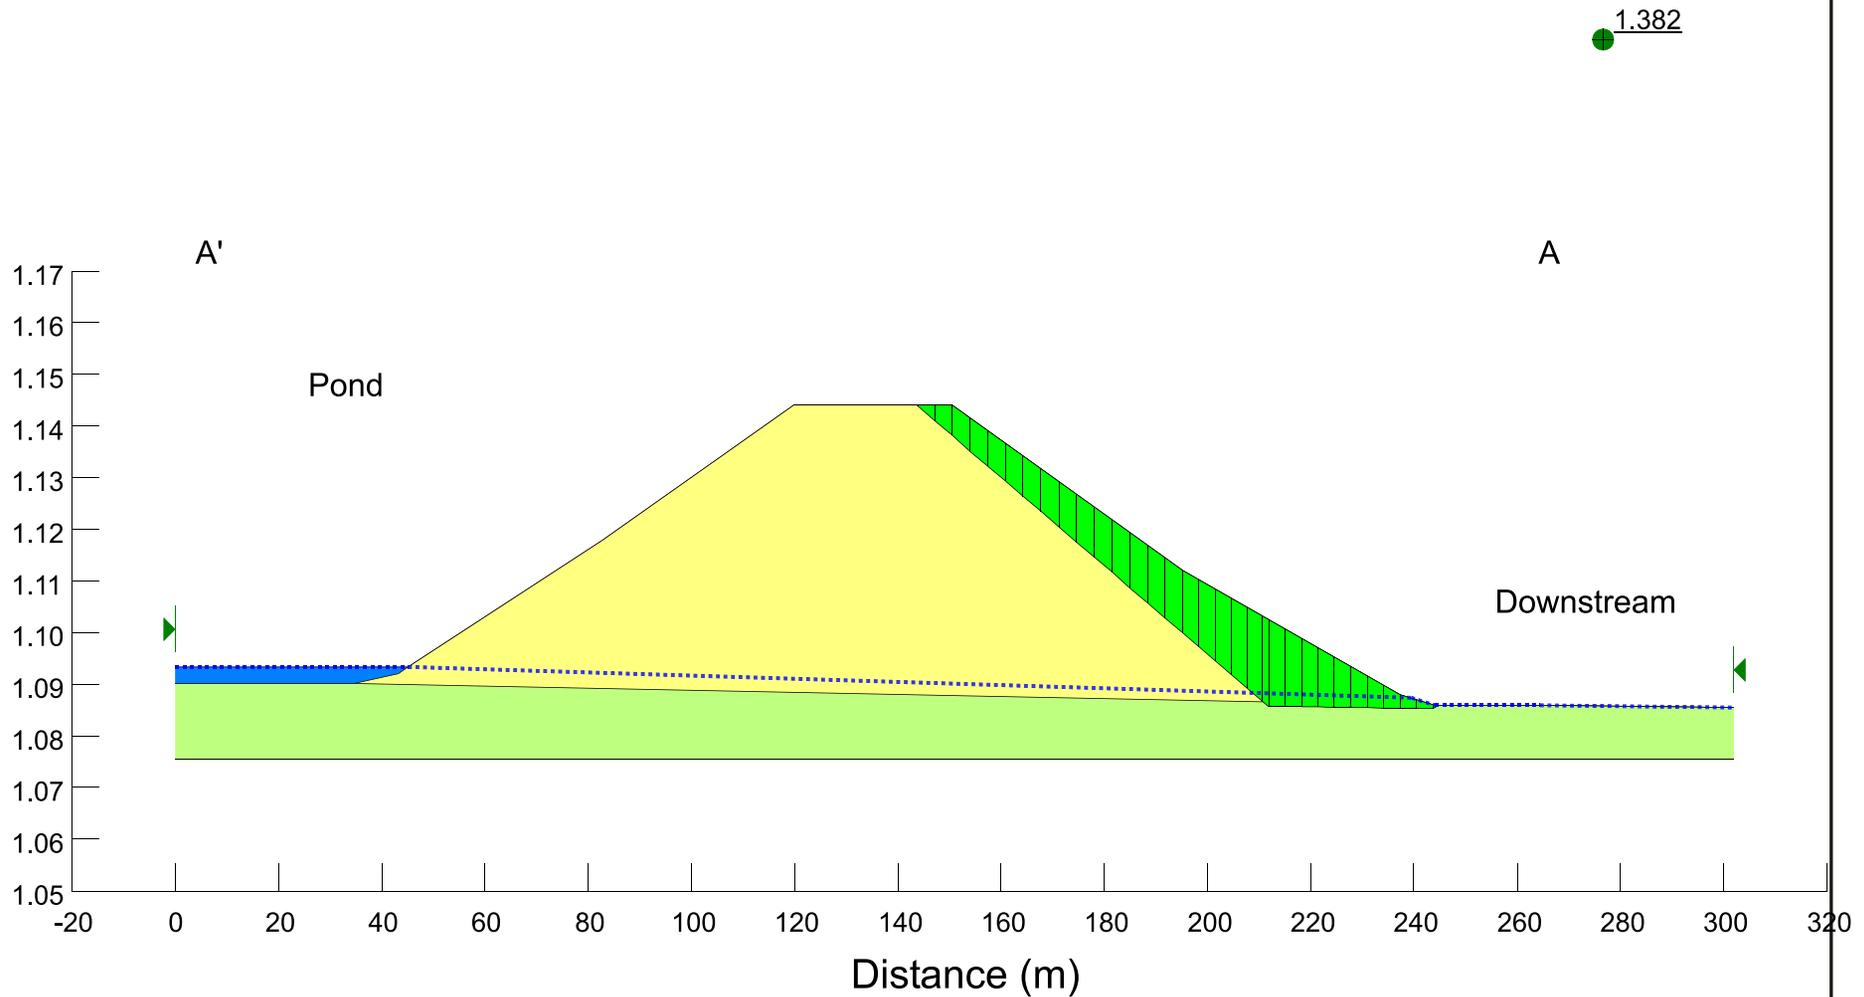
PROJECT No. 0257-023-03	DWG. No. 11	REV. 0

The stability analysis was repeated for pond elevations of 1095, 1100, 1105 and 1110 m amsl. The results were similar to those shown in Figures 10 and 11 and the resulting calculated factors of safety are listed in Table 7. The elevation of the water exiting the toe of the NFRD was selected in this analysis based on the relationship between pond and exit water elevations measured in May and October 2004. The results of this analysis assume static water levels. A discussion of the effects of seepage on the stability of the toe is included in Section 6.4. It should be noted that predicted water elevation during the 1,000 year return period flood is less than 1104 m amsl, so the results presented for a pond elevation 1110 m amsl are well above what will need to be withstood by this structure. Therefore the static stability for a deep seated failure on the downstream face is about 1.2. Given that the downstream face is near the angle of repose, the high water levels would likely induce shallow failures on the face of the dump. Further discussion concerning this type of failure is provided in Section 6.4.

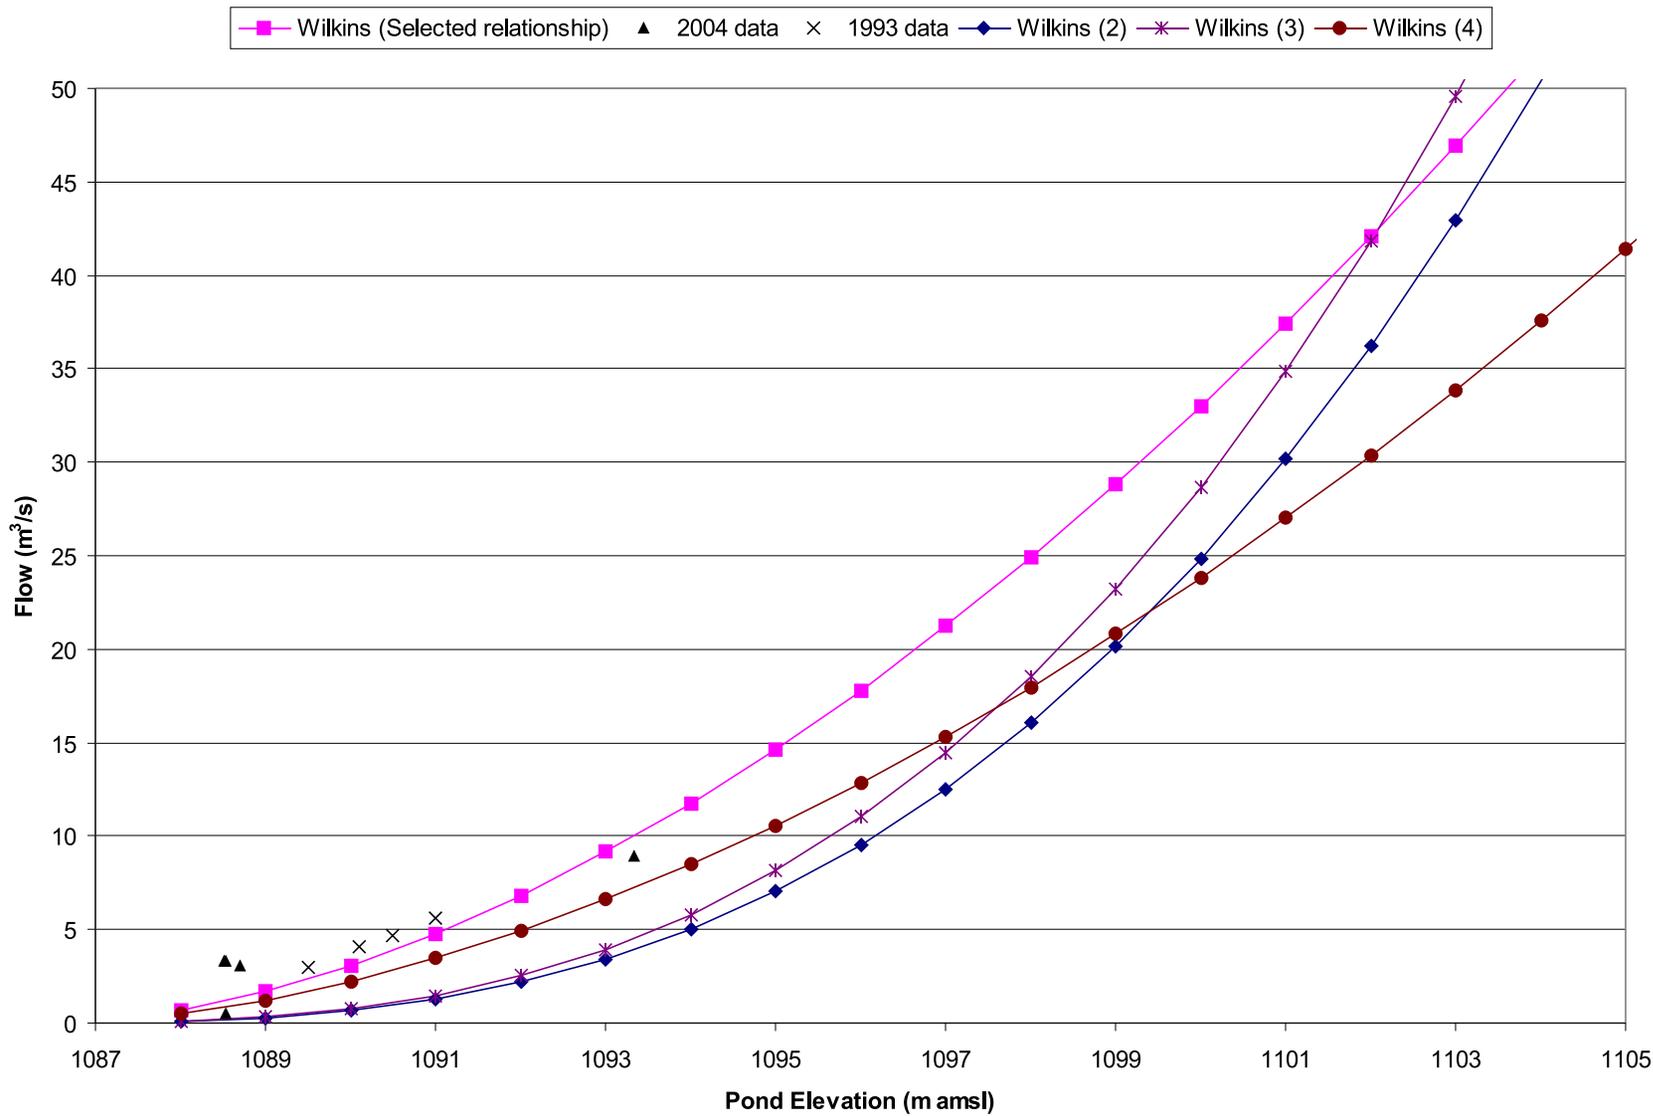
PROJECT      NORTH FORK ROCK DRAIN EVALUATION		
TITLE      SENSITIVITY OF FLOW THROUGH RELATIONSHIP		
PROJECT No. 0257-023-03	DWG. No. 13	REV. 0

In order to test the sensitivity of the flow through relationship a number different assumptions were tested for the main unknowns. A comparison of the measured results and four of the developed relationships based on Wilkins' equation are shown in Figure 10. The parameters used in these equations matched, as best possible, the actual conditions with the remainder of the properties selected conservatively (realistically). Inspection of these relationships indicates that only minor differences in the calculated maximum water levels would result. The relationship used provided the best match to the measured flow and pond elevations. Based on this comparison it was concluded that although there were gaps in the data collection for 2004 it is considered unlikely that future data collection will significantly alter the main conclusions of this assessment. It is recommended that additional data be collected and the recommended relationship reviewed once this data becomes available. Additional data is expected to finalize the relationship between pond elevation and flow through capacity.

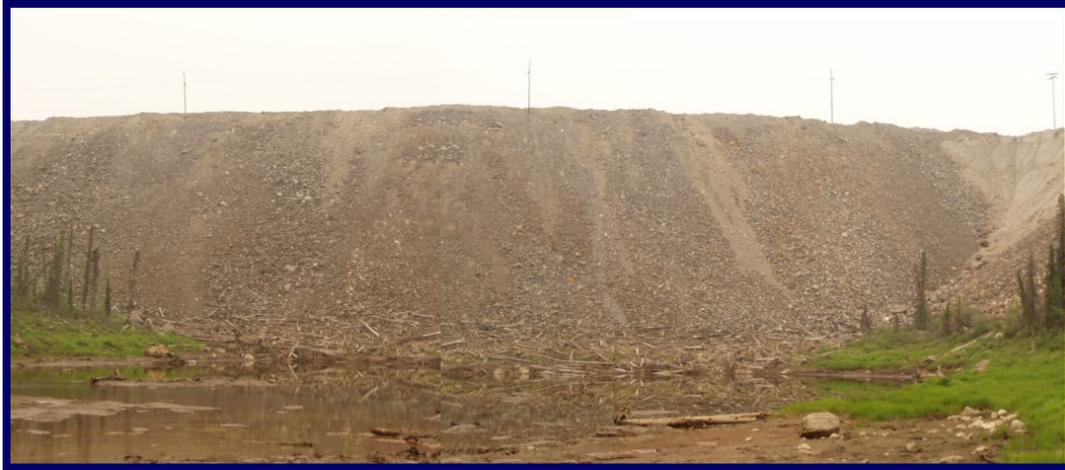
Photo 3 a panoramic view of the upstream side of the rock drain. As can be seen some sloughing of fine grained material from the upper edge of the haul road surface has occurred. Note location of the woody debris on the lower surface of the rock, this marks the previous high water level for the drain since installation.

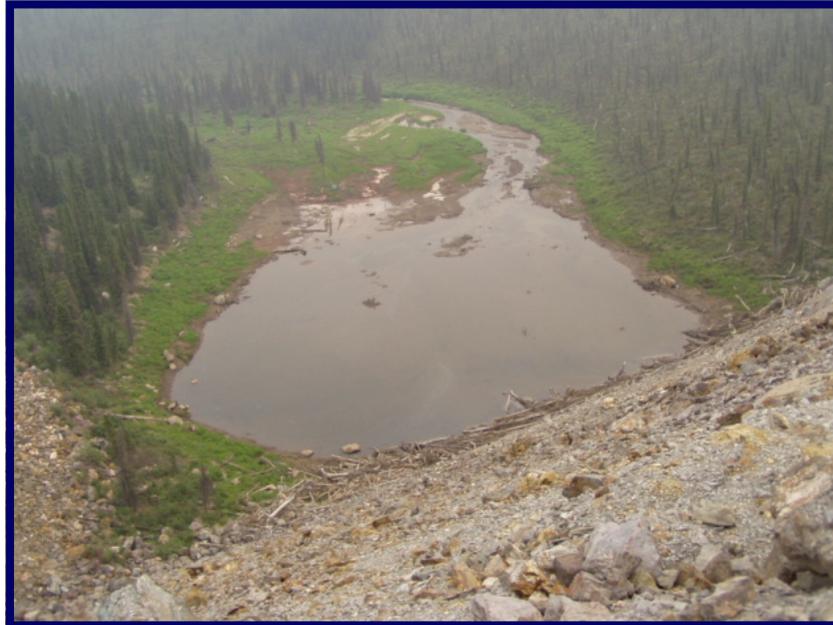
Photo 4 looking upstream at the pond from the haul road. Not the blue barrels marking the initial position of the pond data logger. The second position of the data logger is at the left hand side of the pond, in this photo, near the boulders.

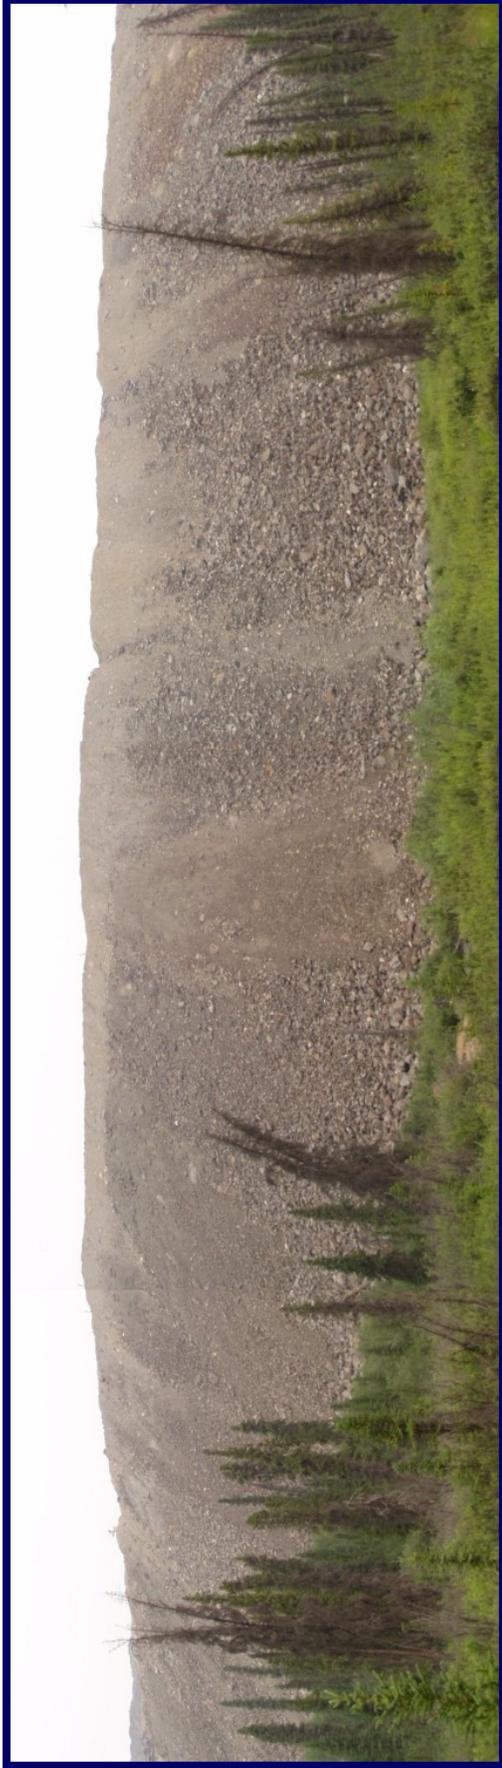
Photo 5 a panoramic of the downstream face of the drain. Note the sloughing of fine grained material from the haul road surface.

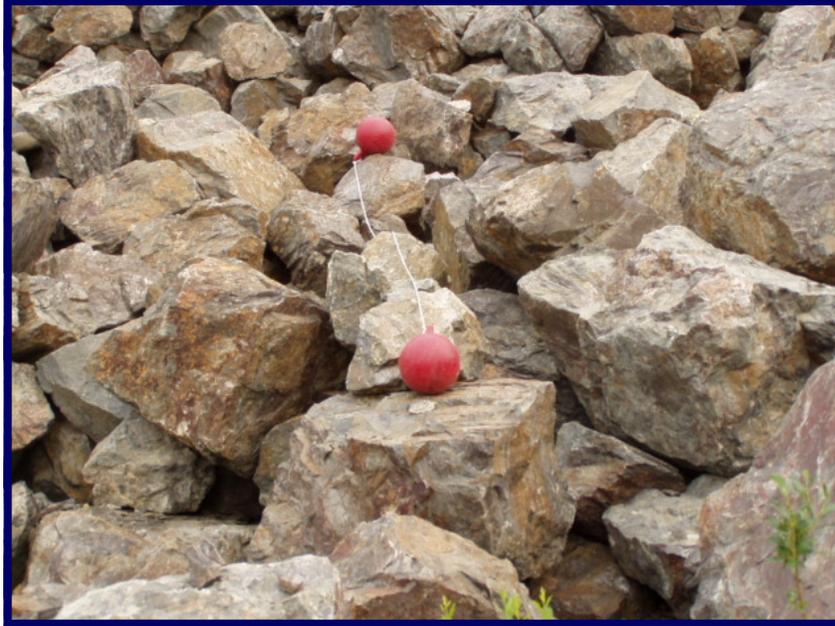
Photo 6 (118) shows the size of the boulders located at the downstream toe of the drain, near the eastern limit of the wetted area. This photo was taken at GPS waypoint 51 (See Figure 4) and includes the two red balls. These balls are 10 inch diameter and were used to estimate the grain size of the rock.

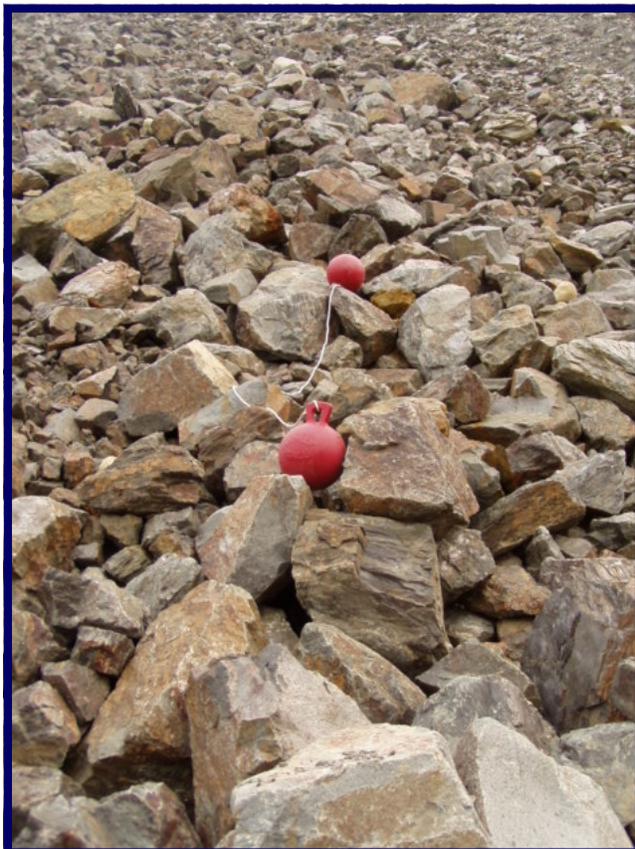
Photo 7 (122) is another view of the boulders at the downstream toe of the drain. This is GPS way station 52 (Figure 4).

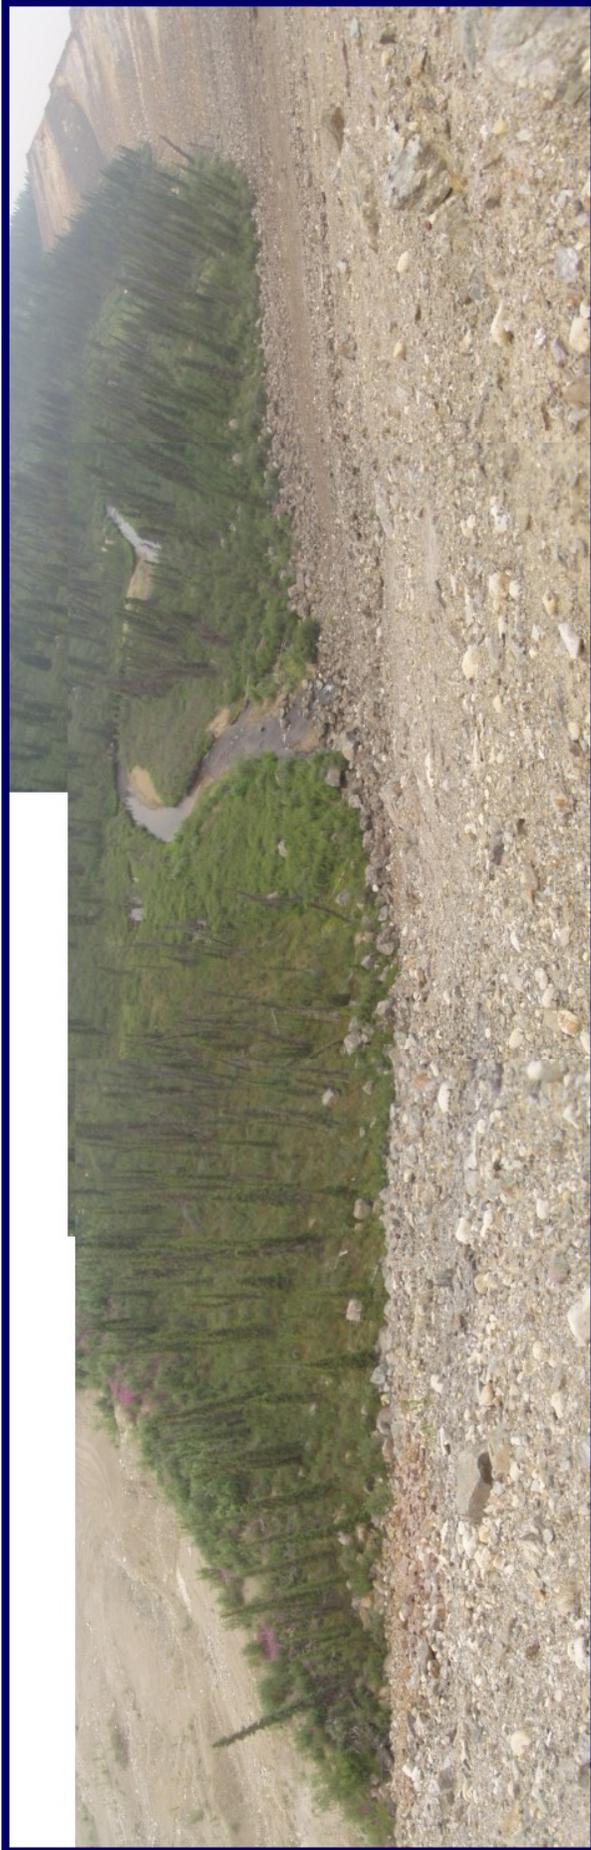
Photo 8 a panoramic showing the toe of the rock drain taken from the downstream crest edge.

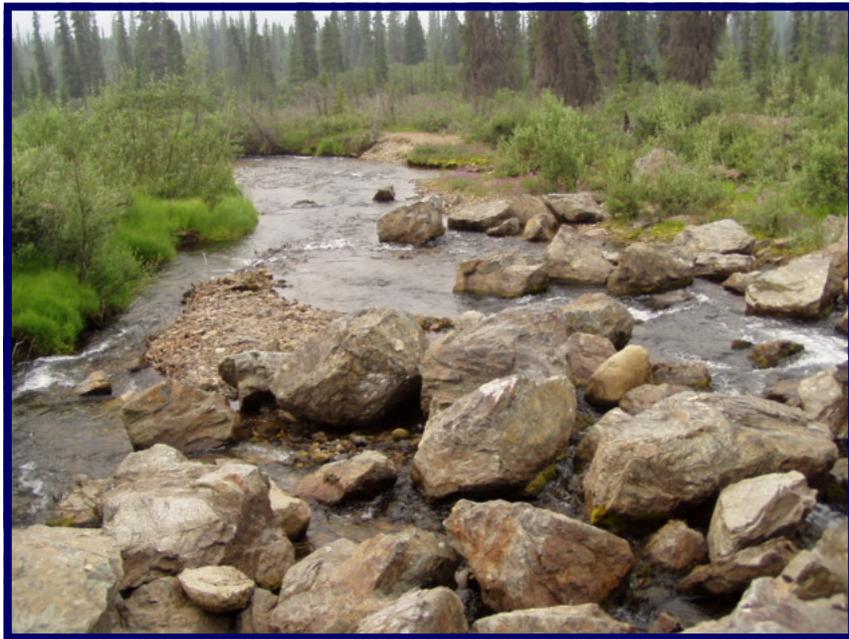
Photo 9 is a view of the water discharging the downstream toe.

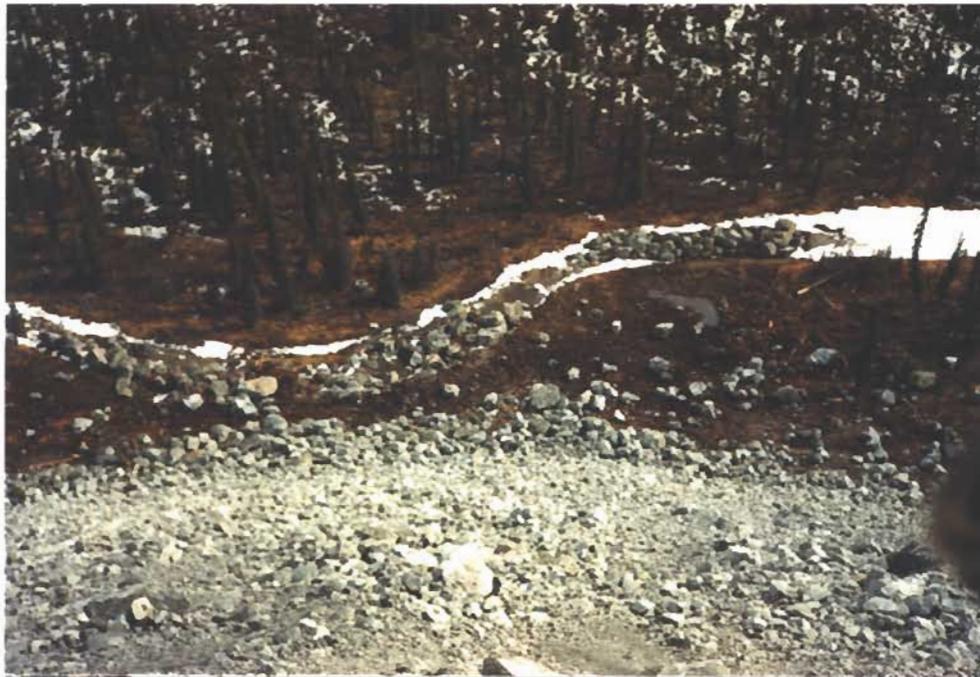
PHOTO 1

VIEW FROM THE CREST OF THE ROCK FILL THAT IS BEING ADVANCED ACROSS THE NORTH FORK OF ROSE CREEK, AS PART OF THE ROAD ACCESS TO THE VAGNORDA ORE DEPOSIT. THE SEGMENT OF THE FILL SHOWN WILL FORM PART OF THE NORTH FORK ROCK DRAIN, AND THE MATERIAL CONSISTS OF CALCIUM SILICATE (C<sub>6</sub>S<sub>1</sub>) BRECCIA. SOME LARGE ROCK FRAGMENTS AT THE TOE OF THE FILL HAVE BEEN SHIFTED BY BULLDOZER INTO THE NORTH FORK DRAINAGE CHANNEL. THE SIZE OF THE ROCK FRAGMENTS THAT SEPARATE ON THE ADVANCING FACE OF THE FILL AND ROLL TO THE TOE, ARE OF SUFFICIENT SIZE THAT PLACEMENT OF THE LARGEST OF THESE FRAGMENTS BY BULLDOZER IS NOT NECESSARY. BULLDOZER PLACEMENT OF ROCK IN THE CHANNEL IS TO BE DISCONTINUED.

A review of the grain size of the material making up the NFRD was undertaken. A summary of the results is provided in Table 1 and a copy of the photos collected during this inspection is included in Appendix II. The rock within the lower 55 m of the advancing face of the NFRD was noted to be “remarkably clean”. Fines were noted only in the upper 10 m of the advancing face.

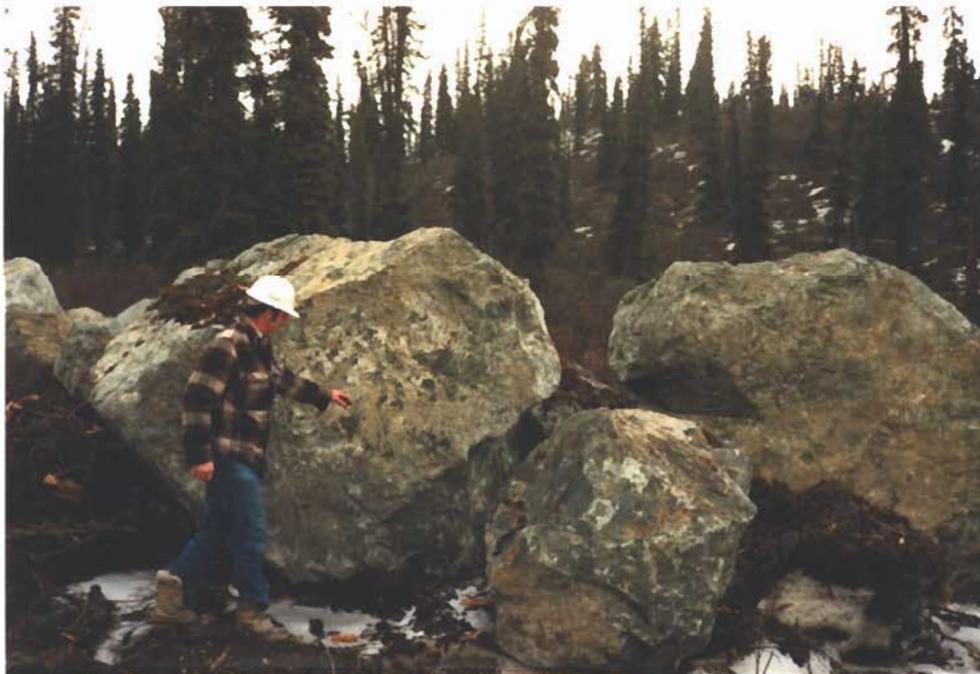
PHOTO 2

AN EXAMPLE OF THE SIZE OF C<sub>6</sub>S<sub>1</sub> ROCK FRAGMENTS THAT HAVE BEEN PLACED IN THE NORTH FORK DRAINAGE CHANNEL.

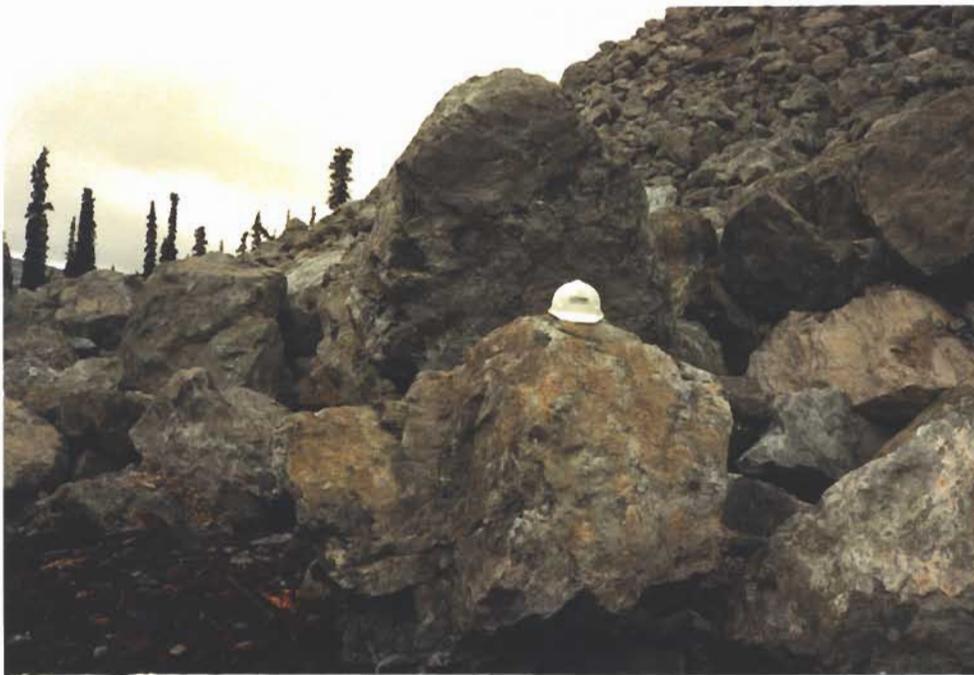
PHOTO 3

ILLUSTRATING THE SIZE OF  $\text{CaSi}$  ROCK FRAGMENTS THAT HAVE SEPARATED ON THE FACE OF THE ROCK FILL, AND HAVE COME TO REST AT THE TOE.
