**NORTH FORK ROCK DRAIN**

**GEOTECHNICAL  
EVALUATION**

**DRAFT REPORT**

PROJECT NO.: 0257-023-03  
DATE: NOVEMBER 22, 2004

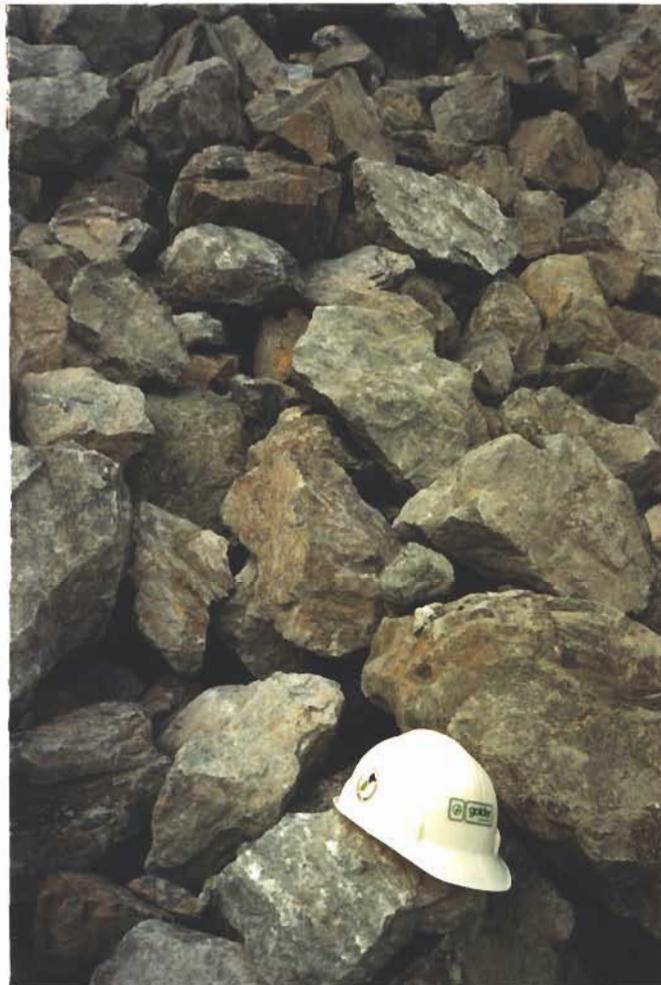
PHOTO 4

ILLUSTRATING THE SIZE OF THE ROCK FRAGMENTS ON THE FACE OF  $\text{CaSi}$  FILL, AT A HEIGHT OF APPROXIMATELY 7m ABOVE THE TOE OF THE FILL AS AT 7 MAY 87. THE 65% SIZE IS ESTIMATED TO BE 0.5m, AND THE 50% SIZE IS ESTIMATED TO BE APPROXIMATELY 0.3m.

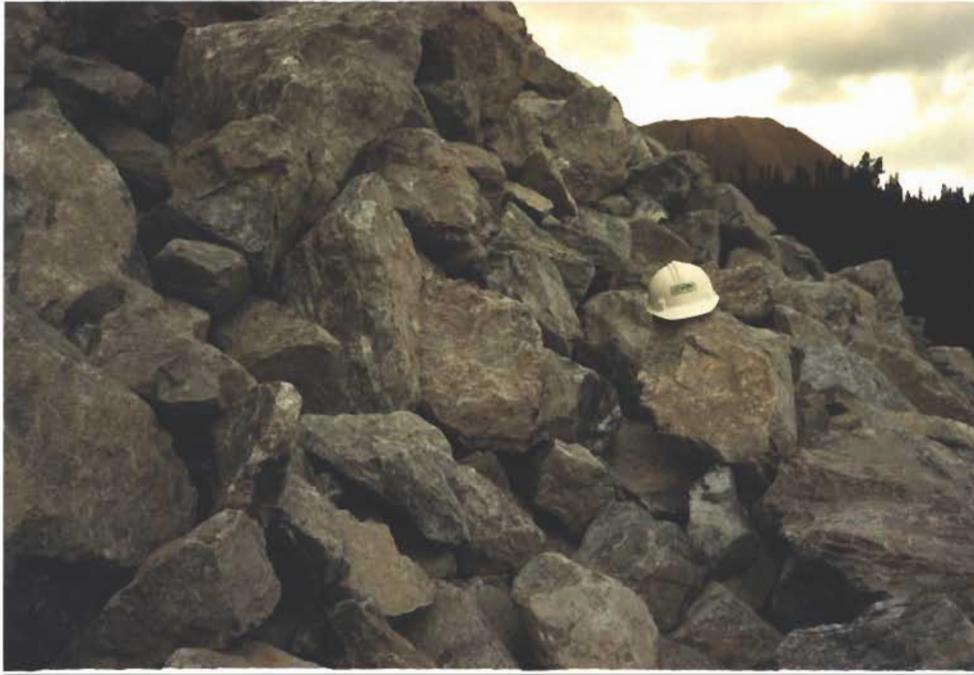
PHOTO 5

ILLUSTRATING THE SIZE OF THE C<sub>651</sub> ROCK FRAGMENTS ON THE FACE OF THE FILL AT A HEIGHT APPROXIMATELY 10m ABOVE THE TOE, AS AT 7 MAY 87. AT THIS PARTICULAR SEGMENT ON THE FACE, THE AVERAGE SIZE OF THE ROCK FRAGMENTS IS SLIGHTLY LARGER THAN THE SIZE OF THE FRAGMENTS AT A HEIGHT 7m ABOVE THE TOE.

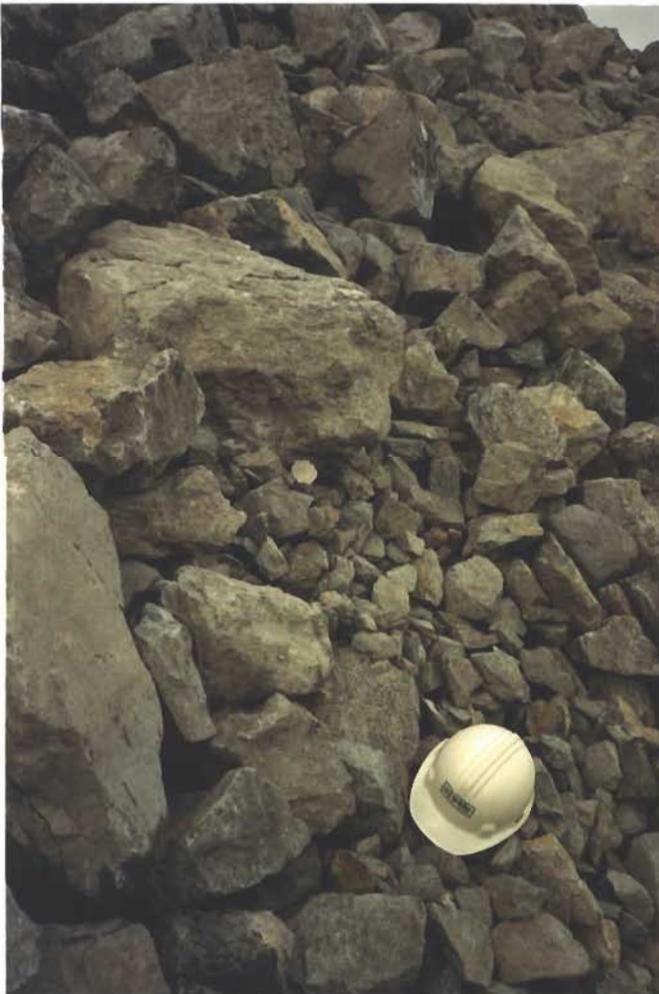
PHOTO 6

SHOWING THE ROCK FRAGMENTS ON THE FACE OF THE ADVANCING ROADWAY FILL AT AN ESTIMATED HEIGHT OF 17m ABOVE THE TOE, AS AT 7 MAY 87. THE 85% SIZE IS ESTIMATED TO BE 0.5m, THE 50% SIZE IS ESTIMATED TO BE 150mm. NOTE THE 75 TO 150mm SIZE FRAGMENTS ON THE FACE, SLIGHTLY ABOVE AND TO THE LEFT OF THE HARD HAT. THE SMALLEST SIZE OF THESE FRAGMENTS IS APPROXIMATELY 40mm.

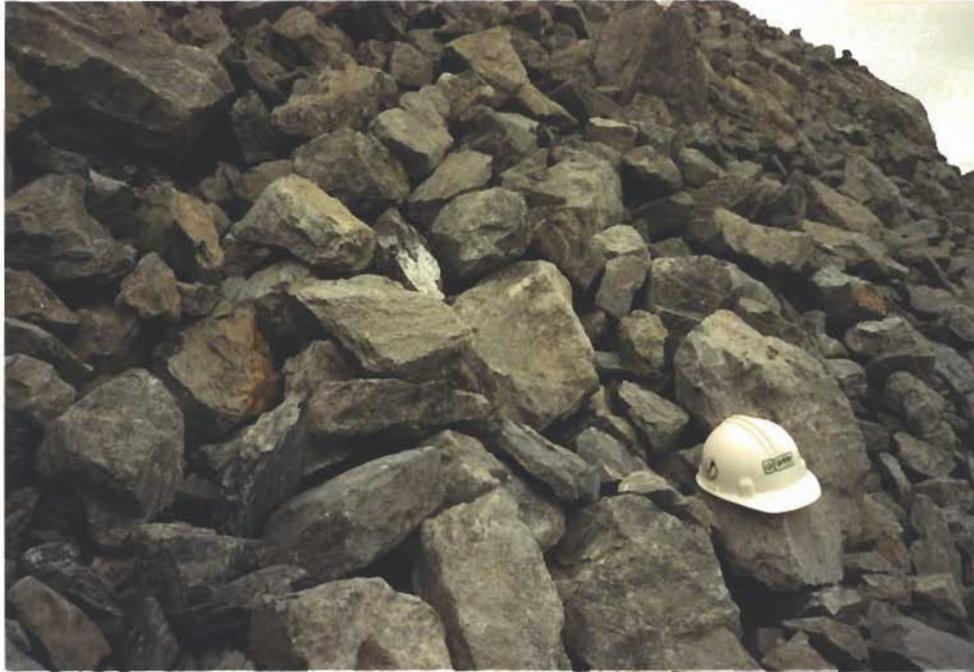
PHOTO 7

ILLUSTRATING THE CaSi ROCK ON THE FACE OF THE VANGORDA ROADWAY FILL AT A HEIGHT ESTIMATED AT 55m ABOVE THE TOE OF THE FILL AS AT 7 MAY 87. AS IS APPARENT IN THE PHOTO, THE ROCK AT THIS LEVEL IS DEVOID OF FINES. FINES WERE EVIDENT ONLY WITHIN THE UPPER 10 METERS ON THE FACE, ie BETWEEN THE CREST OF THE FILL AT 3500 FL AND ELEVATION 3770 FL APPROXIMATELY.
