# Pony Creek Adit Bulkhead, Mt Nansen, Yukon

# **Pony Creek Adit Bulkhead, Mt Nansen, Yukon**

**SRK Project Number 1CY001.03**

Appendix A:	Geotechnical Inspection SRK, September 16, 2005
Appendix B:	Bulkhead Design Westmar Consultants Inc., February 2006

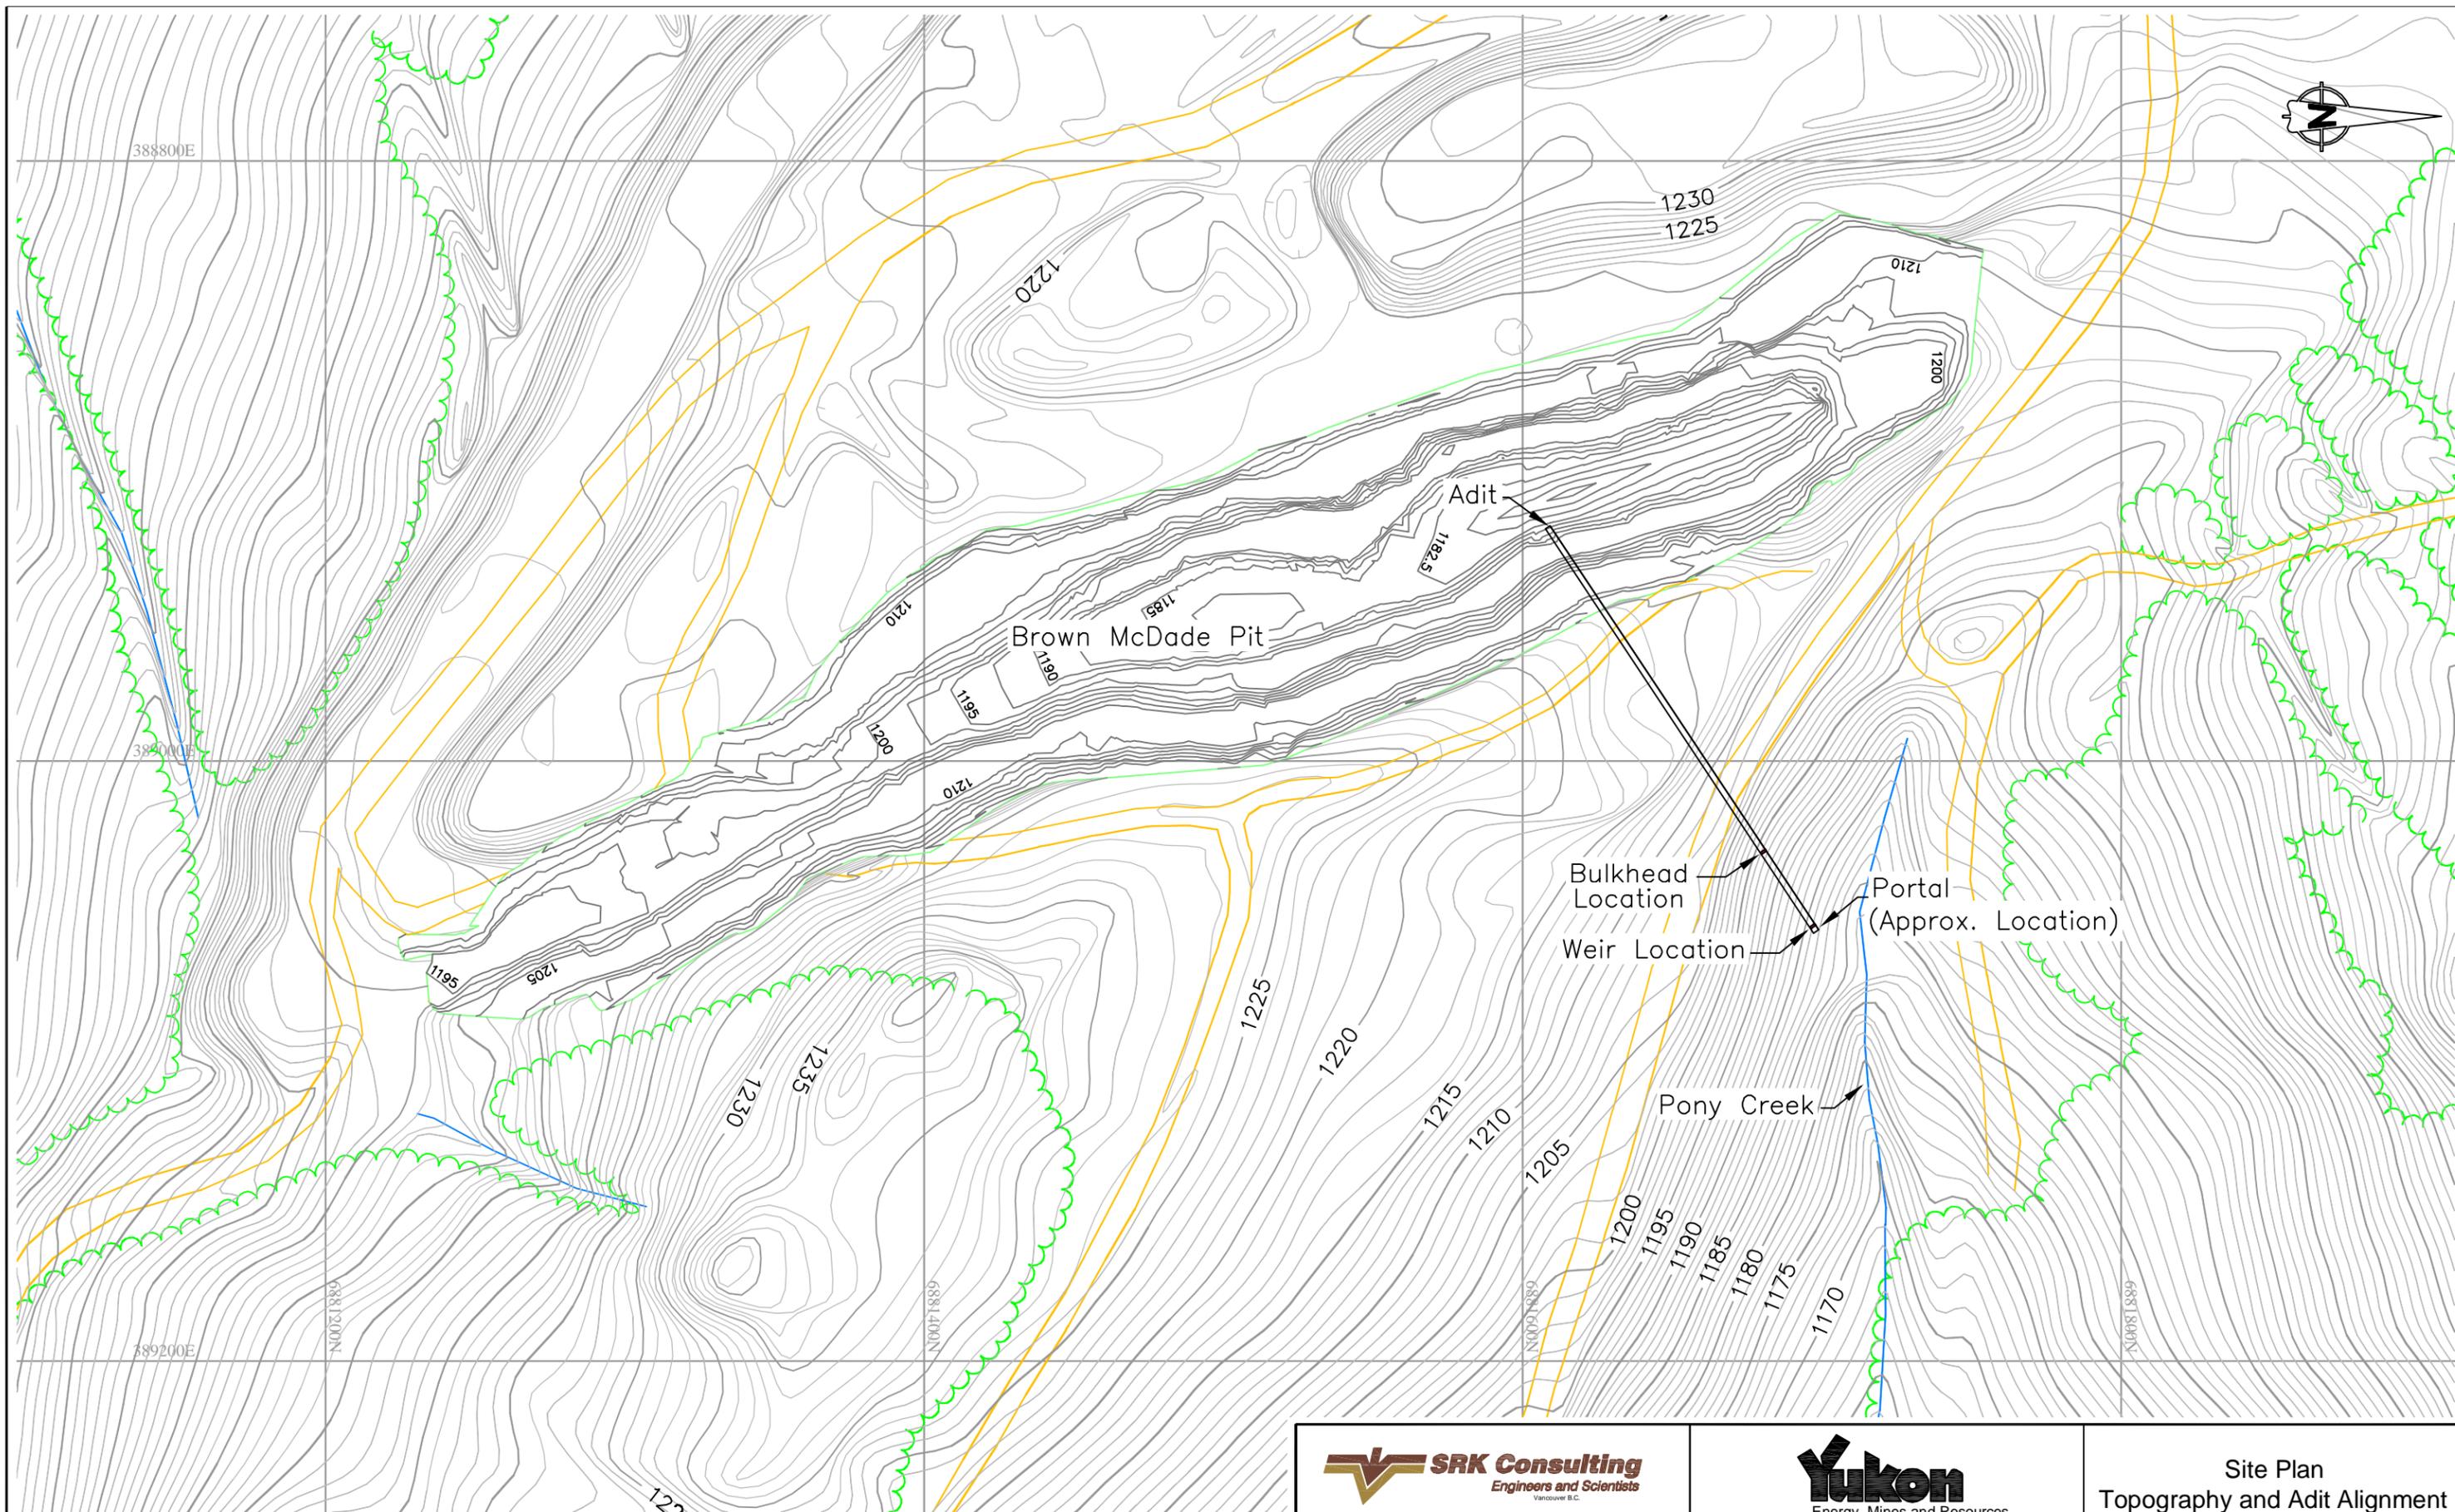
FIGURE: 1

Mining of the Mt. Nansen deposit was conducted between 1996 and early 1999 by open pit methods. The open pit mined through an exploration adit which had been developed in the 1960's. Since the end of mining, water accumulation in the pit has produced a small body of water which, if not managed, would discharge to Pony Creek via the adit. Figures 1 and 2 show the mine workings in plan view and cross-section.

Site Plan  
Topography and Adit Alignment

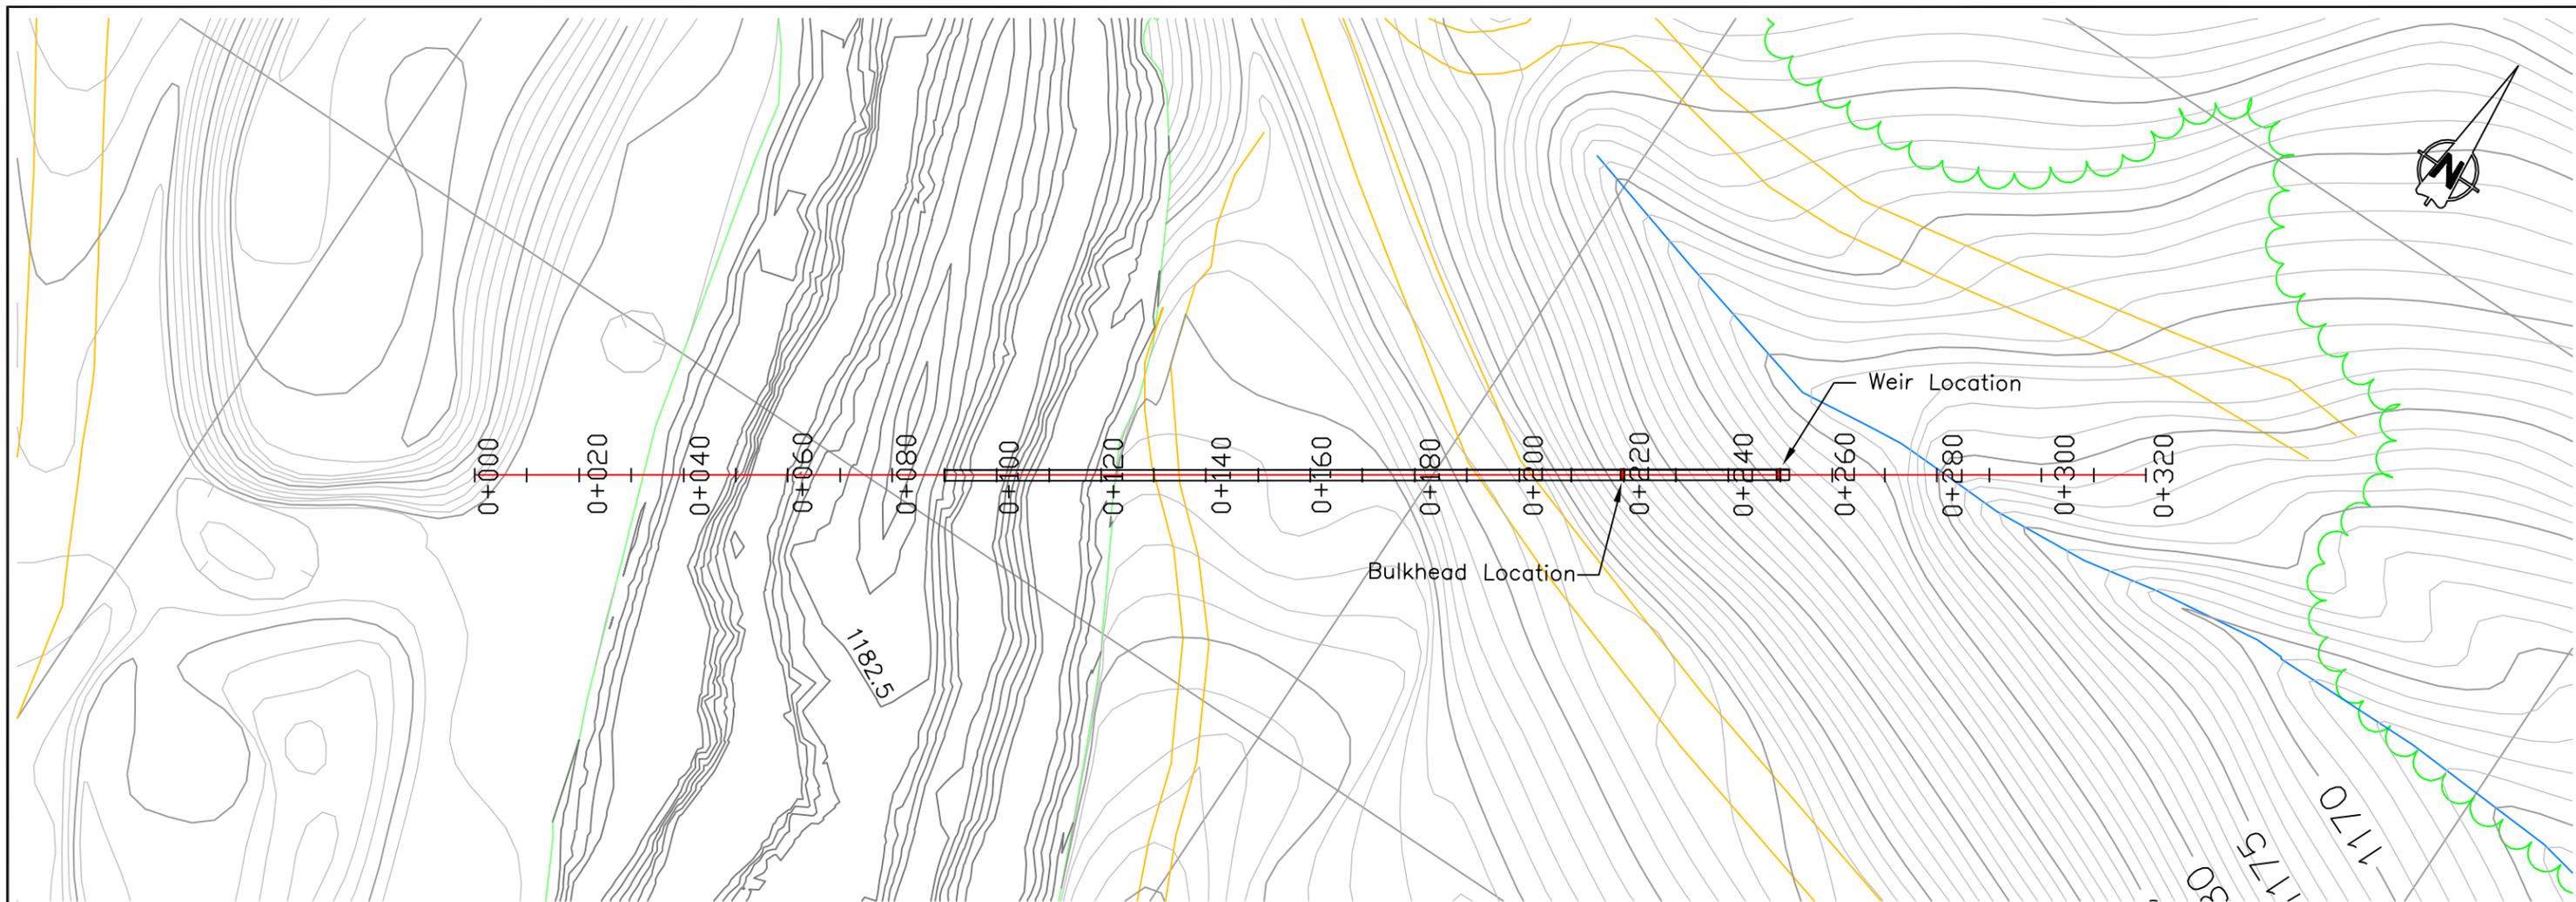
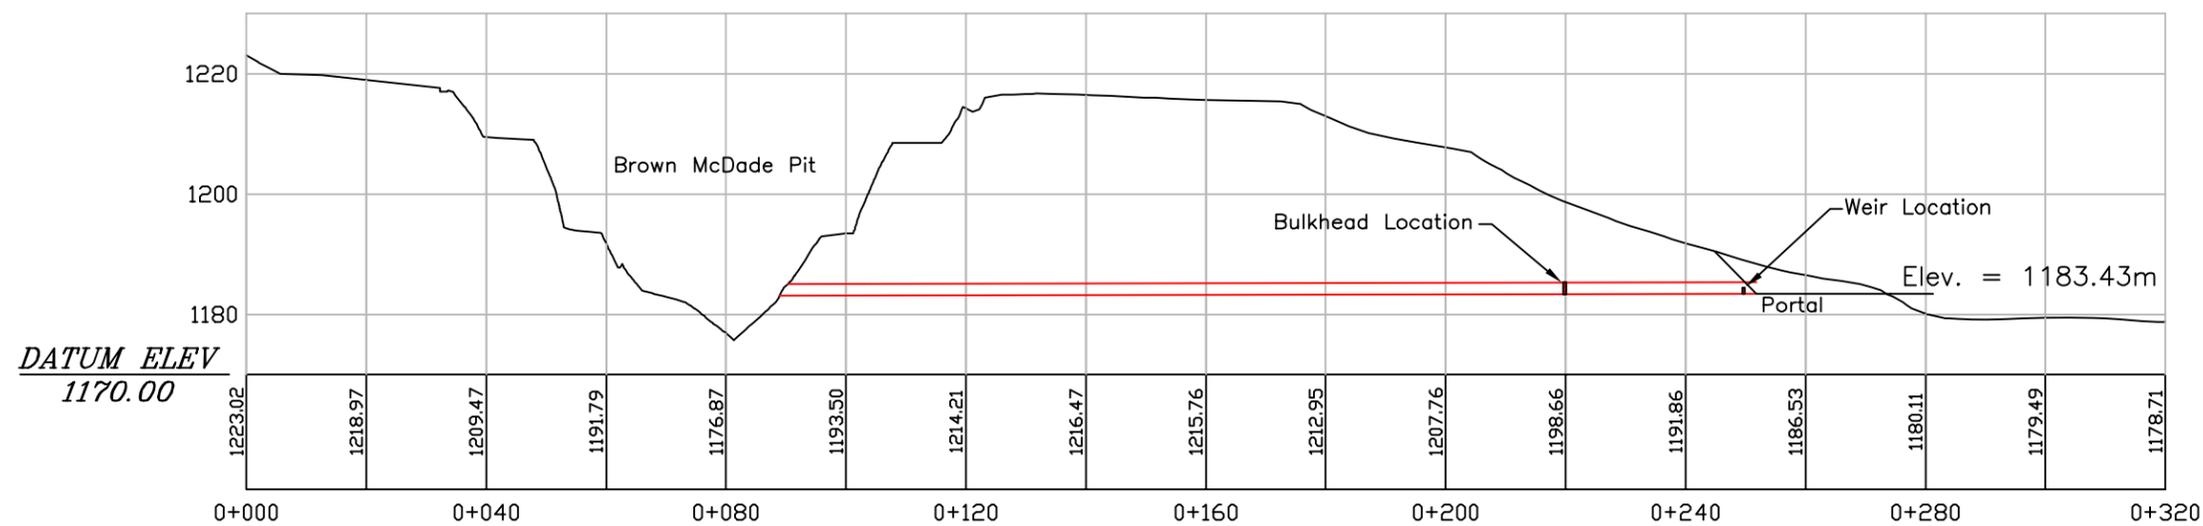
DATE: May 06	APPROVED:	FIGURE: 2
-----------------	-----------	--------------

From the portal, to the point where the tunnel enters the pit, the approximate length of the adit is 165.0 m and the average size is 2.0 m high by 1.8 m wide.

Pony Creek Adit Section

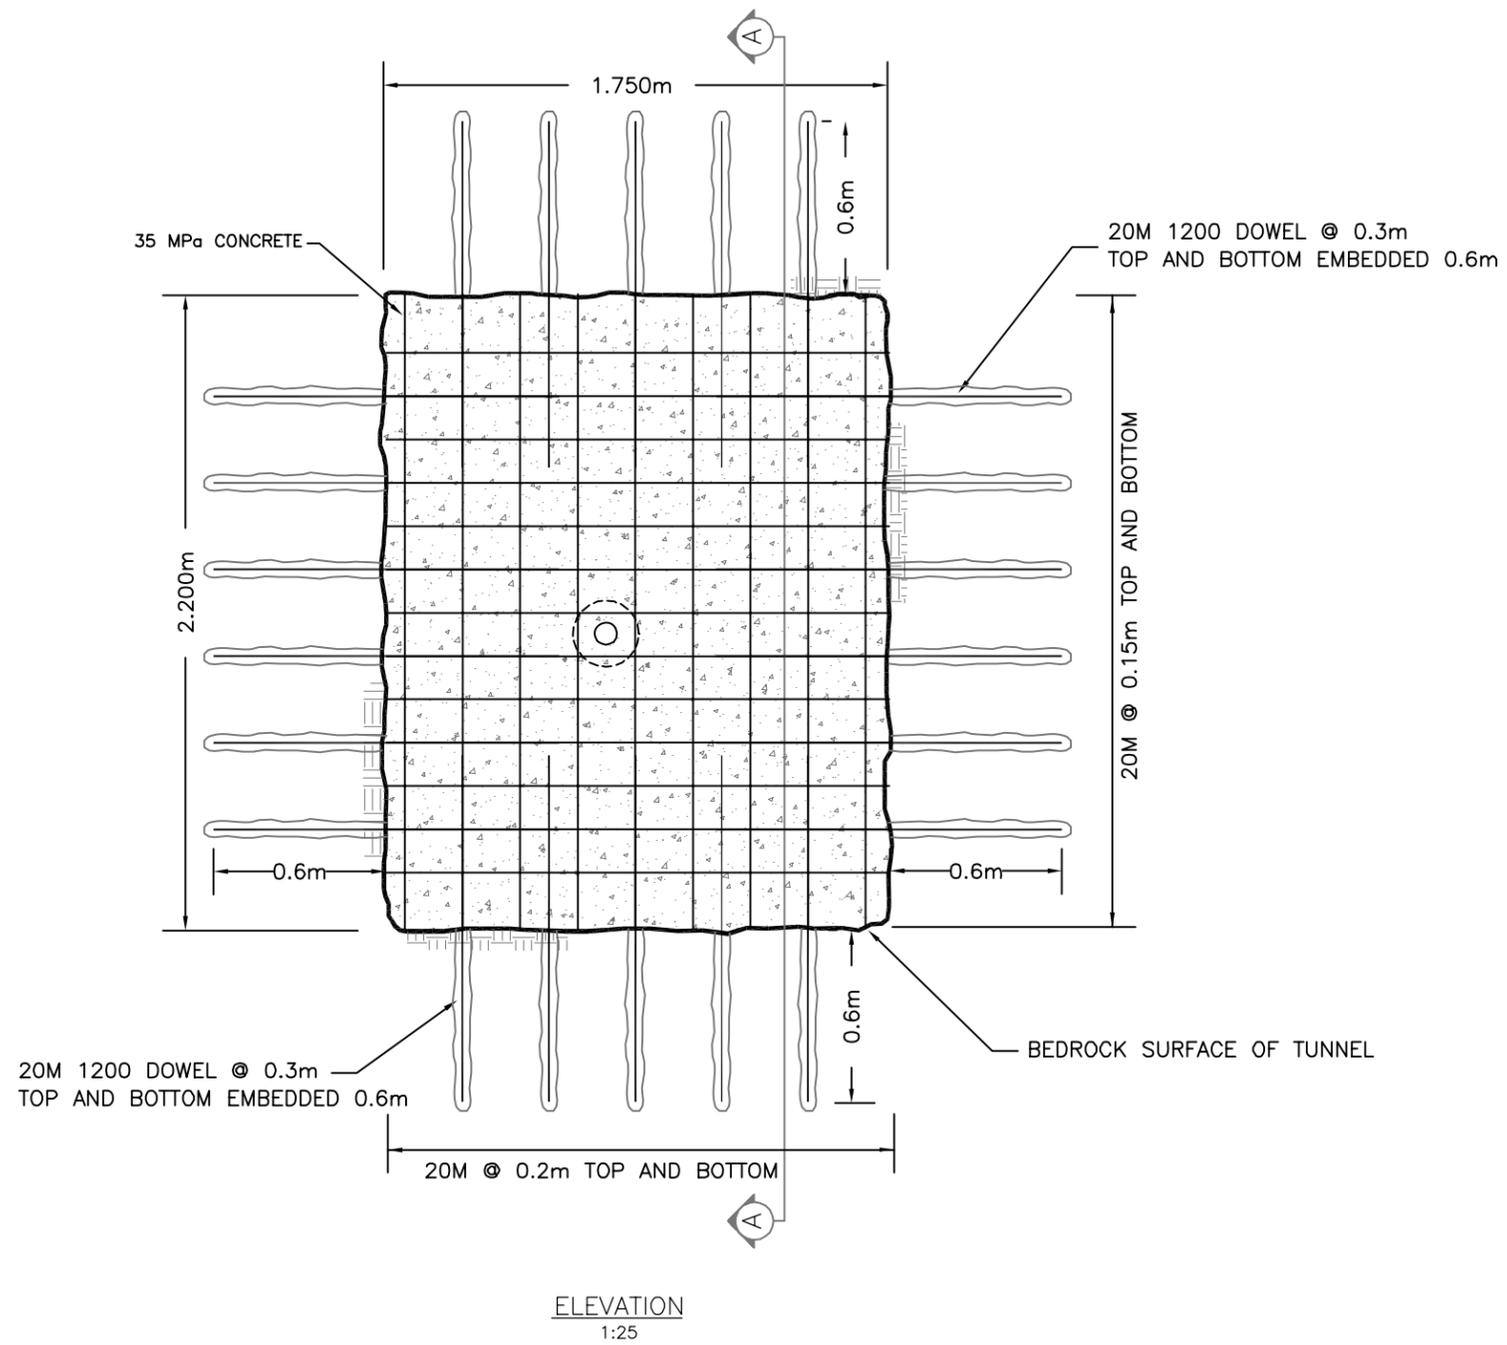
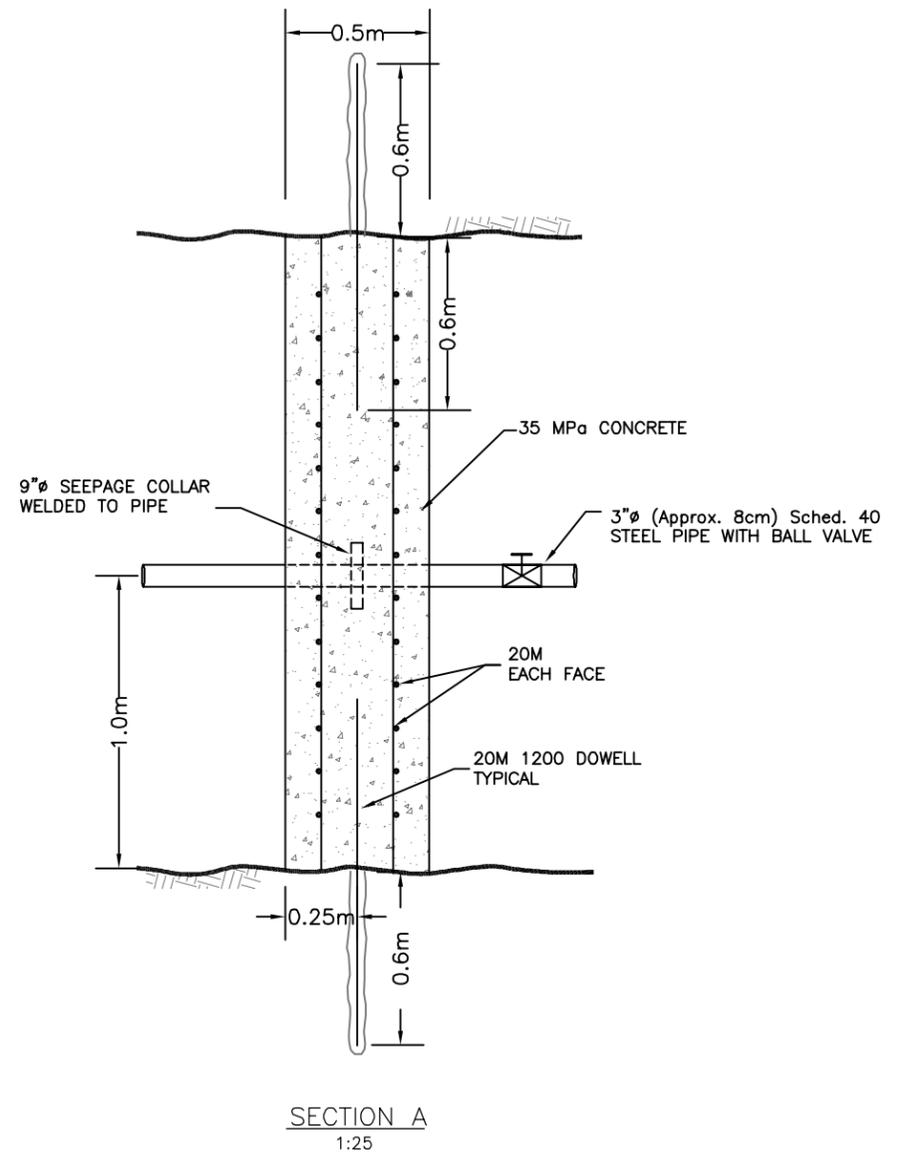
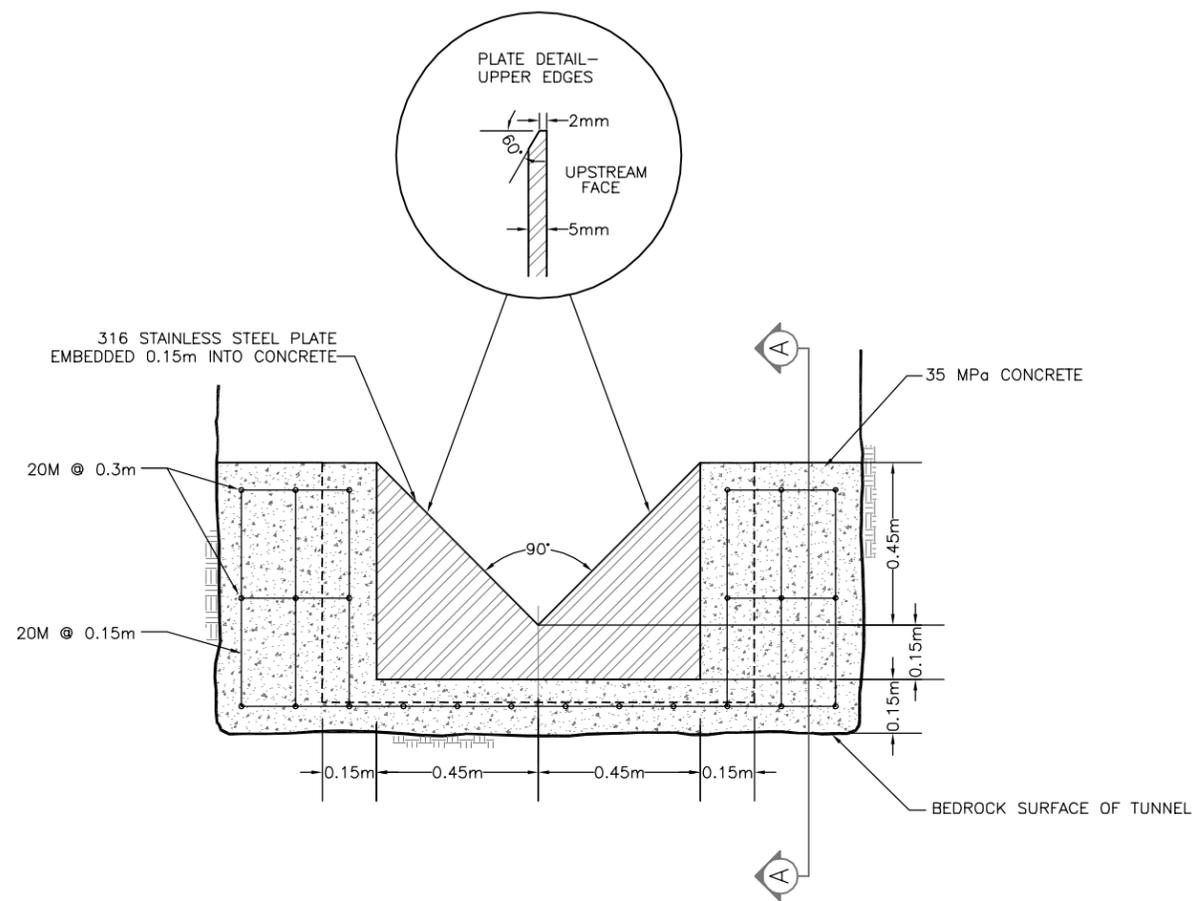
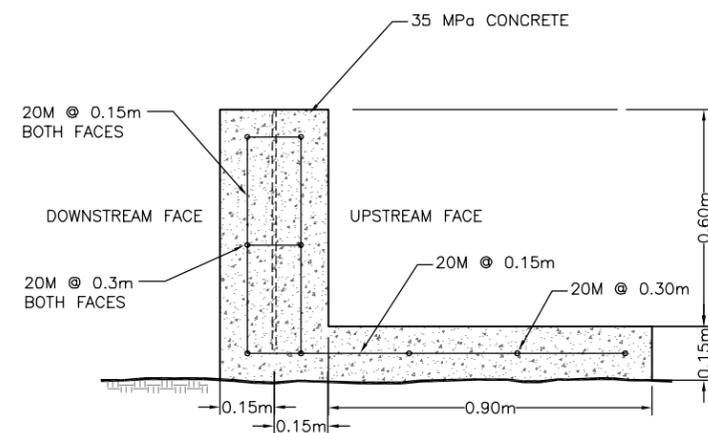
<b>Yukon</b> Energy, Mines and Resources	Bulkhead Details		
		SRK JOB NO.: 1CY001.003	Mt. Nansen	
FILE NAME: Figure 3.dwg			APPROVED:	FIGURE: 3

Figure 3 shows the recommend design for the reinforced concrete bulkhead. The following specific recommendations provide further detail:

1. The bulkhead should be located approximately 30 m from the portal.
2. The bulkhead should be constructed of re-inforced concrete a minimum of approximately 50 cm thick, with shear pins to prevent movement.

3. Prior to forming the bulkhead, the rock surface would be treated with a penetrating grout to reduce the permeability of the rock in the vicinity of the bulkhead. In addition, an expansive waterproofing agent would be placed at the upstream edge of the concrete/rock contact; which will tend to reduce the permeability of the contact as water pressure rises.

4. The concrete should be sulphate-resisting low air-content Portland cement.
5. After pouring of the bulkhead, the concrete-rock contact at the roof would be treated with penetrating grout to seal any gap that may have opened due to settling of the concrete and to fill any high points which may have not been effectively sealed with concrete.

6. The bulkhead should include a pipe to facilitate drainage of water should that ever be necessary.

ELEVATION  
1:20

SECTION A  
1:20

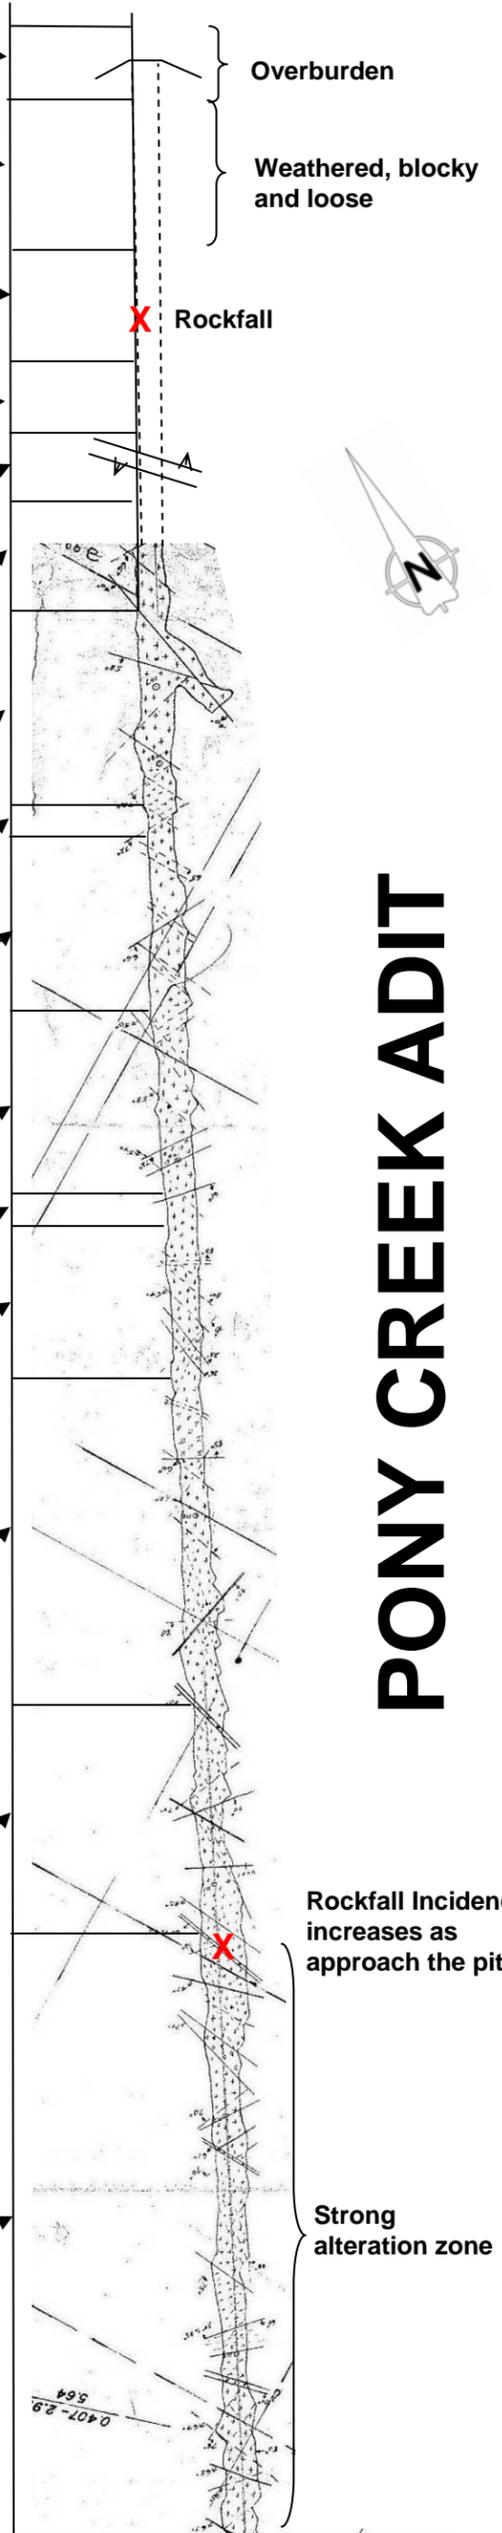
PROJECT: 1CY001.003	DATE: March 2006	APPROVED:	FIGURE: 1
------------------------	---------------------	-----------	--------------

5.0	15.0		Weathered, blocky, loose, overburden area was dripping water.	
15.0	23.0		Heavily jointed, weak structures dipping towards the pit, sub-parallel to the pit (50°/245°) and other features to the northwest (60°/280°) The rock strength is higher as the material is less weathered, but there are still some large weak areas as indicated by the sidewall failure at approximately 20.0m. Some of the large structural features have altered walls of 2 - 15 cm.	Resupport work will be required before contractors can access this area.

23.0	27.0		This area is slightly more jointed and the sidewalls are more damaged by the same larger structures as in the previous zone.	Resupport work will be required before contractors can access this area.

31.0	39.0		More discontinuity features, but the ground conditions are still reasonable. Structural features are more altered. At 39m a strong structural feature is coming through (50°/285°); 0.15m commutated shear zone, some quartz fill, weak altered rock adjacent to this.

39.0	51.0		The rockmass becomes more altered (slightly, 10 - 20%) and disturbed over this length.	
51.0	53.0		A more mafic band 25°/250° - adit direction at 245°. Reasonable ground conditions with RMR's of approximately 55 - 65 and a fracture frequency of 1.0 - 2.0/m

Not Recommended Area  
 Recommended Area

Geotechnical Conditions Within the Pony Creek Adit

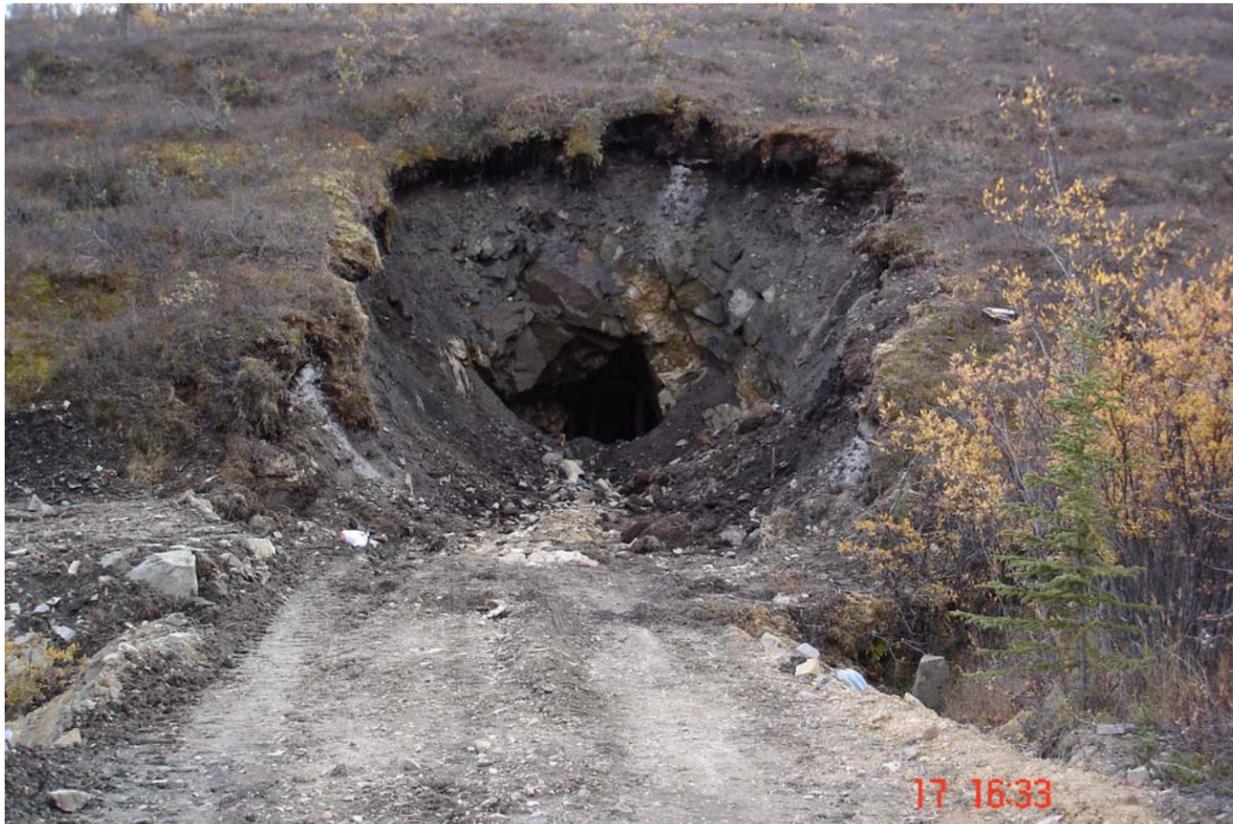
Photos 1: Pony Creek portal overview

The current portal area has been loaded out until a relatively stable rock face was achieved and the overburden material stopped failing.

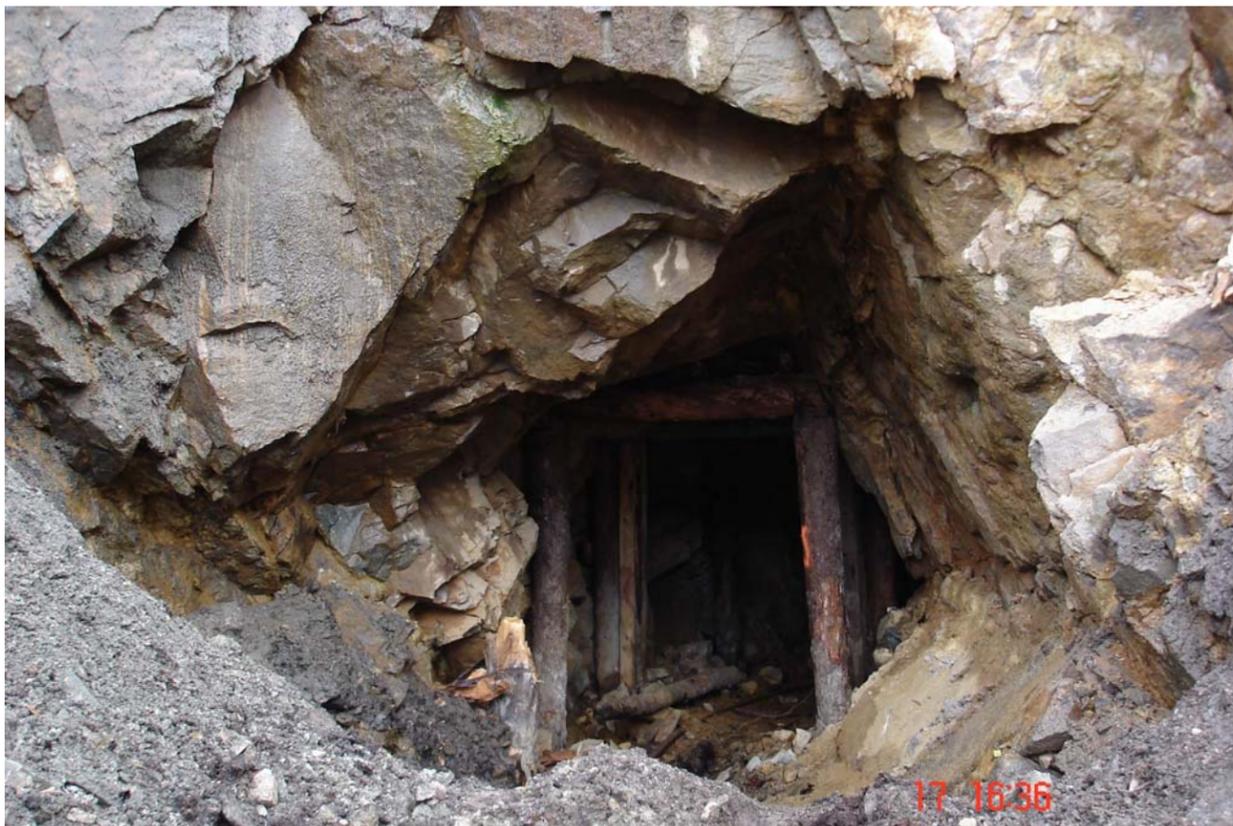
Photo 2: Portal close-up ground conditions

The overburden material above the portal will need to be scraped back to remove the currently overhanging soil/vegetation brow. This work could be undertaken with a backhoe.

Once the portal face area has been further cleaned by the backhoe, the face area will need to be inspected and barred by a competent person. Based on the assessment of the competent person, some limited spot bolting and mesh will be required to secure the rock face area. Additional timber sets will need to be installed in the immediate entrance of the portal.

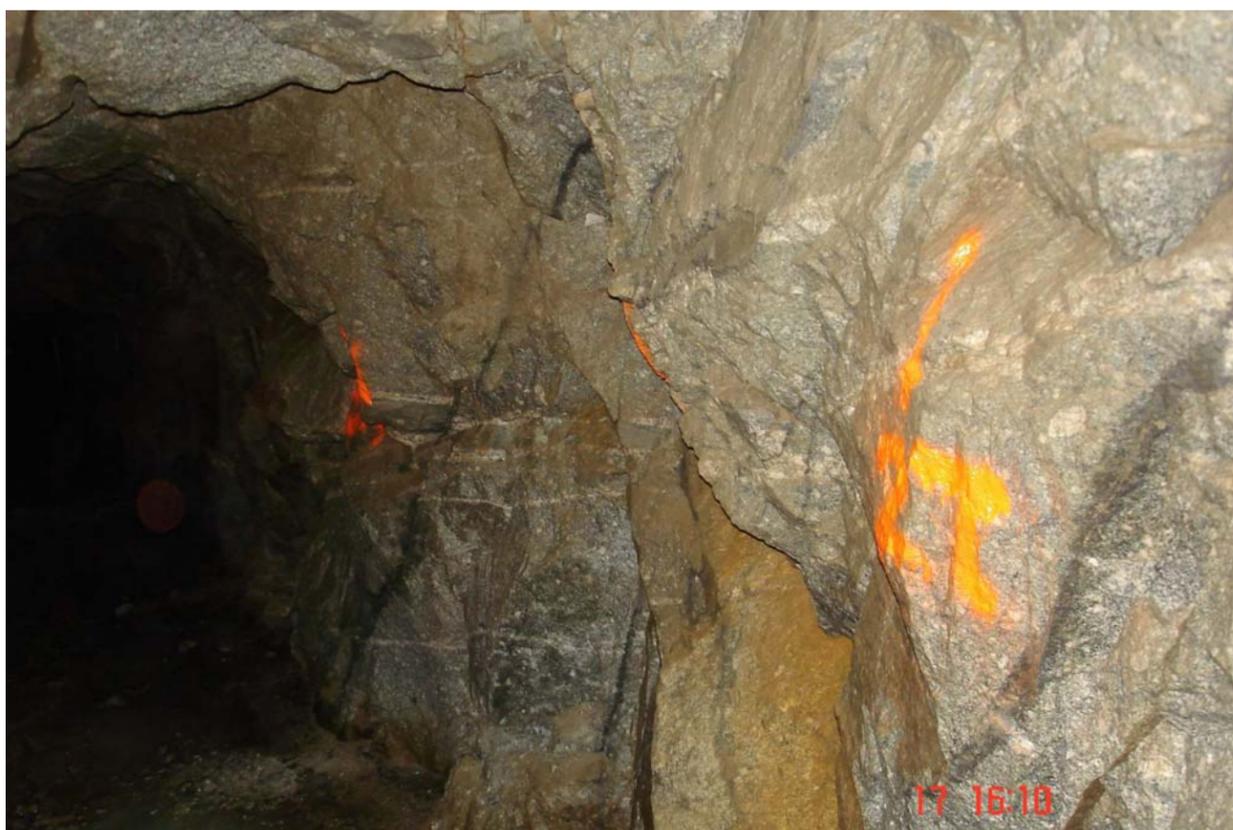
Photo 5: Rockmass conditions of North sidewall at 27 to 31m area

Distance from portal (m)	Rock Condition	Comments
27 – 31	Competent in this interval only, strongly jointed d/s of location Uncertain extent/geometry of competent rock extending into walls, floor and roof of adit Low confining pressure – joints may be open	easier construction due to proximity to portal concern for ice infilling in fractures due to shallow rock cover very short interval of quality rock
95 - 110	rock is fractured and altered, alteration may reduce permeability of fractures	this location may be in alteration halo of ore zone, leading to a reduced risk of seepage by-pass as the fractures appear to have more infilling

In the area of the bulkhead construction 27.0 – 31.0 m the level of bolting support should then be increased to a systematic pattern of 1.2 x 1.2 m on the tunnel back and upper sidewall. This requirement is based on the fact that this will be a high activity area and substantial drilling will be undertaken for the installation of shear pins, as part of the bulkhead design. In the immediate vicinity of the bulkhead (3 m upstream and downstream of the approximate location) only fully grouted rock bolts should be used so that connectivity between rock fractures is not increased.

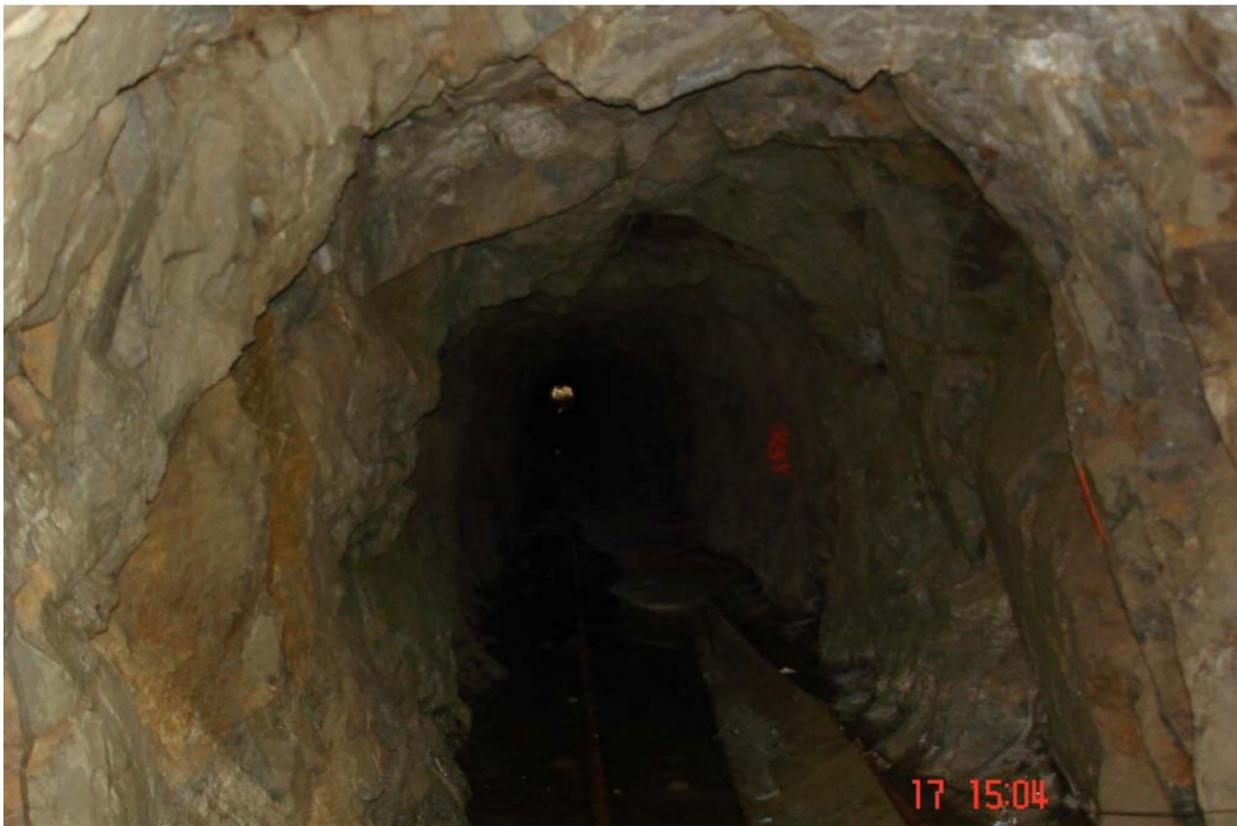
Photo 8: Rockmass conditions at 75m – View towards the pit

65.0	77.0	75.0	Ground conditions are generally Fair with some weak zones related to the more prominent structural features. Very strong feature coming through	65.0 - 70.0m the rockmass conditions are reasonable, a possible bulkhead location position. Increased support and remediation requirements.

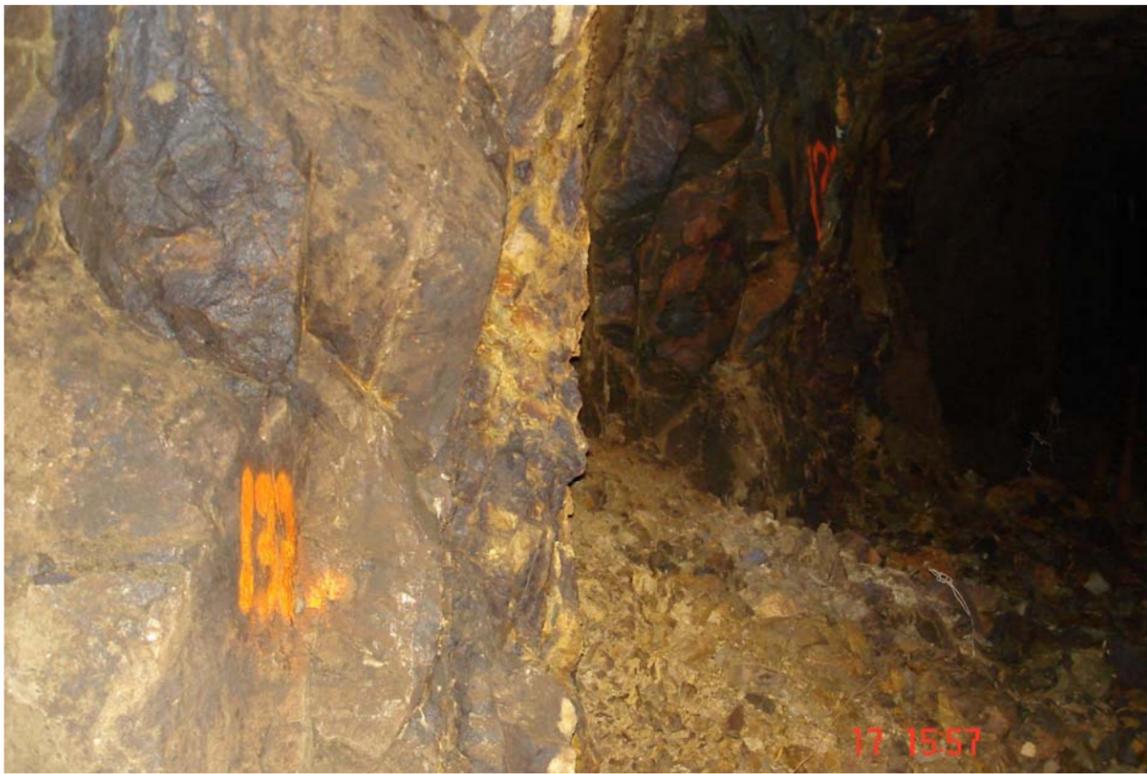
Photo 16: Rockmass poor at 132m

132.0	A large altered structure crosses through the drift, which is very weak and weathered, 58°/293°.	
		154.5	A strong structure is intersected by the adit. The rockmass condition after this point are weak and loose, with multiple falls on the ground. These poor ground conditions are related to the increased levels of alteration and shake-up due to blasting as a result of the close proximity to the pit.	
	165 m		End of adit

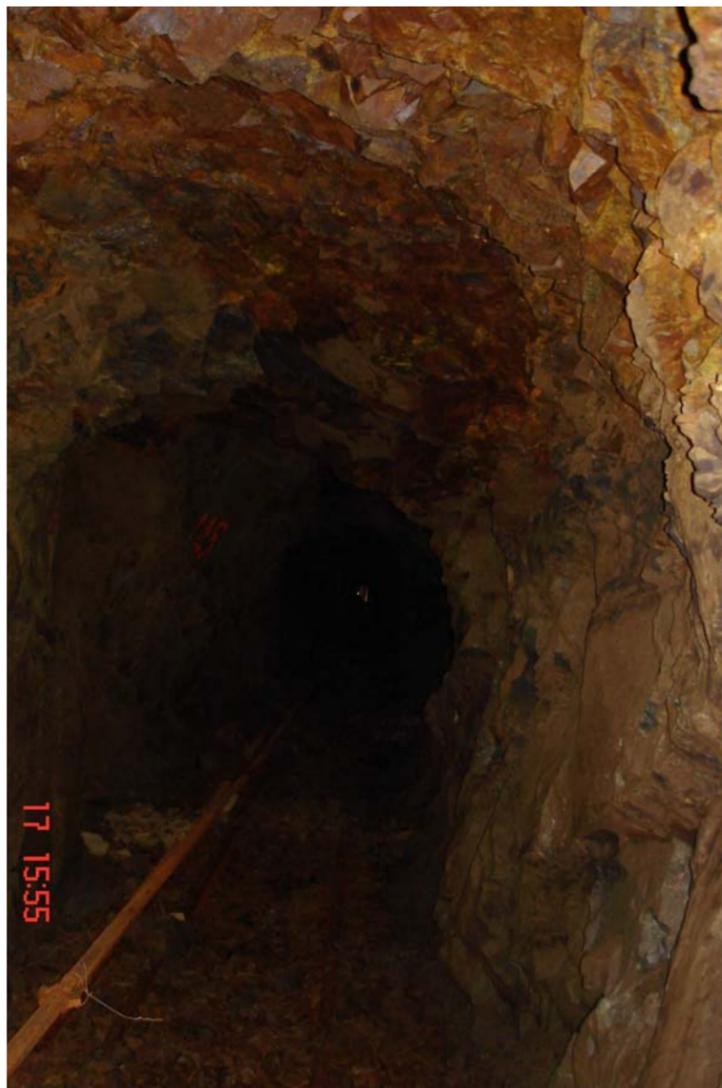
Photo 17: Rockmass poor at 145m – View towards the portal

125.0	165.0		Level of alteration increases substantially. Oxidation levels are intense. The weak zones are up to 0.5 m thick. The number of falls of ground noted, from the back increases.

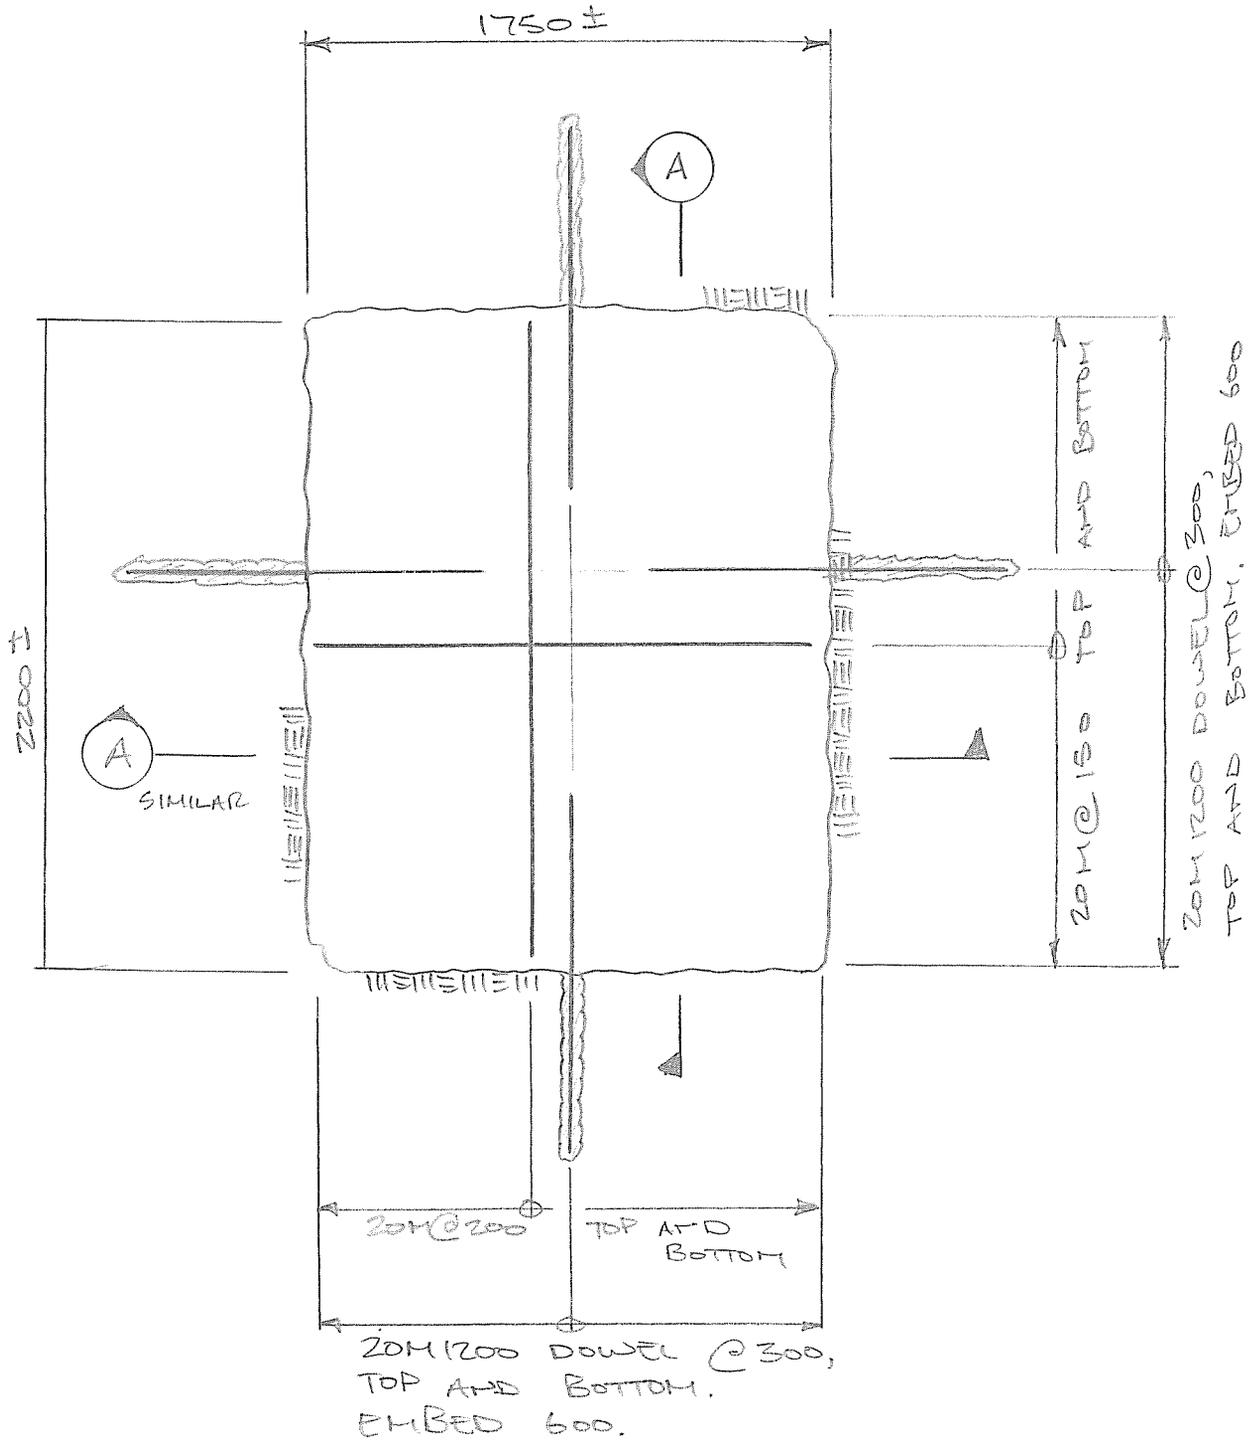
ELEVATION

Project	PAPA CREEK ADIT	By	RAM	Date	FEB/06	Page	1	of	
Subject	BULKHEAD SKI	Ckd		Date		Job No.	06029
