# Pony Creek Adit Bulkhead, Mt Nansen, Yukon

# **Pony Creek Adit Bulkhead, Mt Nansen, Yukon**

**SRK Project Number 1CY001.03**

Appendix A:	Geotechnical Inspection SRK, September 16, 2005
Appendix B:	Bulkhead Design Westmar Consultants Inc., February 2006

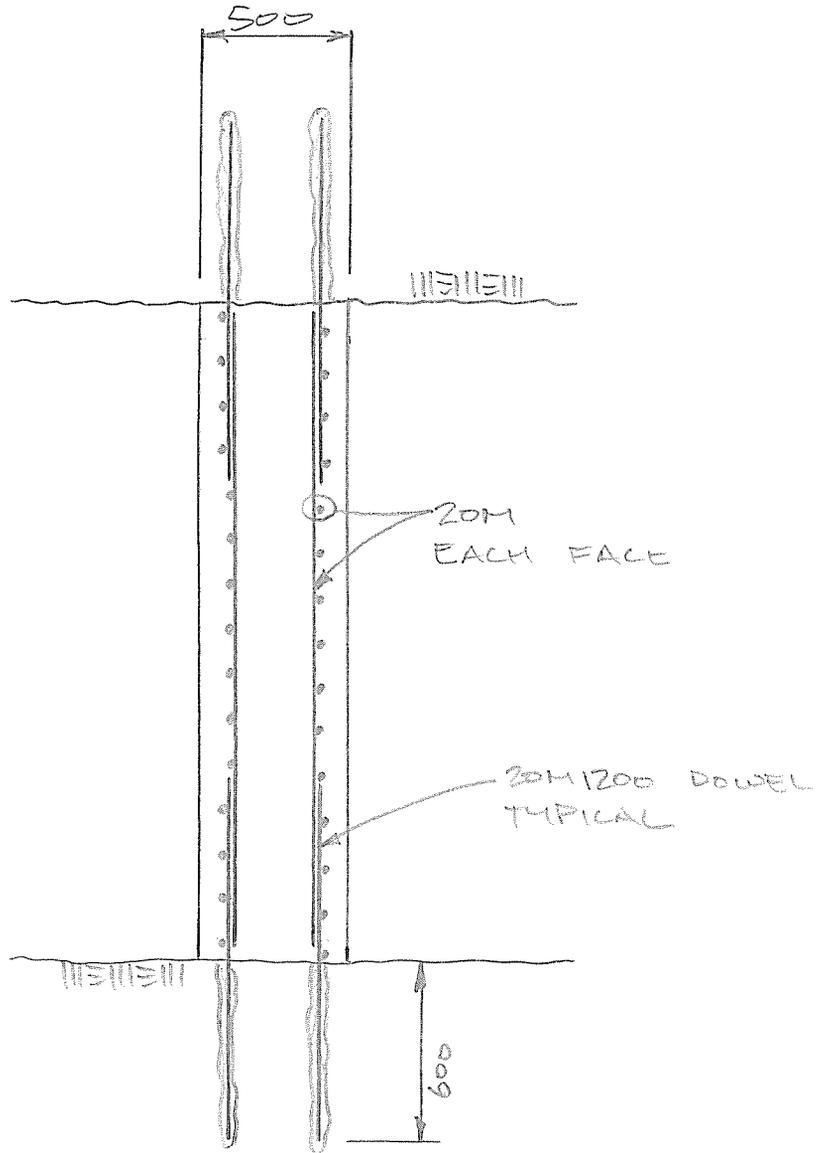
SECTION A

Project POWY CREEK ADIT	By RAM	Date FEB/06	Page 2 of
Subject BULKHEAD SKZ	Ckd	Date	Job No. 06029
