Project Description

Abandoned Clinton Creek Asbestos Mine

Creek Channel Stabilization

Prepared by:
Indian and Northern Affairs Canada
Northern Affairs Program, Yukon Region
Renewable Resources
Waste Management Program
August 2002

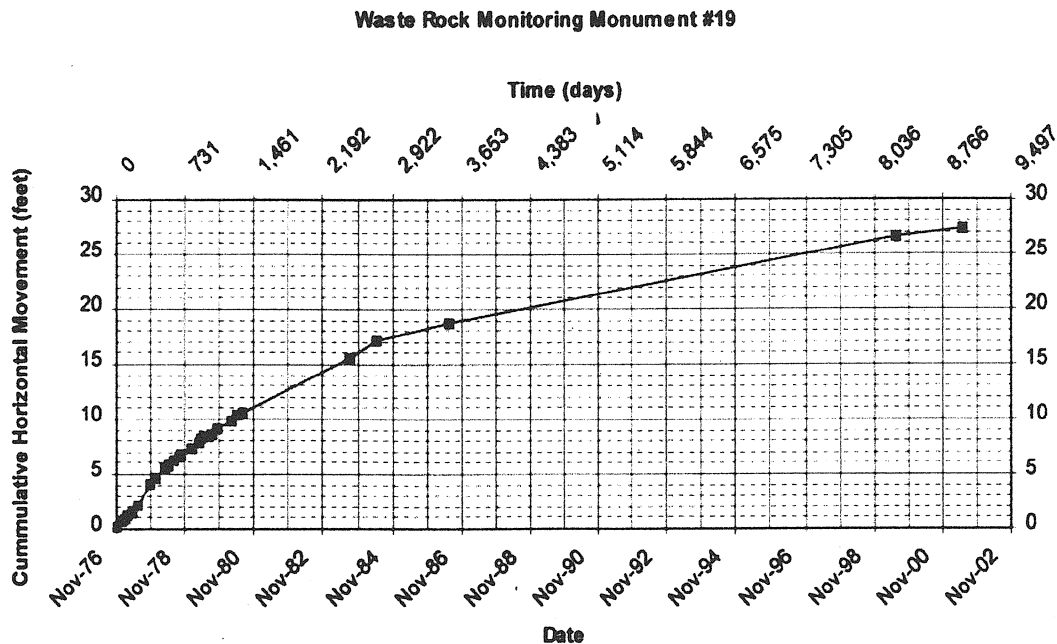
Horizontal movements over time are summarized in Figure 2.

Figure 2: Waste Rock Dump Movements (UMA Engineering Ltd., 2002)

Over the two year period from July 1999 to June 2001, annual horizontal movements ranging from one to eleven centimetres, or an average annual rate of seven centimetres were observed. Over the same time period, the average rate of vertical settlement appears to be in the order of seven centimetres. The movements confirm previous observations that waste rock pile movements are small (in comparison to movements prior to 1986) and may be referred to as creep movements.

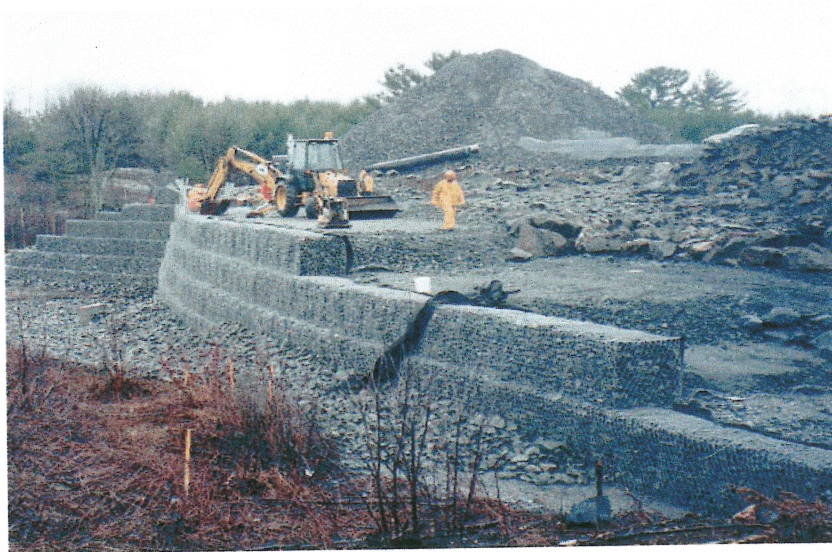
The recommended channel stabilization work involves flattening of the channel grade through the use of gabion drop structures (see **Photograph 1**). Gabion structures are preferred over rigid structures because of their flexibility that allows them to undergo deformation while remaining structurally sound, which is an important consideration given the observed creep movements of the waste rock. Gabion structures are simple to construct with conventional construction equipment, using material available at the mine site. The only materials requiring transportation over a long distance are the gabion baskets and geotextile.

Photograph 1: Gabion Structures - Example

The drop structures would be constructed from 0.5 x 1.0 x 3.0 m gabion baskets placed empty on a geotextile, above gravel bedding. The baskets are tied together with wire and will be machine filled with cobbles. The gabions are placed as steps, which provides energy dissipation between each step as the water travels through the structure. The weir at the top of the structure creates a constriction that reduces the water surface draw-down immediately upstream of the structure to control the channel flow velocity along that length of channel. An end sill prevents a floor jet during high discharges (see Figures 5a and 5b). Using as many 0.5 m steps as required creates the desired hydraulic drop of approximately 35 m over the entire stabilized channel.

As the weir and end sill are made of gabions, a part of the channel flow will pass through the gabions rather than over them. As a result, neither the weir nor the end sill will cause any significant ponding of water. In fact, during low flows, the water surface may be below the top of the gabions i.e. between the cobbles. Because there will be a small flow of water through the gabions most of the time, it is important that the gabions sit on a geotextile and gravel bedding layer to prevent the loss of fine grained material below the baskets. Some sand and gravel will be washed through the channel, in particular during spring runoff. The finer material will become trapped between the cobbles in the gabion baskets further stabilizing the structure.
