**PROJECT DESCRIPTION
ABANDONED CLINTON CREEK ASBESTOS MINE**

**STAGE 2 (2003) CLINTON CREEK
CHANNEL STABILIZATION**

**Submitted by:
Government of Yukon
Energy, Mines and Resources
Abandoned Mines Project Office**

May 2003

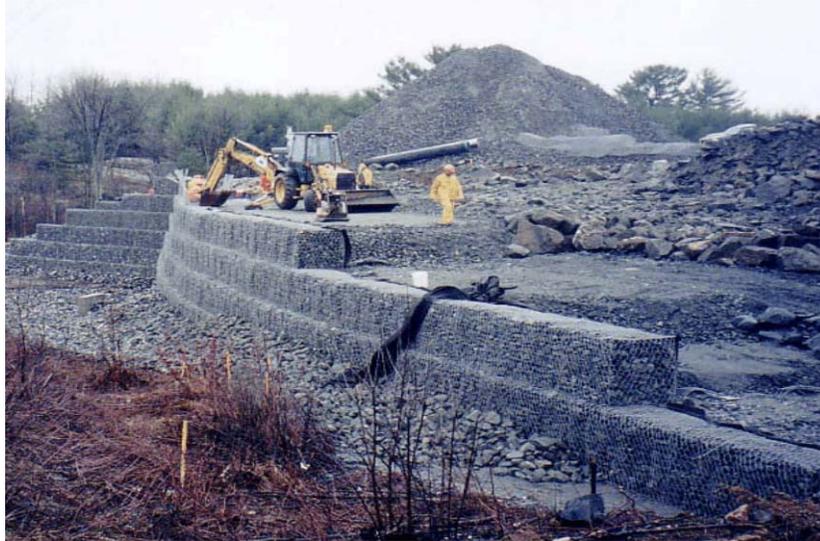
Photograph 1: Gabion Structure

The recommended channel stabilization work involves flattening of the channel grade through the use of gabion drop structures (see **Photograph 1**). Gabion structures are preferred over rigid structures because of their flexibility that allows them to undergo deformation while remaining structurally sound, which is an important consideration given the observed creep movements of the waste rock. Gabion structures are simple to construct with conventional construction equipment, using material available at the mine site. The only materials requiring transportation over a long distance are the gabion baskets and geotextile.

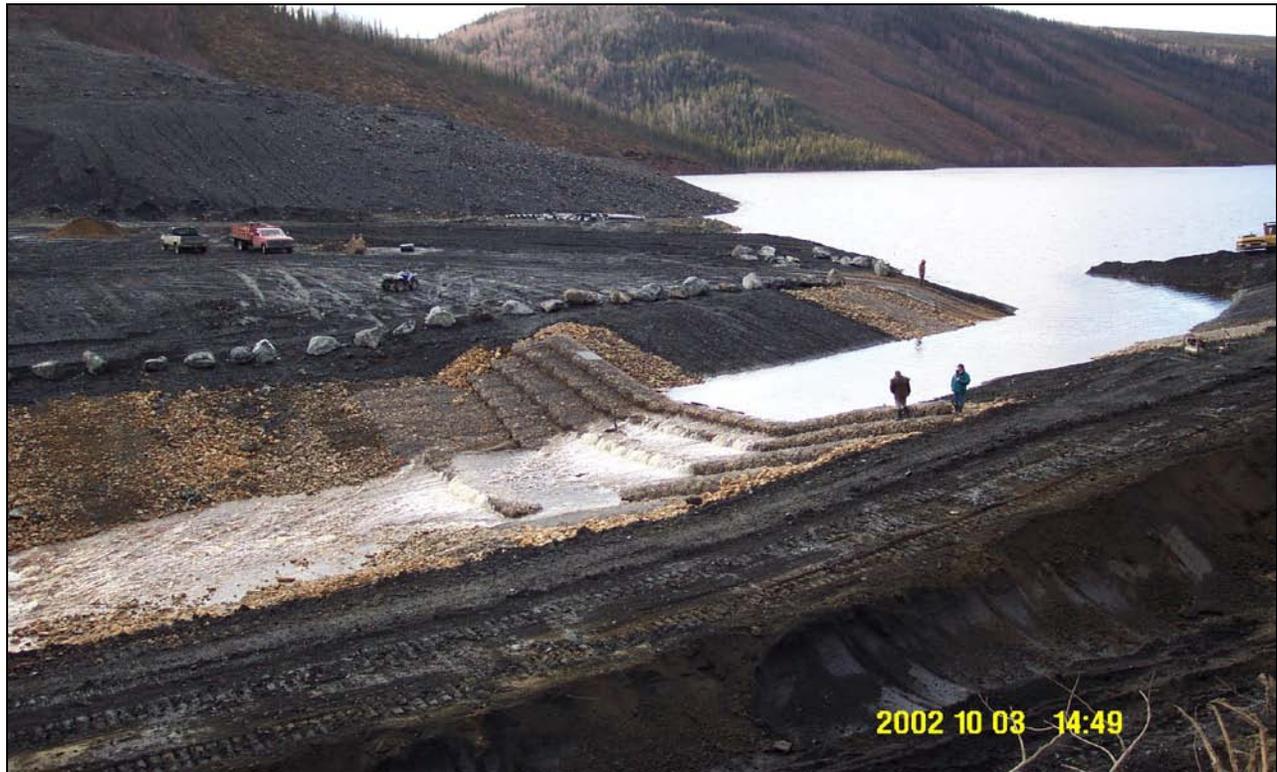
Photograph 1: Completed drop structure at outlet of Hudgeon Lake (UMA, 2002)

Another problem encountered was seepage from the toe of the waste rock pile at the lower level of the drop structure. This problem was overcome by building a granular blanket drain under the floor of the lower level of the drop structure.

The construction of the first gabion structure and re-shaping of the lake outlet took place between August 28 and October 4, 2002. The general construction events required to complete the work included:
