**PROJECT DESCRIPTION
ABANDONED CLINTON CREEK ASBESTOS MINE**

**STAGE 3 (2004) CLINTON CREEK
CHANNEL STABILIZATION**

**Submitted by:
Government of Yukon
Energy, Mines and Resources
Abandoned Mines Project Office**

January 2004

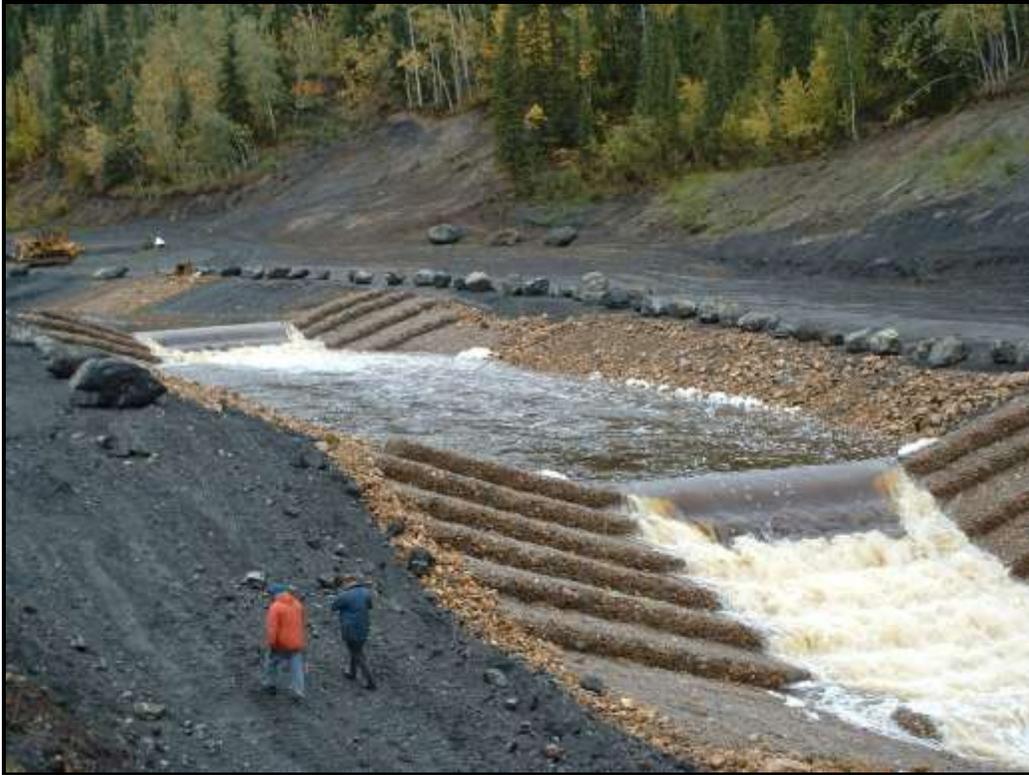
Figure 3: Clinton Creek Drop Structures 1&2 - High Flows September 2, 2003

It was planned that the remaining two drop structures would also be installed in 2003. Four days of heavy rainfall beginning on August 30 caused Hudgeon Lake to rise and the Clinton Creek flow approached spring freshet levels (see figure 3, High Flows)

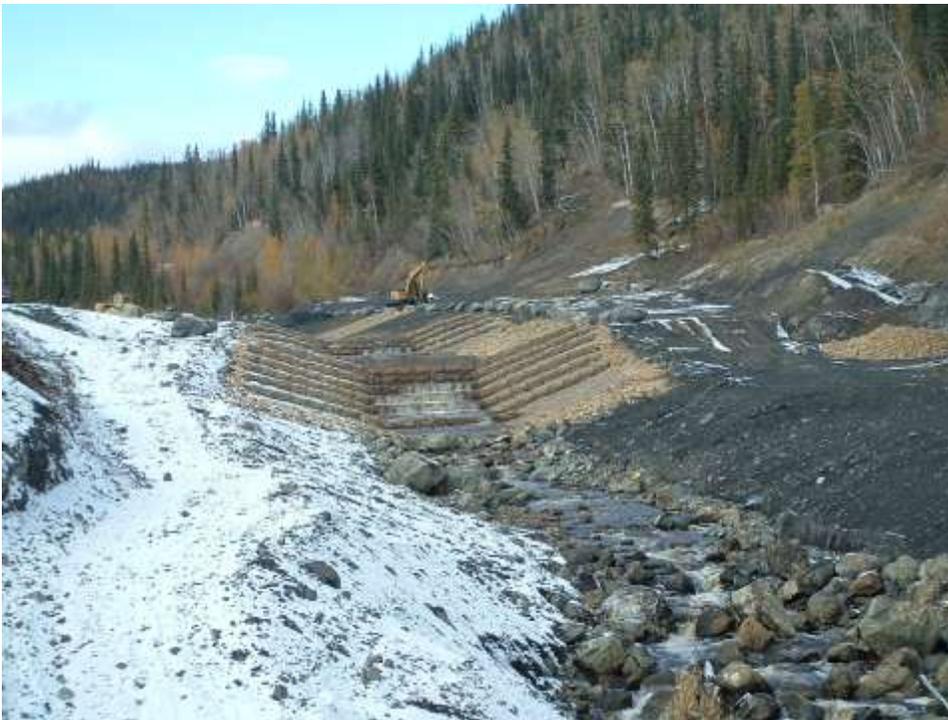
Figure 4: Clinton Creek Drop Structures 1&2 - Normal Flows September 22, 2003

Lake levels failed to drop fast enough to the minimum level where cofferdam installation would be feasible before the end of September. Due to an early onset of snow and cold weather in the third week of September construction of the remaining two structures was deferred until 2004 (see figure 4, Normal Flows).

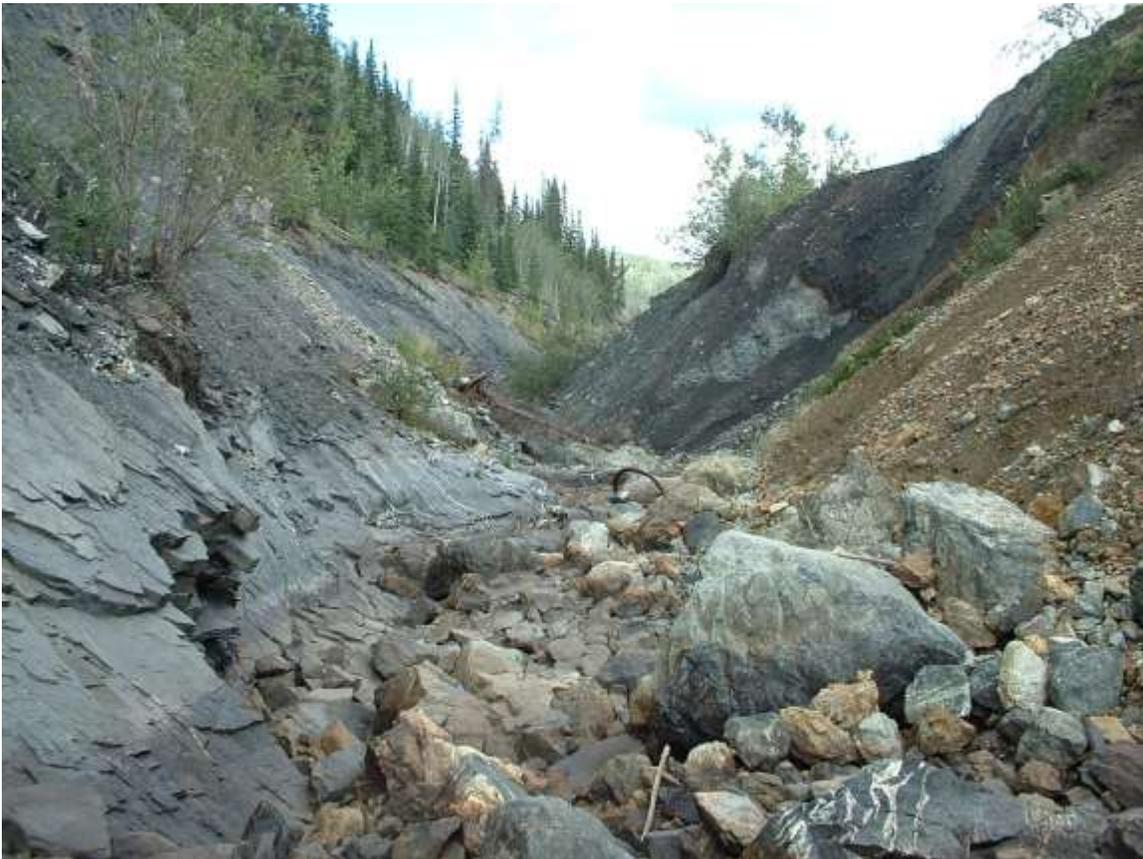
Figure 5: Clinton Creek Canyon, looking downstream

The Clinton Creek channel immediately downstream of the last proposed drop structure is underlain by bedrock (see figure 5, Clinton Ck. canyon). This contrasts with the very soft and erodible waste dump argillite underlaying the upper section of the creek below Hudgeon Lake where the drop structures are being installed. The final drop structure will tie into the bedrock, eliminating any sections of easily erodible material within Clinton Creek at the mine area.
