RE: HAUL ROAD TRANSMISSION LINE TO GROUND CLEARANCES

The previous engineering assessment of the 69 kV Over head system along Haul road had raised concerns with the line to ground clearances over the waste rock.

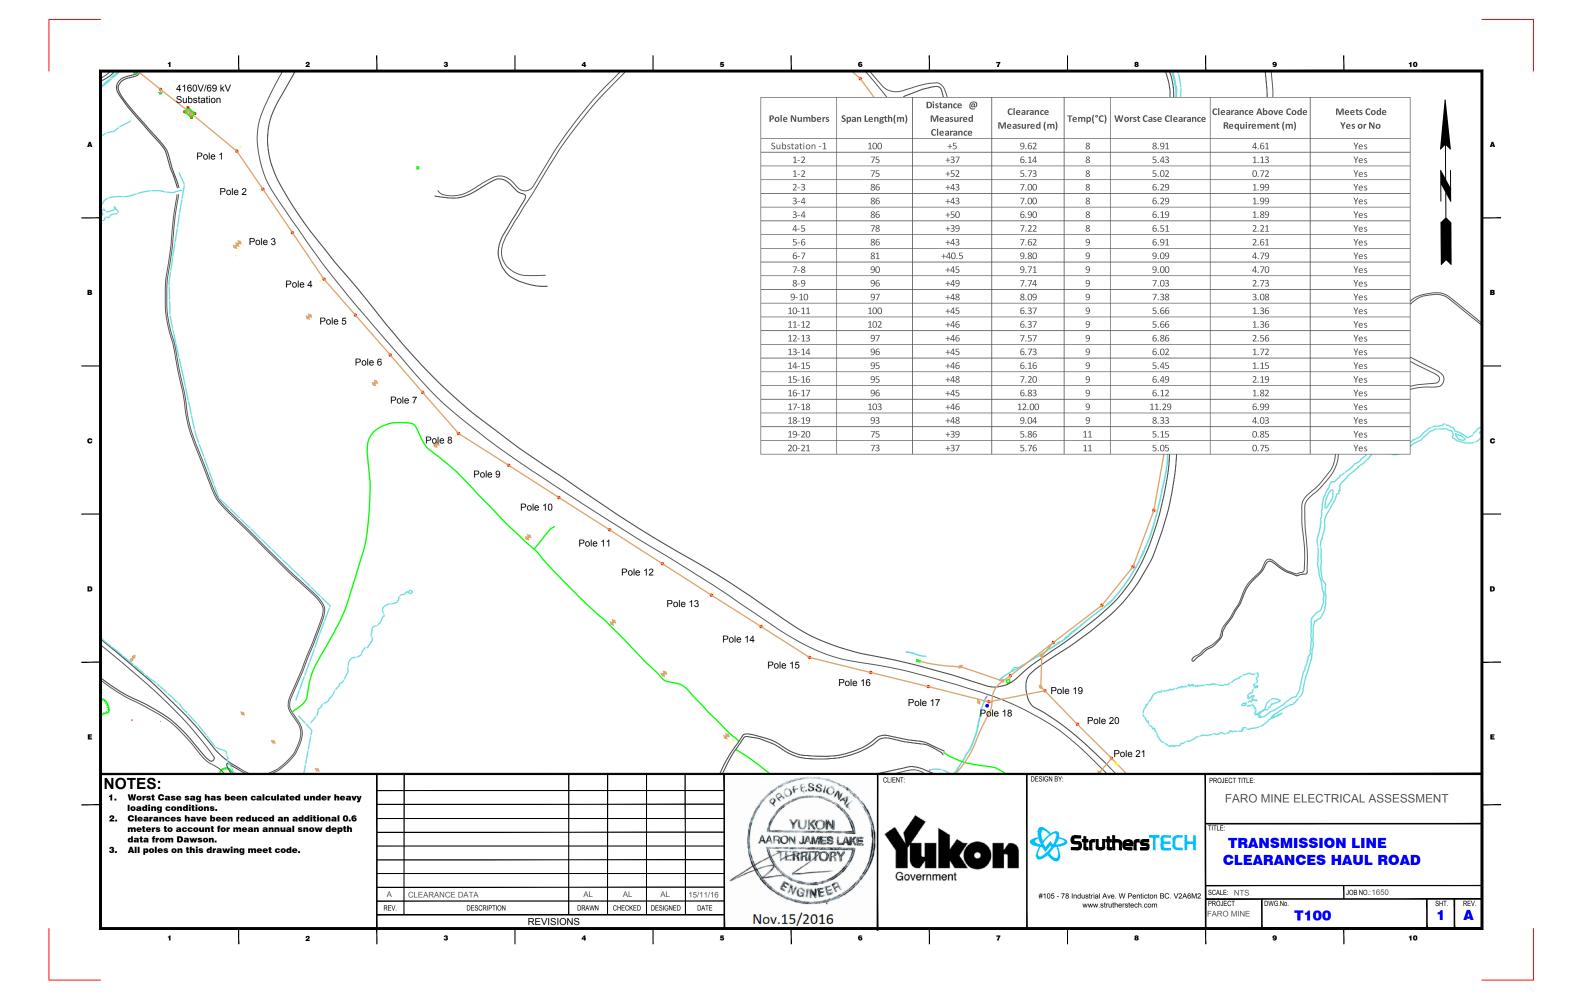
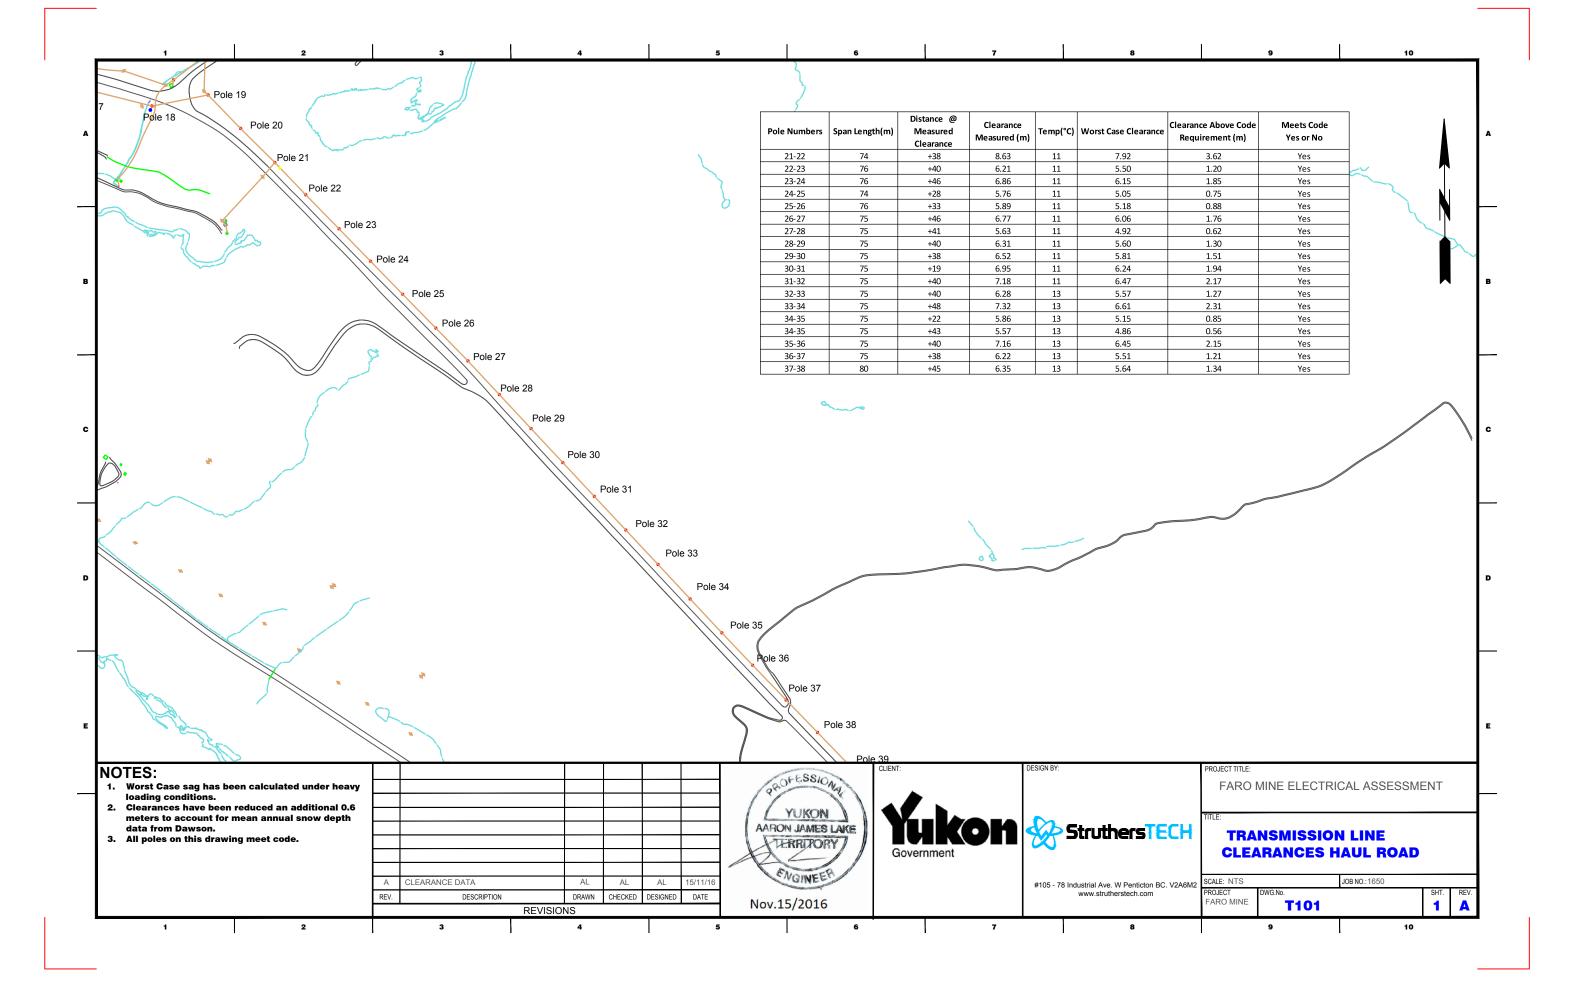
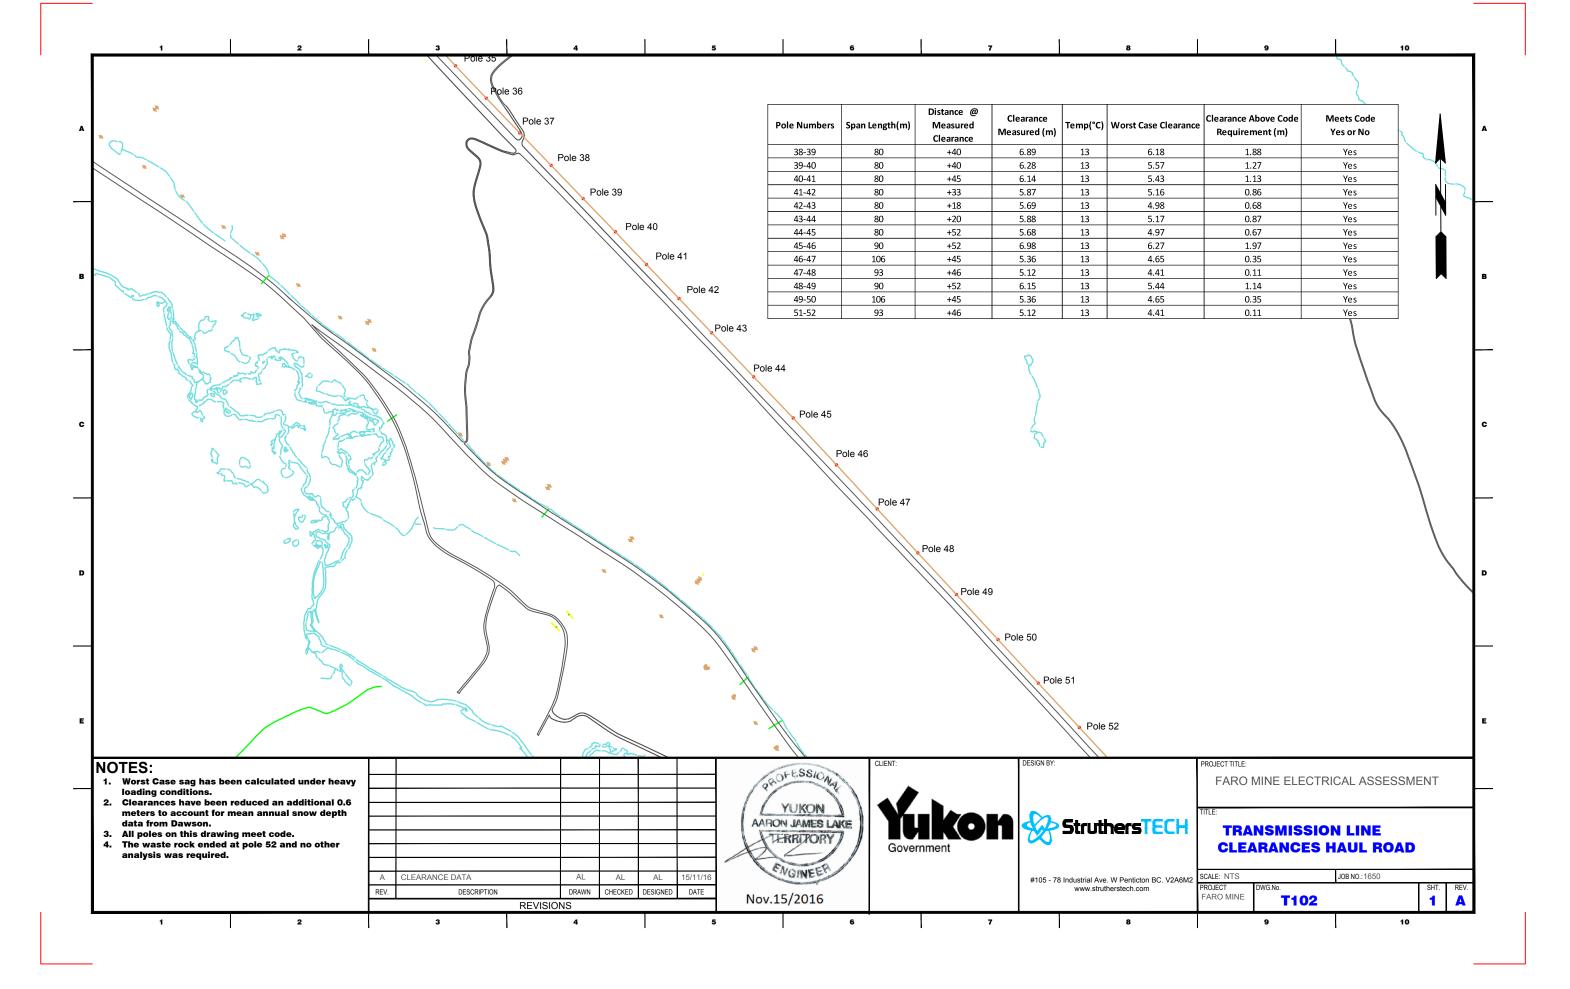
The drawings attached to this document have tables embedded in them with the clearance results for each span along the transmission line. Each column can be read as follows:

Pole Numbers: Corresponds to the span between poles along the transmission line.

Span Length: Length between the two poles mentioned in the previous column.

Distance @ Measured Clearance: Gives the distance at which the clearance was measured from the first pole in the span.

Clearance Measured: The field acquired measured clearance.

Temp: The ambient temperature (this is important factor in reverse engineering the data).

Worst Case Clearance: This is what the clearance will be with 0.5 inches of ice on the conductor, while exposed to winds speeds up to 93 km/hr (this is the heavy loading condition required in code).

Clearance Above Code Requirement: How much the worst-case clearance exceeds the pedestrian clearance with the addition of snow.

Meets Code: Simply yes or no. Shows there are no spans on the line that require upgrading.

For clarity, the poles in the drawings have been given numbers and overlaid with road boundaries and water outlines. Since the waste rock ended at pole 52, no further analysis was required.

The results show a few spans are within 0.5 meters of a code violation after worst case sag. We recommend taking no action on these spans because they still meet code and there is only a 0.3% chance of the heavy loading condition occurring over the next 15-years.
