FINAL REPORT

Government of Yukon Community Services, Land Development

Phase I Environmental Site Assessment Lot 519 and 520 Copper Ridge Whitehorse, Yukon

AE Project Number: 2022-8202.001

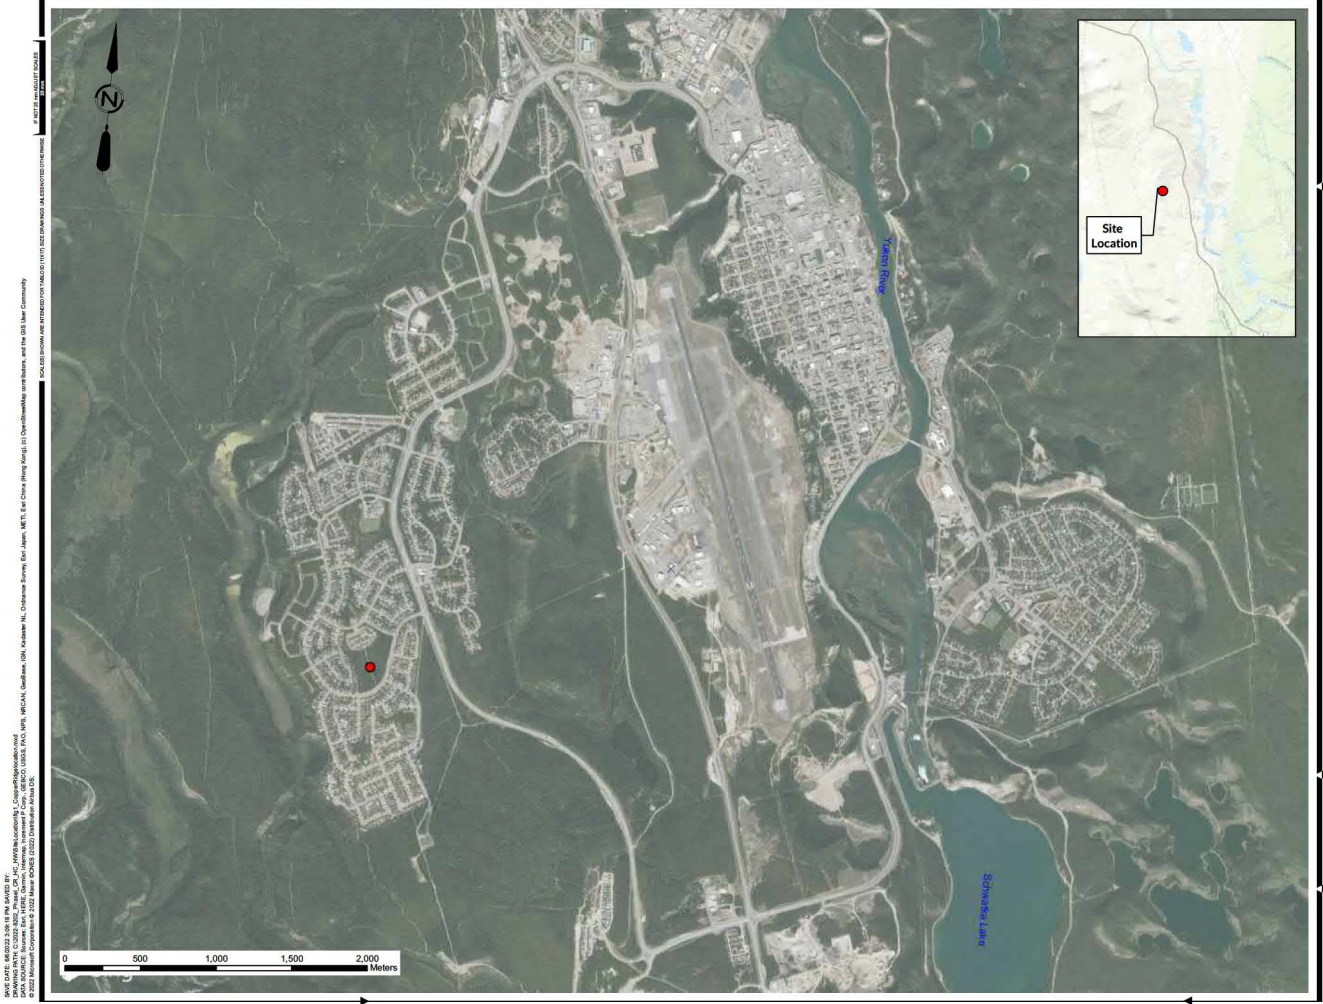
FIGURE 1
 PHASE I ESA'S COPPER RIDGE, HILLCREST AND
 HEMLOCK WHITEHORSE YT
 COPPER RIDGE SITE LOCATION

Figure 1: Subject Site Location

Associated Environmental Consultants Inc. (Associated) was retained by the Government of Yukon, Community Services Land Development Branch in May 2022 to conduct a Phase I Environmental Site Assessment (ESA) at two land parcels located at Lot 520 and Lot 519 in the Copper Ridge Subdivision of the City of Whitehorse, Yukon (the Subject Site) (Figure 1), to support the potential development of the Subject Site.

The Subject Site comprises two legal lots located in the Copper Ridge Subdivision of Whitehorse, Yukon Territory (Figure 1), one land parcel is zoned Public Services and the second is zoned Parks and Recreation (the City of Whitehorse. 2022) (Table 4-1).

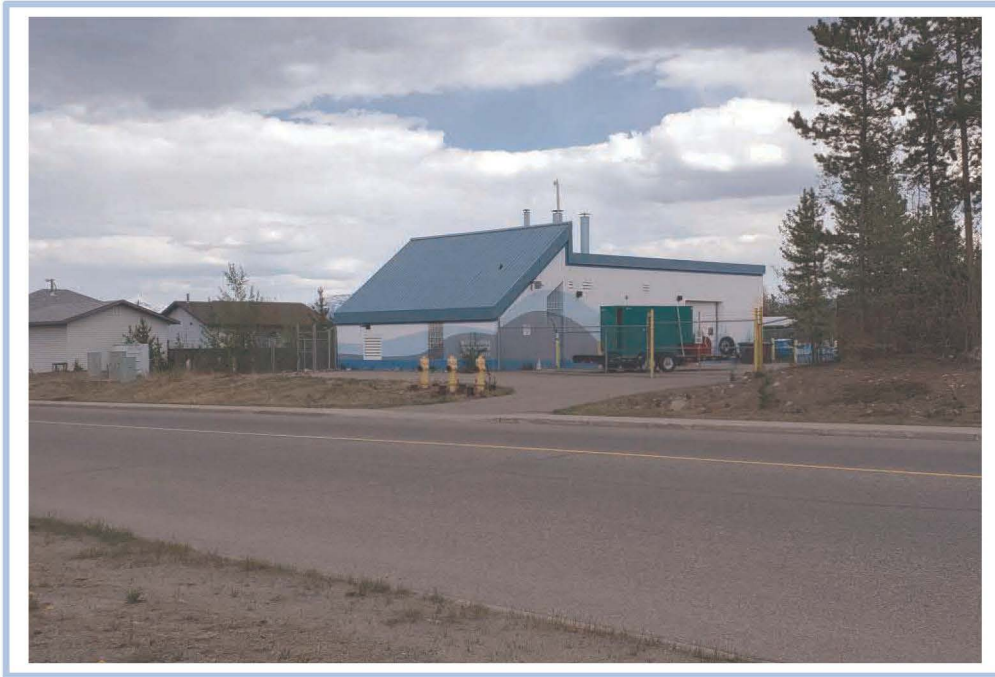
Photograph 1: Pump house located on Falcon Drive to the south of the Subject Site (looking southeast) (June 3, 2022).

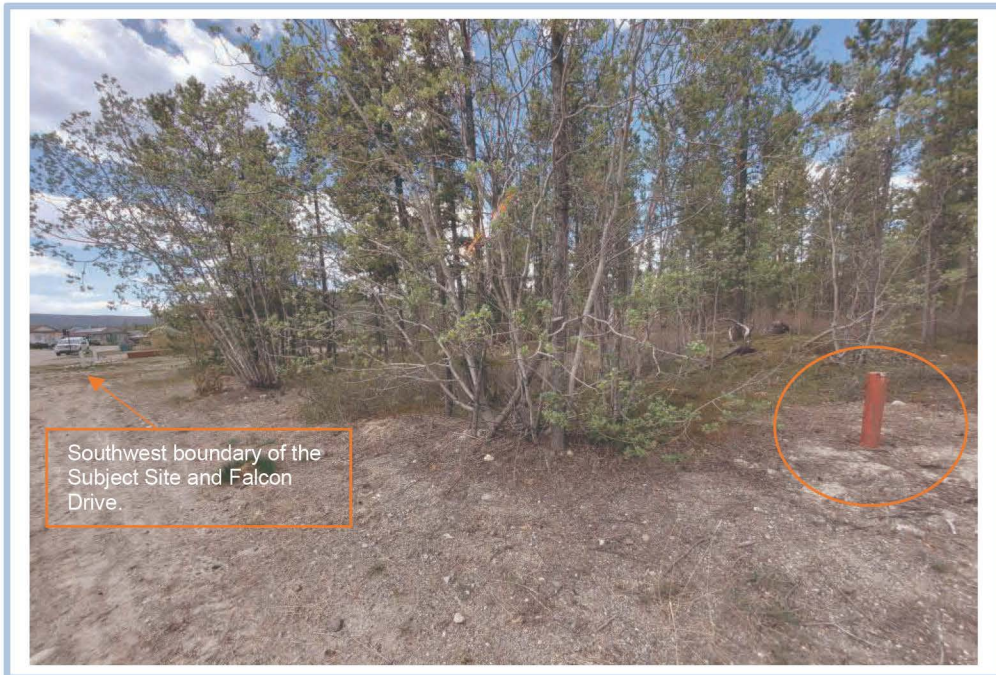
Photograph 2: a groundwater monitoring well (circled), was observed in the southwest of the Subject Site and close to Falcon Drive in the south. The well was locked. (June 3, 2022).

Groundwater wells	One groundwater monitoring well was observed the southwest of the Subject Site (on Lot 520), close to Falcon Drive (<i>photograph 2</i>).
Non-hazardous waste generation and handling	Waste is not being generated on the Subject Site.
Hazardous materials/chemical and fuel storage	None observed.
Drains/Sumps/Oil water separators	None observed.
Pits, lagoons	None observed.
Wastewater or other discharges	None observed.
Surface waterbodies, ditches or standing water	A rock pit was observed in the southwest corner of the Subject Site (on Lot 520) (<i>photograph 4</i>). The pit was dry at the time of the site visit. The pit receives and temporarily holds excess stormwater from adjacent residential properties, which infiltrates into the underlying soil.
Drainage	Surface water drainage is through infiltration into underlying soils.

An on-site groundwater well was observed in the southwest (on Lot 520). The well is not listed on the Water data catalogue (Government of Yukon. 2022d.) or the Groundwater water well registry (Government of Yukon. 2022b) however, based on discussions with the City of Whitehorse Water & Waste Services, it is understood that the well is used to assess local groundwater (flow and level monitoring) and the performance of the rock pit on Lot 520, which receives surface drainage from the residential properties to the west of the Subject Site. The City of Whitehorse advised that any future development on the Subject Site will need to consider surface water drainage and the incorporation of the monitoring well and rock pit located on Lot 520.

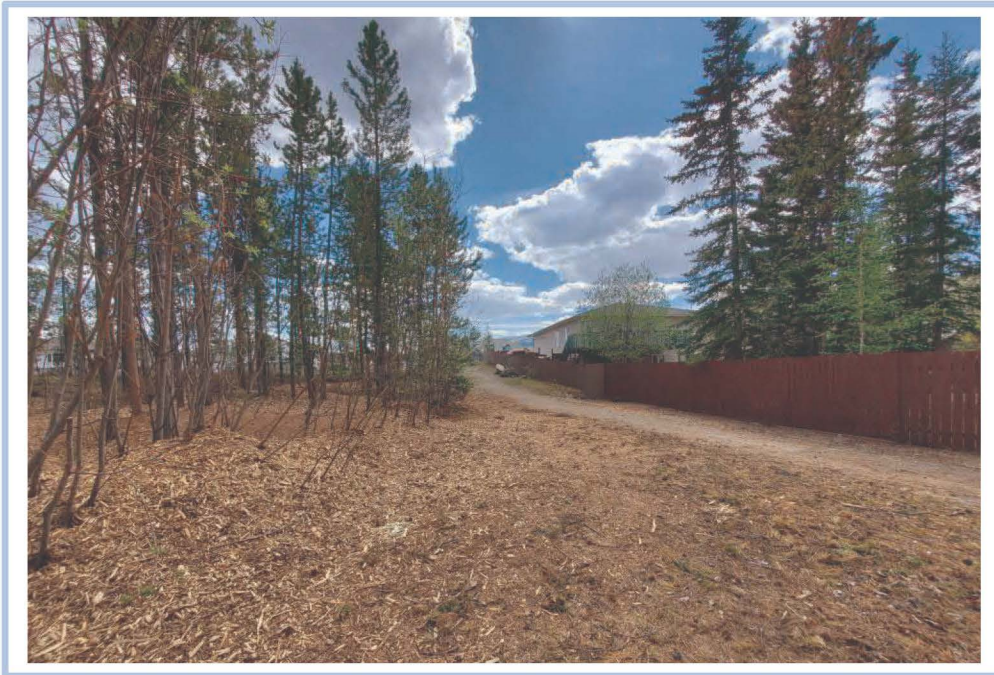
Photograph 3: a dirt trail in the west is used as a throughfare between Falcon Drive and residential buildings on Tigereye Crescent (June 3, 2022).

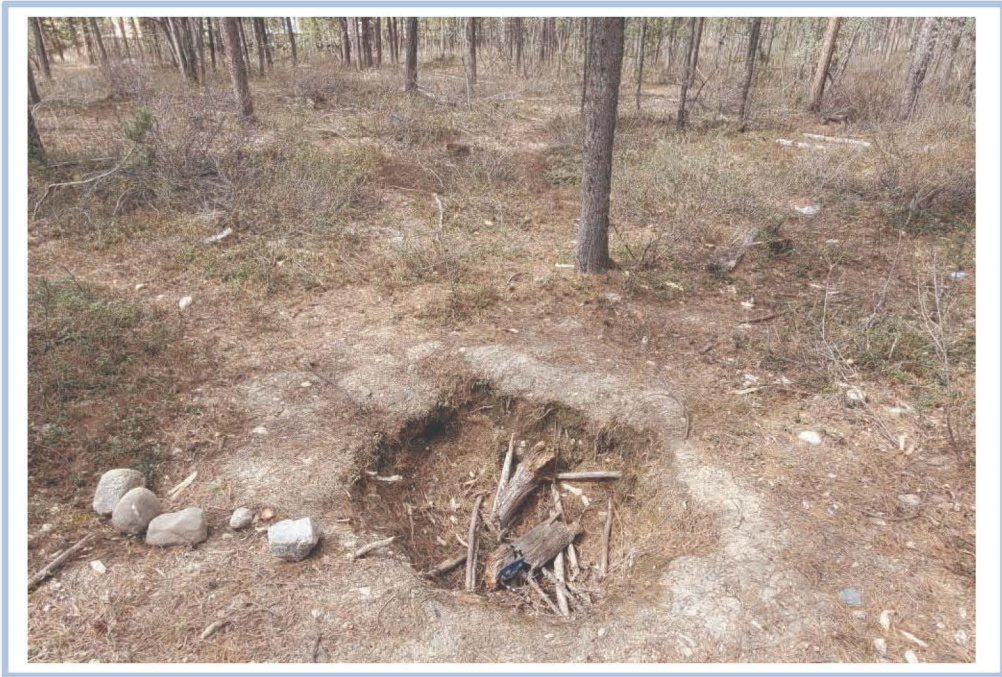
Photograph 7: fire pits were observed on the Subject Site (June 3, 2022).

Subject Site Grounds	Comments/Observations
Ground cover	Bare ground and vegetation, including mature trees (forested). Fire pits were observed (<i>photograph 7 and 8 (Appendix C)</i>).
Roads, Parking, Rights of Way	A thoroughfare dirt track is located between Falcon Drive to the south and Copper Ridge Place to the north (<i>photograph 5</i>). There are also several smaller dirt trails throughout, which are used for recreation and as thoroughfares.
Overhead and/or underground lines	Overhead and underground utility lines surround the Subject Site.
Potential noise sources	None identified at the time of the site visit.
Vegetation	Vegetation appears to be within seasonal norms.
Visual or olfactory signs of contamination	None observed.
Fill Materials	None observed.
Storage Tanks (aboveground or underground)	No evidence of ASTs or USTs.
Evidence of underground structures	No evidence of underground structures.

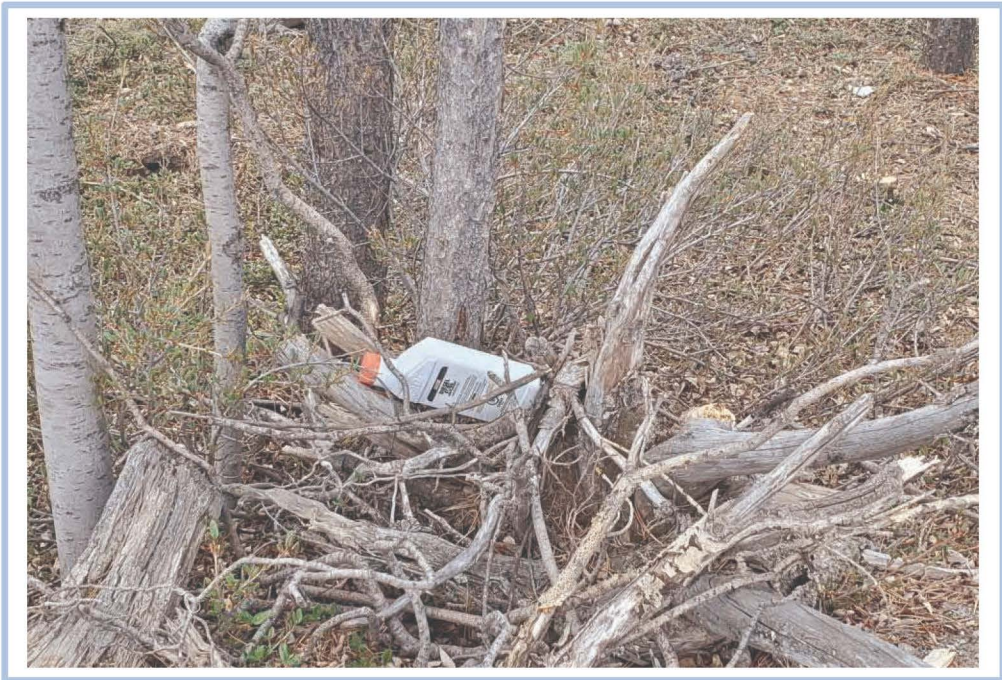
Photograph 8: empty diesel bottles – possibly used as a fire igniter (June 3, 2022).

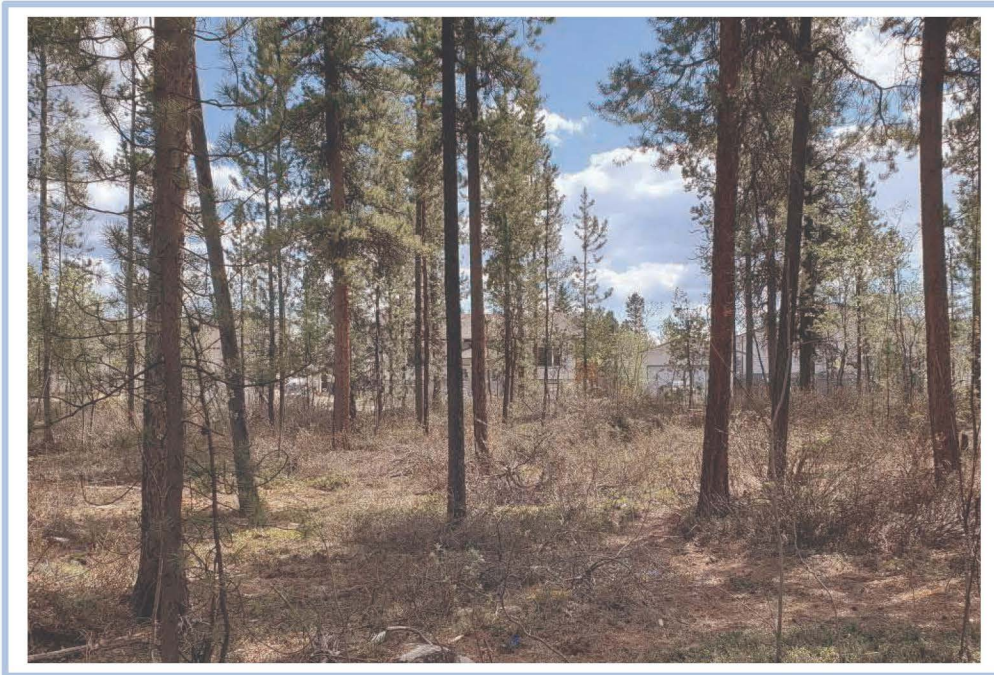
Photograph 9: residential properties located along the western boundary of the Subject Site (looking west) (June 3, 2022)

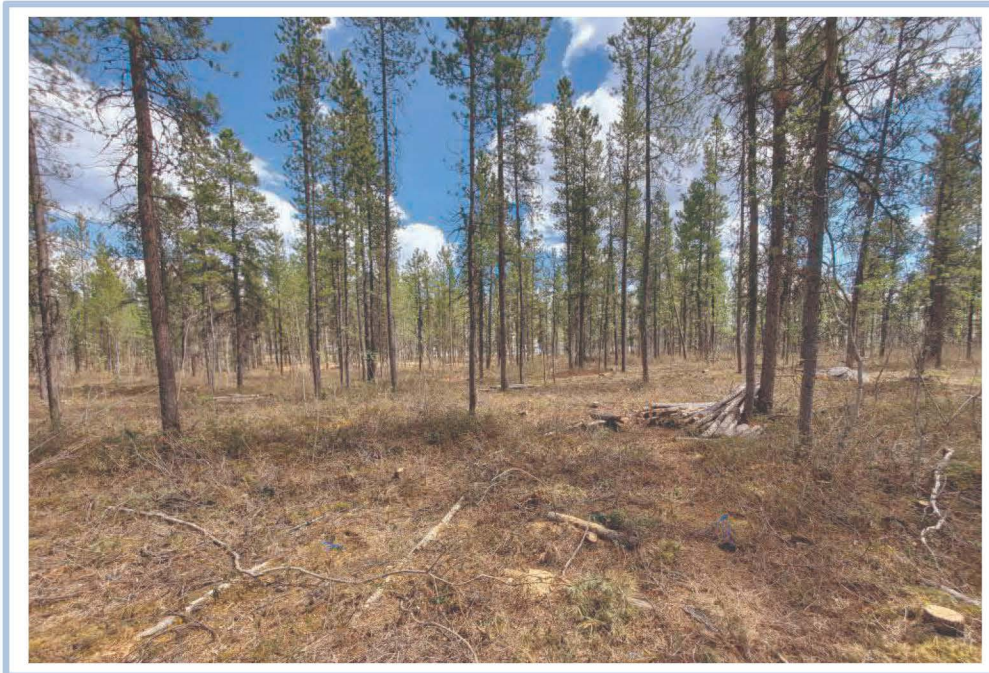
Photograph 10: areas have been cleared, with stacked log piles seen on the Subject Site (June 3, 2022)

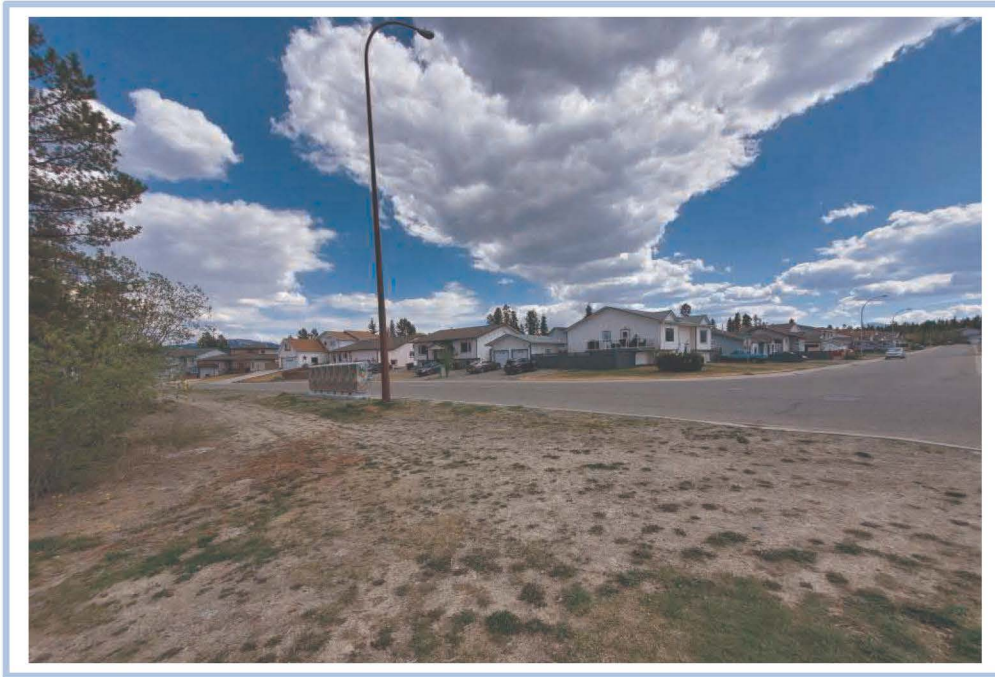
Photograph 11: Falcon Drive to the south, with residential buildings and Iron Horse Drive (looking southeast from the corner of the southwest Subject Site boundary) (June 3, 2022)

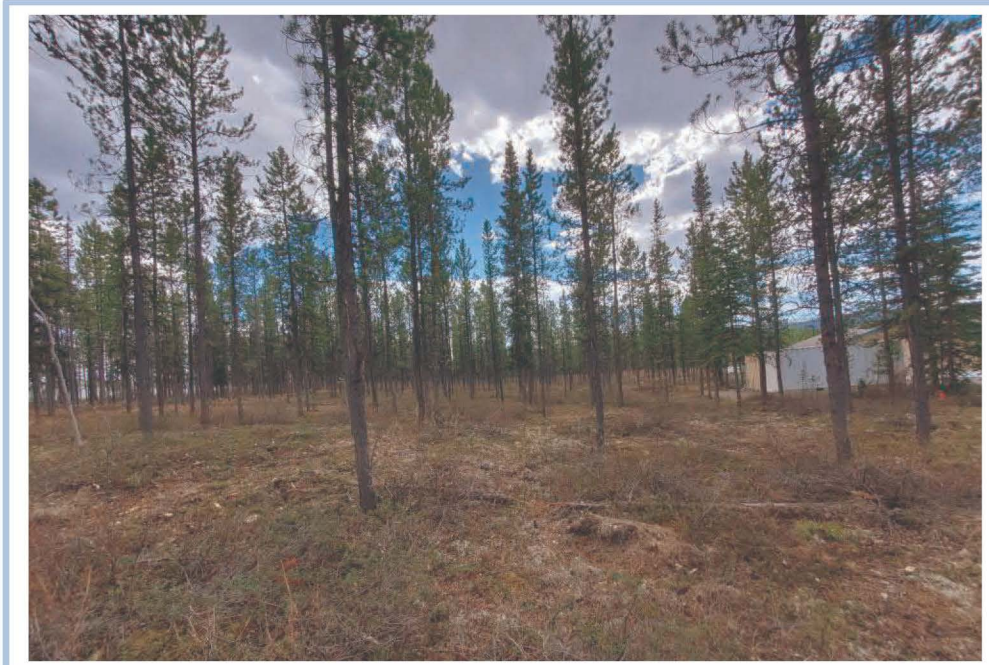
Photograph 12: view of the eastern portion of the Subject Site and Copper Ridge Place to the north (looking west from Diamond Way) (June 3, 2022)
