# Project Planning Guidelines for Permafrost Management in Old Crow

**Government of Yukon**

**Vuntut Gwitchin Government**

**Report No. 2100767.00**  
Date: March 30, 2022

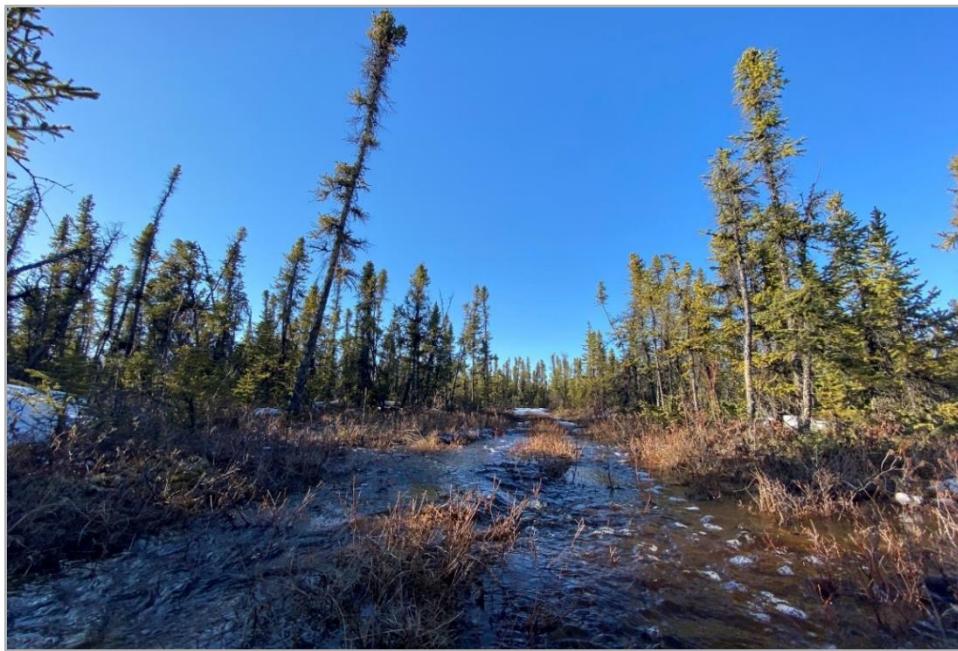
*Figure 6: Sheet Wash Pooling Along Cutline Along Crow Mountain. Photo Courtesy of Paul Josie.*

Seasonal flows measured in the Old Crow and Porcupine Rivers show maximum flow during the spring freshet (May and June), and during this time the community experiences downslope sheet wash (Figure 6), and occasionally flooding (Benkhert et al., 2016).

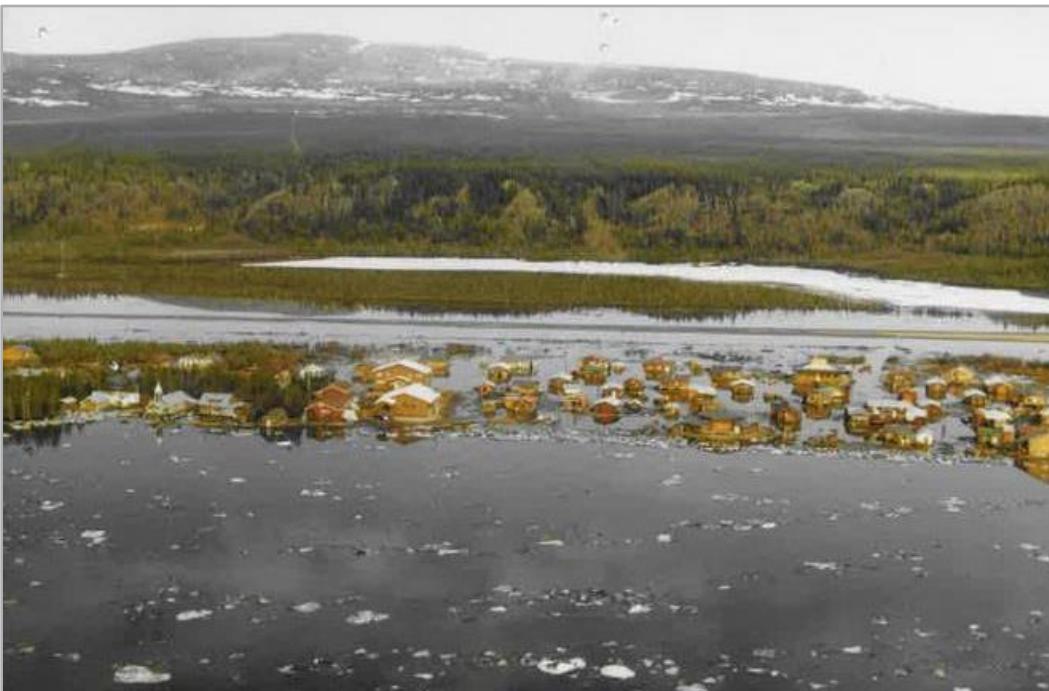
*Figure 7: Old Crow Flooding in May 1991. Photo courtesy of the Yukon Government.*

Historically, there have been severe floods in Old Crow, with the largest known events occurring in 1973 and 1991 (Figure 7). Flooding in the area is typically caused by downstream ice jams during spring break up and backwater effects on the Porcupine River. The extreme water level in May of 1991 was estimated to be approximately 248.8 metres above select datum (mASD) (based on an old datum<sup>1</sup>) as recorded by the Water Survey of Canada (WSC) via a gauging station located approximately halfway along the river front. Based on the statistical analysis of historical water level data recorded at the WSC gauging station, the return period (average estimated time between such events) for the extreme water elevation of 248.07 mASD is approximately 20 years (MH, 2020a).

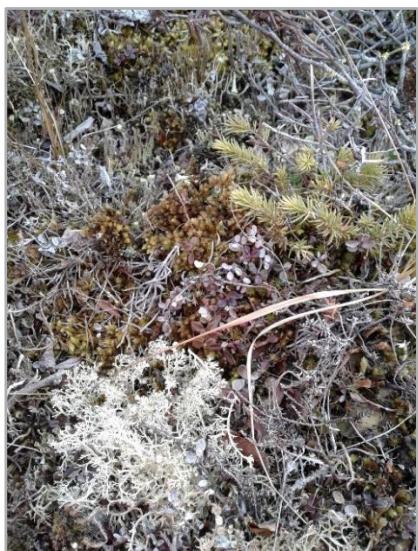
*Figure 9: Ground vegetation, including Caribou Lichen, Labrador Tea, Moss, etc.*

The Old Crow area is capable of supporting stands of black spruce, tamarack and minor white spruce, with ground cover of dwarf birch, willow, ericaceous shrubs (such as blueberry and Labrador tea), cottongrass, lichen, and moss (Figure 9 and Figure 10). Cryosols, the soils formed under conditions of permafrost, in the area either consist of static cryosols (no cryoturbation, mineral parent material, ≤1 m depth to permafrost) on sandy alluvial material or turbic cryosols (cryoturbated, mineral parent material, ≤2 m depth to permafrost) on lacustrine deposits (Ecological Stratification Working Group, 1995). Trees in the area may appear stunted or with a “bent knee”, in-part due to the underlying permafrost marking the limit of rooting or changing conditions in permafrost causing displacement from normal vertical alignment. The tree line sits at approximately 600 masl, along Crow Mountain (Smith et al., 2004), above which

The vegetative mats present in and around the Old Crow area, largely consist of moss, along with lichen and Labrador tea. Moss cover plays a significant role in heat exchange at the surface in Arctic environments. It has a low thermal conductivity in the summer and a high thermal conductivity in the winter, leading to lower mean annual temperatures through facilitating cooling and storage of cold within permafrost (Riseborough and Burn, 1988). A study carried out in northern Alaska supports this theory, as it indicated that the addition of 10 cm of moss, can result in almost a 3°C decrease in mean summer soil temperature and a reduction in thaw depth (Kade and Walker, 2008).

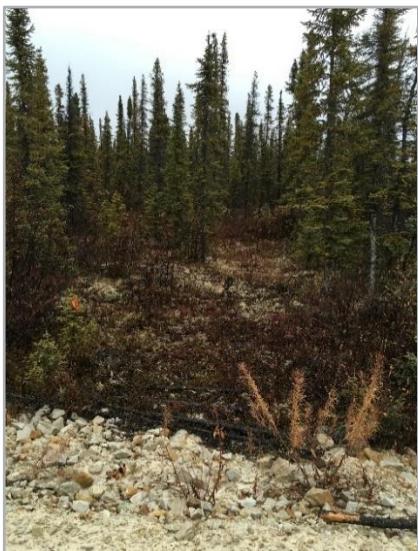
*Figure 10: Stands of Spruce Along Crow Mountain Road.*

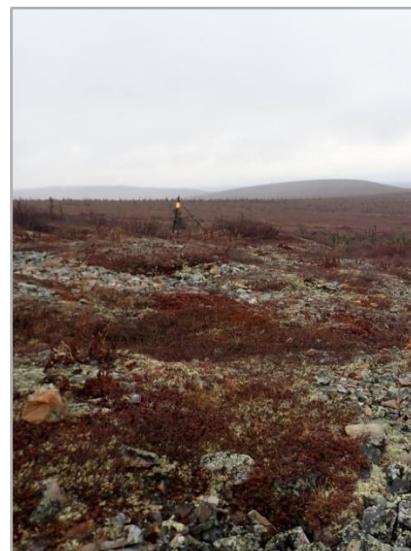
*Figure 11: Sparse Low-Lying Vegetation Above Tree Line on Crow Mountain.*

only low-lying ground vegetation is supported (Figure 11). Due to the subarctic climate, the growing season in Old Crow is short, but intense because of the long periods of daylight.

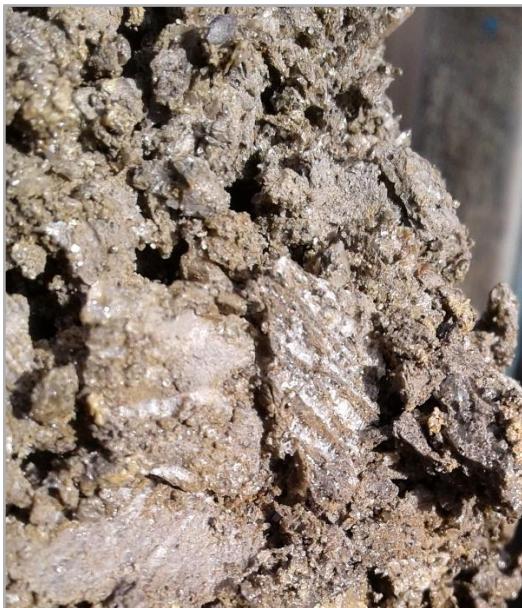
*Figure 12: Visible Ice Lenses in Intact Section of Soil from Subsurface in Old Crow*

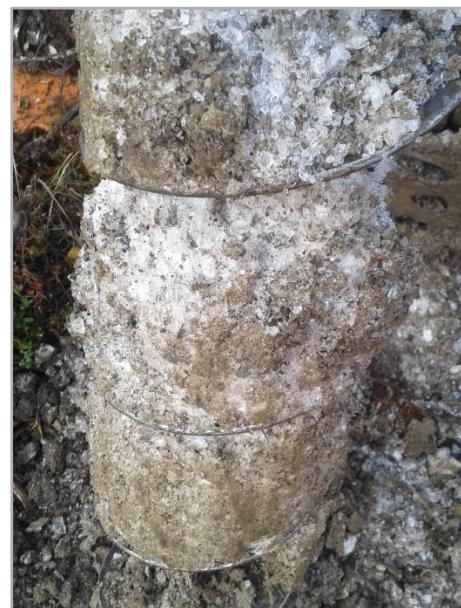
*Figure 13: Ice Rich Interval Encountered during Drilling of Borehole in Old Crow.*

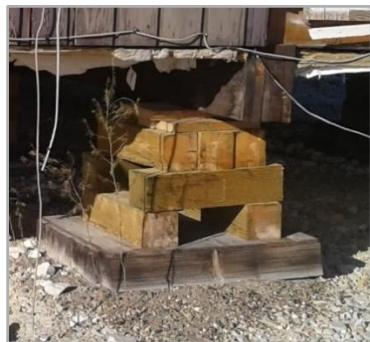
*Figure 18: Shallow Foundation - Pad and Wedge, Old Crow.*

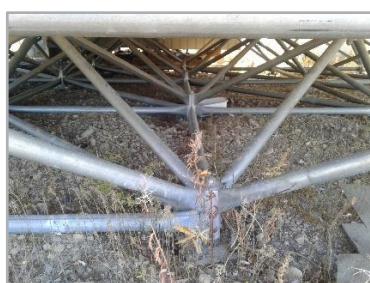
*Figure 19: Shallow Foundation - Space Frame, Old Crow.*

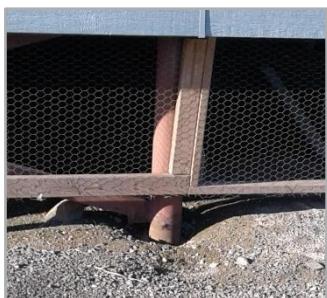
Figure 20: Pile Foundation for Building in Iqaluit, Nunavut.

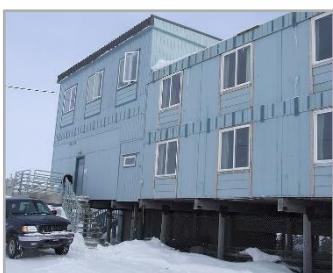
Figure 21: Adfreeze Piles Supporting Building, Barrow, Alaska (Thester11, 2008).

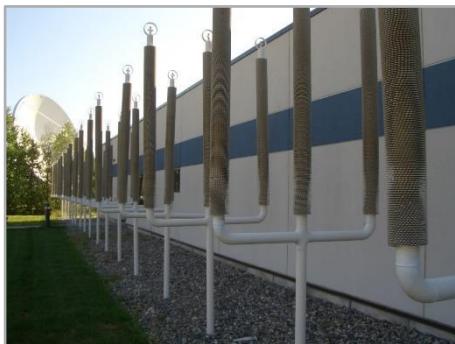
*Figure 22: Thermosyphons at the Fairbanks Airport in Alaska, Used to Chill the Permafrost Beneath the Airport Structure (Ryu,2008).*

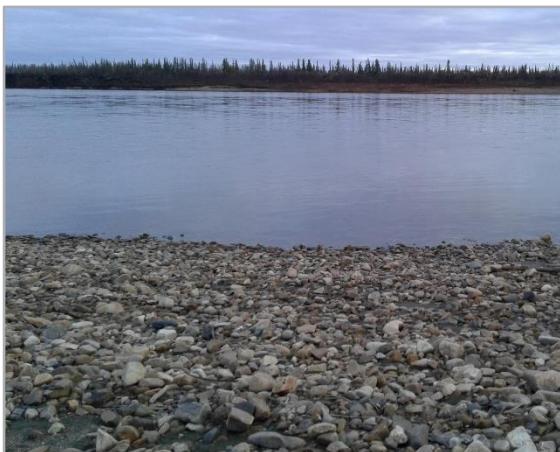
*Figure 24: River Stone Along Bar of Porcupine River.*

Generally, the river gravel is comprised of rounded pebbles to cobbles and varies in colour (Figure 24 and Figure 25) while the crushed aggregate from the mountain quarry is distinctly light coloured sandstone (Figure 26 and Figure 27) (Morrison Hershfield, 2020a). Asphalt is usually very dark in colour and traditionally has a low albedo, which means it reflects radiation poorly and instead absorbs. Heat absorption of the pavement can then result in a temperature increase and possible thawing of the permafrost beneath the roadway embankment. In comparison, the light-coloured quarry rock often used in Old Crow likely has a higher albedo than asphalt (as well-as the river rock, but less so), and other darker coloured aggregates used elsewhere for gravel roadways, which is preferable for permafrost protection. A study by Liu (2020), which compared average road temperatures for asphalt, chipseal, and gravel using thermistor data from down to a depth of 0.3 m below and along the Ingraham Trail (NWT Highway 4), in Yellowknife, determined that chipseal was the most heat absorbent, followed by asphalt, and then gravel on average. The use of pavement or chipseal in construction is not practical in Old Crow. Gravel roadways are common in areas of continuous permafrost because they are less costly to construct and easier to maintain than paved surfaces.

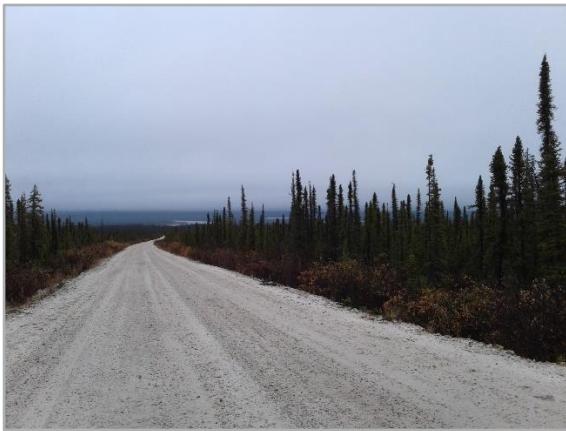
*Figure 26: Light Coloured Crushed Quarry Rock Forming the Crow Mountain Road.*

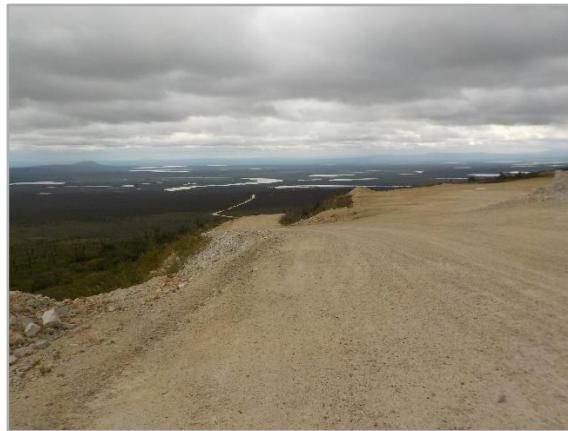
*Figure 27: Crushed Quarry Rock at Top of Crow Mountain, at Quarry Site.*

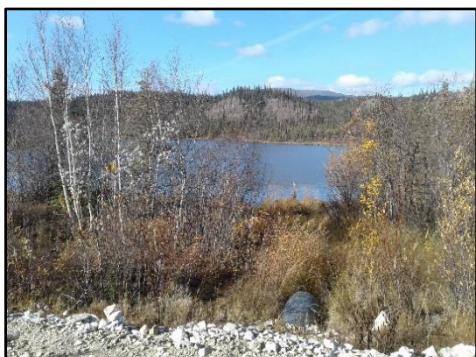
Figure 28: Culvert under North Road,  
Old Crow.

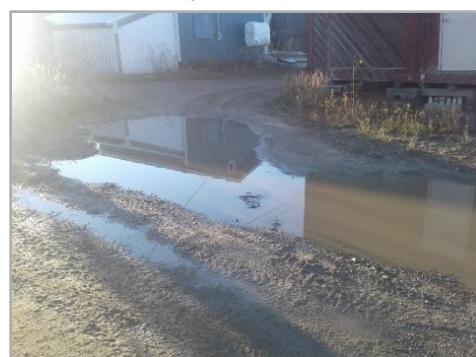
Figure 29: Drainage Ponding Along  
Roadway in Old Crow.

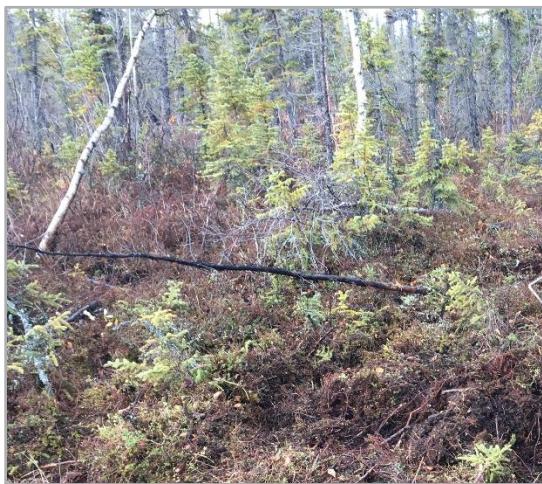
*Figure 31: Vegetative Cover in Old Crow, East of the Sewage Lagoons. Vegetative Mat and Some Trees Visible.*

Permafrost requires an insulating surface cover, consisting of accumulated organic matter and living plants (Figure 31) to remain cool and stable. Without vegetative cover, the permafrost may

melt quickly and result in melted ground, ground saturation, and then slumping and erosion (Matheus and Ontzigt, 2012). Vegetation removal and recovery after disturbance prompts changes in not only the active layer thickness, but also sensitivity to erosion and soil moisture levels. The shallow active layer is a nutrient source for vegetation, maintaining water and nutrient supplies close to the surface. Black spruce, for example, and forest floor moss, have adapted to the presence of permafrost and often sustain permafrost as well as being sustained by it (Riseborough et al., 1990).

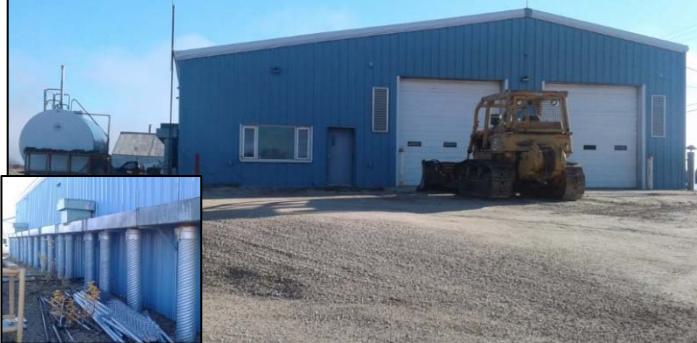
Yukon Government Buildings/Sites		
Building Name: Grader Station	YG and (VGFN) Building Number: 2660 (130)

<b>Foundation Type</b> Forced air ventilated concrete slab.	
	<b>Observations</b> <ul style="list-style-type: none"> <li>- Single storey building with metal sheeting exterior, double garage. It is not clear if the forced air slab cooling is operational. Concrete slab with gravel pad (approx.) 1 m thick.</li> <li>- No guttering on roof, drains to the north and south sides of building. Positive drainage on-site on all sides, with minor ponding observed at the north side of property.</li> <li>- No subsidence or leaning building lines observed.</li> <li>- Two (2) thermistors present, on the southeast side and northwest corners of property.</li> <li>- No vegetation or shaded areas observed.</li> <li>- Road drainage between pad and runway may be poor.</li> </ul>	<b>Recommendations</b> The forced air ventilation system should be confirmed to be in working condition. Otherwise, the site and building appear in good condition.

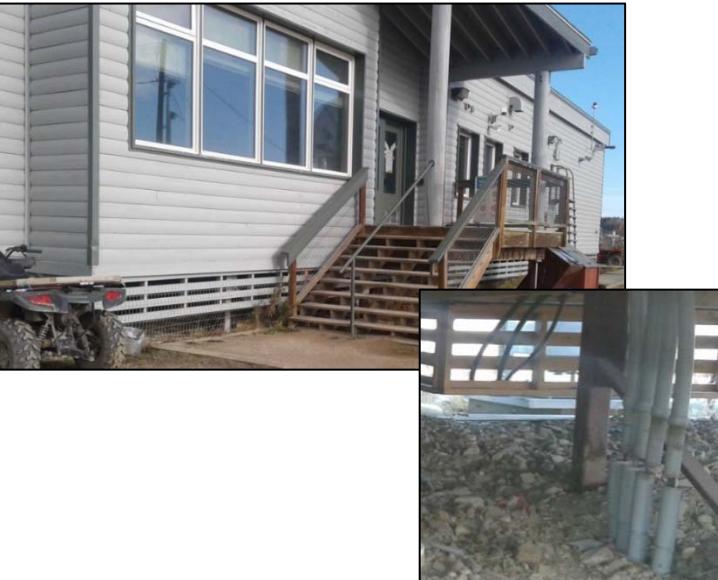
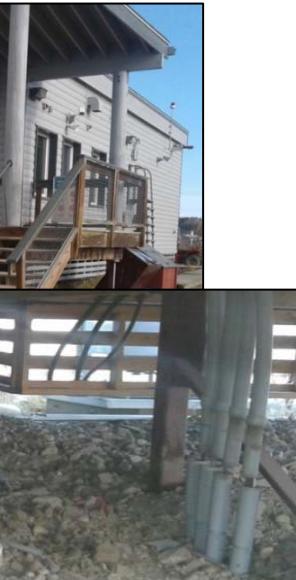
<b>Foundation Type</b> Deep foundation - building appears to be on piles.

<b>Observations</b> <ul style="list-style-type: none"> <li>- Raised, singles storey, heated building. Wood siding, shingle roof with gutters but no downspouts. Gravel on all sides, no shade or significant vegetation.</li> <li>- Crawlspace below building is approximately 1 metre, with slatted siding and wire allowing airflow. Water and sewer tanks and other stored items in crawlspace. Vertical shift evident in conduit joints within crawlspace, below building.</li> <li>- Building appears level and site drainage appears to be ok. No ponding visible.</li> <li>- There appears to be a surrounding monitoring network for water and temperature.</li> <li>- Existing records indicate thermistor strings were installed under the building and that there have been some foundation issues since construction. The contractor opened entire excavation resulting in freezeback and surface water ponding issues in crawlspace since (Tetra Tech, 2018).</li> </ul>	<b>Recommendations</b> Check on thermistors under building. If operational, data should be downloaded and compared to historical data (if possible) to see if there are any warming trends. If ponding within the crawlspace is an issue, the area around the building should be regraded to promote drainage away from the building. Additionally, gutters (where not already present) and downspouts to splash pads can be installed to promote drainage away from the building and reduce potential for ponding within the crawlspace.

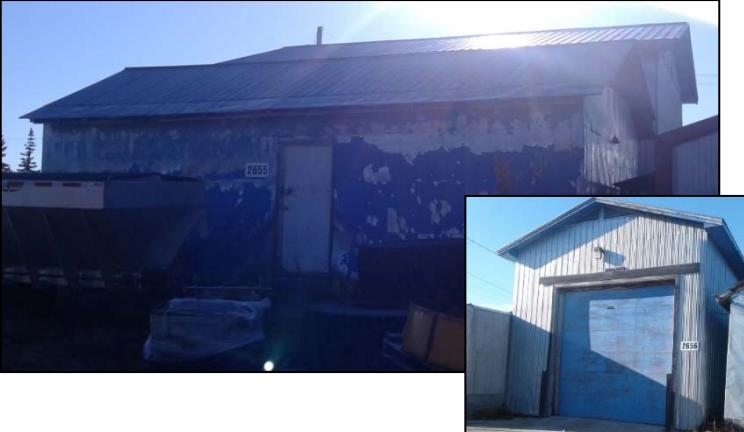
<p><b>Foundation Type</b></p> <p>Shallow foundations. 2655 has cribbing on gravel. 2656 has concrete slab, and some cribbing on gravel under small building addition.</p> <p><b>Observations</b></p> <ul style="list-style-type: none"> <li>- Single storey buildings, with metal sheeting exterior and/or wood.</li> <li>- No guttering and drainage between buildings appears to catch roof run-off. Positive drainage with sloping away of ground on all sides. No ponding observed.</li> <li>- 2655 is not completely level and appears to be due to building age and some disturbed/uneven cribbing on southeast corner of building.</li> <li>- No vegetation or shaded areas observed.</li> <li>- Monitoring wells and/or thermistors installed within vicinity of property.</li> </ul> <p><b>Recommendations</b></p> <p>Disturbed cribbing could be righted. Otherwise, the site and buildings appear in adequate condition.</p>

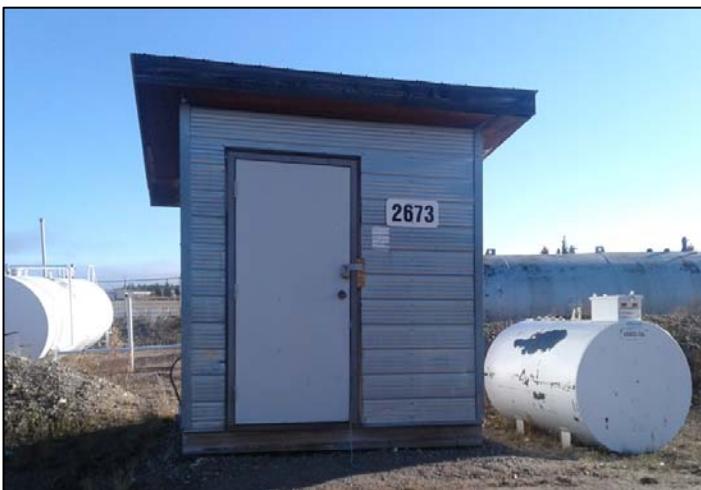
<p><b>Foundation Type</b></p> <p>Shallow foundation - small wooden structure with metal siding. Wooden sill foundation on gravel pad.</p> <p><b>Observations</b></p> <ul style="list-style-type: none"> <li>- Building appears to be for fuel pump.</li> <li>- Drainage appears to be good.</li> <li>- Three above ground storage tanks nearby building.</li> <li>- Monitoring wells and/or thermistors installed within vicinity of property.</li> </ul> <p><b>Recommendations</b></p> <p>None. The site and buildings appear in good condition.</p>

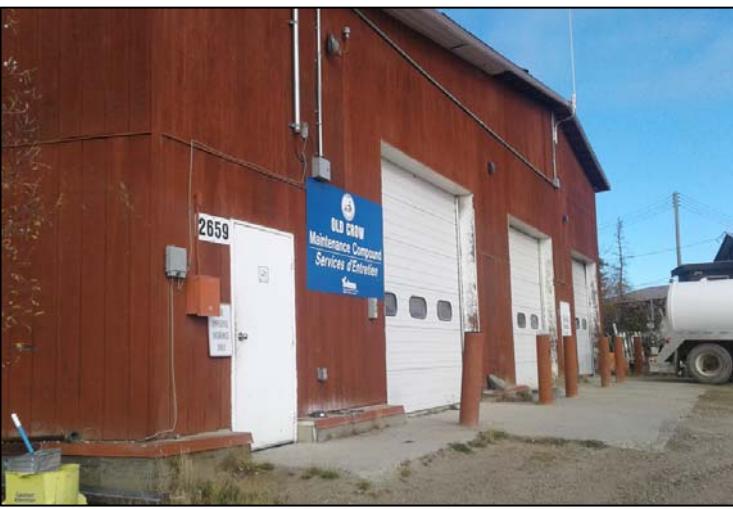
<b>Foundation Type</b>	Mechanically chilled slab (dismantled) (Tetra Tech, 2018). Concrete slab is on gravel, above grade by approx. 5 m.

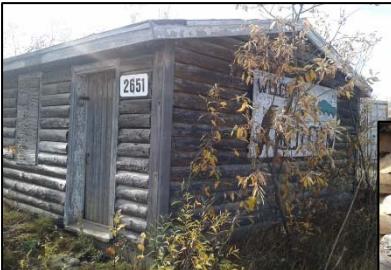
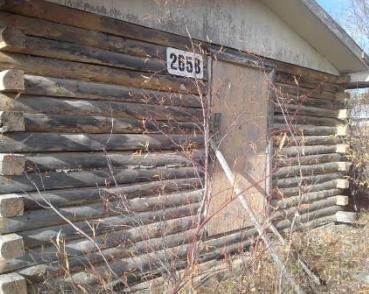
<b>Foundation Type</b> Shallow foundations. Wood directly on ground or possibly on wooden footings (limited visibility).	<b>Observations</b> <ul style="list-style-type: none"> <li>- Single storey buildings made of wood. Buildings do not appear to be heated.</li> <li>- As the buildings are mostly made of wood, they appear to be somewhat flexible, and the building lines are not perfectly level. Both seem to be low on the river side (south side). The icehouse is also slightly lower on the northwest corner.</li> <li>- No guttering or eavestrough. Roof is slanted for drainage. The icehouse roof is bowed. Roadside swales drain to boat launch area to the south. Drainage is good.</li> <li>- The building is surrounded by vegetation (grass and shrubs). No shaded areas observed.</li> </ul>

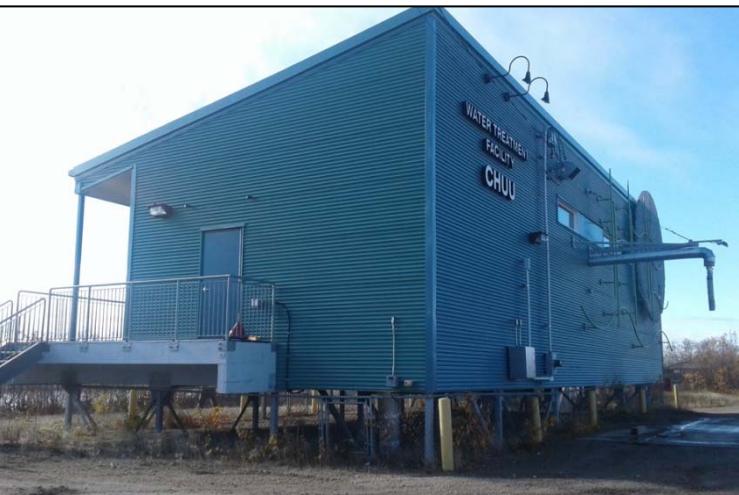
<b>Foundation Type</b> Deep foundation - steel building on piles, 4 feet above grade.	<b>Observations</b> <ul style="list-style-type: none"> <li>- Roof is sloped with gutters and downspouts. Downspouts include short (0.5 m) drain away from building.</li> <li>- Splash pad present under truck filling area.</li> <li>- Crawlspace under building is open for airflow with chain link fencing, no stored items.</li> <li>- Gravel pad and concrete splashpad present at truck fill point. This area was wet at the time of inspection.</li> <li>- No subsidence observed and building is level.</li> <li>- No vegetation or shade.</li> <li>- Few small puddles observed on-site.</li> <li>- Swale present between water plant and health centre for drainage towards the river.</li> <li>- Portable thermistor ports installed on-site related to Health Centre monitoring, but not operational.</li> </ul>

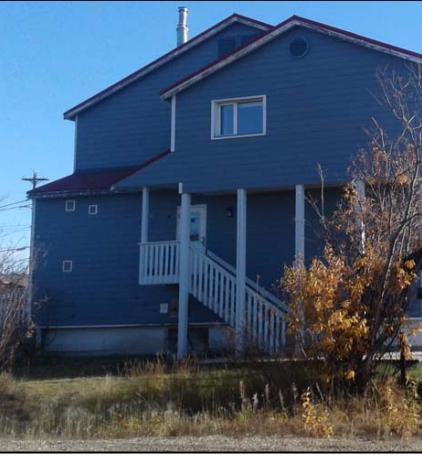
<b>Foundation Type</b>	Appears to be post and wooden beam with gravel pad.
		<b>Observations</b>	<ul style="list-style-type: none"> <li>- Two-storey wooden building with complex gable roof. Building raised 1 m above grade.</li> <li>- Some building edges have gutters and downspouts but not all. There is a drainage extension at front of building to side garden. Some gutters are in poor condition.</li> <li>- Skirted crawlspace beneath building on all sides, except for below front entrance stairway. Each skirted side had one small vent. Some signs of settling below decking at southwest side of building.</li> <li>- Grass present to the south and west of building, exposed gravel to the north and east.</li> <li>- Extensive on-site monitoring network. Above ground fuel tank on-site on concrete slab. Concrete slab may be slightly unlevel.</li> <li>- Ditch present along east side of property draining towards the river. Site drainage is ok, some areas likely to puddle within driveway (due to pitting). Trees along south boundary of the property (by river) likely provide some shade on-site.</li> <li>- Multiple sheds on-site for storage. Shed at northeast corner not completely level.</li> </ul>

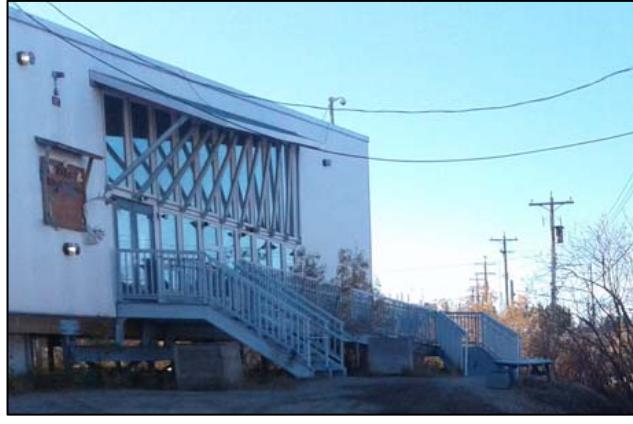
<b>Foundation Type</b>	Deep foundation - steel frame on piles with gravel pad.
		<b>Observations</b>	<ul style="list-style-type: none"> <li>- Building raised 1 m above gravel pad, and gravel pad is approximately 1 m thick. Building is single storey with metal siding and is level.</li> <li>- Sloped roof with drainage to northeast corner with extended gutter past roof edge which drains into a garden/cobble pit.</li> <li>- Crawlspace is open and only stores sewage and water tanks. Fuel tank to east of building.</li> <li>- Some vegetation (shrubs and grasses) present around building on gravel pad.</li> <li>- Site grading is good with drainage way from building on all sides. Northwest of the raised gravel pad may be prone to ponding. No signs of subsidence.</li> </ul>

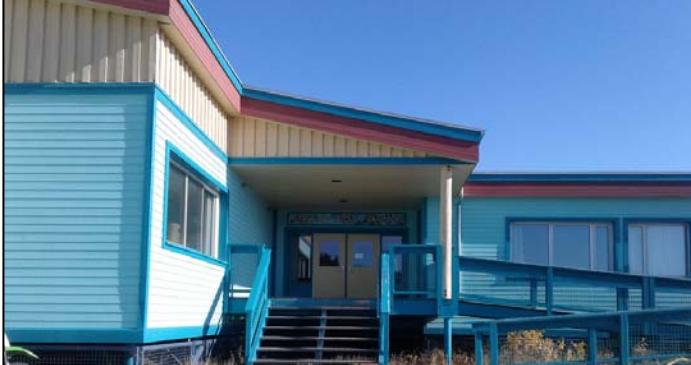
<p><b>Foundation Type</b></p> <p>Deep foundation - adfreeze steel pipe piles.</p>
		<p><b>Observations</b></p> <ul style="list-style-type: none"> <li>- Single storey building. Raised from grade by 0.5 m at perimeter. There is a larger vault under the building centre where tanks are stored and separated from the ground.</li> <li>- Crawlspace is skirted with wire mesh to allow airflow.</li> <li>- Above ground fuel tank present at northeast side of building.</li> <li>- Roof slopes in all directions with a few flat sections. Gutter only over entrance.</li> <li>- Site is well drained.</li> <li>- Building lines appear to be good with exception of east entrance where deck support beam experienced frost jacking.</li> <li>- No interior inspection could be completed. Tetra Tech (2018) previously reported cracking in kindergarten bathroom and outside shop area, and large cracks around a column in the library. Tetra Tech (2018) identified that the south entrance canopy has settled and recommended that a solar shield be installed on ground surface along south wall of school to protect foundation piles and south entrance. No solar shield was observed on-site.</li> </ul>

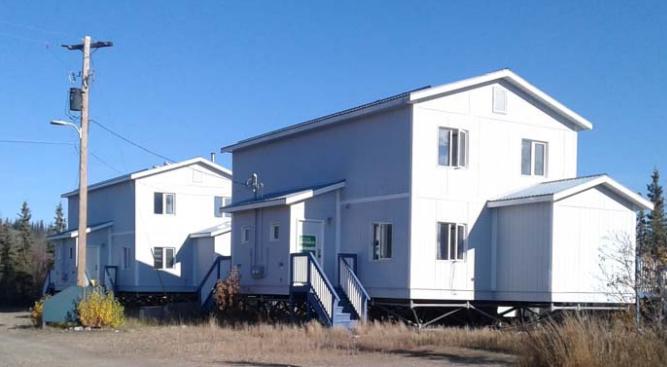
## Yukon Government Buildings/Sites

<b>Recommendations</b>	None. The site and building appear in good condition.
---	------------------------	---

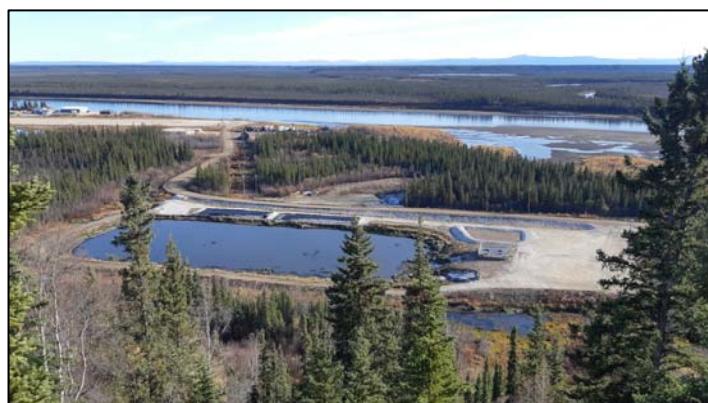
<b>Foundation Type</b>	Gravel pad.
<b>Observations</b>	<ul style="list-style-type: none"> <li>- Sewage Lagoons have recently been significantly upgraded.</li> <li>- No evidence of subsidence or ponding water on-site.</li> </ul>
<b>Recommendations</b>	None. The site and structures appear to be in good condition.

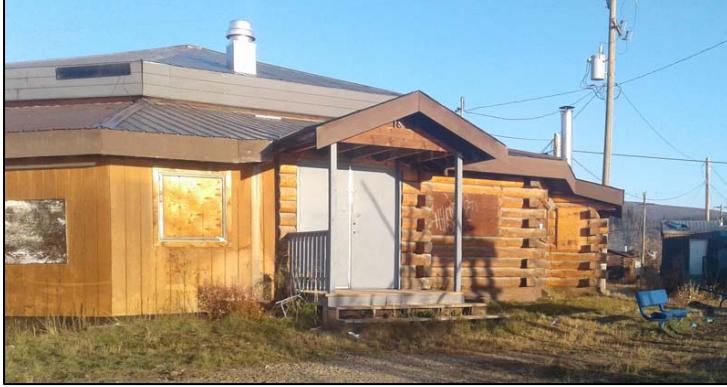
<b>Observations</b>	<ul style="list-style-type: none"> <li>- Single storey wooden building on gravel pad.</li> <li>- Positive drainage on all sides of building with grading and/or swales/ditches.</li> <li>- No gutters or downspouts, but roof is sloped.</li> <li>- Grassy vegetation surrounds building. Drainage appears to be slightly south, towards the roadway and river.</li> <li>- Good building lines.</li> <li>- Above ground fuel tank located at north end of building.</li> <li>- No signs of settling.</li> </ul>
	<b>Recommendations</b>	None. The site and building appear in good condition.
<b>Building Name:</b> Chief Peter Moses Centennial Hall		<b>VGFN Building Number:</b> 570

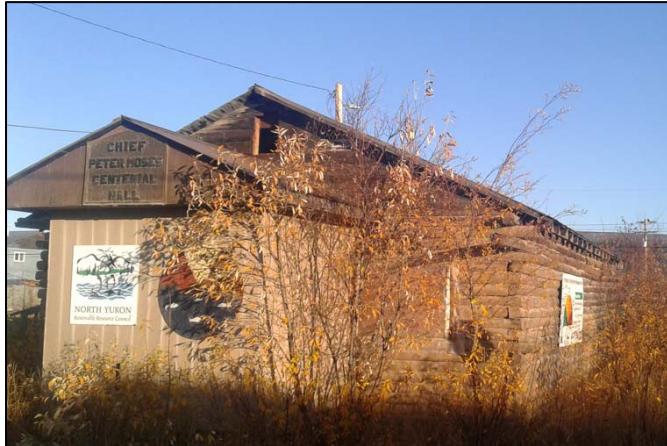
<b>Foundation Type</b>	Shallow foundation. Wood building on wooden footings.
	<b>Observations</b>	<ul style="list-style-type: none"> <li>- Single storey wooden building on gravel pad.</li> <li>- Positive drainage on all sides of building with grading and/or swales/ditches.</li> <li>- No gutters or downspouts, but roof is sloped.</li> <li>- Grassy vegetation surrounds building.</li> <li>- There appears to have been some shifting of wooden logs on western side of building.</li> </ul>

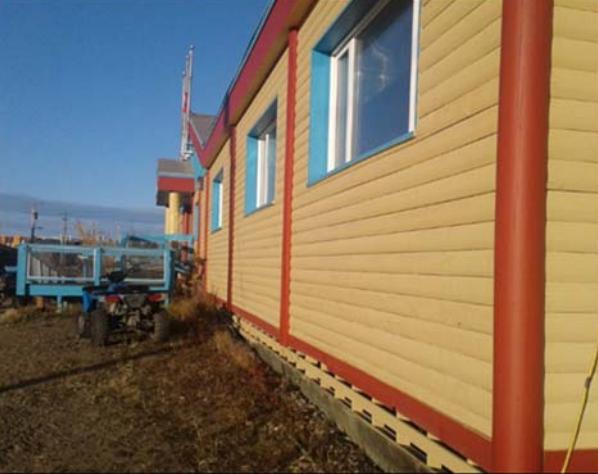
<b>Observations</b>	<ul style="list-style-type: none"><li>- Single storey building with wood and some metal siding.</li><li>- Roof appears flat in some spots. No observed gutters or downspouts.</li><li>- Building is on gravel pad that is slightly elevated compared to adjacent roadway.</li><li>- Some vegetation around building.</li><li>- Building is raised approx. 0.3 m above ground. Crawlspace has slatted wooding skirting with some restriction of air flow.</li><li>- Building lines look good.</li></ul>
		<b>Recommendations</b>	None. The site and building appear in good condition.

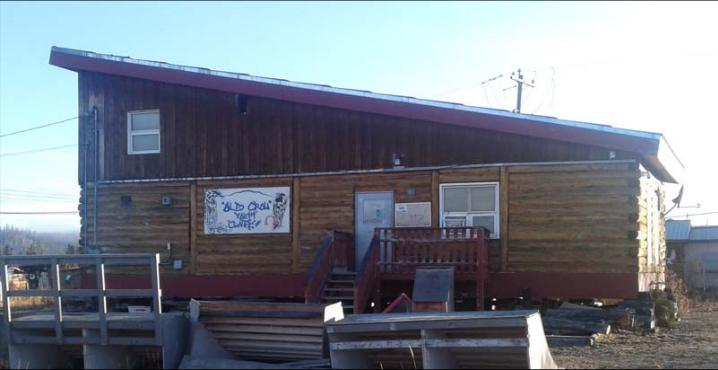
<p><b>Foundation Type</b></p> <p>Shallow foundation – cribbing on gravel.</p>
	<p><b>Observations</b></p> <ul style="list-style-type: none"> <li>- Multi-storey wooden building. Building raised approx. 0.5 above ground. Crawlspace is unrestricted to airflow.</li> <li>- No gutters. Slanted roof. No ponding observed.</li> <li>- Building lines look good.</li> <li>- Some storage of items within crawlspace beneath building.</li> <li>- Appears to have positive drainage on all sides of building with ditching to the west and south.</li> </ul>
	<p><b>Recommendations</b></p> <p>None. The site and building appear in good condition.</p>
<b>Building Name:</b> St. Luke's Anglican Church	<b>VGFN Building Number:</b> 490

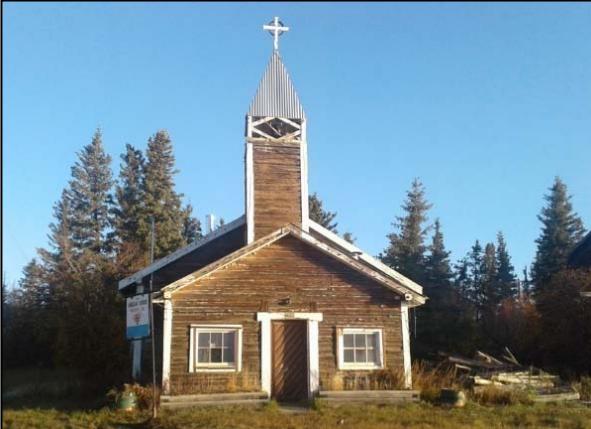
<p><b>Foundation Type</b></p> <p>Shallow foundation. Wood directly on ground or possibly on wooden footings (limited visibility).</p>

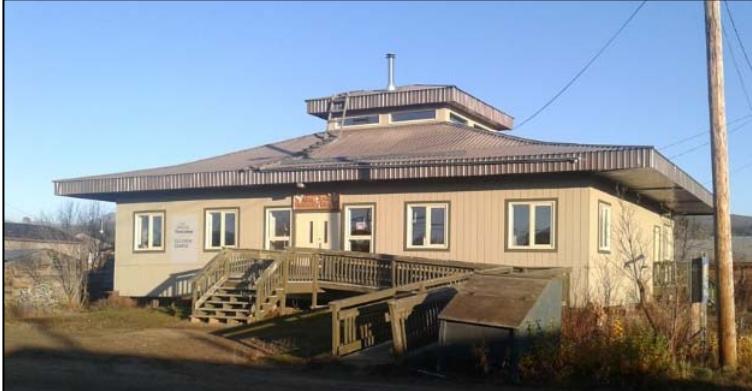
<p><b>Foundation Type</b> Shallow foundation – cribbing on gravel.</p> <p><b>Observations</b> <ul style="list-style-type: none"> <li>- Single storey wooden building. Building raised approx. 0.35 above ground. Crawlspace is unrestricted to airflow.</li> <li>- Gutters only above entranceway.</li> <li>- Building lines look good.</li> <li>- No ponding observed. Site drainage looks ok.</li> </ul> </p> <p><b>Recommendations</b> None. The site and building appear in good condition.</p>
<b>Building Name:</b> Archdeacon McDonald Memorial Church	<b>VGFN Building Number:</b> 495

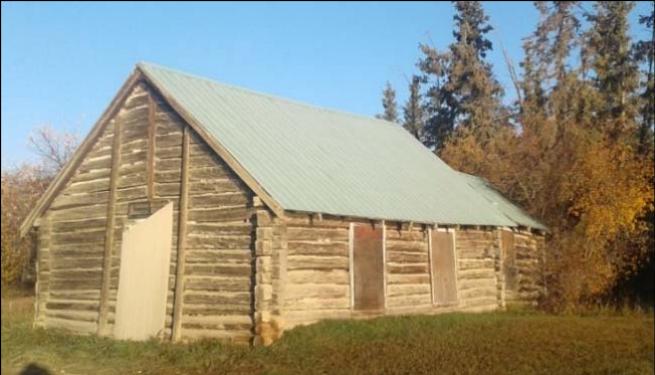
<p><b>Foundation Type</b> Shallow foundation. Wood directly on ground.</p> <p><b>Observations</b> <ul style="list-style-type: none"> <li>- Single storey wooden building.</li> <li>- No gutters or downspouts, but roof is sloped.</li> <li>- Grassy vegetation surrounds building. Drainage appears to be slightly south, towards the roadway and river.</li> <li>- Building lines are off which is consistent with building age and wooden structure.</li> </ul> </p> <p><b>Recommendations</b> None. Building is a historical building, and it is understood that it is not in use and not heated.</p>

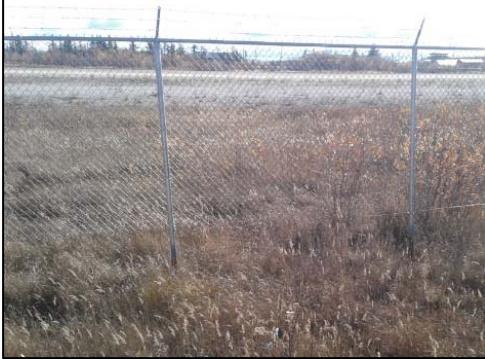
<b>Observations</b>	Perimeter fencing around airport runway was observed to be frost jacked in some locations.
	<b>Recommendations</b>	None. Not likely related to permafrost.

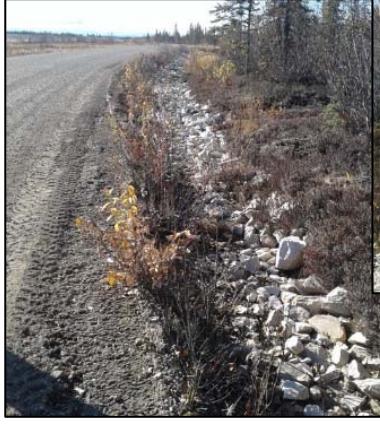
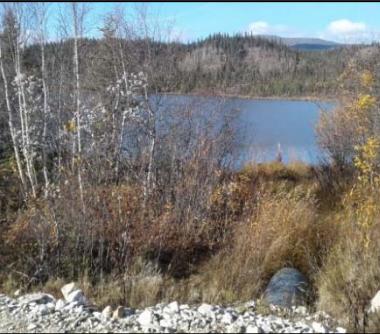
#### Area: North Road

<b>Observations</b>	<ul style="list-style-type: none"> <li>- Eastern portion of airport runway area and North Road appears to drain to the north via ditches and culverts to Lakes.</li> <li>- Western portion of airport runway area and North Road appears to drain to the two small lakes nearby, and to a westward flowing stream adjacent to the roadway which appears to drain westward to the Porcupine River.</li> <li>- Drainage in the area of North Road and the Airport Runway appears to be good.</li> <li>- Young willows and other shrubbery were observed growing on both sides of North Road, which may promote snow drifting and accumulation resulting in an insulating impact along the gravel roadway.</li> </ul>
	<b>Recommendations</b>	Roadside shrubbery should be removed to prevent snow accumulation along the edges and ditches of the gravel roadways.

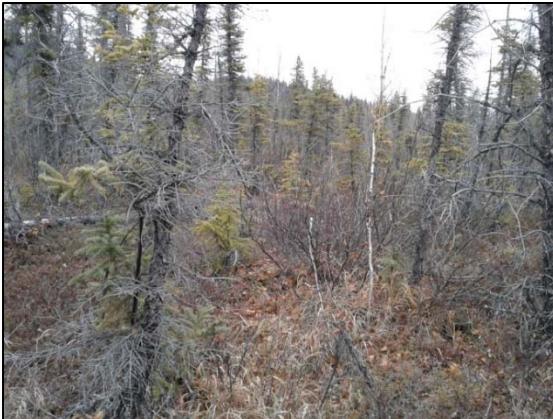
### Area: North of North Road, east of Sewage Lagoons

- Low lying area at the toe of a colluvial apron/fan. Likely subject to flooding.
- Transected by a number of ski trails and accessible by Ski Chalet to the northeast.
- Characterized by forest of black spruce, some birch, and many large shrubs, grasses, and thick hummocky ground cover.
- Ice content in active layer and permafrost is high and likely quite susceptible to warming and subsidence.
- There may be ephemeral streams in this area, present or flowing during or shortly after snow melt or rainfall events. Ponding may be an issue in this area.

The presence of water at ground surface can have significant impact on ground temperature, especially where drainage is limited. Additionally, high ground ice contents can be susceptible to thaw and significant subsidence. Careful consideration should be taken for any future development plans (if any) for this area.

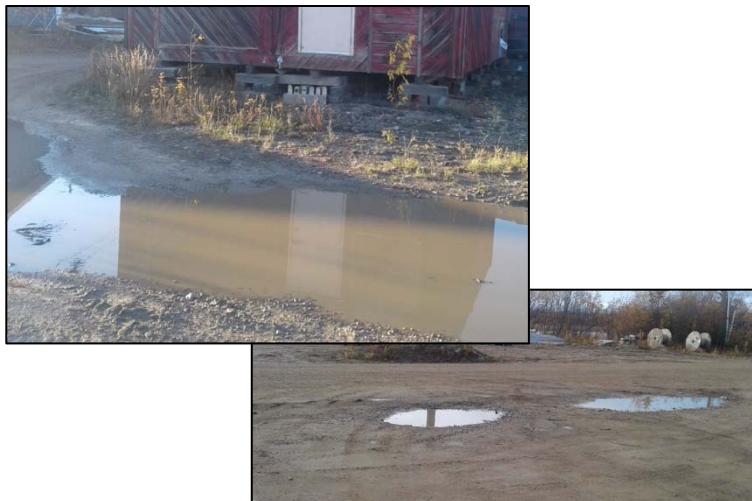
### Area: Roadways in community core (not including North Road or Crow Mountain Road)

- Ponding of water was observed in low lying areas along gravel roadways within the community core.
