## Ross River Suspension Bridge Ross River, Yukon

### Life Cycle Cost Analysis

#### **Yukon Government Community Services Department**

**November 29, 2013**

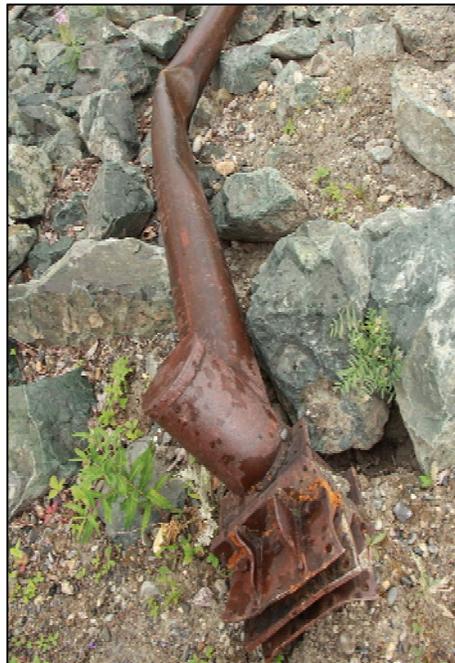
**Figure 1. SW Sway Cable Anchor destroyed by flooding of Pelly River in early 2013**

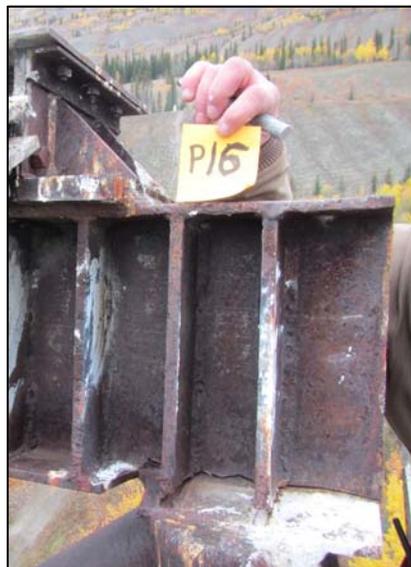
**Figure 4. Damaged Steel Head Beam located on top of North Tower**

In 2013, YTG-CS retained DNA to prepare contract documents for the repair of the Ross River suspension bridge based on Option 1 described in our Oct 16, 2012 Repair Options report. In a pre-design inspection of the bridge in October 2013, the steel cross beam located on top of the north tower of bridge was discovered to be severely damaged and laterally unstable. Given this finding and the age and overall poor condition of the bridge, DNA concluded in a memorandum to YTG-CS dated September 30, 2013 that it was no longer practical from a structural and construction safety perspective to repair and salvage the bridge. Furthermore, we recommended that the bridge be demolished as soon as possible for safety reasons.

The bridge is in a critical structural condition and in danger of collapse. Given the critical condition of the steel cross beam, the age of the bridge and its poor condition, DNA concluded (see DNA Memorandum to YTG-CS dated September 30, 2013) that it was no longer practical from a structural and construction safety perspective to repair and salvage the bridge. Furthermore, we recommended that the bridge be demolished as soon as possible for safety reasons.

DNA is currently preparing contract specifications for a public tender to demolish the bridge with an option to leaving both the steel towers in place for cultural reasons. We note that the severe condition of the steel cross beam on top of the north tower of the bridge presents a significant challenge and safety risk for the demolition contractor. We expect that the most cost effective and safest approach is to carry out the demolition of the bridge during the winter freeze up of the Pelly River. At this time, our preliminary cost estimates for the demolition of the bridge during the winter freeze up of the Pelly River is in the order of \$ 350,000. We note that the demolition costs are dependent on the method of demolition proposed by the contractor.
