FLAME & MOTH (#18)
(MINFILE# 105M 14)

Public Works And Government Services Canada	Travaux publics et Services gouvernementaux Canada	designed by:	correct:
	Architectural & Engineering Services Western Region		concur par:	
			drawn by:	C.S. Nov./99
			designed par:	
			approved by:	
Drawing title:			approved par:	revision:
Flame and Moth Site #18 Site Assessment			Time du dessin:	
Yukon Territory			project no. no. du projet	design no. dessin no.
			125-12.01	1 of 2

Flame and Moth Site # 18
Site Assessment
Yukon Territory

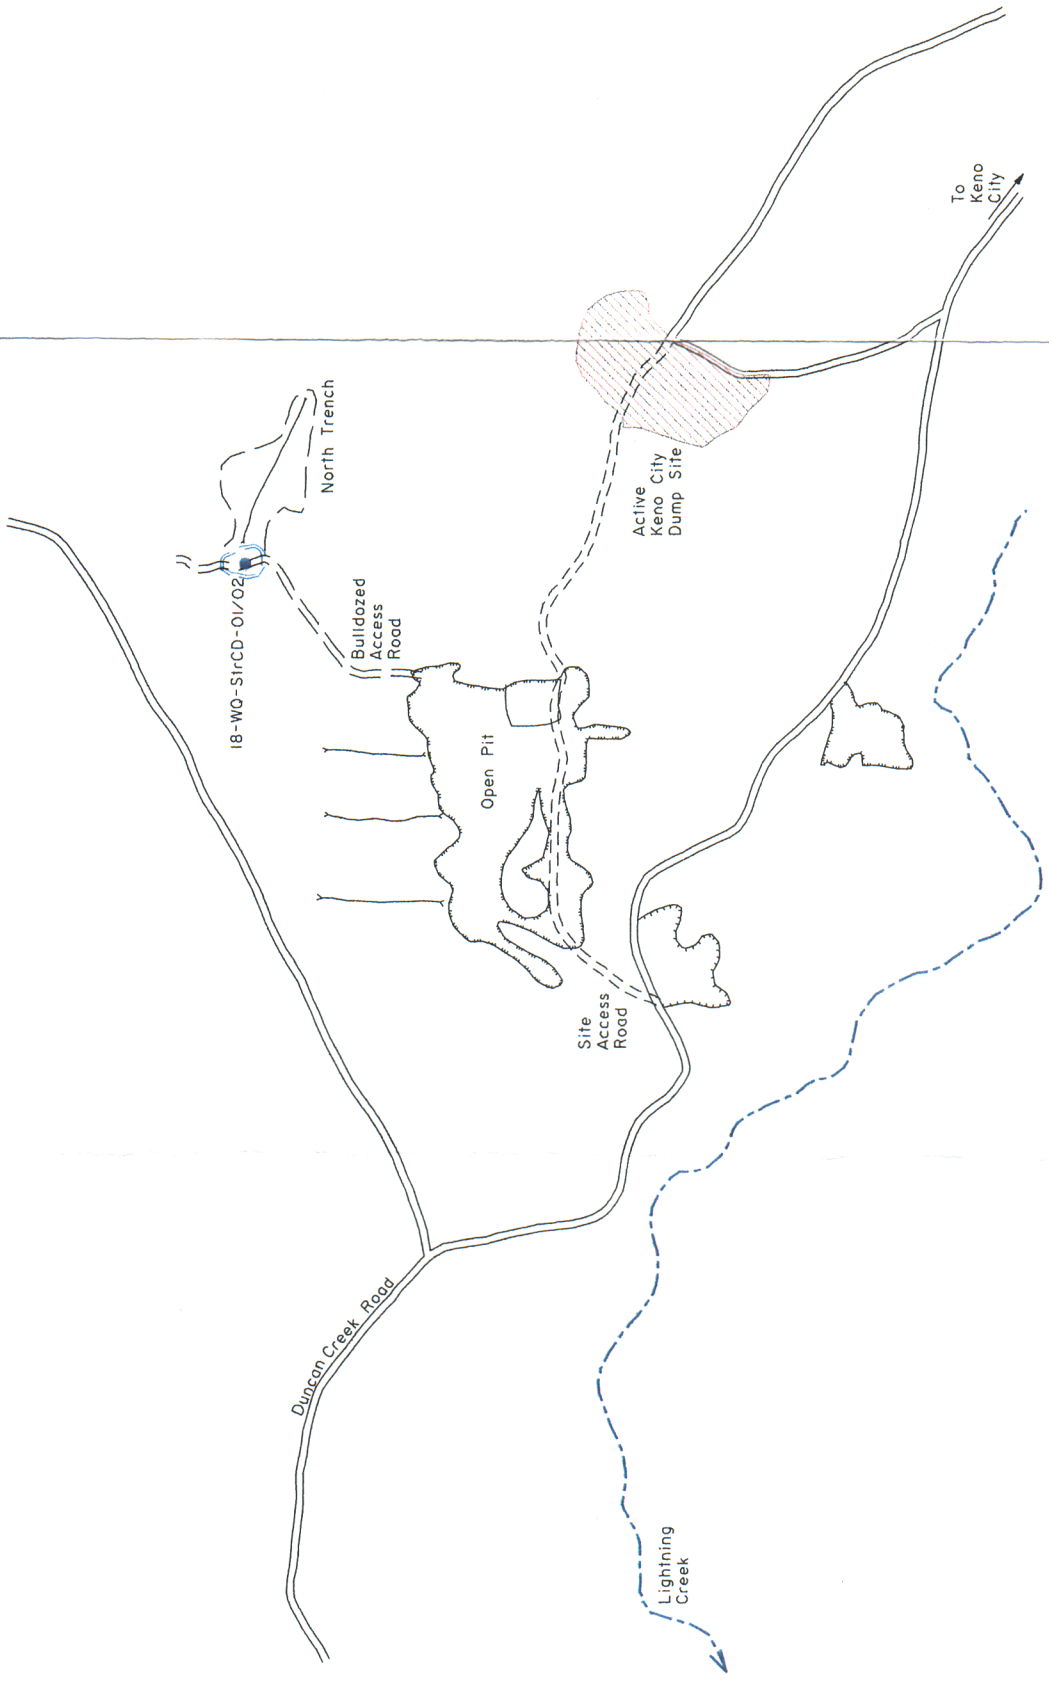
Location: See map. The disturbed area includes considerable trenching, and is thought to extend to the southwest well beyond the open pit.

Location: See map. Waste rock was identified throughout the site in varying sized piles.

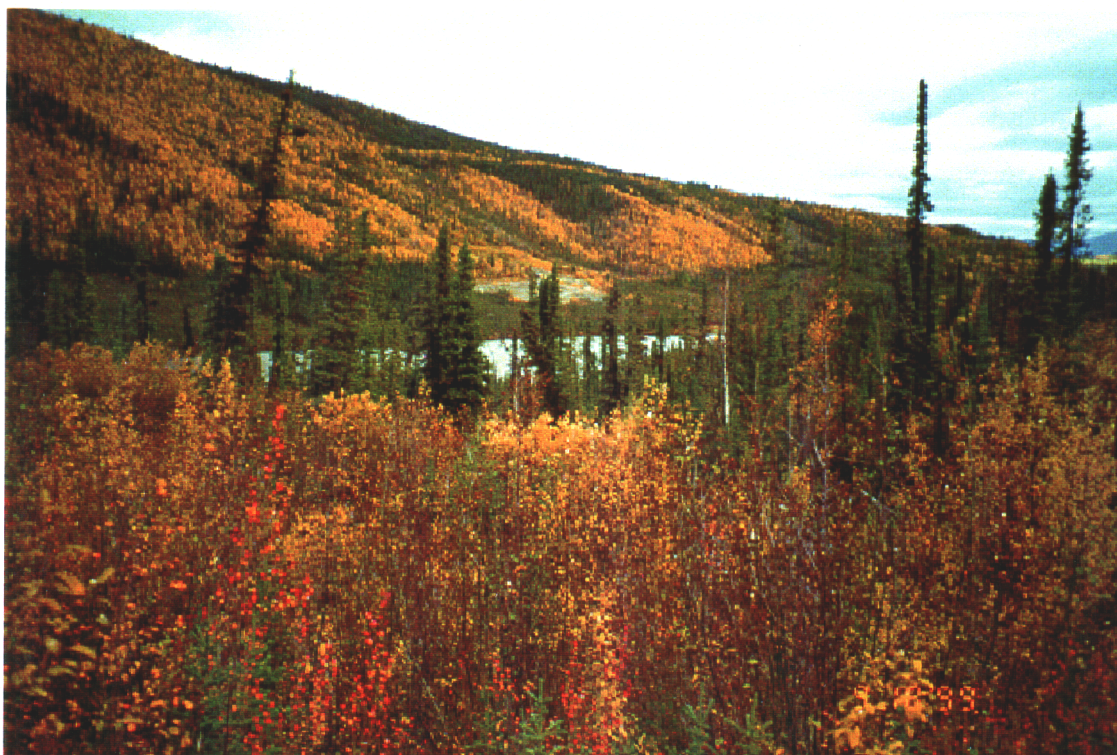
Photo 18-1: Forested area and Christal Lake in background north west of site.

The site is immediately west of Keno City and the main solid waste dump site. The area slopes gently towards Christal Lake approximately 750 m to the northwest (photo 18-1). Surrounding properties are heavily forested with typical subalpine features although most of the vegetation has been removed from this site. Drainage from the main pit is to the west and drainage from the trench is to the north west. Surface runoff from both areas is eventually into Christal Lake.

There was evidence that water had ponded in the north trench in the recent past, however, it was dry during the site visit. The north trench area drains northwest towards Christal Lake, a distance of approximately 750 m (photo 18-1). Surface runoff from the site enters a pond immediately north west of the site (photo 18-6), which discharges into a small creek flowing into Christal Lake. A water sample (18-WQ-Str-CD-01) and duplicate (18-WQ-Str-CD-02) were collected from the pond. Laboratory and field analyses are provided in Attachment B.

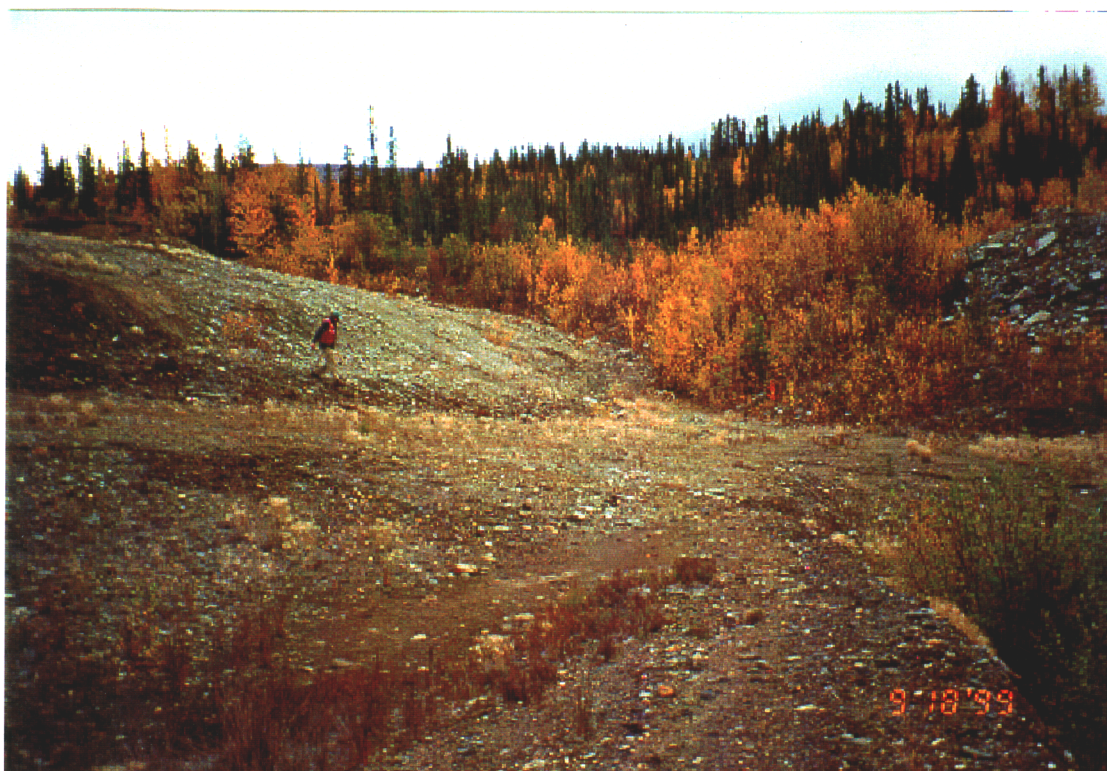
Photo 18-2: Waste rock area near north end of main site.

Open Pits (photo 18-2)

Open pit mining was in progress when the operation was closed, however very little ore was produced. There are no benches cut into the rock. The boundaries of the mineralized area and pit outline are not clear.

Dimensions (L x W x H): Irregularly shaped with max. length 160 m x max. width 90 m x max. depth 5 m.

Condition: The site is fairly level, and appears to be stable. Some dump slopes are steep but of minimum height.

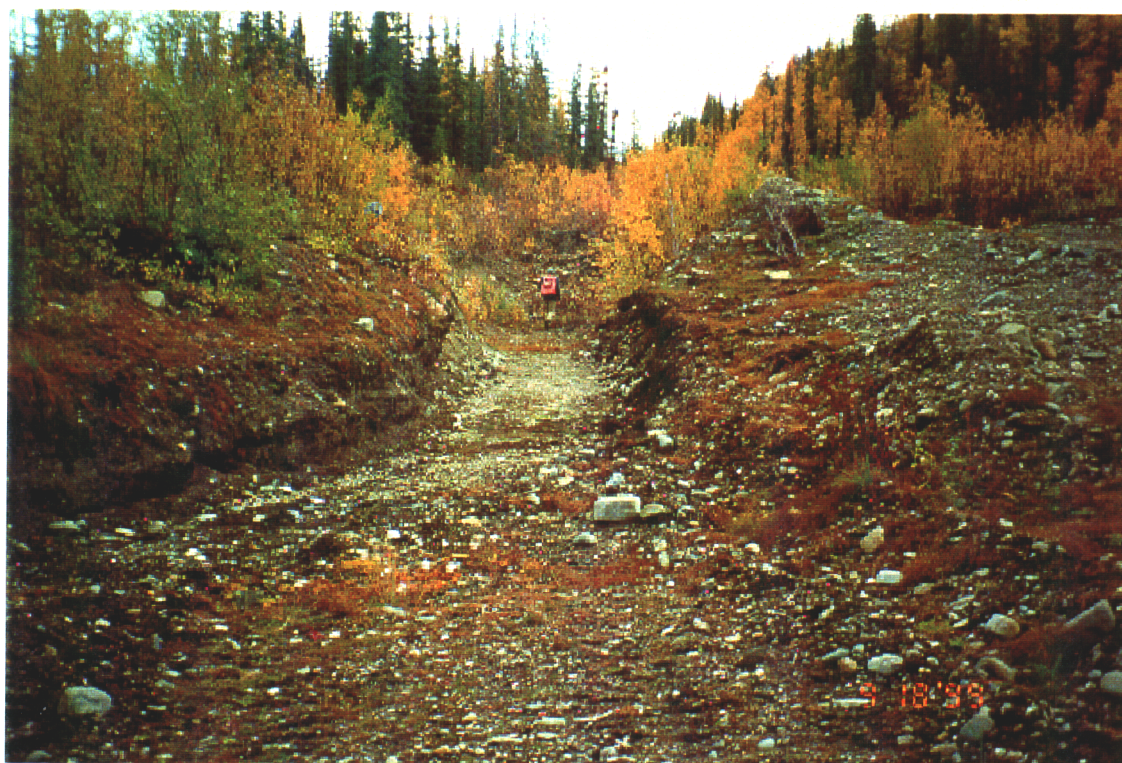
Photo 18-3: Bulldozed trench at second site.

Trenches (photo 18-3)

Trench is a long thin bulldozed pit, aligned in an east-west orientation. More development has occurred at the east end of the trench where placer mining appears to have occurred in the recent past. Only a small amount of bedrock is exposed.

Dimensions (L x W x H): 45 m x 5 m x max. 3.5 m.

Condition: The site is level and drainage slopes towards the west end of the site. Slopes appear stable.

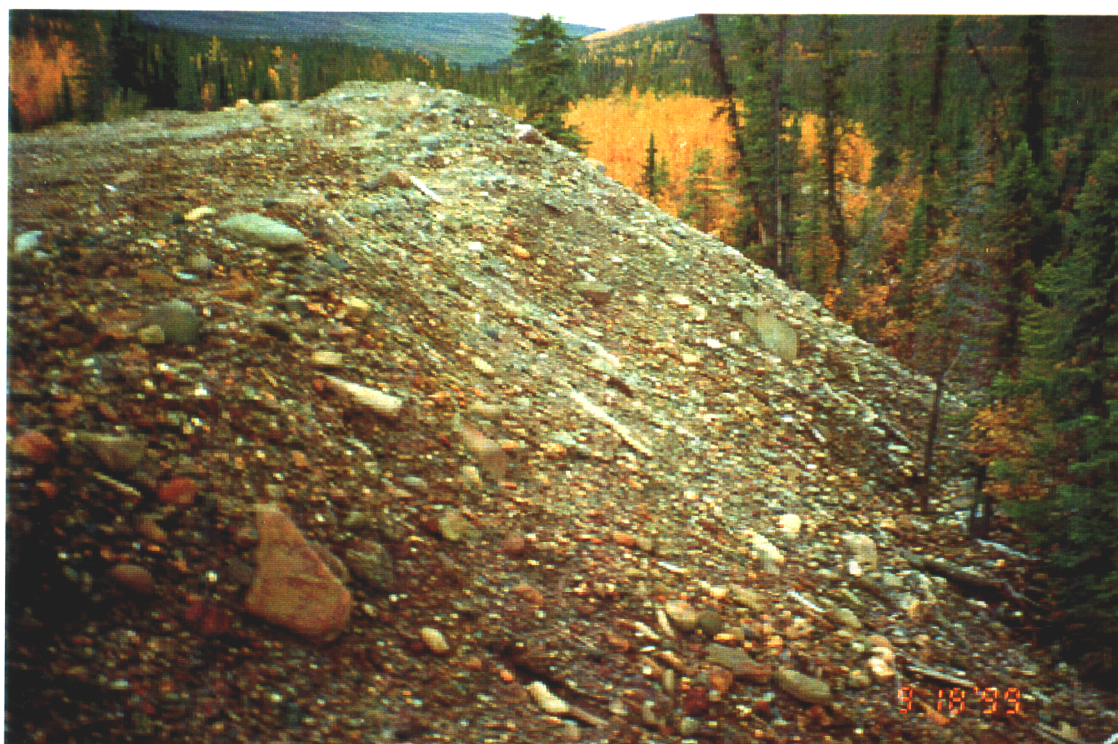
Photo 18-4: Large waste rock pile slope at north end of main site.

Waste rock piles (photo 18-4 & 18-5)

General Description: Open pit development has produced four lobes of waste rock. The two northwestern lobes are dominantly barren overburden (photo 18-4). The northeastern lobe, site of sample 02, is composed of mixed mineralized material and overburden (photo 18-5). The southern lobe, site of sample 03, is dominated by barren quartzite. The waste rock dumps are partially revegetated, except near well-mineralized areas. Vegetation is well established where there is fine-grained material or moisture traps. There is no apparent drainage at the site, as it is dominated by well-drained gravel. Oxidation related staining of the waste rock is apparent at the northeastern lobe of waste.
