ENVIRONMENTAL CLEAN-UP STUDY
OF
21 DEW STATION SITES IN CANADA
FINAL REPORT: DRAFT

VOLUME 4
BAR 2
Shingle Point, Yukon Territory

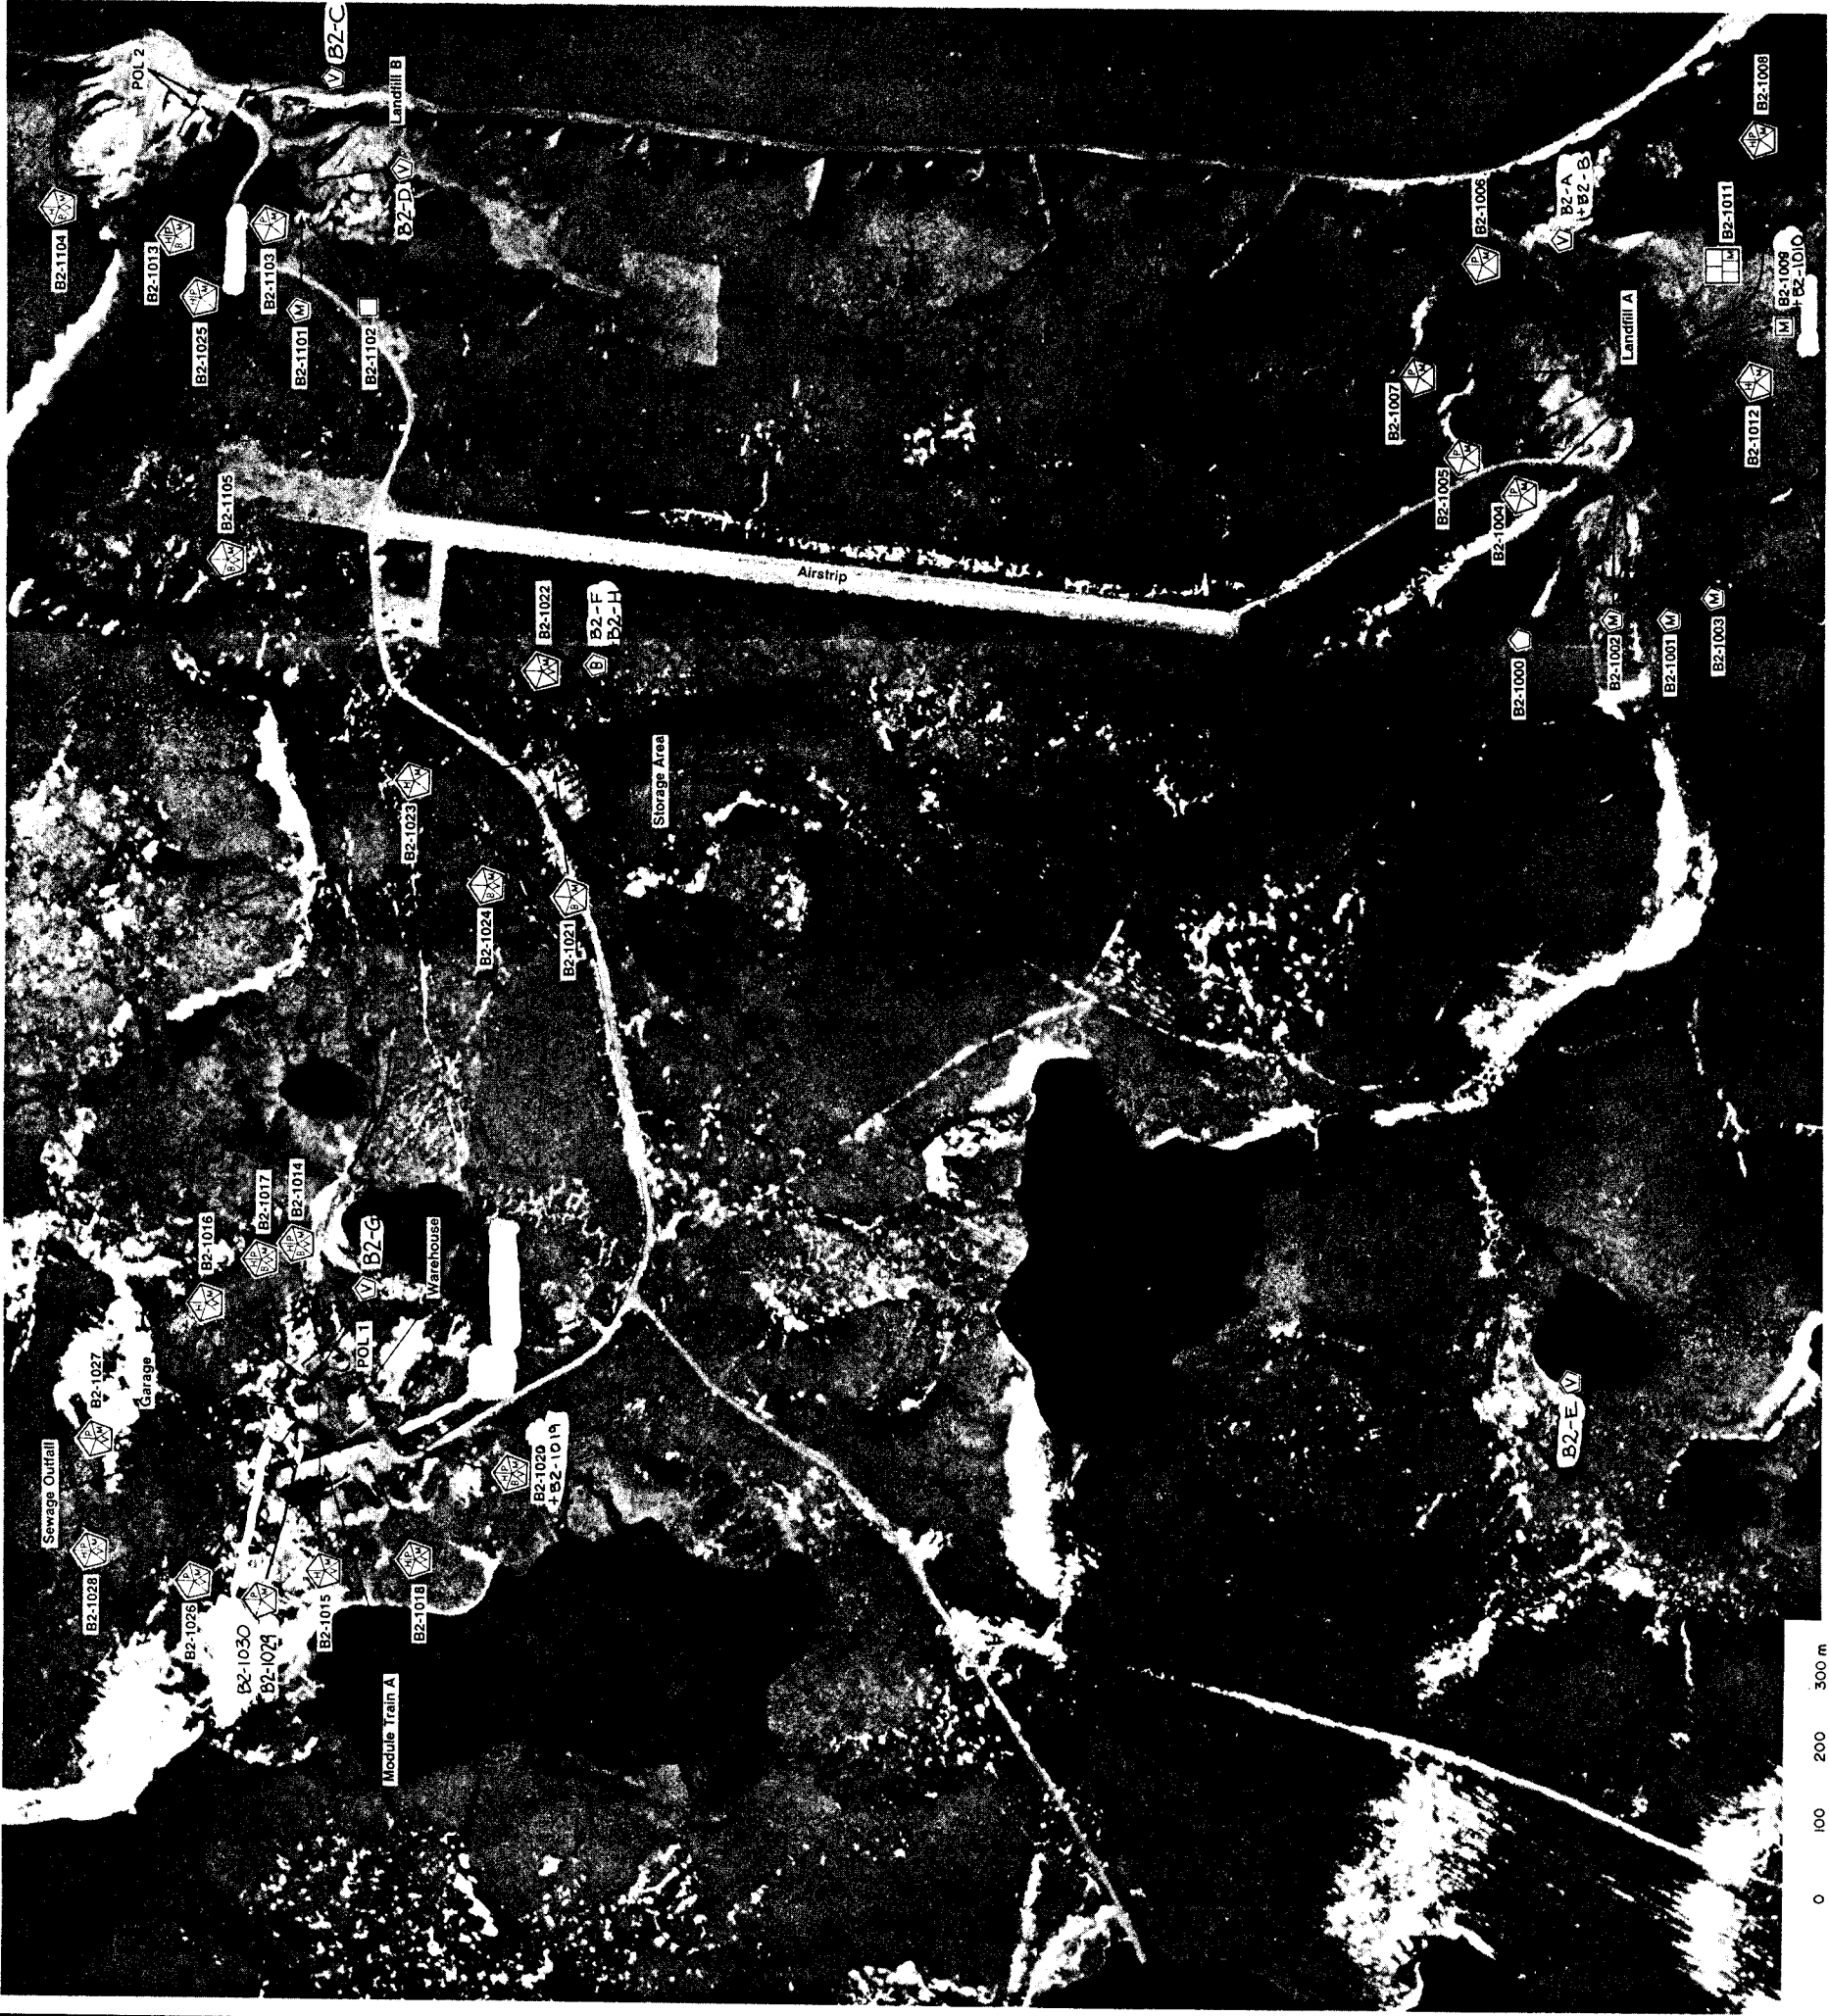
FIGURE 6.1

STATION AREA SAMPLE SITES
AND PARAMETERS IDENTIFIED

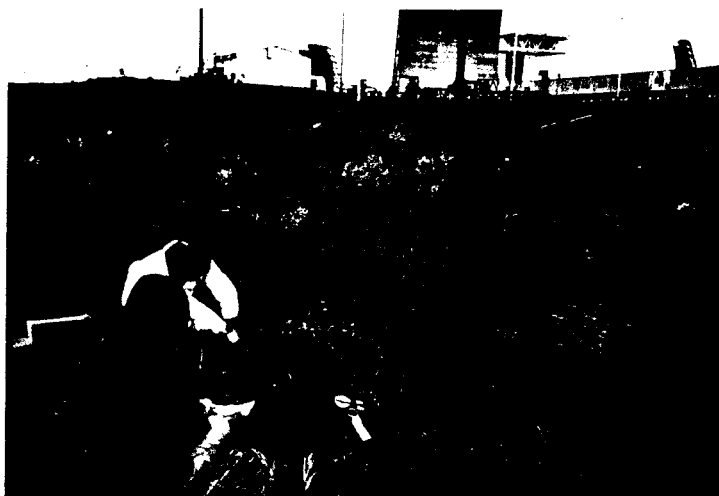
PLATE 1

SEWAGE OUTFALL AREA

The sewage outfall area was located 200 m north of main module (Plate 1). Sewage is discharged directly onto organic terrain and disperses along local drainage channels and over the surface. The organic layer was approximately 30 cm thick, with the inclusion of clay at a depth of 15 cm. Permafrost was encountered at 30 cm. The area has experienced eutrophication, as indicated by the lush vegetation and the occurrence of *Senecio* spp. which are characteristic of outfall areas. Some stressed vegetation was noted in the vicinity of the outfall.

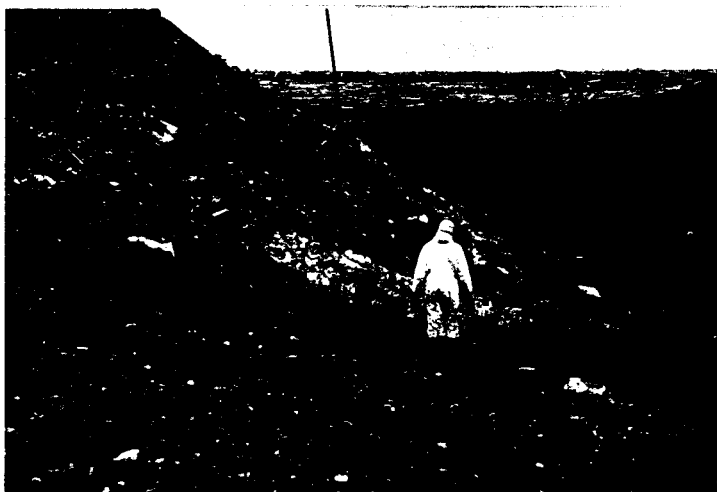
PLATE 2

ACTIVE LANDFILL AREA

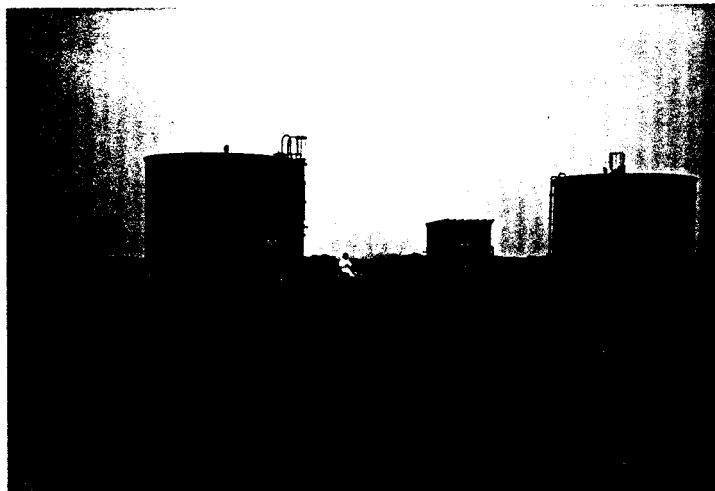
PLATE 4

BUILDING SITE
POL TANK FACILITIES

POL 1 storage facilities are located 100 m north of the module train and consist of two 295 m³ diesel tanks (Plate 4). General drainage in this area is to the north and northeast (Figure 3.1). Within the catch basin and immediately outside the berm walls, the soils encountered were a silty gravel with some sand. At greater distances, this was overlain by organic soil. The tanks were elevated on a gravel pad above the catch basin, which was partially filled with water; ponded water was also noted outside the berm walls. A slight sheen was noted on the surface of the water inside the basin. The northwest wall of the catch basin berm showed some signs of sloughing.

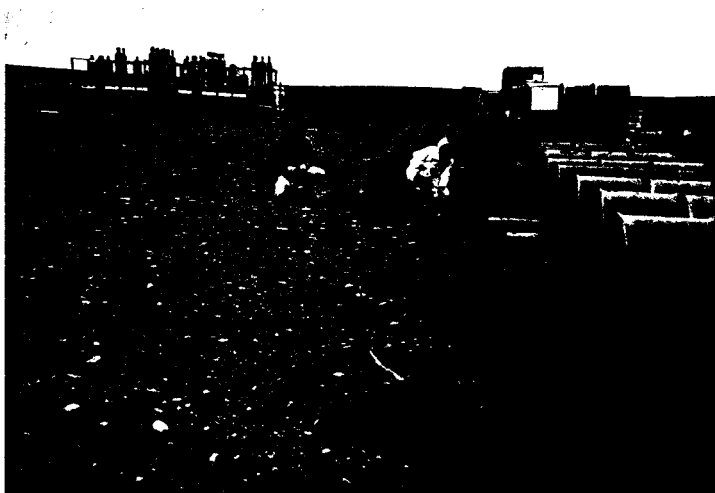
PLATE 5

SOIL SAMPLING WITH RRMV
AT POL DRUM STORAGE PALLET LINE

Due to the availability of gravel on this site, the storage pad was generally in good condition. It was located 1 km northeast of the main module and contained approximately 75 drums which contained alcohol, varsol, gear oil, lube oil and propylene glycol. Staining was noted on the storage pad in three distinct areas, each covering approximately 3 m². Ponds of water along the north edge of the storage pad had an oily sheen, and stressed vegetation was noted in the vicinity.

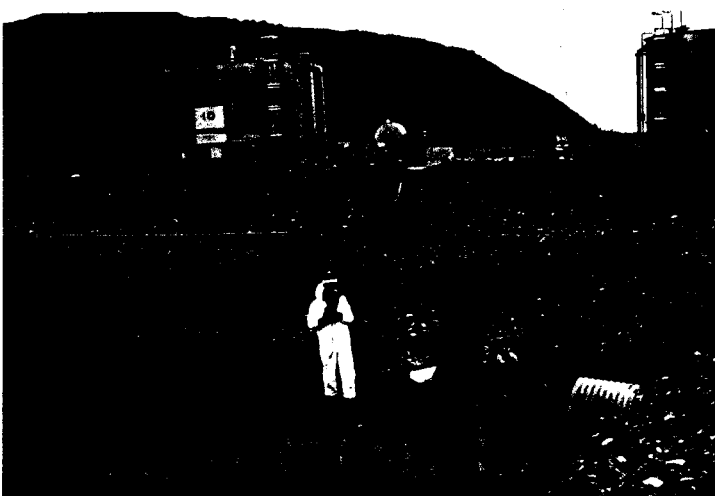
PLATE 6

WATER SAMPLING
NEAR BEACH POL TANK FACILITIES

The POL 2 storage facilities (two 295 m³ diesel) are located 600 m northeast of the airstrip, within 40 m of the shoreline (Plate 6). The shoreline in this area was characterized by a wide cobble beach, and a steep exposed slope which rose approximately 30 m to the elevation of inland areas. The storage pad and general area was situated on the beach approximately 5 m asl. Staining and odours were noted on a small area of the tank pad. Due to the coarse nature of the fill material on the pad, only two samples were taken. North and west of these facilities, extending to the beach, the material encountered consists of cobble-sized gravel. A small stream which drains the upper slopes of a ravine runs past these POL facilities.

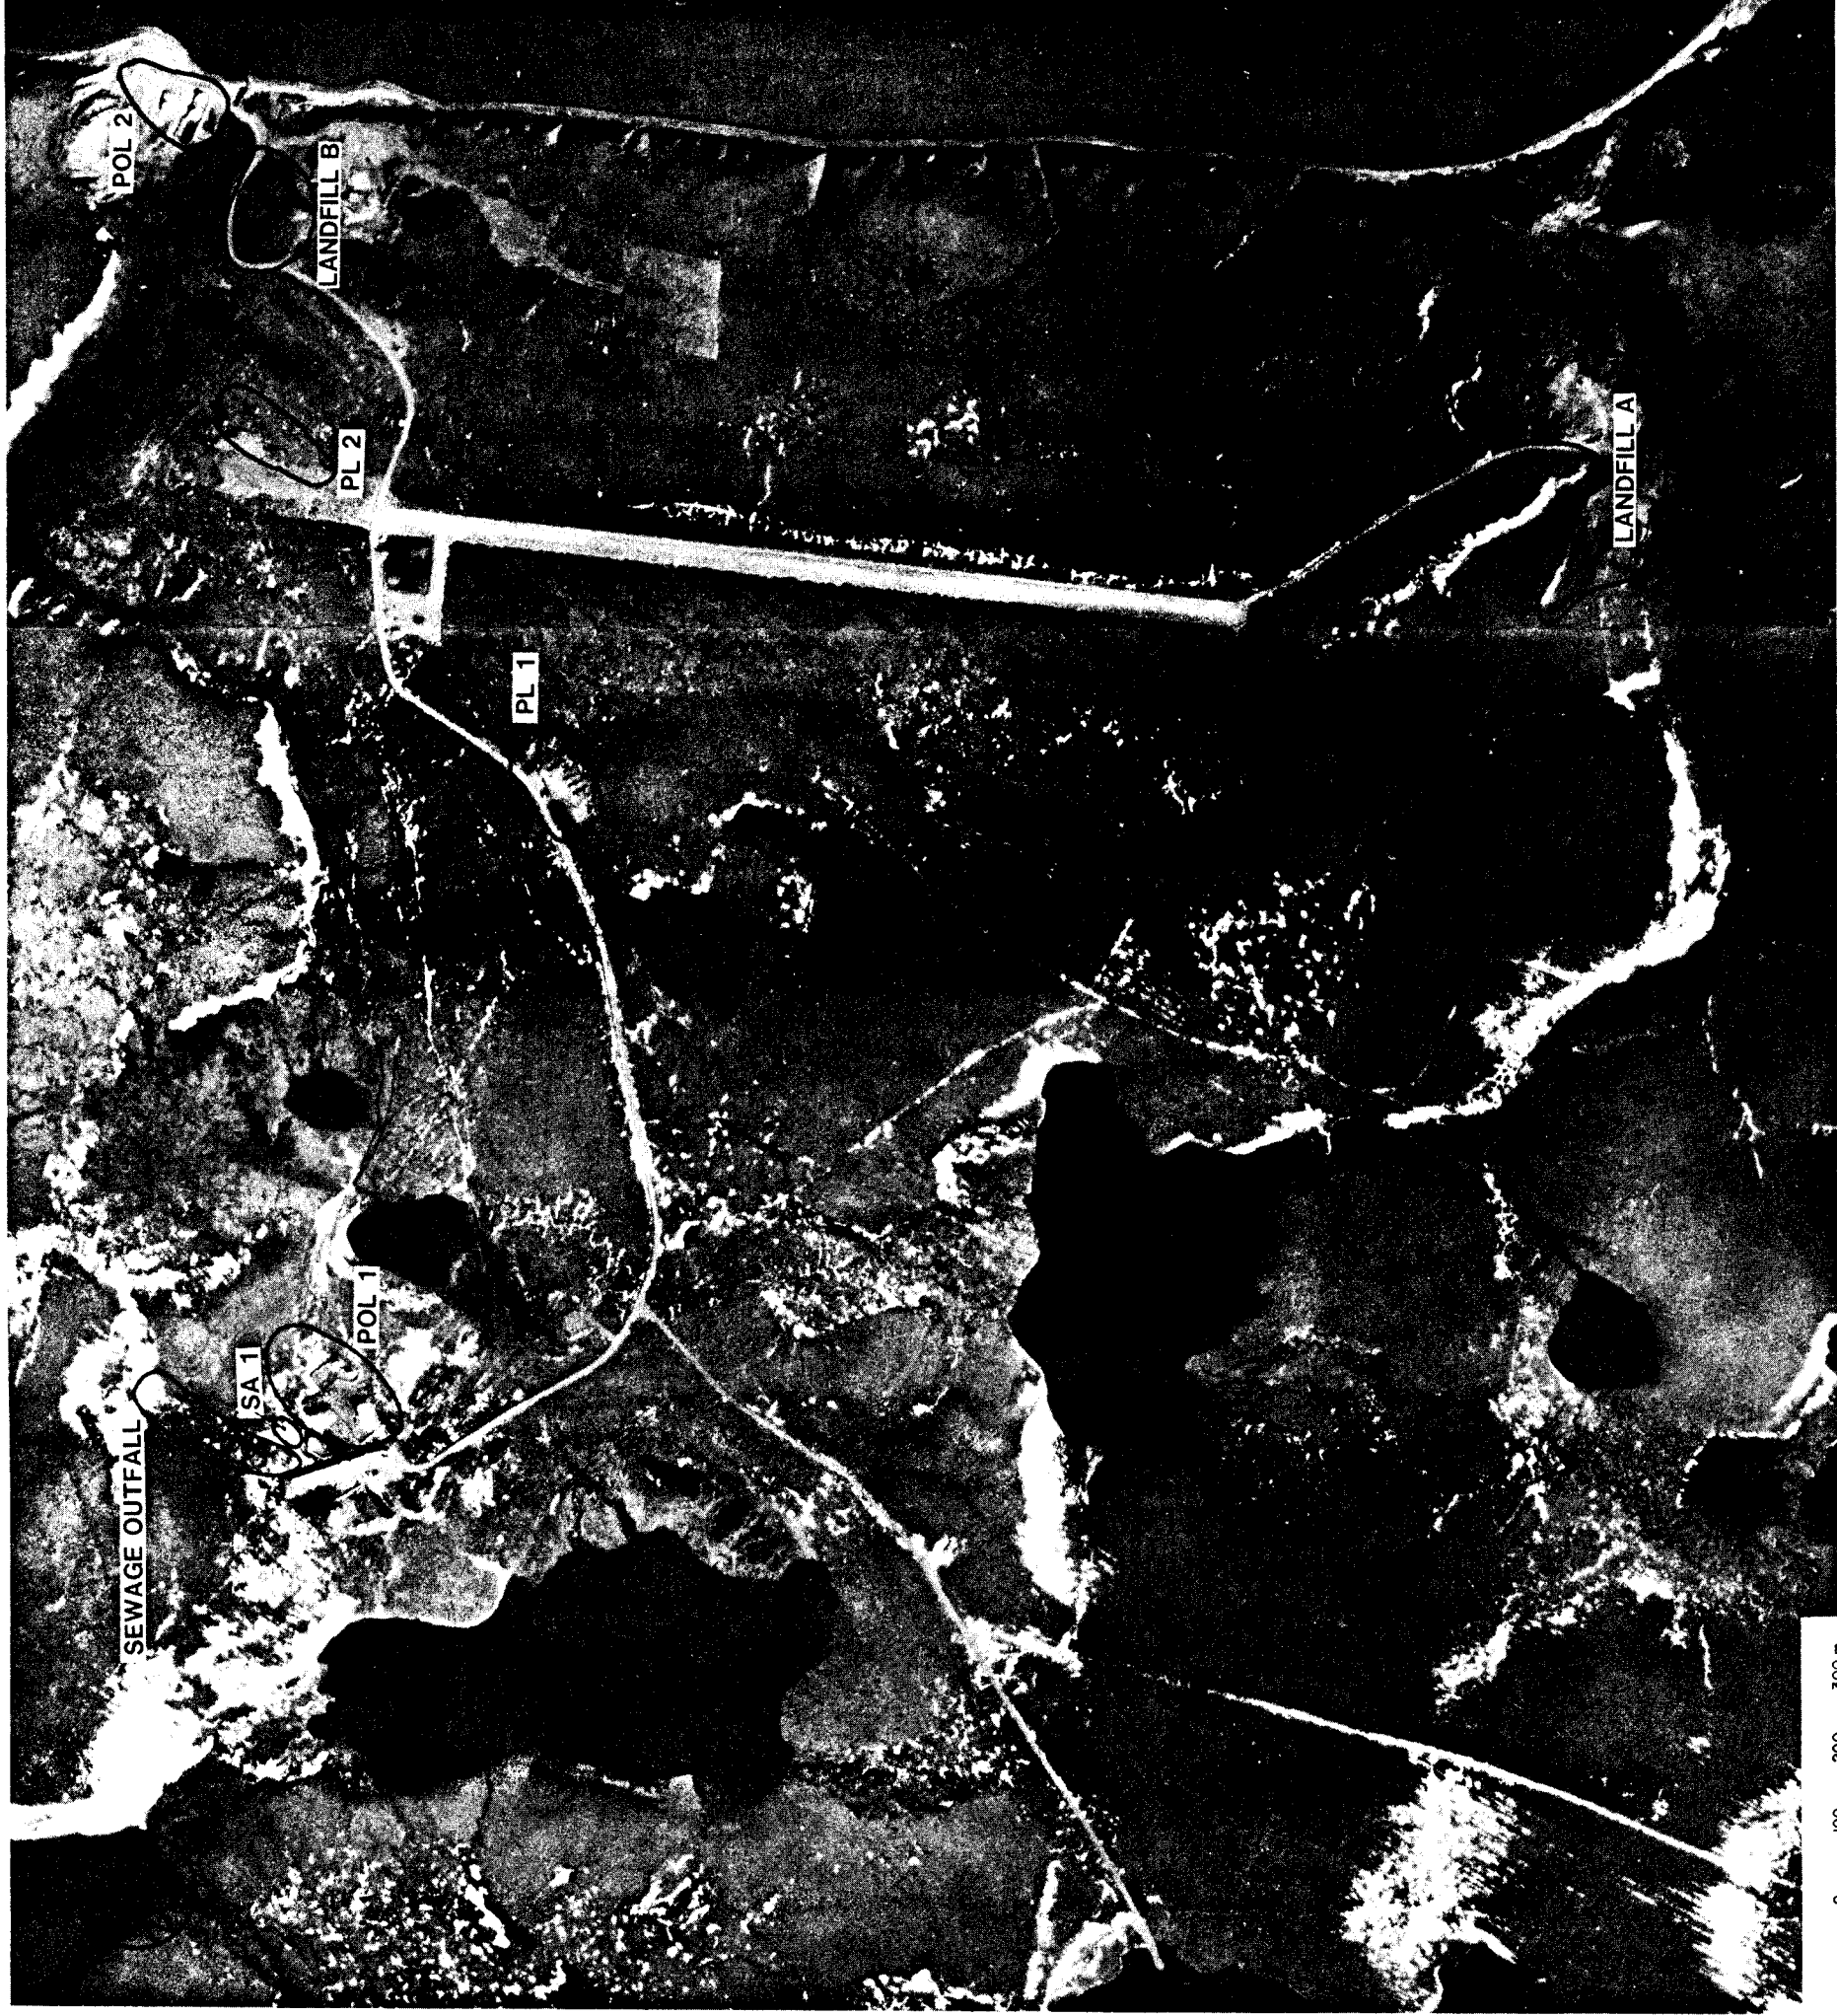
CONTAMINANT MAP

A summary of the significant soil contaminants found at BAR-2 is given in Table E-1. Each location shown in Figure E-1 is listed in this table if a significant soil contaminant concentration was found from the lab analysis. As may be seen, twelve contaminants were found in one or more locations and the number of contaminant concentrations found to be greater than the method detection limit (MDL) in any one location varied from 1 to 13. Four contaminants, barium, nickel, arsenic, and mercury were found generally throughout the site. PAHs included eleven different polynuclear aromatic hydrocarbons which were evaluated as a group. Silver was found in only one sample at a concentration less than MDL and was therefore not included in Table E.1.
