Quality in Environmental Services VENUS MINE TAILINGS

SITE REHABILITATION

CONSTRUCTION MANAGEMENT REPORT

December 1995
Amended January 1998

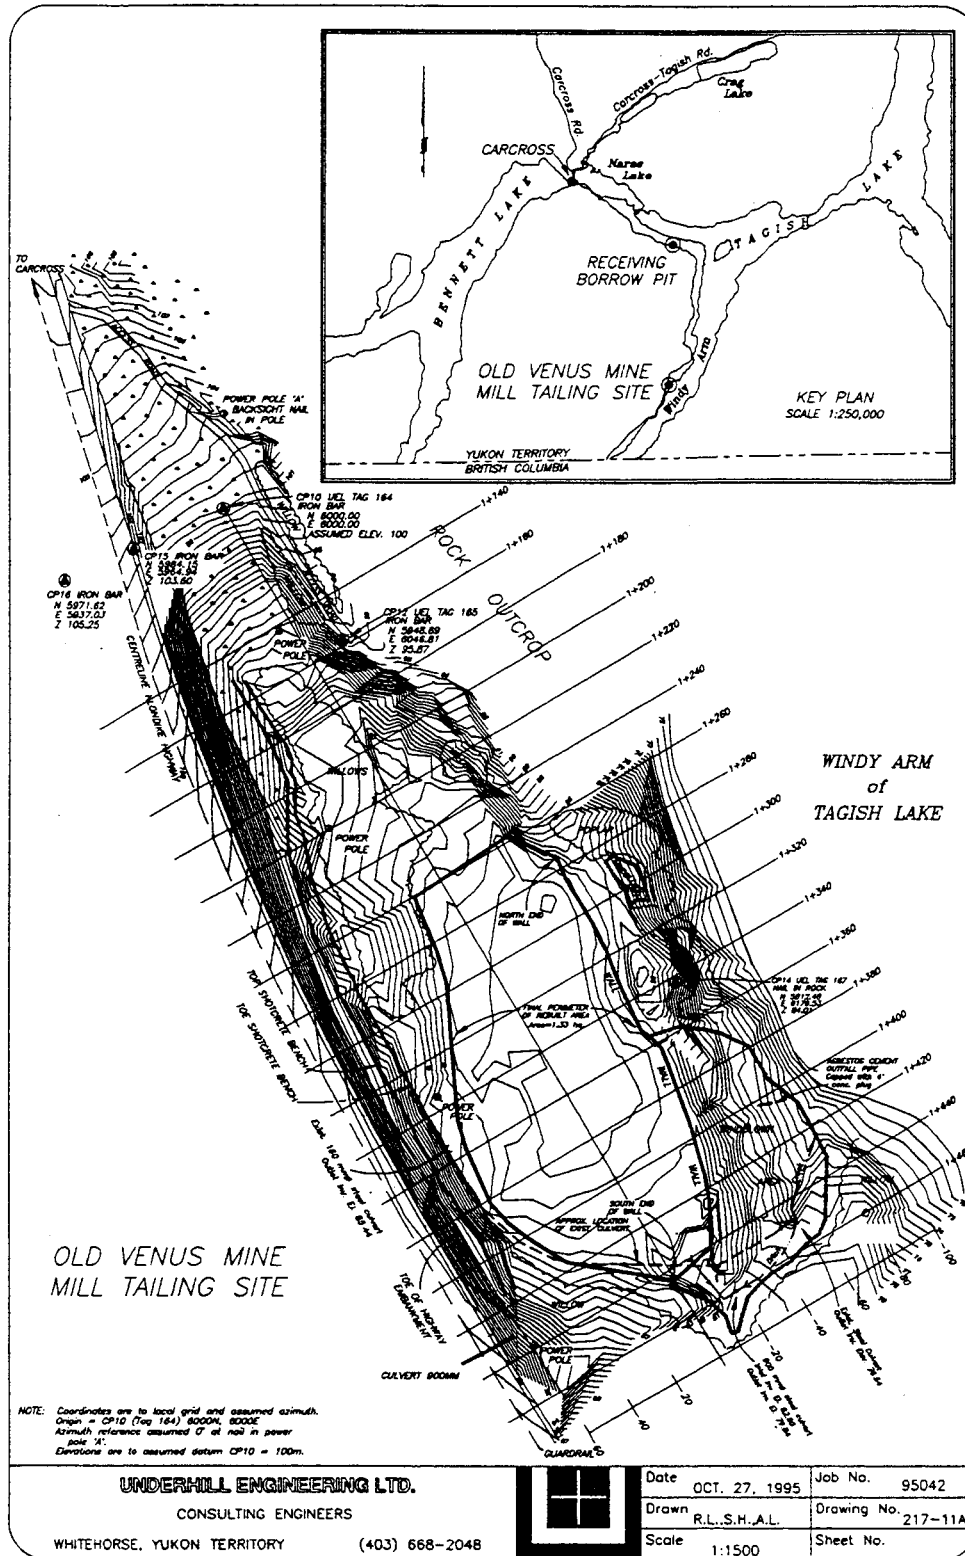
Diagram 1: Site Drawing

The design drawing show the Waterloo Barrier at the edge of the existing berm, leaving no work space on the east side of the wall. The wall location was therefore amended and offset inward by 5 m toward the tailings(see as-built drawings in Annex D). The second reason for altering the wall location was the shallow bedrock encountered near the outcrop at survey benchmark no. 166. Overburden was excavated at the west side of the outcrop during the levelling of the tailings. The ground elevation was lowered by approximately 2 m. A trench was dug at the intended location of the wall. The bedrock was found at a depth of 0.1 m to 0.5 m. Therefore, the wall was relocated farther around the outcrop to enable a deeper section of the wall to be installed, making it more stable (see annex D for details).

The PWGSC drawings indicate the design location of the Waterloo Barrier wall. However, circumstances dictated a slight offsetting from its intended location. The wall varied from the design for two reasons: lack of staging area for the installation equipment and shallow bedrock profile. The first reason for modifying the wall location was that the installation crew required a 5 m wide working area on both side of the wall for their heavy equipment.

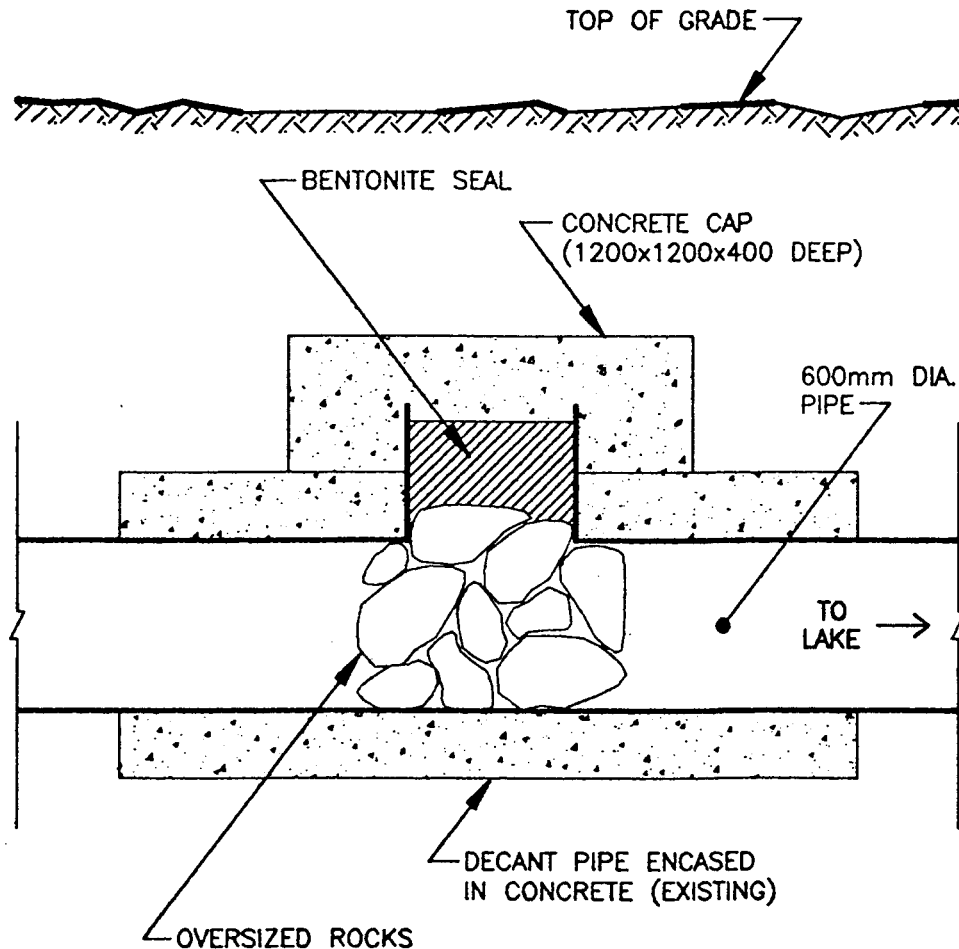
Diagram 2: Details of Decant Pipe Plug at Inlet

Also included under this item of the contract, a low permeability plug was constructed at the inlet and outlet of the asbestos cement decant pipe. The inlet was plugged with bentonite clay and capped with concrete as shown in Diagram no. 2. This work was performed on August 29th and 30th.

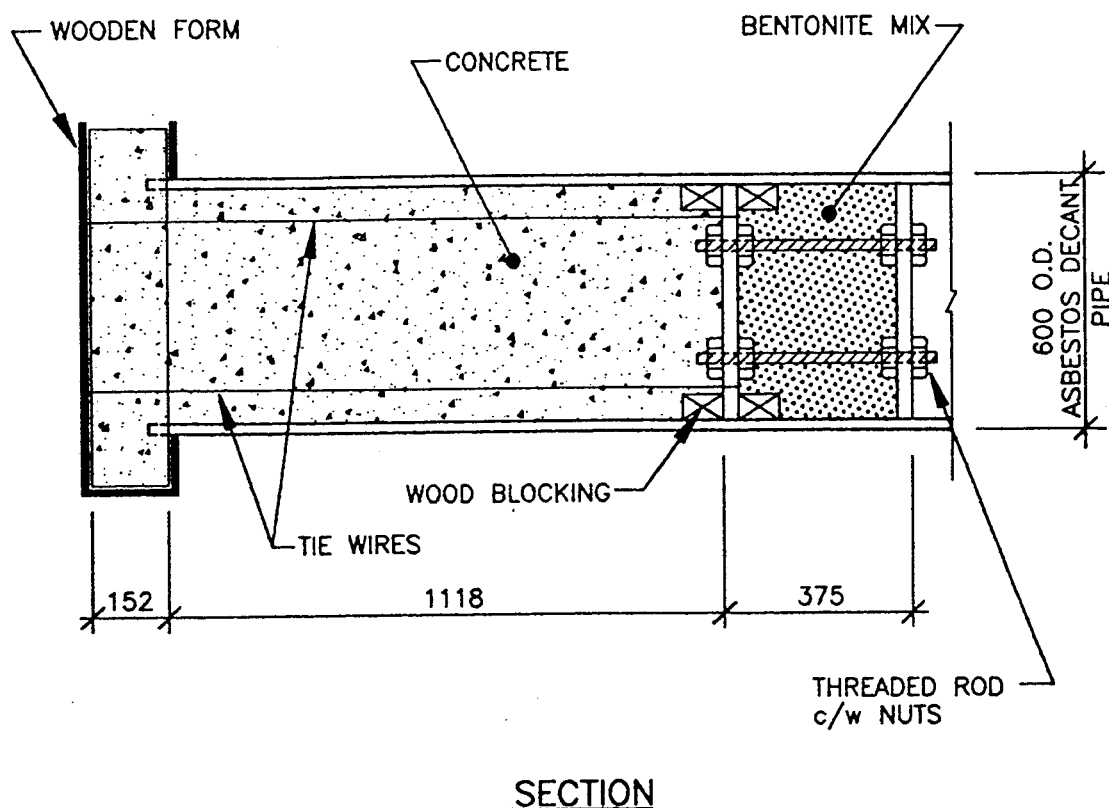
Diagram 3: Detail of Decant Pipe Plug at Outlet

A concrete plug was also constructed at the outlet of the asbestos cement pipe at the lake shore. Three 12' asbestos pipe sections were removed at the outlet. A plug was constructed consisting of a 1.2 m concrete plug and a bentonite plug of 375 mm thick (see Diagram no.4 for details).

The work involved building circular wooden forms and placing them into the asbestos pipe. The concrete was poured on Saturday, October 14. Due to cool nights in October, a torch and a tarp were installed to maintain a warm environment for the curing process. On the following Monday, the bentonite plug was poured from the top of the asbestos pipe. J.R.Paine and Associates recommended using a 1:1:1 mix of PUREGOLD bentonite chips, X-tra Gel high yield bentonite and portland cement.

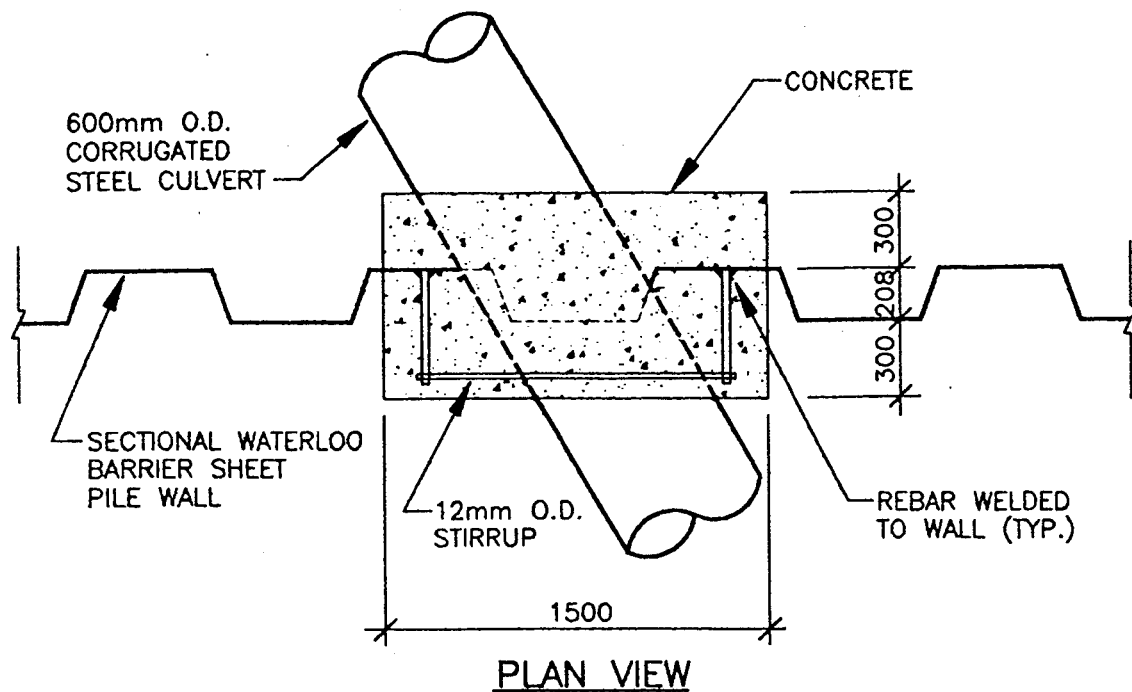
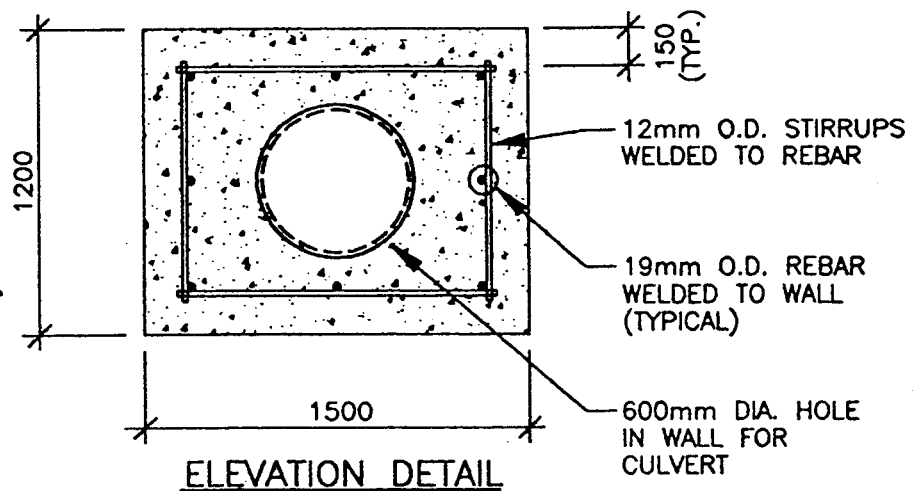
Diagram no.4: Highway Culvert/Waterloo Barrier Intersection

The work involved replacing a section of highway culvert located along the temporary drainage ditch and at the Waterloo Barrier. The culvert section located below the temporary ditch was damaged during the excavation and a 2 m section needed replacement. The YTG crew from Carcross were on site to perform these repairs. During the installation of the Waterloo Barrier, the sheet piles damaged the Highway culvert. Both sides of the Waterloo Barrier were excavated to a depth of approximately 5 m exposing the culvert. Approximately 5 m of culvert were removed from both side of the wall. A hole was cut into the wall in order to place the new section of culvert. The hole was cut as small as possible and a concrete plug was poured on both side to seal the Waterloo Barrier/wall intersection. The design for this plug was reviewed and approved by the Waterloo Barrier installer, C3 Environmental Ltd. The details are shown in Diagram no.4 on page no. 16. The excavation was then backfilled with tailings and native clay. The labour, equipment and materials costs claimed and approved for this additional work was \$12,000. This extra cost is claimed under Progress Claim no.3

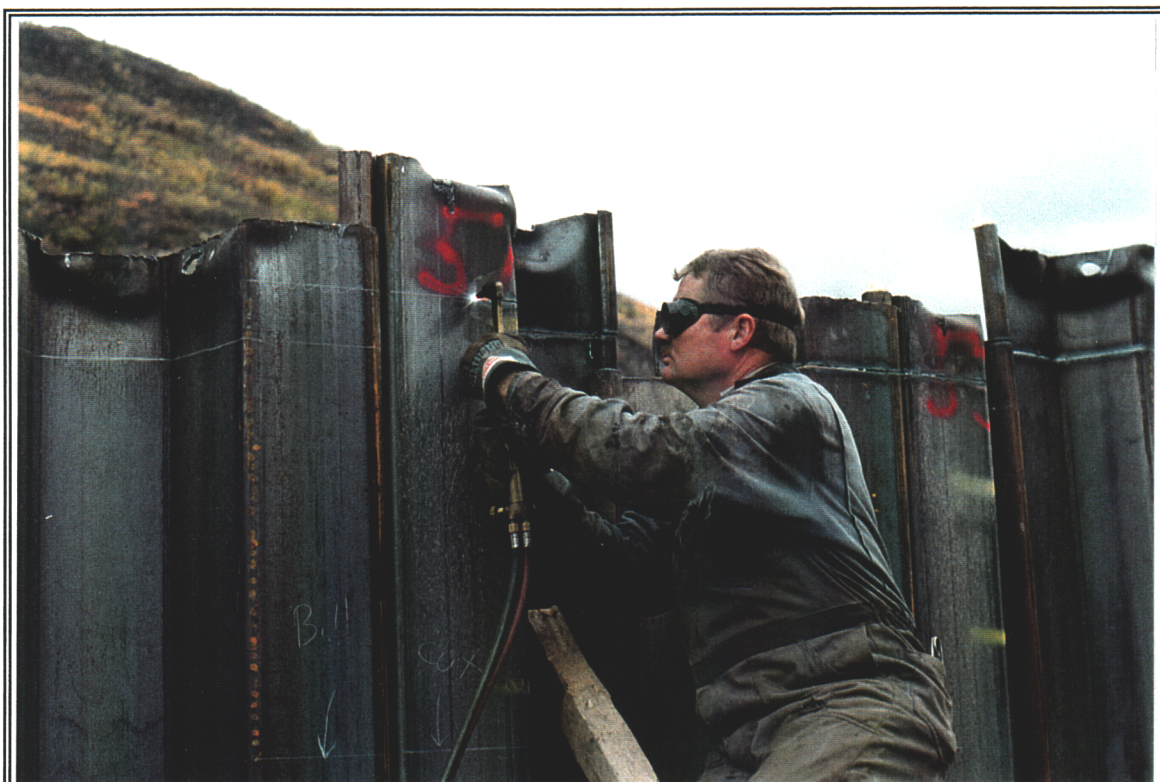
Photo 3: Welder Cutting Top of Wall to Design Elevation
8 September 1995

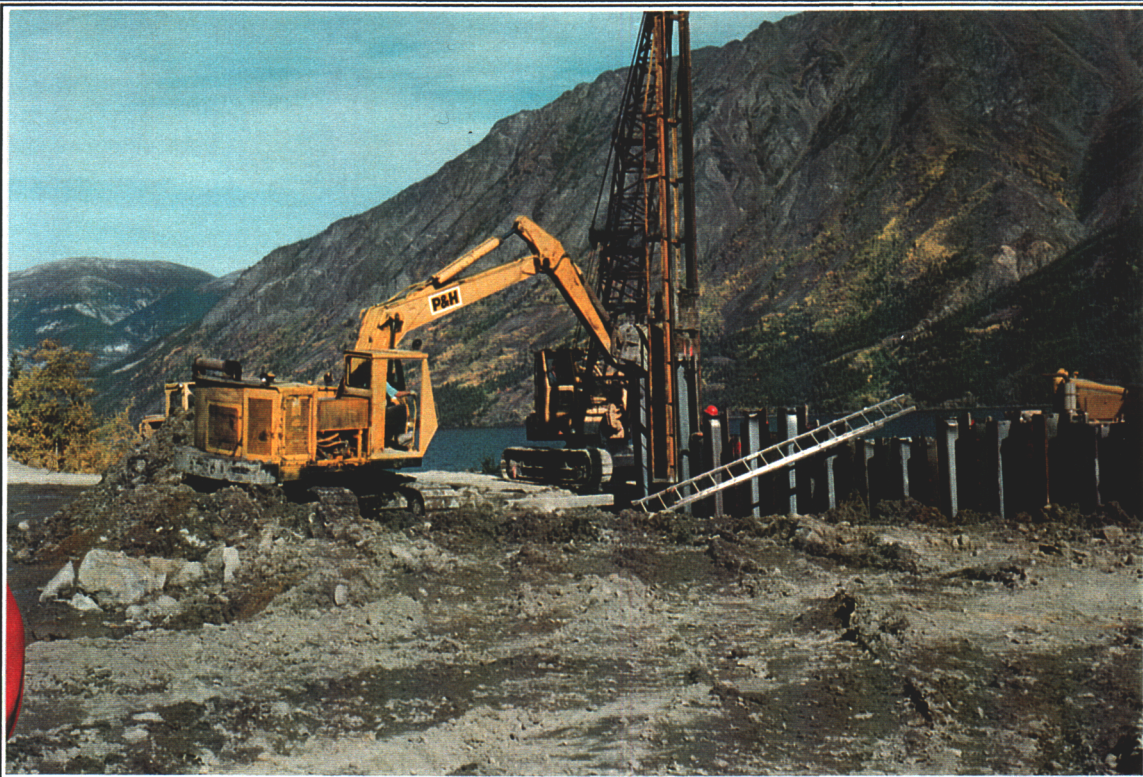
Photo 1: Waterloo Barrier Installation
5 September 1995

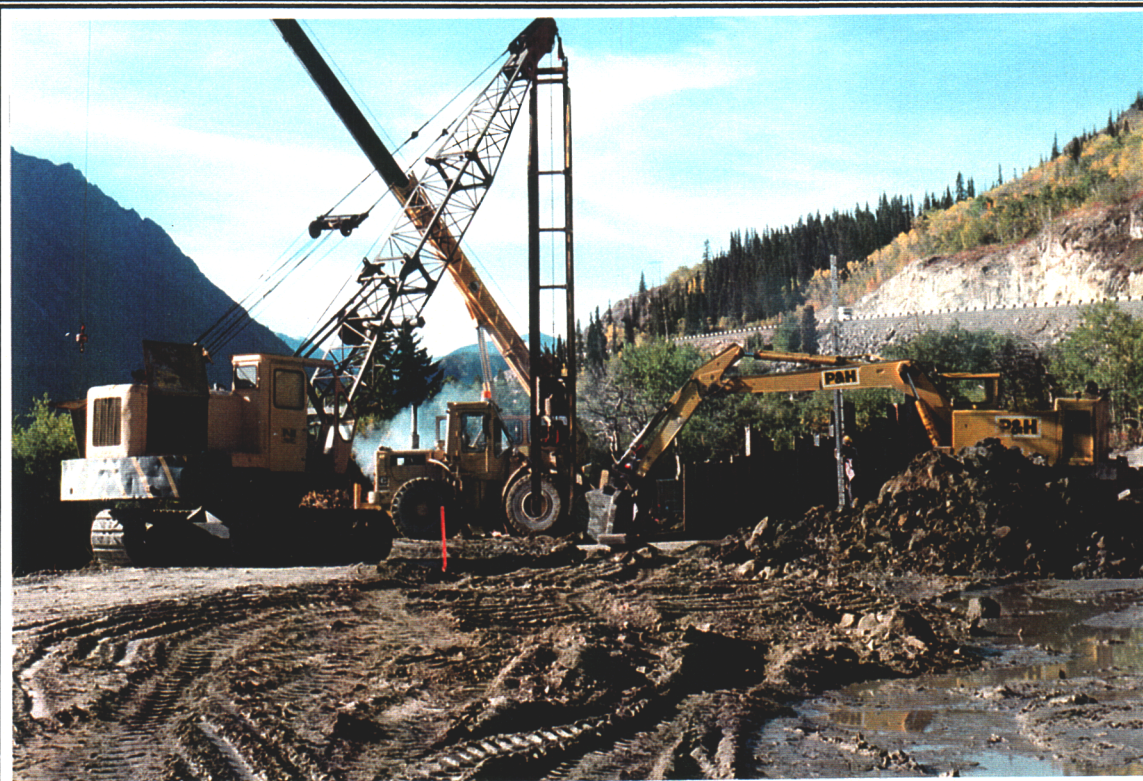
Photo 2: Waterloo Barrier Installation
5 September 1995

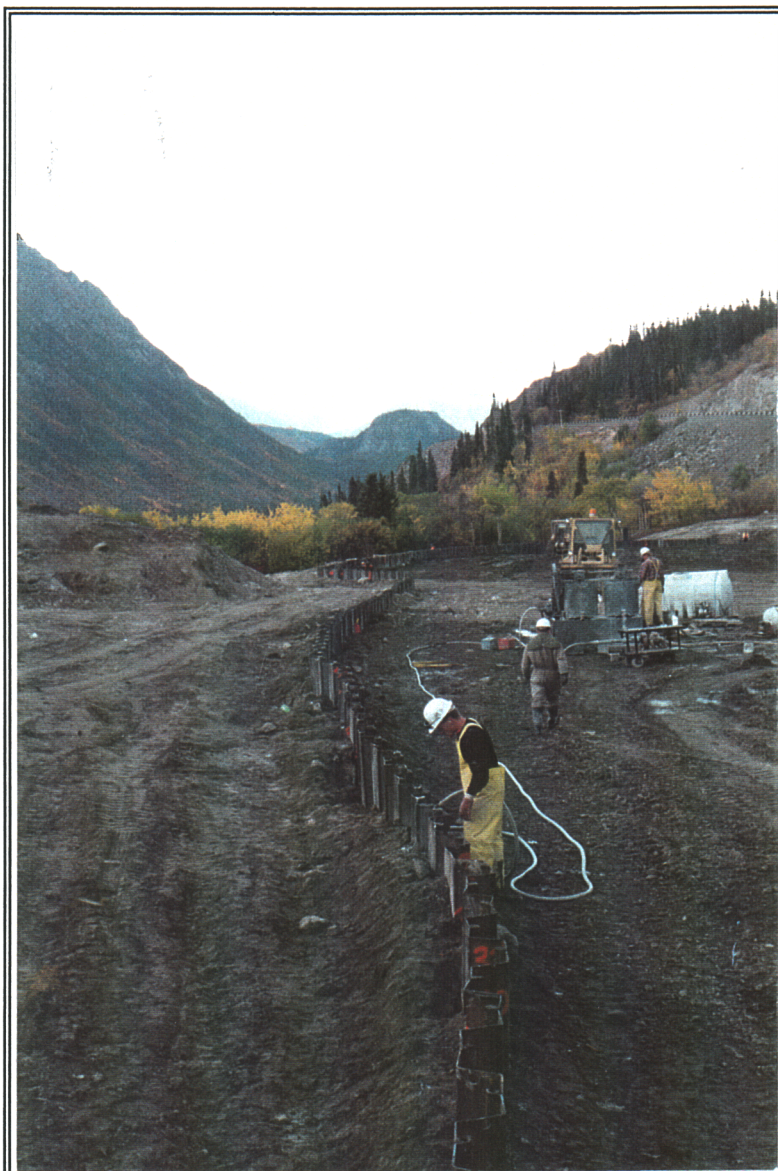
Photo 4: Sealing Wall Joints
18 September, 1995

The sheet pile joints are sealed with silica fume modified, thiotropic cementitious based grout WBS Type 301. The process of grouting begins by a "flushing stage". Flushing involves lowering a high water pressure hose into the wall joints and flushing accumulated soil. At the same time, the joint is checked for depth which indicates the condition of the sheet pile wall. Quality control of the cementitious grout was also ongoing.

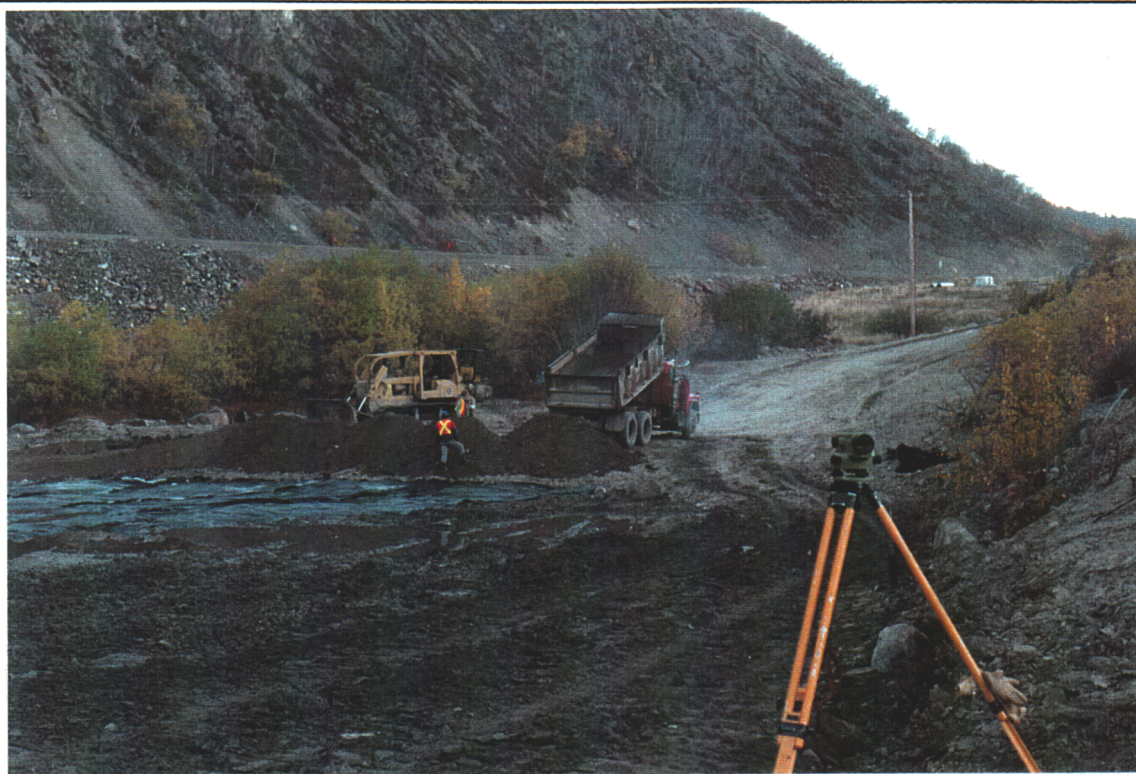
Photo 5: Hauling and Placing of Clay Cap Material
19 September 1995

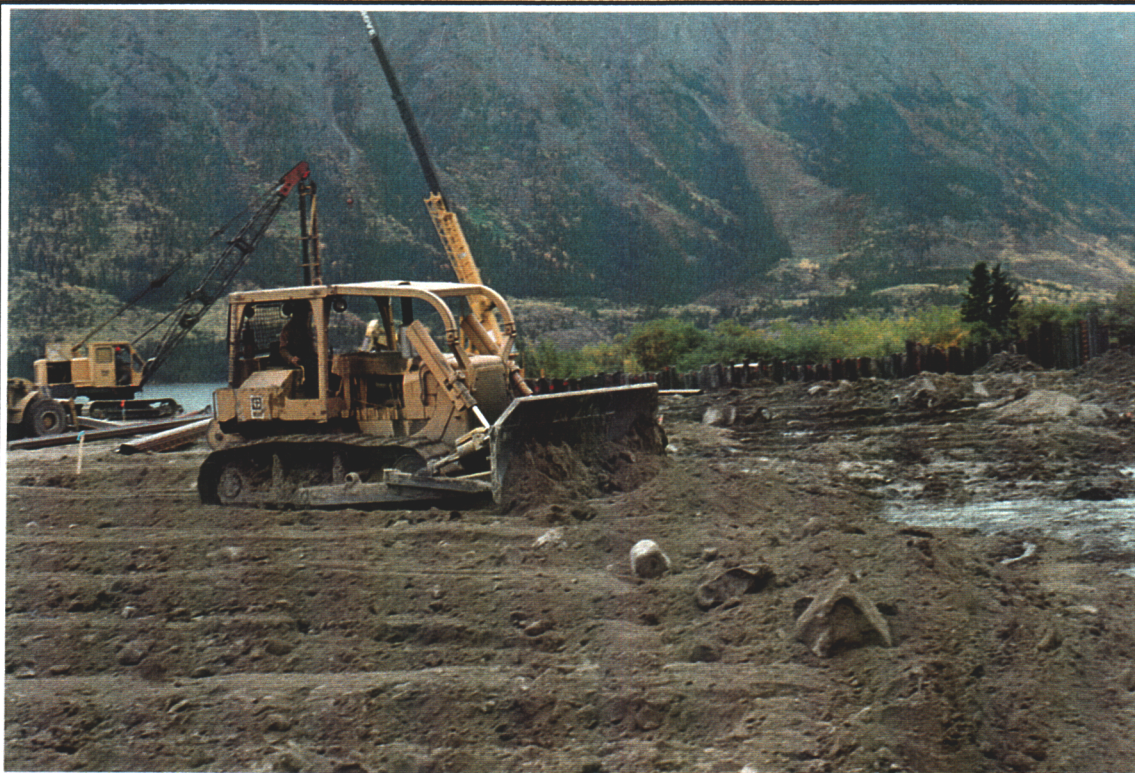
Photo 6: Placing Clay Layer above Geotextile
2 October 1995

The materials arrived on site on September 8. On September 18, the hauling and placing of the clay material commenced, hence, the geotextile was placed concurrently. The cloth was overlapped by 24" in areas where the tailings was very soft. A 12" overlap was used in areas of stable tailings. The entire levelled tailings pond was covered with the textile and overlaid by the silty cap. Additional textile was placed to cover a 3000 sq.m. area at the west edge of the tailings. Due to extremely saturated and unstable conditions, the textile may have been damaged when the clay was placed. Approximately 25 rolls of geotextile were placed below the clay and an additional 5 rolls to cover the 3000 sq.m. of wet clay.

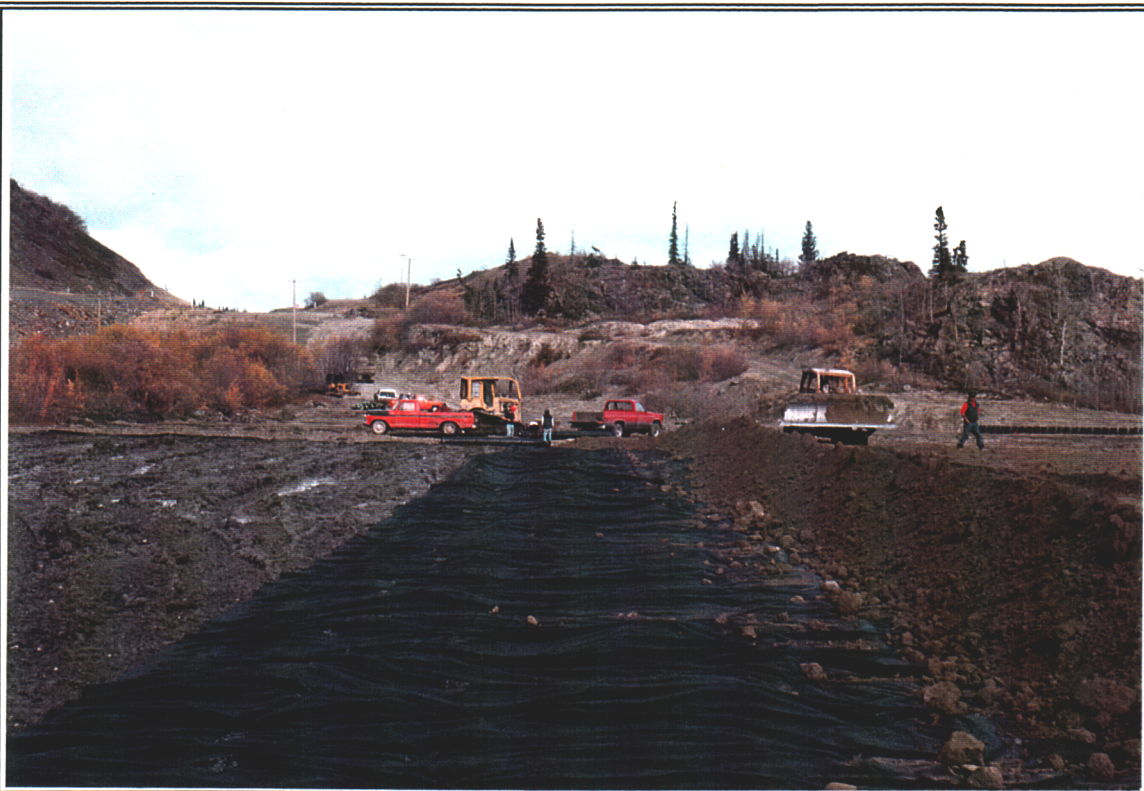
Photo 7: Placing Wind Blown Tailings onto Tailings Area.
7 September 1995

The dry condition of the wind blown tailings also assisted greatly in the levelling of the tailings: dry material placed above wet tailings made it easier for the levelling process. Once the 1120 cu.m. were relocated, a mass-balance calculation was conducted by Underhill. The results of this calculation indicated that an additional 1400 cu.m. was required to bring the level of the tailings to the design elevation of 82.5 m. This estimated volume did not account for consolidation and would most likely be in the order of 1600 cu.m. after consolidation and settlement. To avoid cost overruns for this item, the final elevation of the tailings was lowered from 82.50 m to 82.35 m (thus requiring no additional material to be hauled).

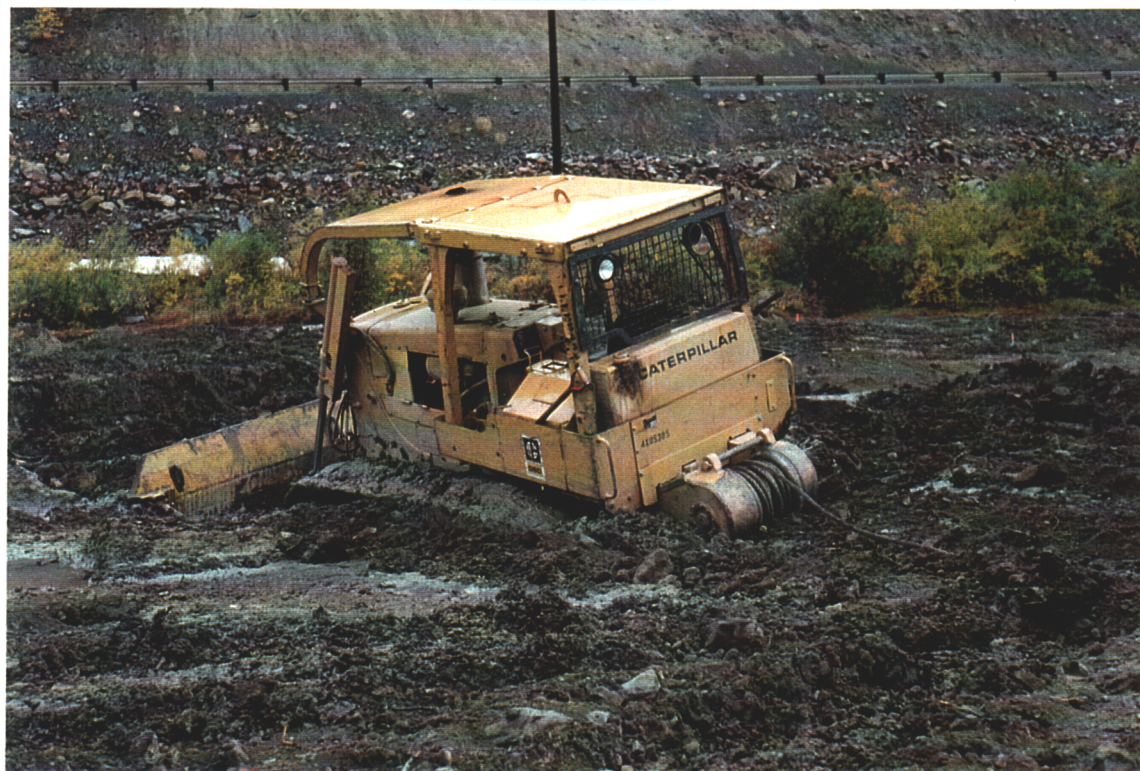
Photo 8: Difficulties during the Levelling of the Tailings
9 September 1995

To achieve 82.35 m across the entire site, excessive handling of the tailings pond material was required. Through capillary forces, the pore water migrated upward. The top 500 mm layer of tailings quickly exceeded its liquid limit and became unstable and unworkable. Several attempts were made to let the tailings dry before resuming the levelling process. However, only a few passes were necessary before the D4 LGP dozer would get stuck. Levelling proceeded very slowly due to these saturated conditions. Consequently, the contractor tried a different approach. He placed the D6 dozer at the perimeter on stable ground and tied the winch cable to the back of the D4 LGP dozer. The D4 would crawl across the saturated tailings pulling the D6D's winch cable. Once he was far enough and almost stuck, the D4 LGP would get winched out as it backbladed. The D4 LGP would once again venture into the saturated tailings and get pulled out by the D6D and so on. This "Yo-Yo" method was much more effective for relocating saturated soil.

Finally, the saturated tailings final grade was achieved at 82.35 m. However, the moisture content was so high (exceeding the liquid limit), that the contractor was unable to place the textile and the clay without creating deep ruts with the dozer and damaging the geotextile material in the process. After covering the north half of the tailings pond, it became evident that a solid base would be required in order to properly place the geotextile and the clay. Several attempts were made to allow the tailings to dry and the pore water to settle. However, when the tailings appeared dry and stable, only a few passes with the dozer was required before saturated and unstable conditions would return. This meant that additional dry soil would be required, hence, the tailings final grade was reset to 82.5 m. The least expensive and most readily available dry material was located at the wind blown tailings area.

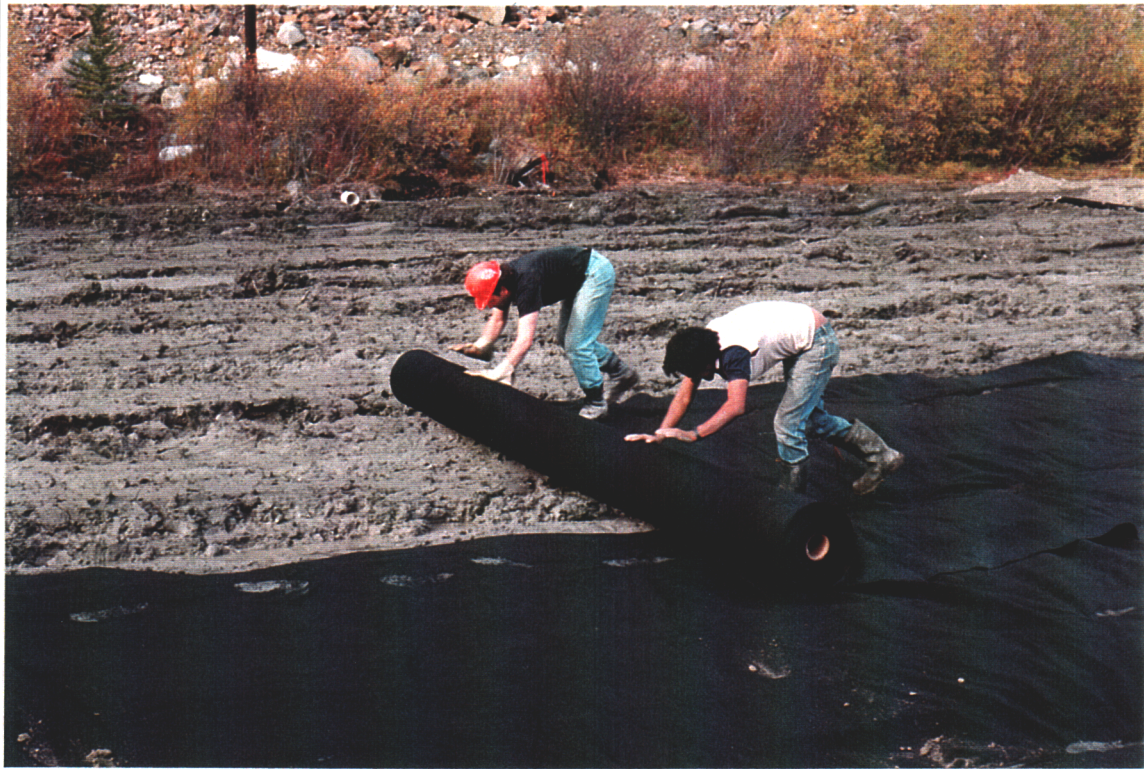
Photo 9: Labourer Placing Geotextile
2 October 1995

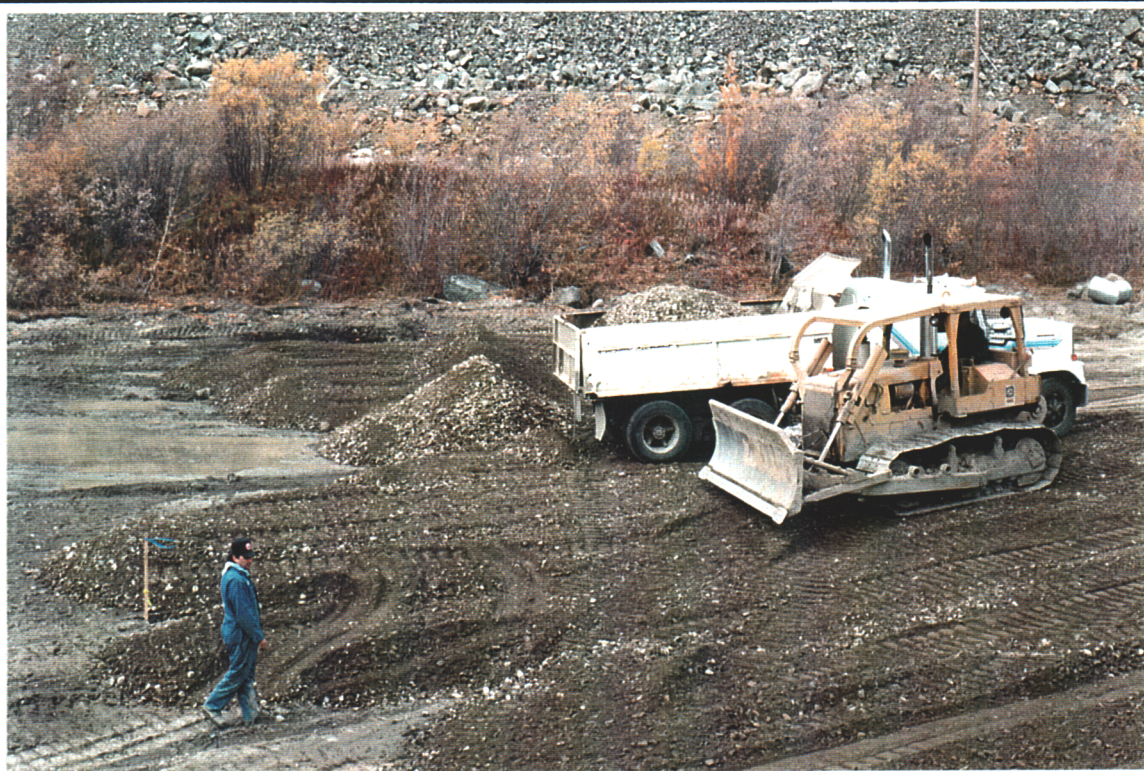
Photo 10: Hauling and Placing of Capillary Break Material
11 October 1995

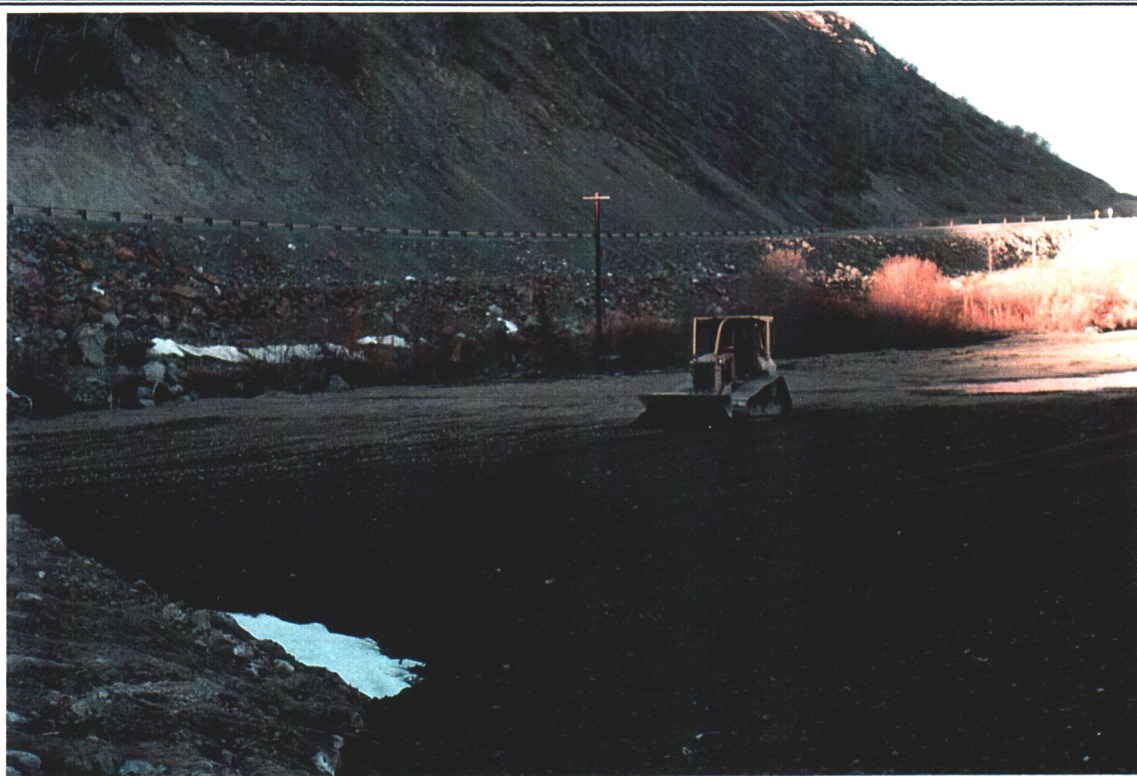
Photo 11: Final Levelling of the Capillary Break Material
17 October 1995

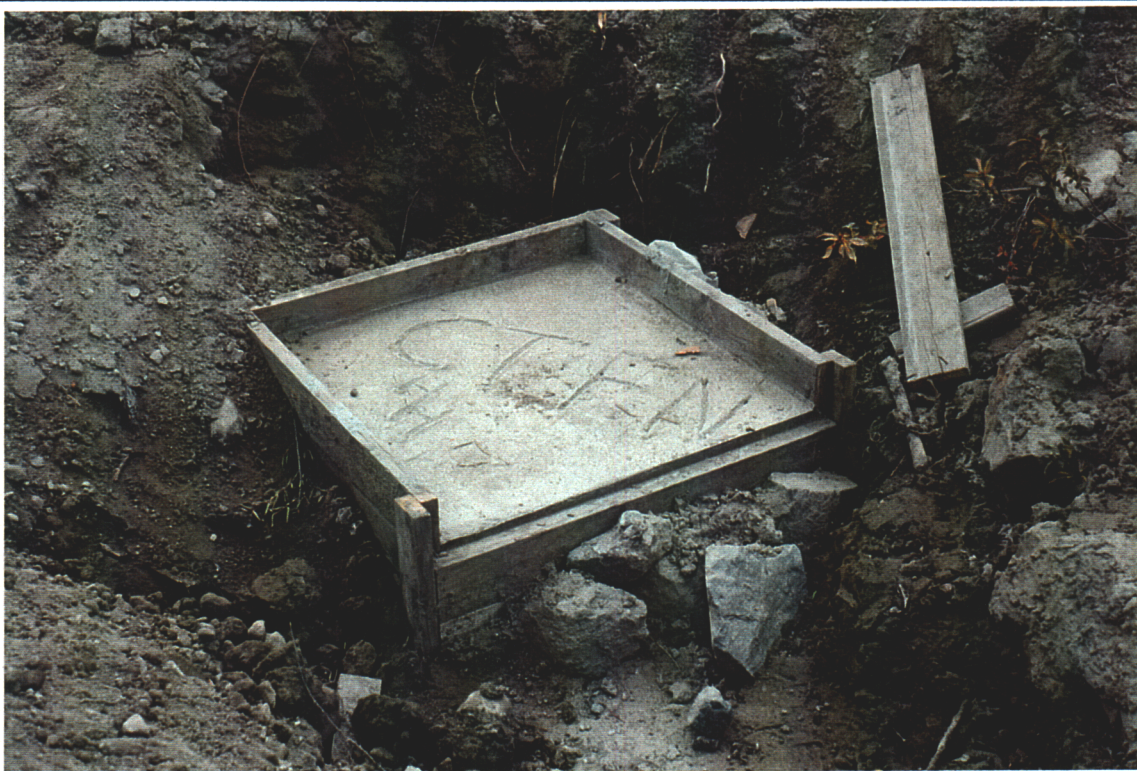
Photo 12: Concrete Plug at Inlet of Decant Pipe
8 September 1995

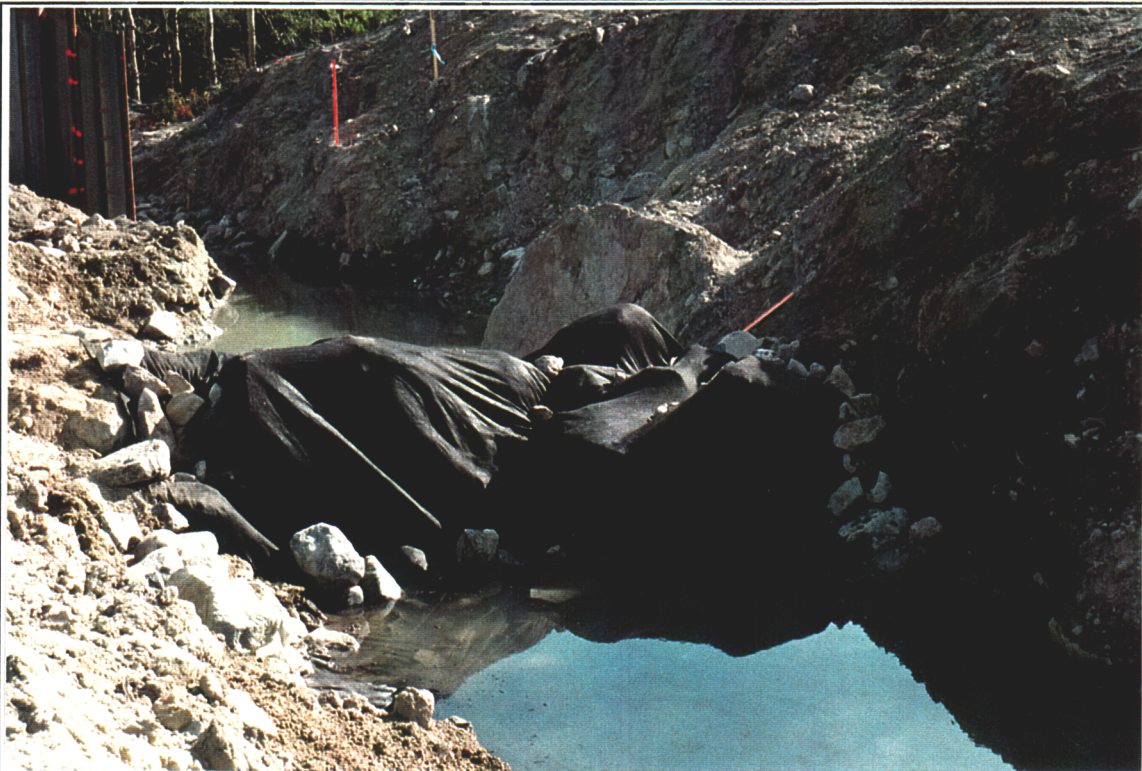
Photo 13: Filter Dike in Temporary Drainage Ditch
5 September 1995

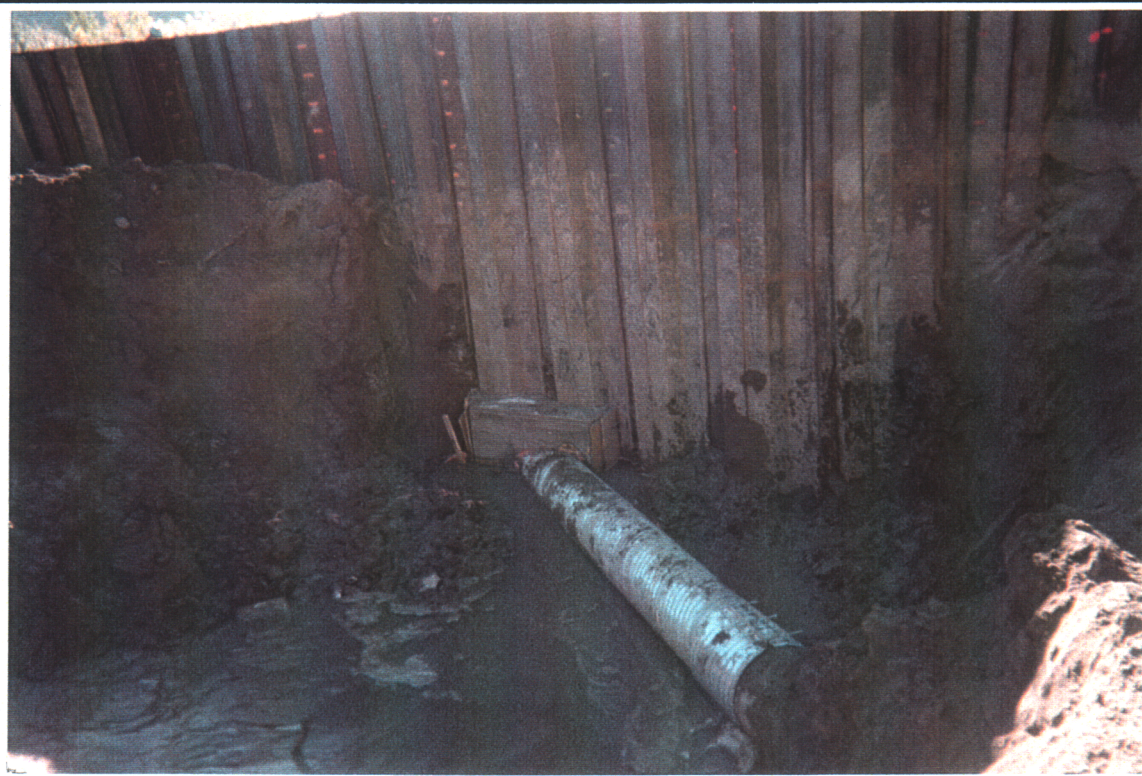
Photo 14: Highway Culvert Repair
17 September 1995

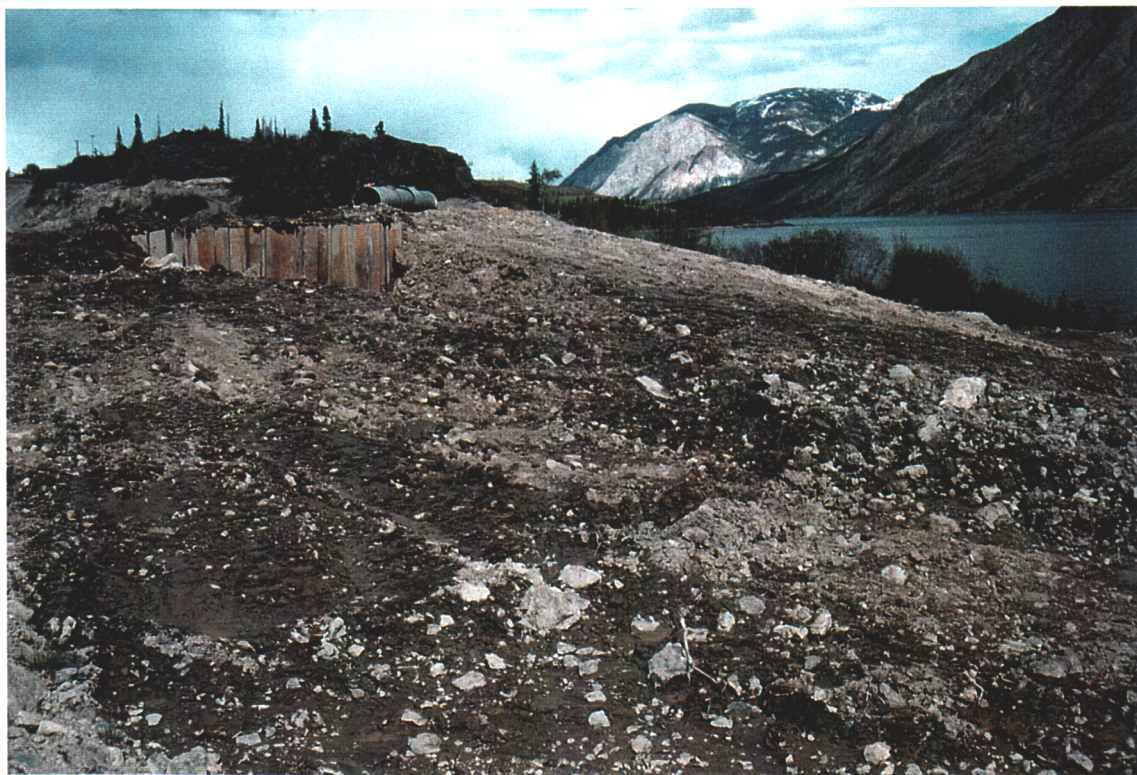
Photo 21: Depressions at South Wall requiring Additional Material

It was planned to haul in an additional 10 loads of waste crushed gravel to fill in a void at the location outside the wall where excavation had taken place. The initial attempt to haul gravel was a failure as the loaded truck got stuck before it could dump its load. Further attempts at hauling were suspended to prevent damage to the tailings cap. As a result there remains a void at the south end of the wall. Should further attempts be made to fill in this void, they should be undertaken only under winter conditions.

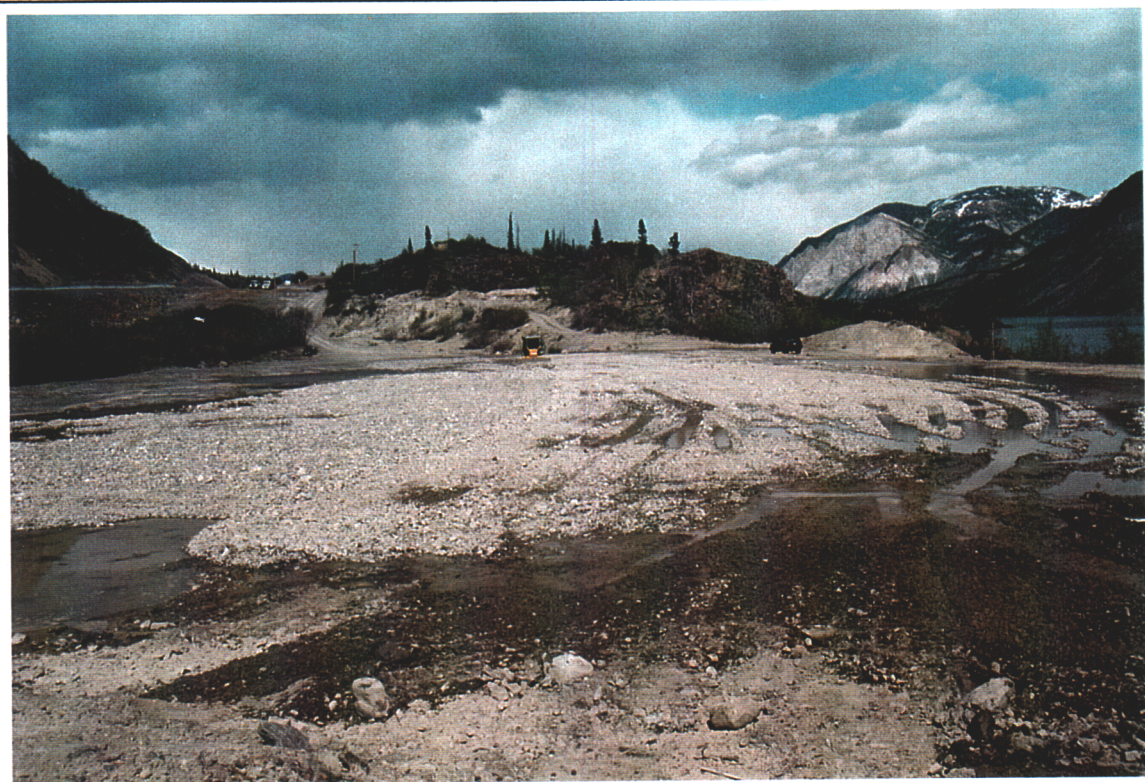
Photo 23: Coarse Material placed in December, 1996

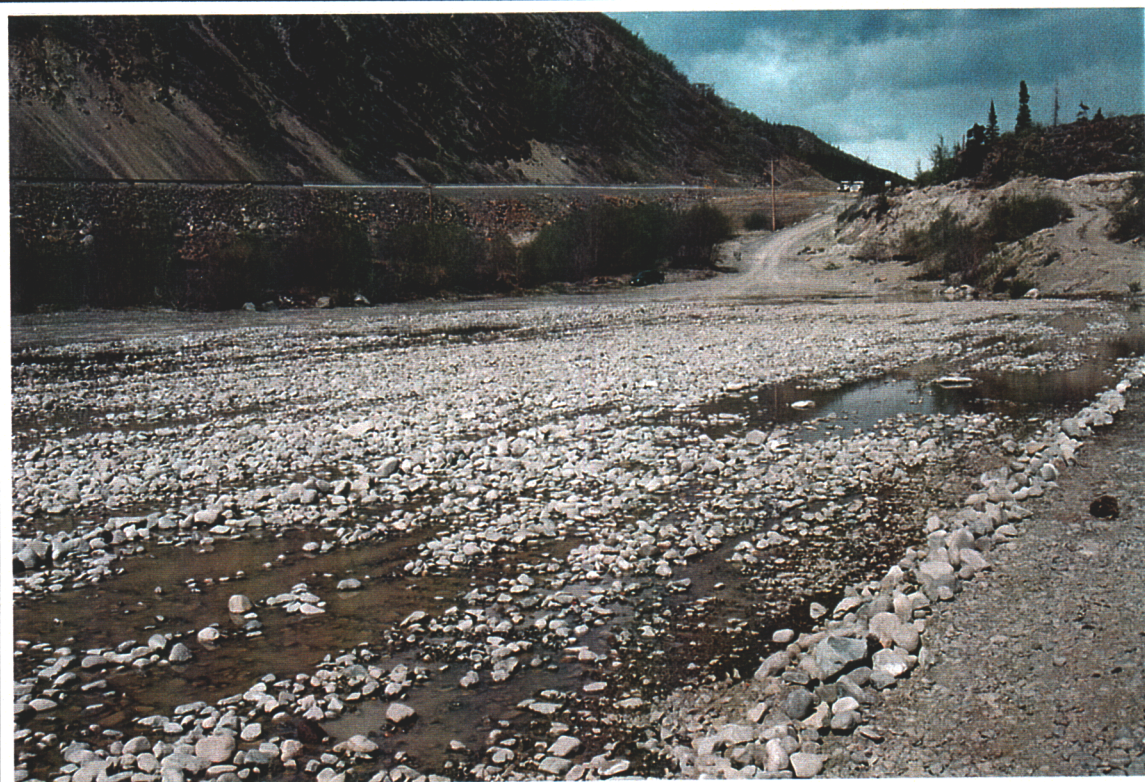
Photo 24: Coarse Material regraded. Final Appearance May, 1997
