SNAG AIRSTRIP REMEDIATION/FOLLOW-UP

Snag, Yukon

March, 1999
File: YT20501/281-004.02

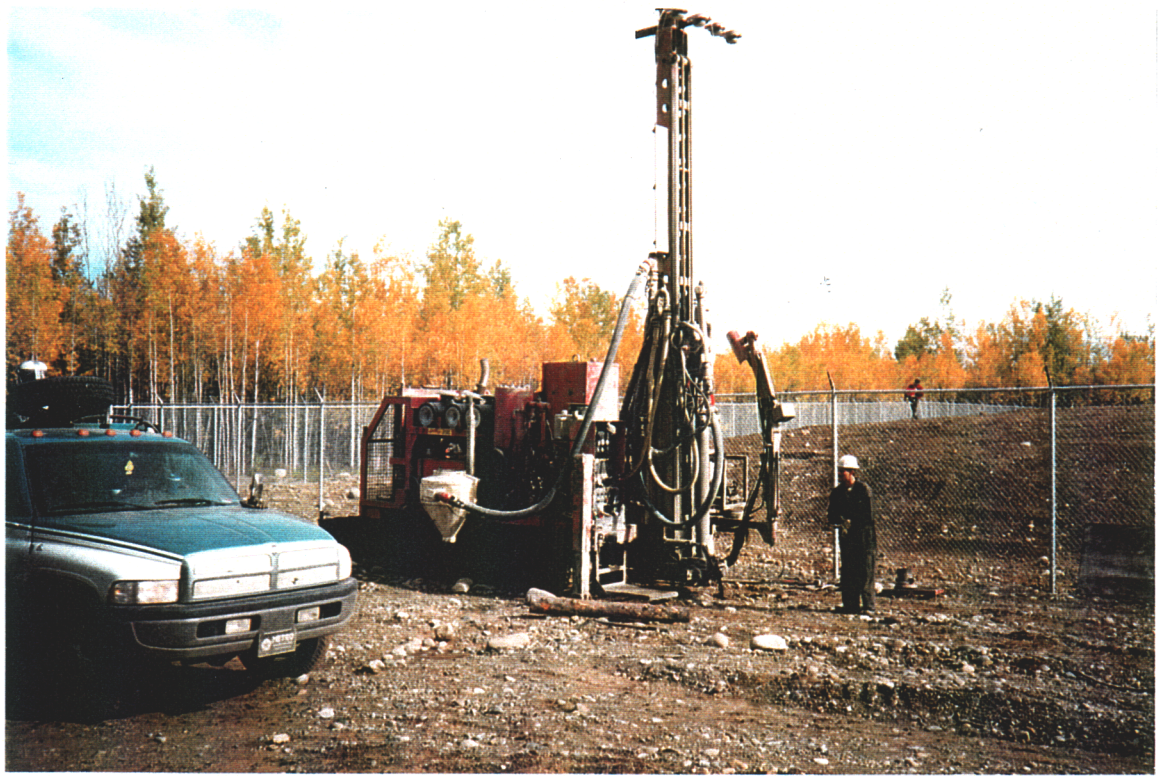
PHOTO 1: Air Rotary Drill.

In September of 1997, an air rotary drill rig from Midnight Sun Drilling was mobilized to the site (Photo 1). Drill holes were advanced to the groundwater table on the four sides of the containment cell using the percussive action of an air hammer drill bit and monitoring wells were installed (monitoring wells H97-4, H97-5A, H97-6 and H97-7). Monitoring well H97-5 had to be re-drilled as the hole was lost during the installation due to bentonite falling into the standpipe. It was re-drilled 1 metre away and designated H97-5A. The standpipe for H97-5 was cut to ground level and backfilled. The cuttings were brought to surface using compressed air. Visual logging of the cuttings allowed for an assessment of the stratigraphy as well as the depth of the water table. No soil samples were submitted for analysis.

Note: Seeding taking place in background, using manual broadcast seeder.

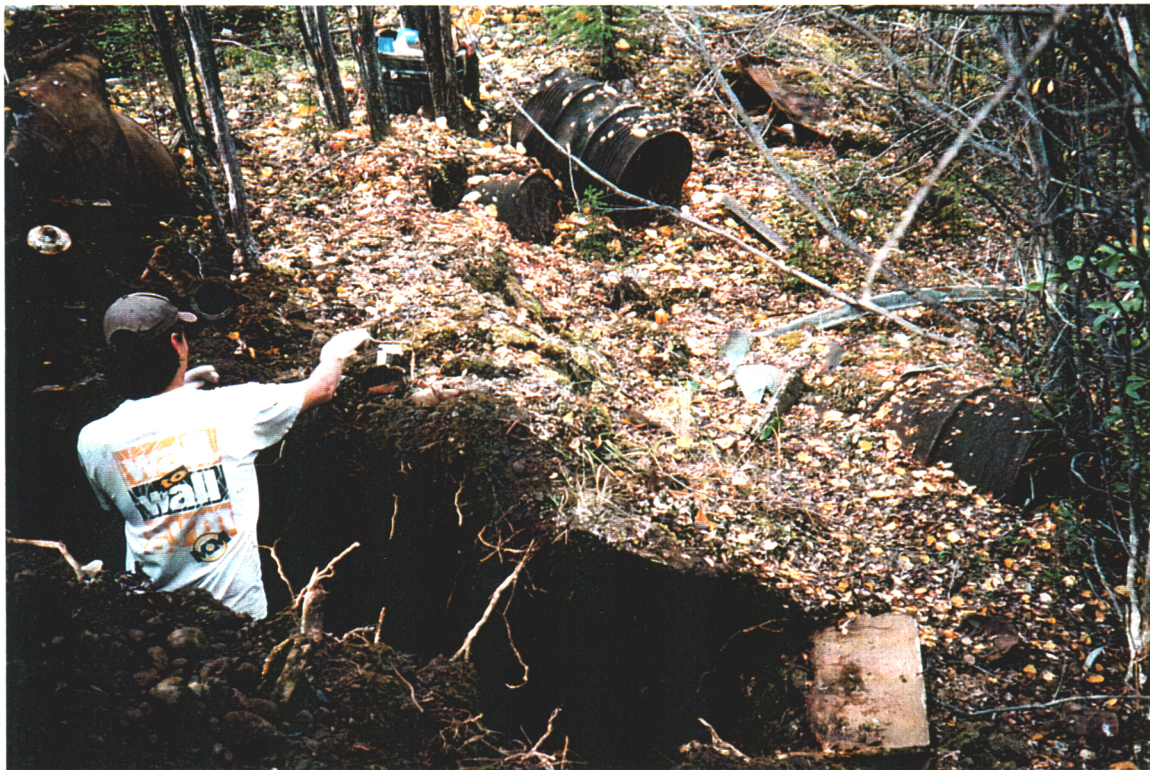
PHOTO 3: Drums & Other Metallic Debris Stewn Around Landfill.

The stratigraphy in the vicinity of the new landfill consisted of either sand and gravel, with cobbles to 0.18 m diameter, or landfill material over a clayey silty permafrost bearing soil (Photos 3 and 4). The sand and gravel soil was found in test pits located near the top of or above the landfill. The landfill material was likely characteristic of the activities taking place at the Snag airstrip. It consisted of cans, bottles, car and machinery parts, drums, pipes, lumber, clothing, tires, chains and wire, among other things.

The analysis for the concentrations of metals in soil samples collected around the new landfill has indicated that concentrations of chromium, copper, lead, tin and zinc exceed either the CCME₉₁ or the CCME₉₇ criteria for residential/park land use in some of the samples. This is not entirely unexpected given the presence of metallic debris in the landfill (Photo 4). The risk of exposure from these metals is slight given the location of the landfill. One of the soil samples had concentrations of various PAHs in excess of the CCME₉₁, CCME₉₇ and YCSR criteria. During the excavation of the test pits, liquid hydrocarbons or extensive hydrocarbon staining were not observed in the test pit spoils or walls. The presence of 202 litre metal drums were noted in areas of the landfill. However, these appeared to be empty. The presence of machinery, truck and car parts and drums in the landfill which may have had oily residues could have contributed to the presence of elevated PAHs in soil. In any event, the landfill is located well away from the main site of the SNAG airstrip and is covered with thick vegetation.

In order to prevent any erosion of metallic debris and perhaps further contamination of soil with metals, it is recommended that the landfill be covered with a 0.5 m layer of sand and gravel. The area is fairly densely vegetated and the natural evolution and growth of this vegetation on the covered area will act to further reduce the risk of erosion of material from the landfill.
