Indian and Northern Affairs Canada

ABANDONED CLINTON
CREEK
ASBESTOS MINE

CONCEPTUAL DESIGN
REPORT
NOVEMBER, 2000

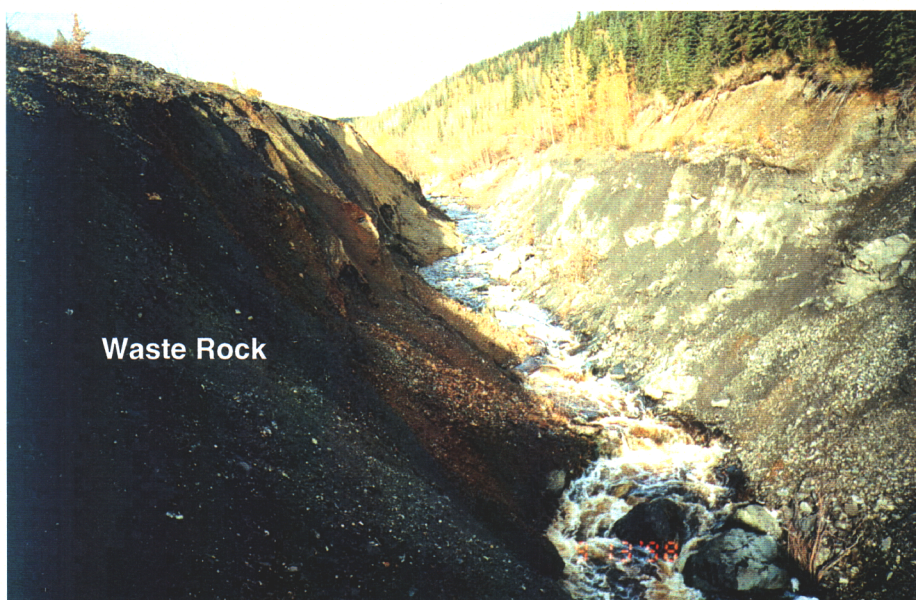
Clinton Creek Channel Over Waste Rock Dump (view upstream)

A significant hazard has been identified associated with continued degradation of the Clinton Creek channel through the waste rock dump (UMA Risk Assessment Report, April, 2000). Of particular concern are potential risks to human life and property downstream of the mine associated with a sudden breach of the channel blockage. In areas with significant relief such as the Clinton Creek valley, flooding from failures of channel blockages can be especially dangerous and unrelated to precipitation events that would normally be expected to produce flooding conditions. Although the potential exists for a sudden release of water from the tailings pile and Porcupine Creek blockages, the consequences of such a failure are less significant by comparison. For these reasons, the conceptual design of remedial measures focuses on the waste rock dump instabilities and degradation of the creek channel where it passes through (over) the waste rock.

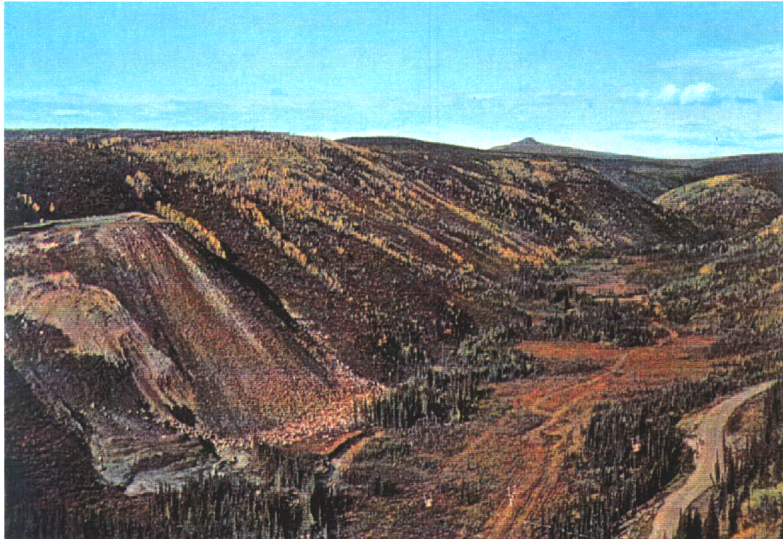
Waste Rock Dump in About 1970 (View Upstream)

Evidence of slumping at the toe of the waste rock dump seen in the 1970 aerial photograph (page 3) was likely the first sign of the impending problem. At this time (1970) there was no water impounded i.e. the time before the formation of Hudgeon Lake. Assuming permafrost existed at shallow depths there may have been zones of varying strength within the waste rock and foundation soils at the time of the failure as follows:

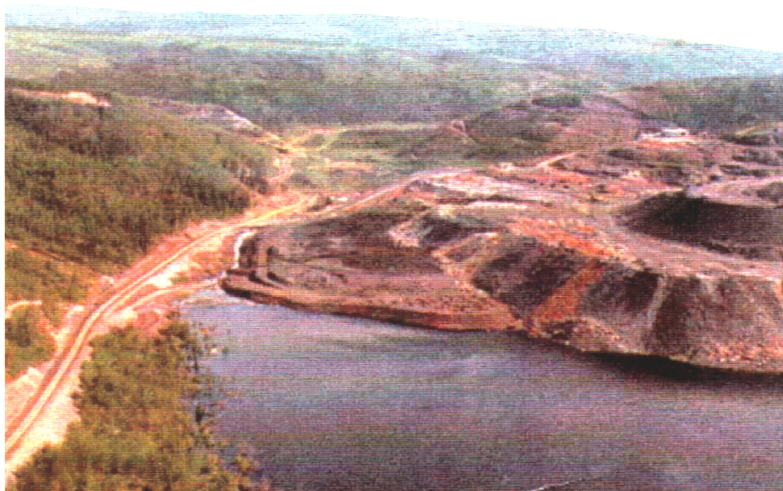
Waste Rock Dump in 1974 (View Downstream)

A significant slope failure of the waste rock dump into the Clinton Creek valley occurred in 1974 and the resulting landslide dam blocked natural drainage through the valley creating a 74 ha lake (Hudgeon Lake). A new creek channel was subsequently formed along the interface between the landslide material and north valley slope, some 25 metres above the original valley bottom at the Hudgeon Lake outlet. Within the area now occupied by the waste rock dump, the creek channel is approximately 700 m long with a gradient ranging from 3 to 5.5 percent compared to its natural gradient of approximately 0.075 percent.

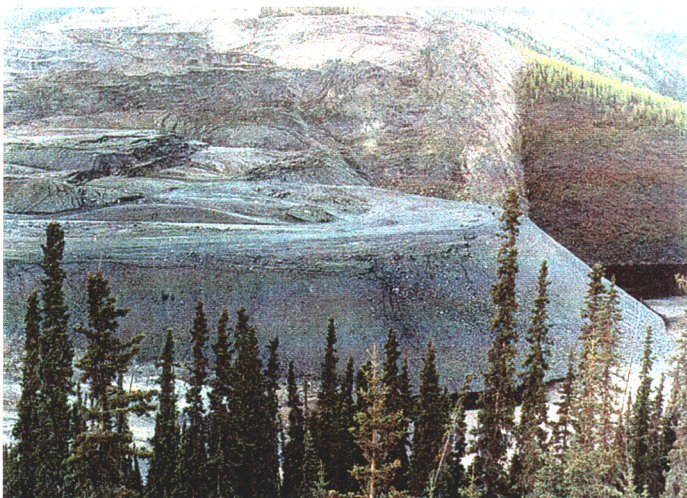
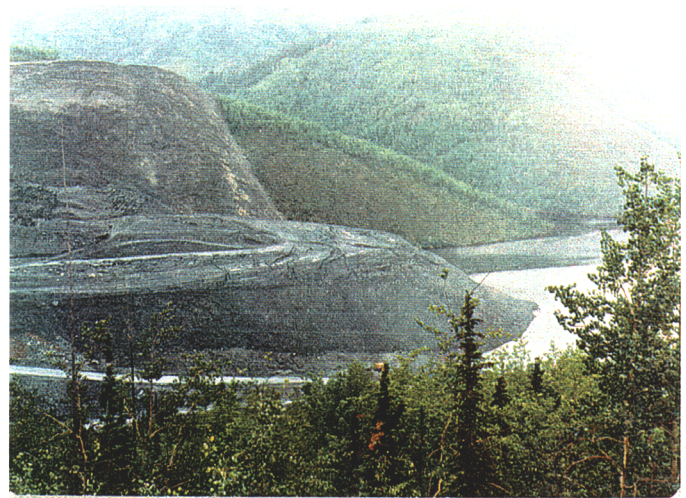
Waste Rock Dump in 1975;

Waste Rock Dump in 1976

Note North South Orientation of Cracks (above left)

Note uniform waste rock face sideslope into Hudgeon Lake (about 40 degrees) in 1974 (above left) followed by evidence of slumping of into Hudgeon Lake by 1976 (above right).

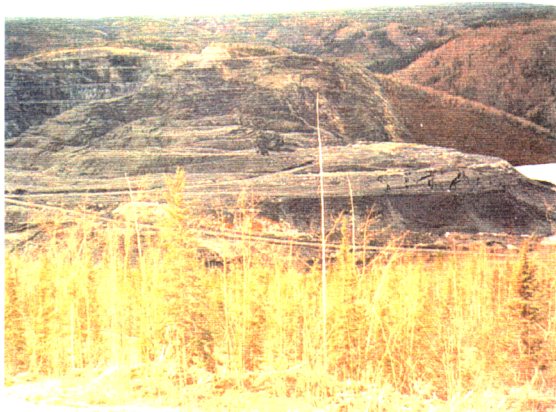
Waste Rock Dump (1977).
Note Cracks in Upper and Lower Portions

- "We understand that as creep was taking place, there was no sudden or deep seated movements of material". "Cracks up to 3 feet and 10 feet deep were observed in the upper portion of the dump. The cracks were oriented east west i.e. parallel to the dump surface and original ground surface contours. In the lower part of the dump, the cracks were oriented north south indicating grabben development. In some areas near the crest of local slopes in the lower part of the dump, cracks have developed parallel to the crests of these slopes" (Golder 1977, V76083, pg1).

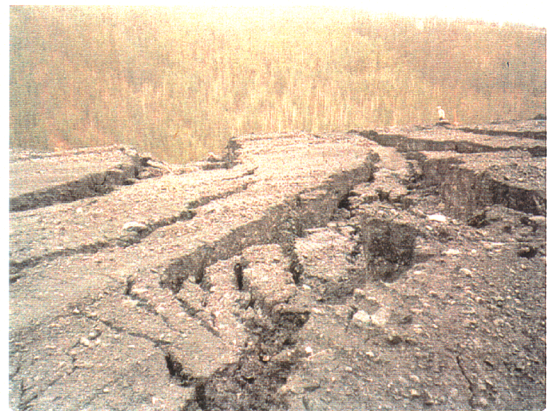
Cracks Near Crest (Mon #7 on Right)

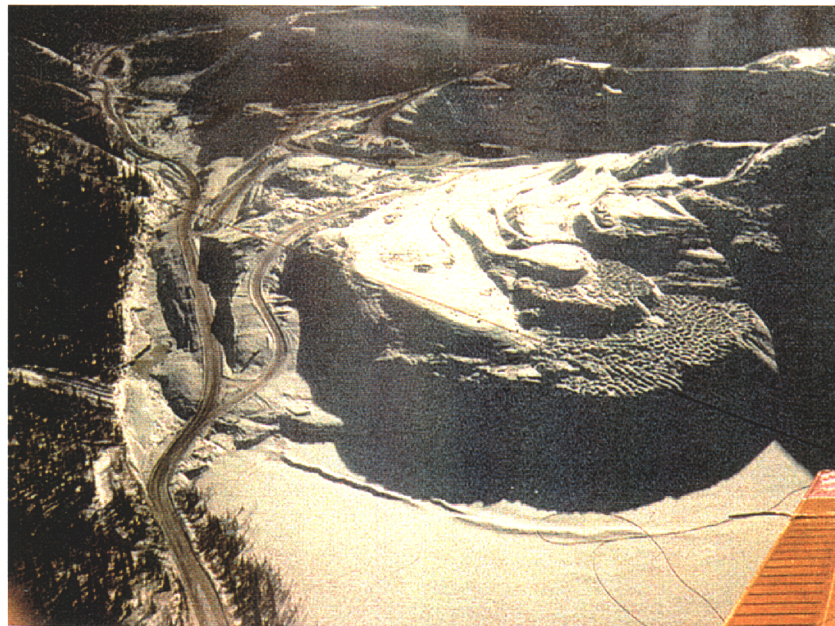
Pressure Ridge on Hudgeon Lake Ice Surface (March, 1978)

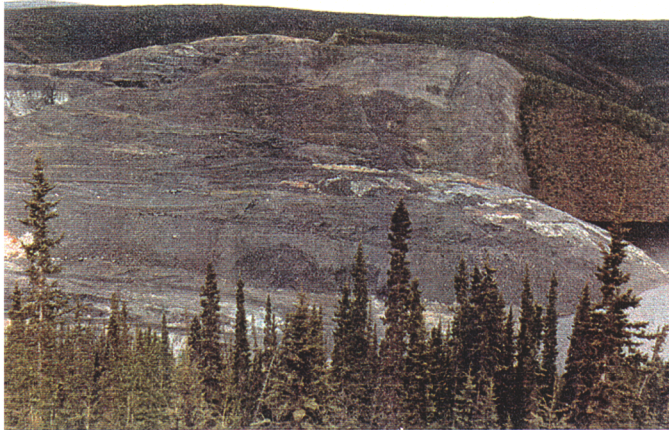
Waste Rock Dump (1982)

- In 1982 Hardy noted that the surface characteristics of the waste rock dump demonstrated sufficiently clearly the ongoing instability and continued movement of the dump. The channel weirs constructed in the fall of 1981 were now by-passed by the stream, which was undercutting and eroding the natural side slope.

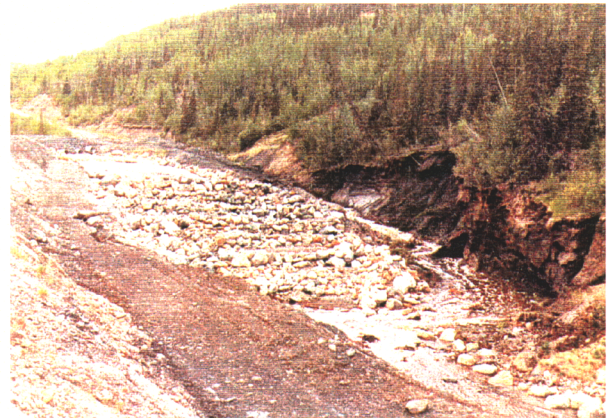
Channel bypassing weirs (1982)

- Remedial work to repair the channel where it had escaped the rock weirs was recommended in 1983 (Klohn 1984, pg2). The work, consisting of a rip rap plug with a geotextile lining at the upstream end of the erosion channel was initiated in November 1983 and completed in 1984. It was further recommended that the channel be widened at the upstream plug to allow for squeezing by future dump movements.

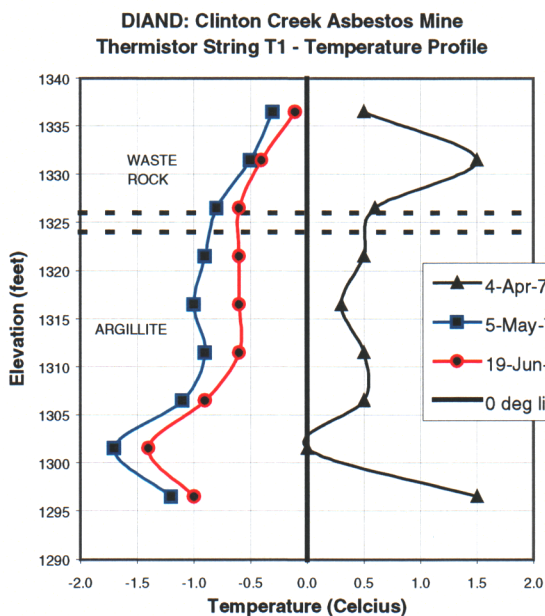
Figures 3-1 and 3-2
Thermistor String T1

Thermistors T1 & T2 are located on the southern edge of the dump (well away from the creek channel) as shown on Drawing 01. Points installed within the waste rock and foundation were below 0 degrees C indicating permafrost had advanced into the waste rock. Temperatures range from close to 0 degrees at the top of the string (within the waste rock) to -1 to -1.5 degrees in the foundation (argillite). Ice chips were noted on the test hole logs within the argillite for Thermistor T1 (BH1) and T2 (BH2).

- The waste rock serves as an insulator, which isolates the foundation from ambient temperatures. More importantly, groundwater seepage from Hudgeon Lake provides a continuous source of heat. As a result, the permafrost beneath the dump is melting. *This contradicts the monitoring results from Thermistors T1 and T2.*

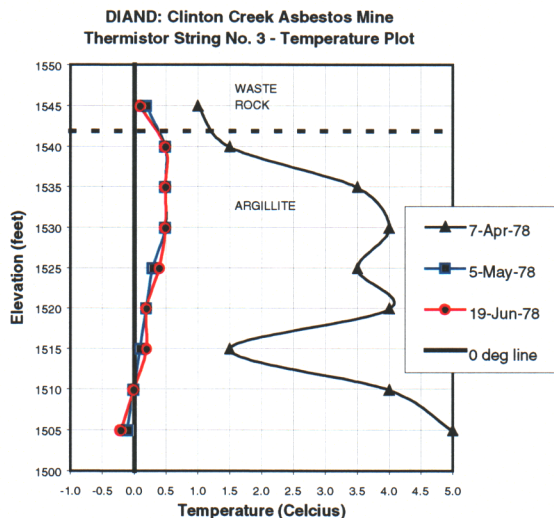
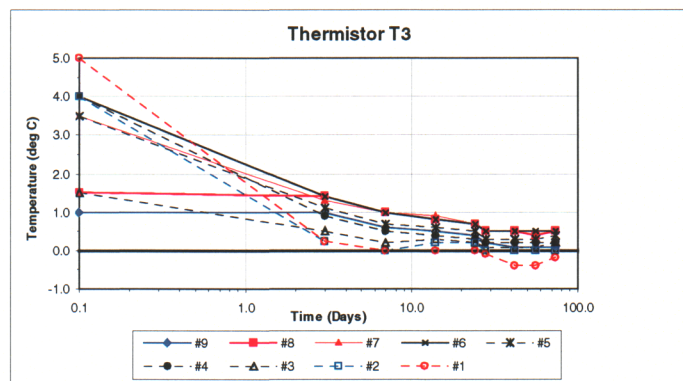
Figures 3-5 and 3-6
Thermistor String T3

Thermistor T3 is located farther to the west but still some distance from the creek. The results indicate the ground temperatures are above 0 degrees (about +0.5 degrees) for a depth of 30 feet below the original ground surface. At the location of T3, the ground surface formed part of a north aspect and quite likely was underlain extensively by permafrost. It appears therefore that the permafrost may have degraded to a depth of 30 feet in this area of the waste rock dump. No ice chips were observed during installation of the Thermistor T3 (BH4).

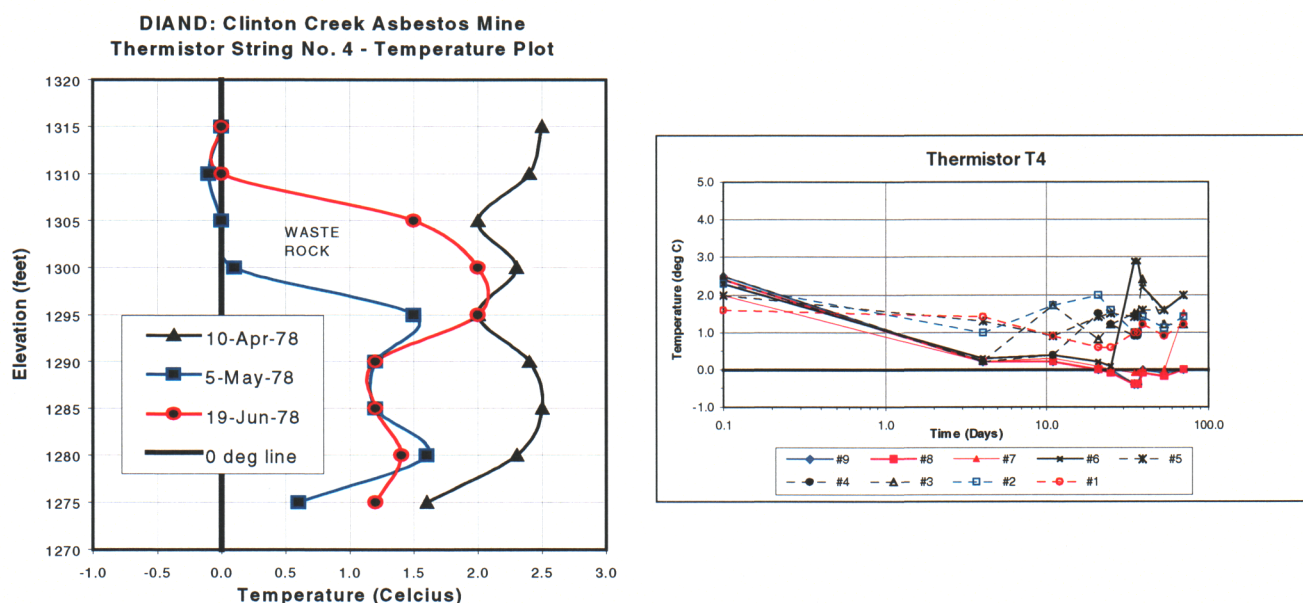
**Figures 3-7 and 3-8
Thermistor String T4**

Thermistor T4 is located near the northern edge of the waste rock dump along the access road adjacent to Clinton Creek, approximately coincident with the original toe of the north valley slope. Unfortunately, the base of the waste rock dump was not reached with the borehole and sloughing prevented the installation of the string to the base of the hole. Golder Associates concluded that the measurements reflected the temperature of seepage water within the base region of the dump. Based on the temperature profile, it was speculated that the phreatic surface was at approximately elevation 396m (1300 ft).

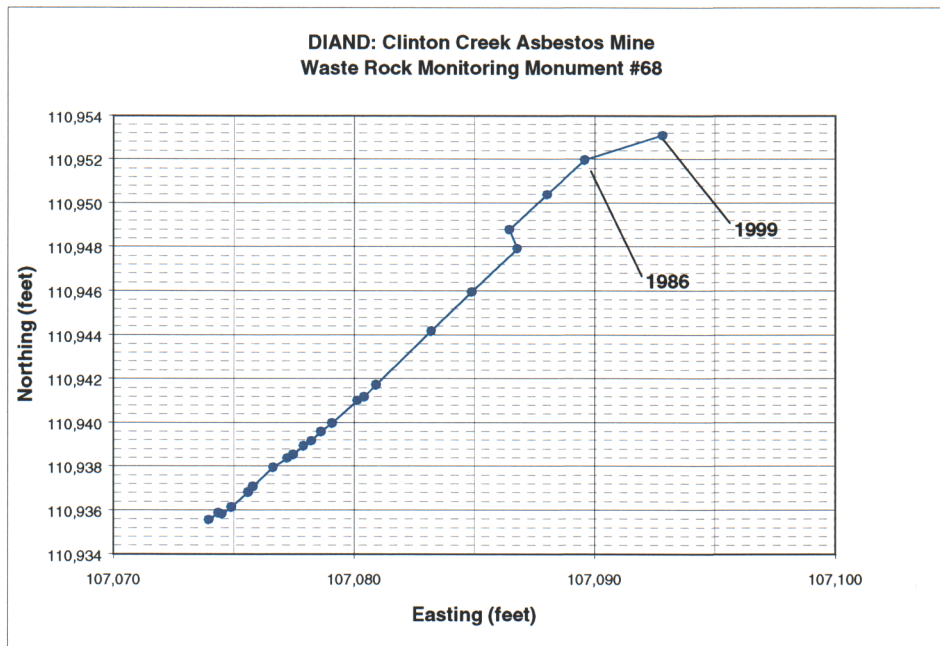
Figure 4-1
Target Coordinates

Plots of movement data are illustrated in Figures 4-1 to 4-3 using Movement Monitor #68 as an example. Movement vectors are generally consistent throughout the observation period i.e. the direction of movement is consistent (Figure 4-1). Current (1999) horizontal movement rates appear to have reduced significantly from those observed prior to 1986 (Figure 4-2). Over the same period, however, settlement rates have remained about the same, currently at a magnitude about double that of the horizontal movement (Figure 4-3). It therefore appears that while the horizontal movement has slowed down considerably or may have ceased, settlement of the waste rock is continuing at a more or less constant rate.
