ASSESSMENT REPORT

105B-01-1

DALE

DIAND TECHNICAL SERVICES

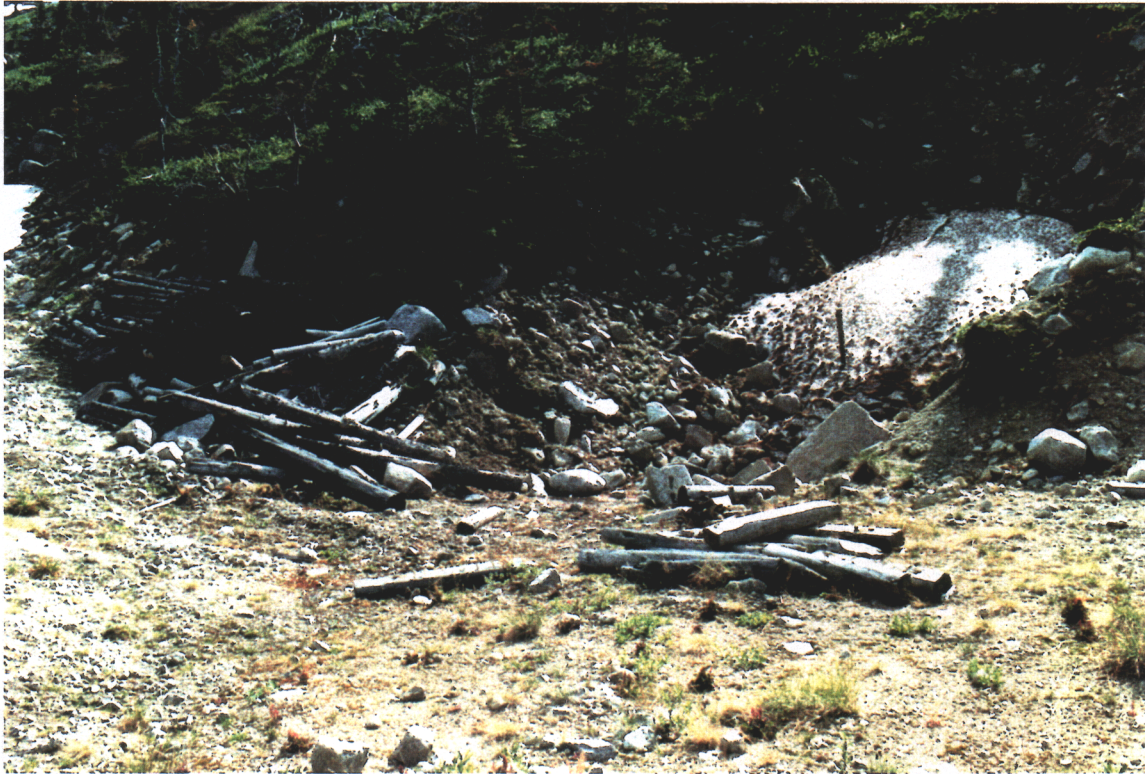
The Dale exploration site is located in the Cassiar Mountains in the southeast corner of the Yukon Territory. This site is on the steep slope of an unnamed mountain. The adit is located approximately 200m vertically below and 300m east of the trenching. The surface material is silty with boulders to 5m diameter.

1. ADIT LOCATION

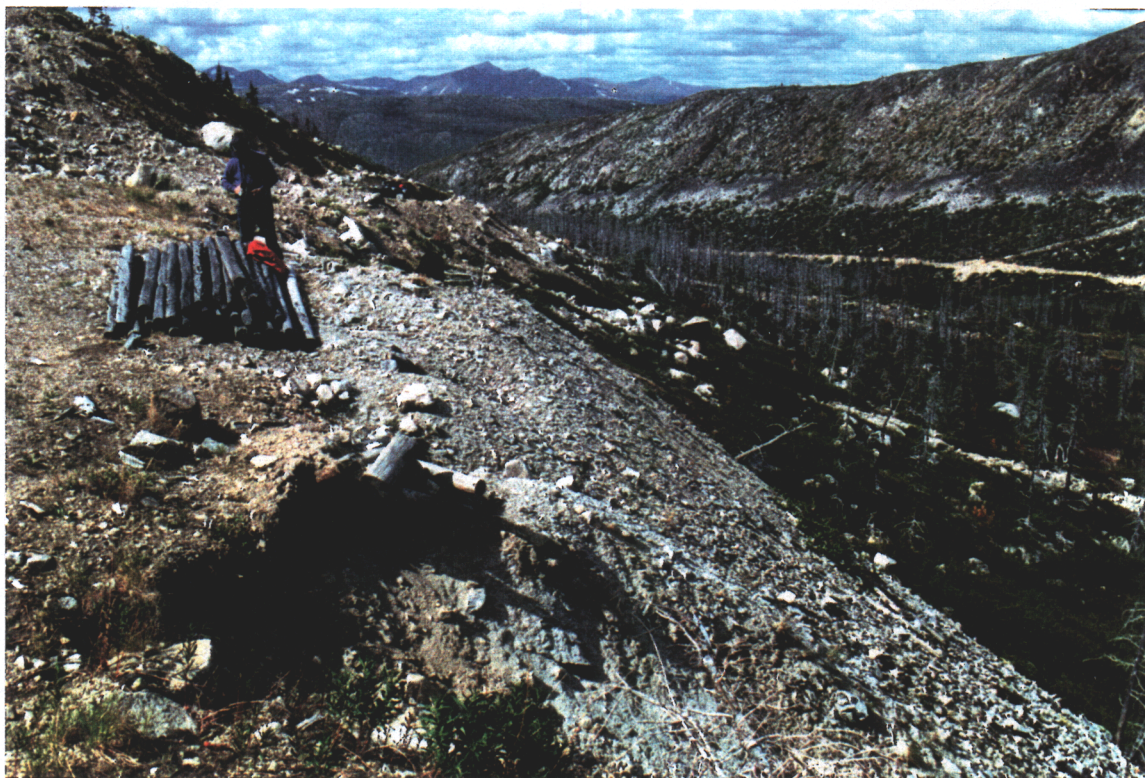
Disturbance from exploration at this site covers an area approximately 0.5x1.0km on the slope and top of an unnamed peak. The site has been developed with roads crossing the exploration area and a gridwork of exploration trenching to a depth of 4-5m, all above the camp and adit location. The vegetation has been removed wherever road or trenching operations took place. The waste from the adit, approximately 400-500 cubic metres of material, has been dumped over the slope and blends into the natural slope material.

2. WASTE MATERIAL AND LAGGING FROM ADIT

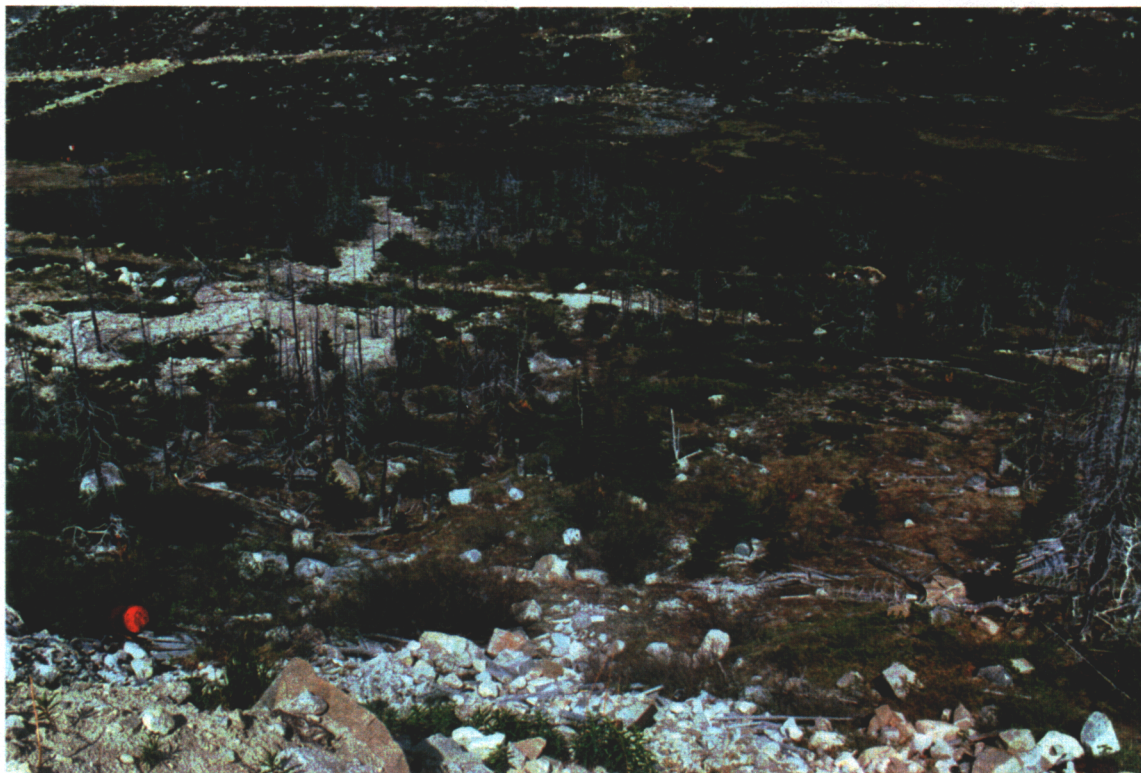
3. WASTE MATERIAL DOWNSLOPE OF ADIT

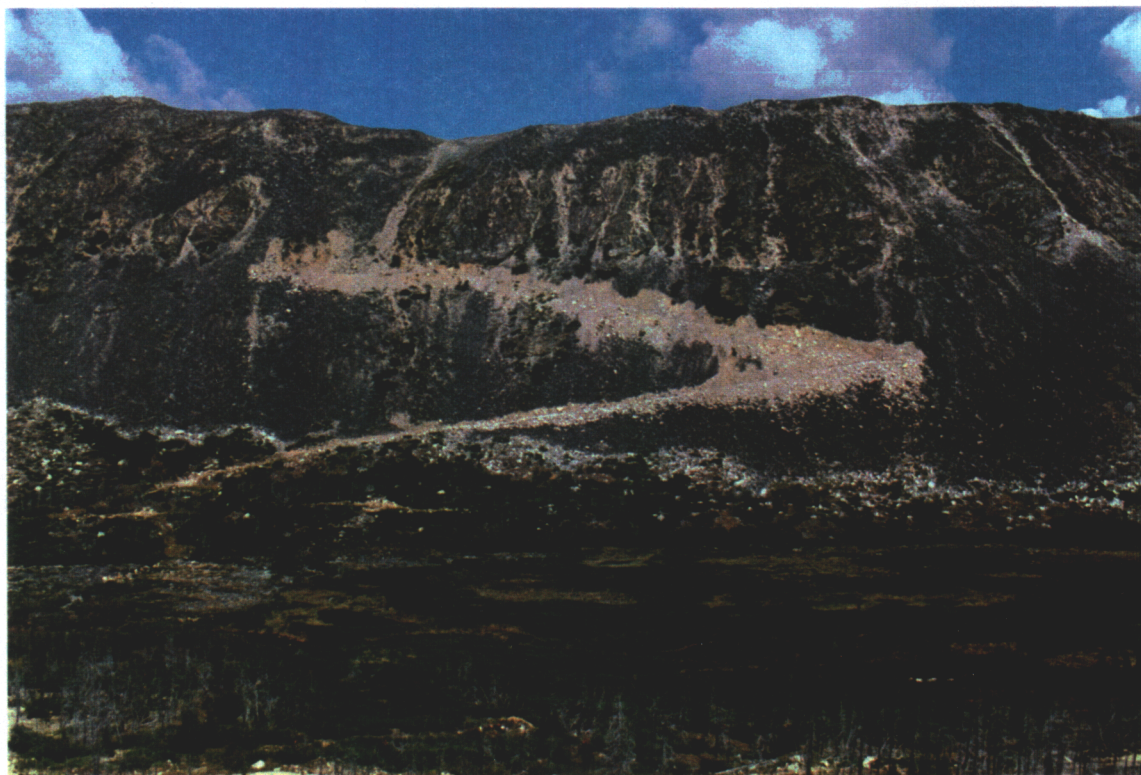
Extensive trenching and stripping across this area has resulted in significant damage to the surface soils and vegetation. The damage to the surface is significant from the exploration activity. Some erosion and slope failures were observed in gullies along the very steep access roads particularly in the area of the adit.

The slope failures and erosion are occurring naturally in the area as part of the local geologic process, as the slopes are naturally oversteepened. Whether or not the original construction of the roads triggered any of the slope failures is speculative, however there is no evidence that leaving the roads in place would cause further failures. As these roads have been in place for a long time, any stability problems caused by the original construction would have likely occurred by now. Site remediation of the roads is considered very difficult and costly in this very remote location. Any site remediation would also cause additional damage to the vegetation. No benefits to attempting any slope stabilization is apparent at this site.

4. EXPLORATION ROAD

Attempting to revegetate the roads and exploration areas would be very difficult. The disturbed areas will eventually revegetate themselves from the local vegetation encroaching into the disturbed areas. This revegetation process is likely the only practical solution in an area that is extremely remote with a harsh climate.

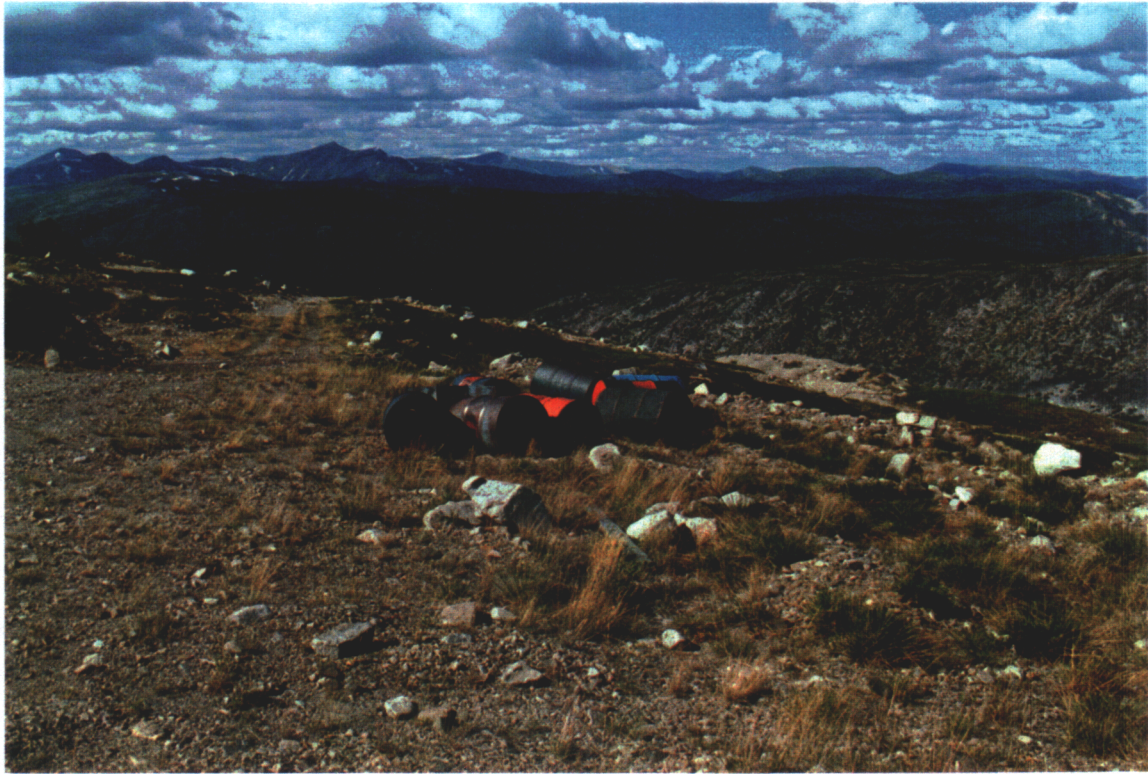
Recovery of the 7 or 8 metal barrels scattered over the site should be completed if a clean-up program is undertaken in the area. These barrels are empty and no sign of leaking hydrocarbons was observed. These could only be flown off the site as road access to the exploration area is impassable.

5. EMPTY BARRELS AT EXPLORATION SITE

- removing the barrels from the site,
- removing and storing any recoverable core from the site, and
- burning any wooden structures in a suitable area.

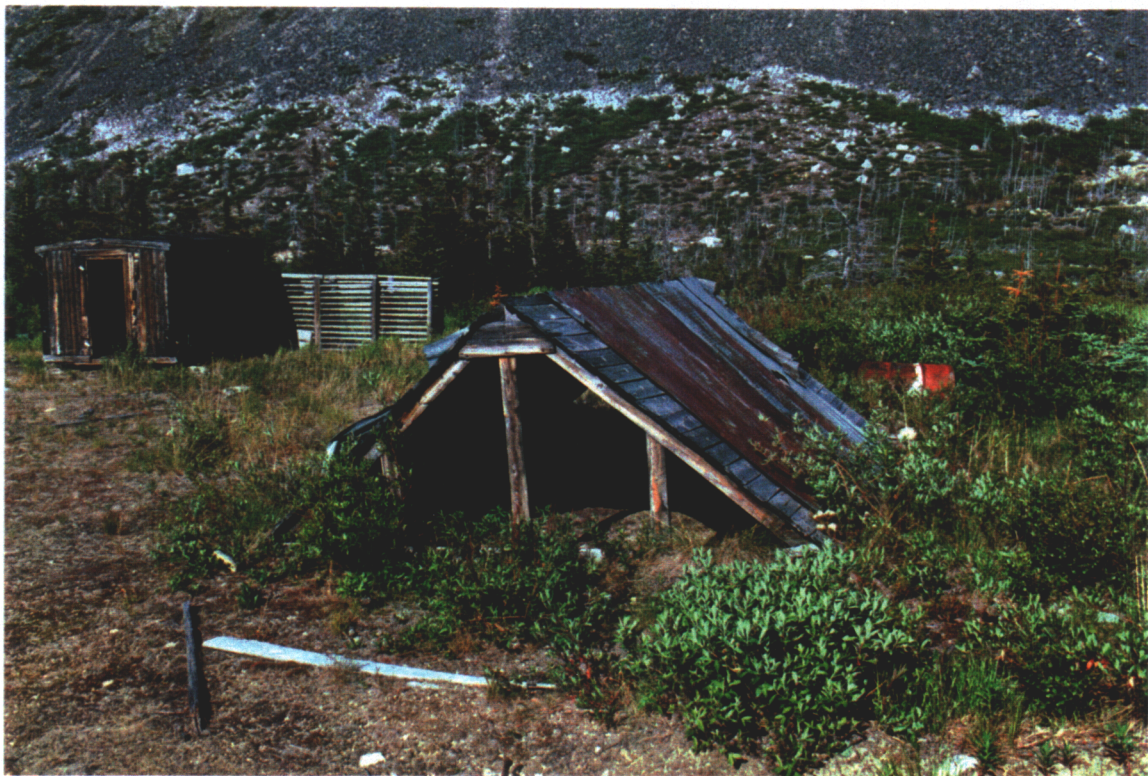
Little remains at the camp site from the original exploration, with a small 4x5m core shed, a core rack, a small wooden A-frame shed, a wooden platform, some scattered core and core boxes, and 8 empty barrels being the only items left. No hydrocarbon products or any equipment remains on-site and no ground or adjacent stream contamination was evident. Although the site is adjacent to a tributary to Freer Creek, the remains of the camp site area is well away from the bank of this stream and does not appear to be having an impact on the stream.

6. A-FRAME, CORE RACK, AND STORAGE BUILDING AT CAMP LOCATION

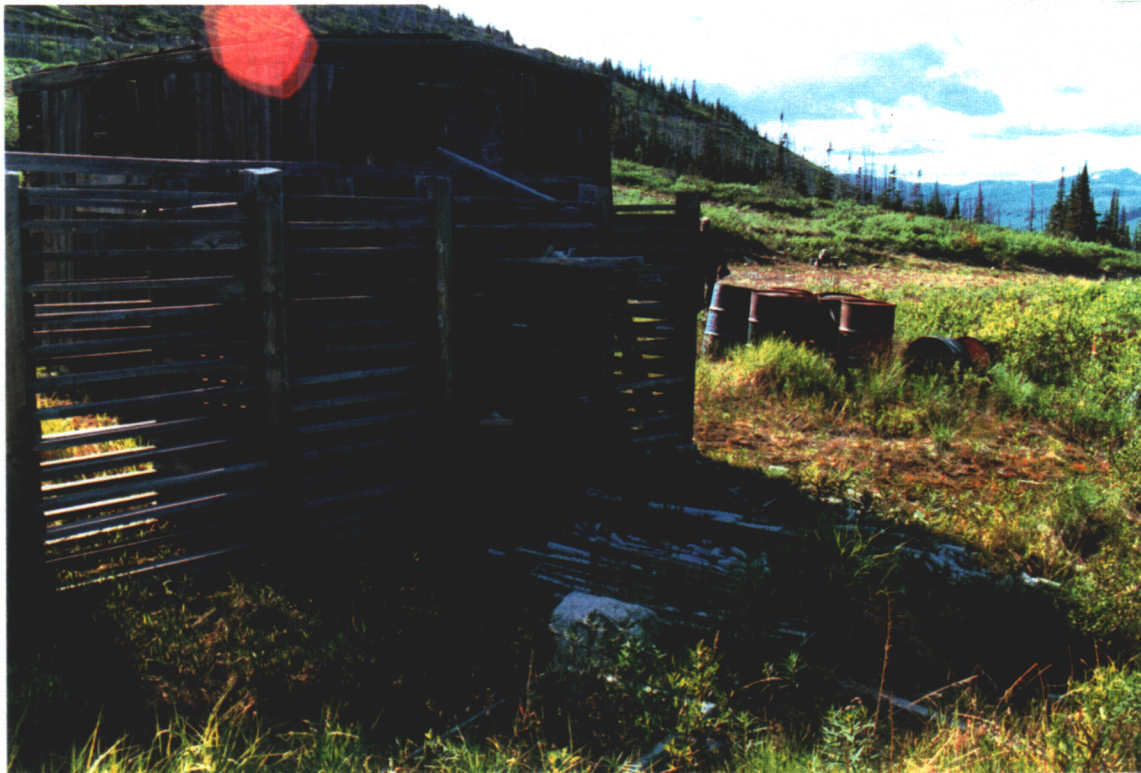
7. CORE RACK, SPILLED CORE, AND BARRELS AT CAMP LOCATION

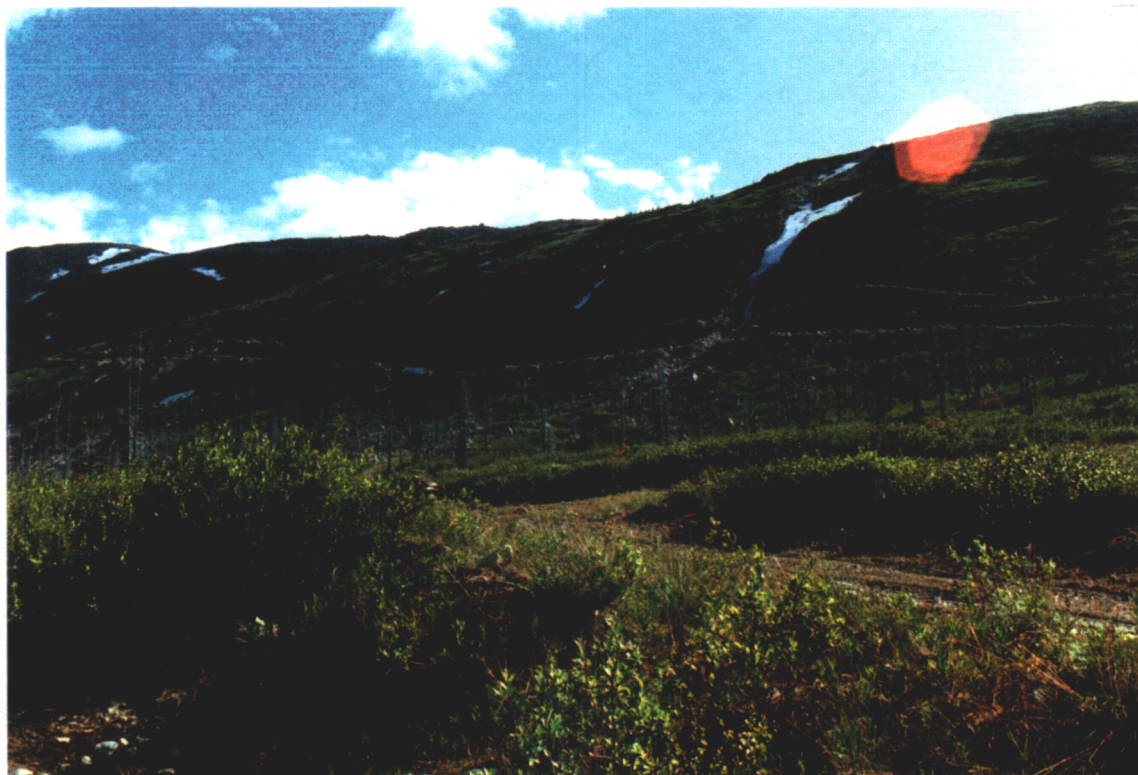
8. EXPLORATION ACCESS ROAD AND SLOPE FAILURES
