ASSESSMENT REPORT

105D-06-4

LEGAL TENDER

DIAND TECHNICAL SERVICES

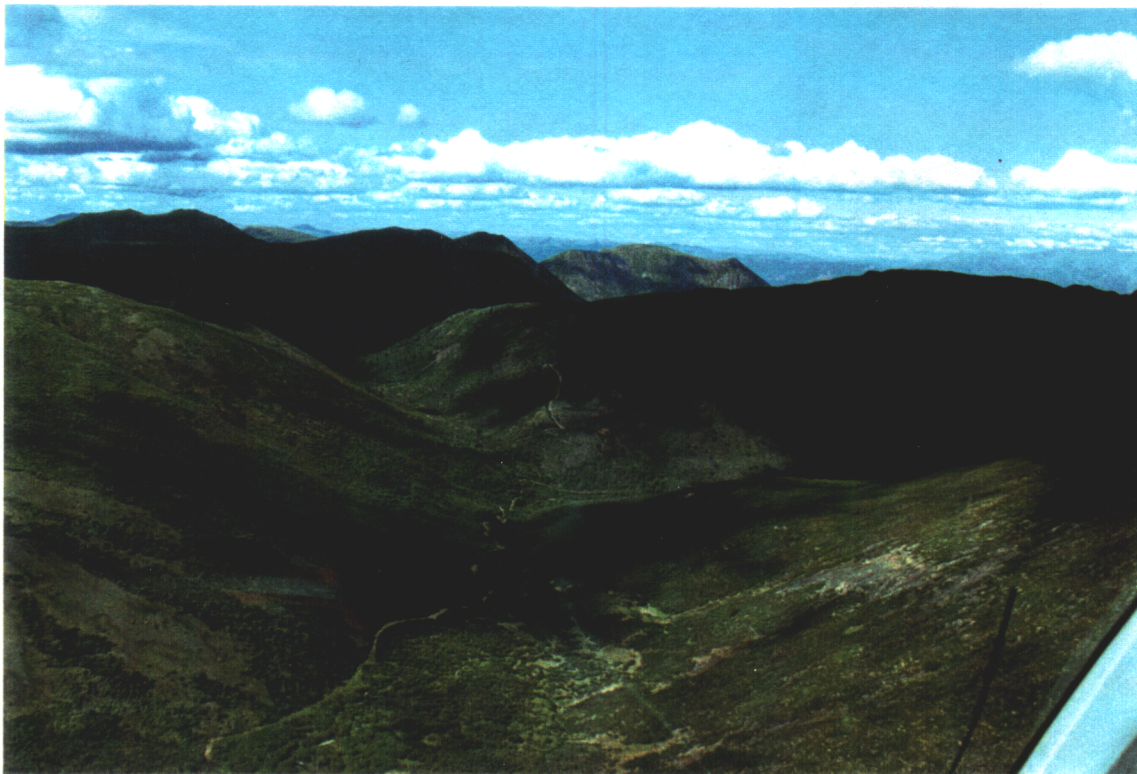
The Legal Tender site is accessible by trail leaving the Wheaton River road on the north side of Annie Lake. From the Wheaton River road the trail follows the Thompson Creek valley then up the Morrison Creek valley partly up Mule Hill a distance of approximately 14km. This trail fords several small creeks along the creek valley. The upper part of the trail is very steep near the exploration site.

ROAD ACCESS TO SITE UP MORRISON CREEK

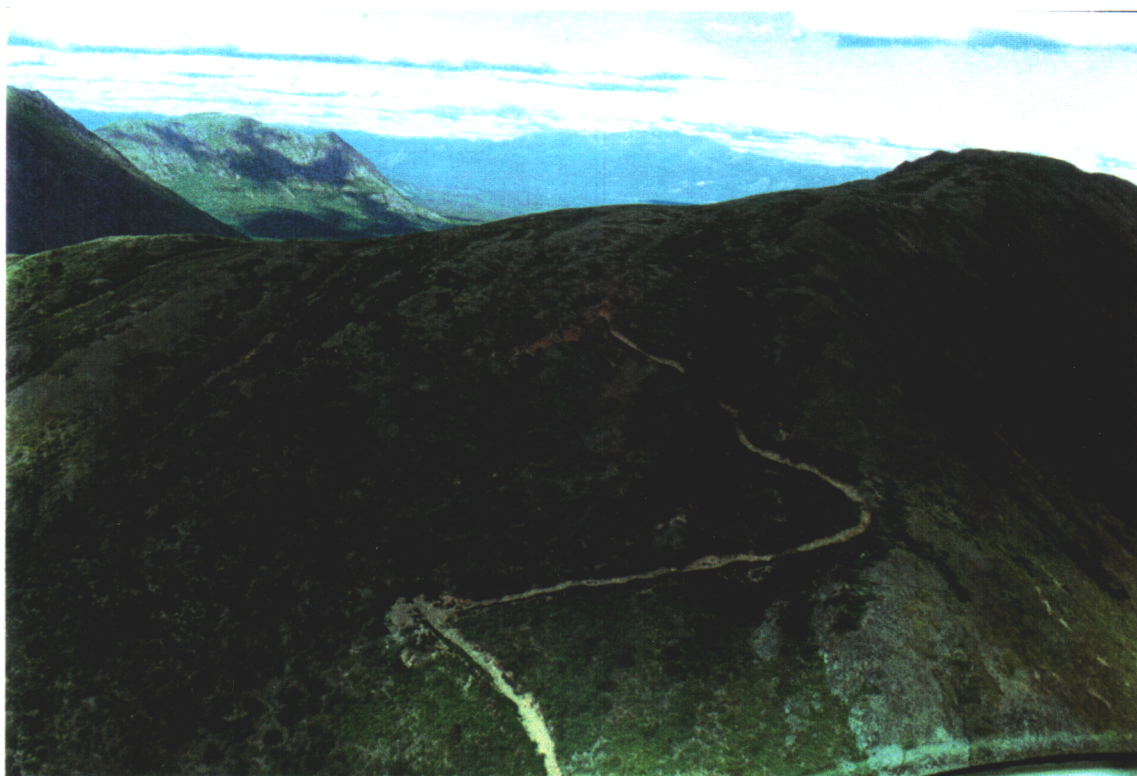
The predominant feature from the past development is the trail up the mountainside. As noted, this trail is very steep and would be susceptible to erosion if there was much water in the area. However the site is very dry and erosion from water appears to be insignificant. Some erosion from wind is occurring, however this is not significant as most of the material is too coarse to be transported. The site does not appear to be unstable as no landslides were observed in the area.

STEEP SWITCHBACK TRAILS TO SITE ON MULE HILL

The most impact at this site is from road development in the area. The road to the site was constructed using typical "cut and fill" methods and is quite noticeable on the hillside. However there is no evidence that any significant slope instability or erosion has been created from this road construction. It is not recommended that any site remediation be considered for the roads or trenched areas. Site remediation of the road would require reestablishing the original ground profile and revegetating the disturbed areas. This is considered a very costly exercise and will set back any natural revegetation which is well underway.
