**ASSESSMENT REPORT**

**105B-04-1**

**LOGTUNG**

**DIAND TECHNICAL SERVICES**

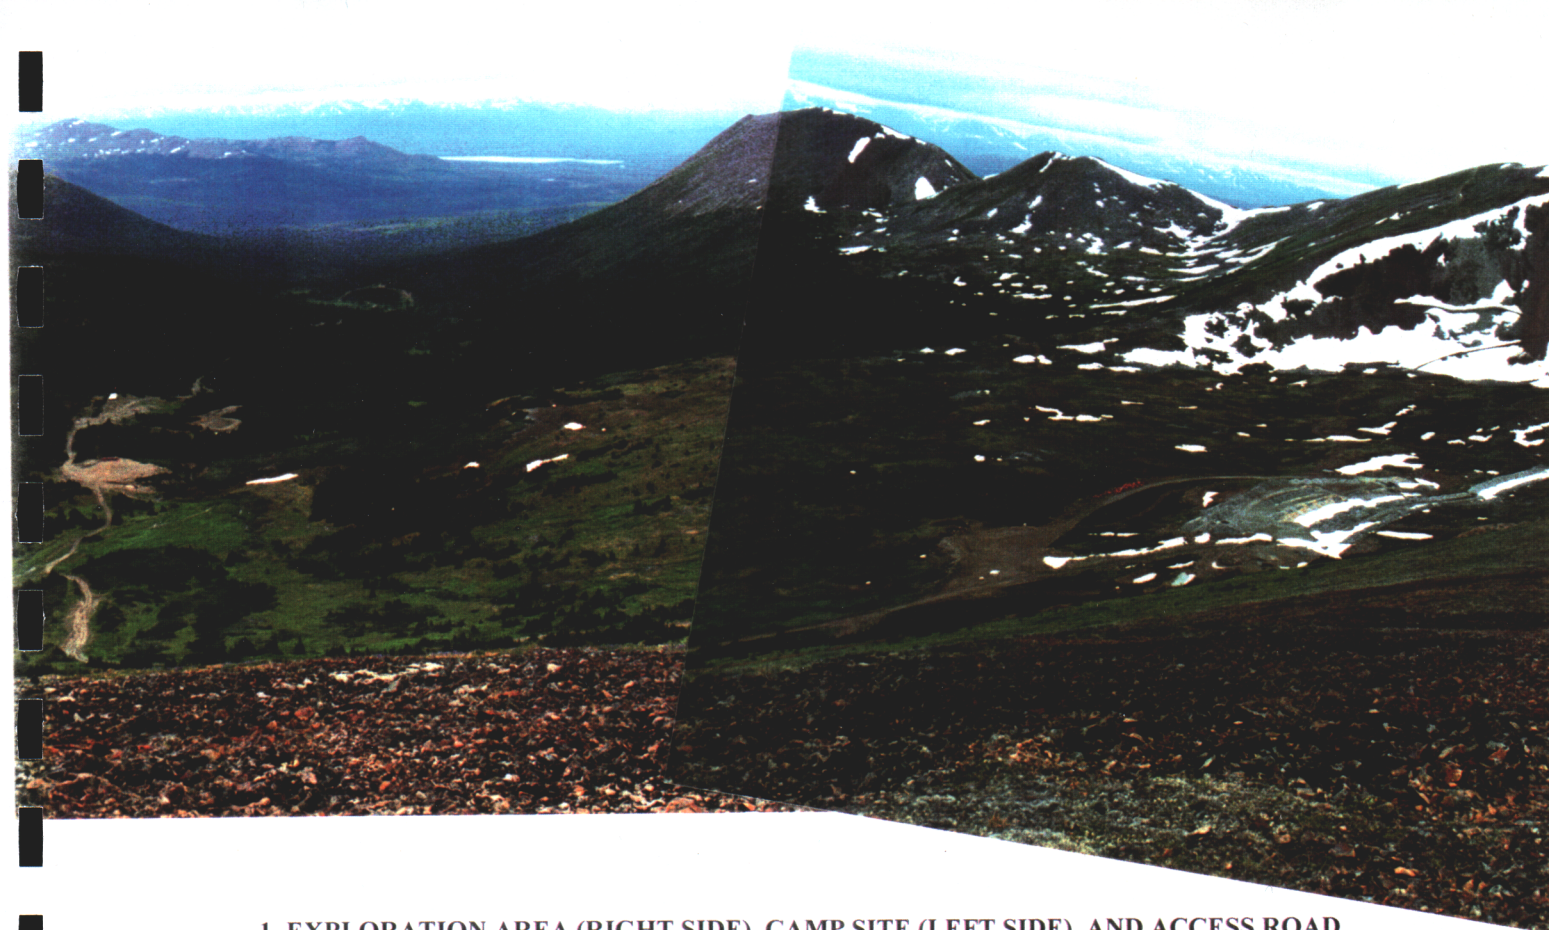
1. EXPLORATION AREA (RIGHT SIDE), CAMP SITE (LEFT SIDE), AND ACCESS ROAD

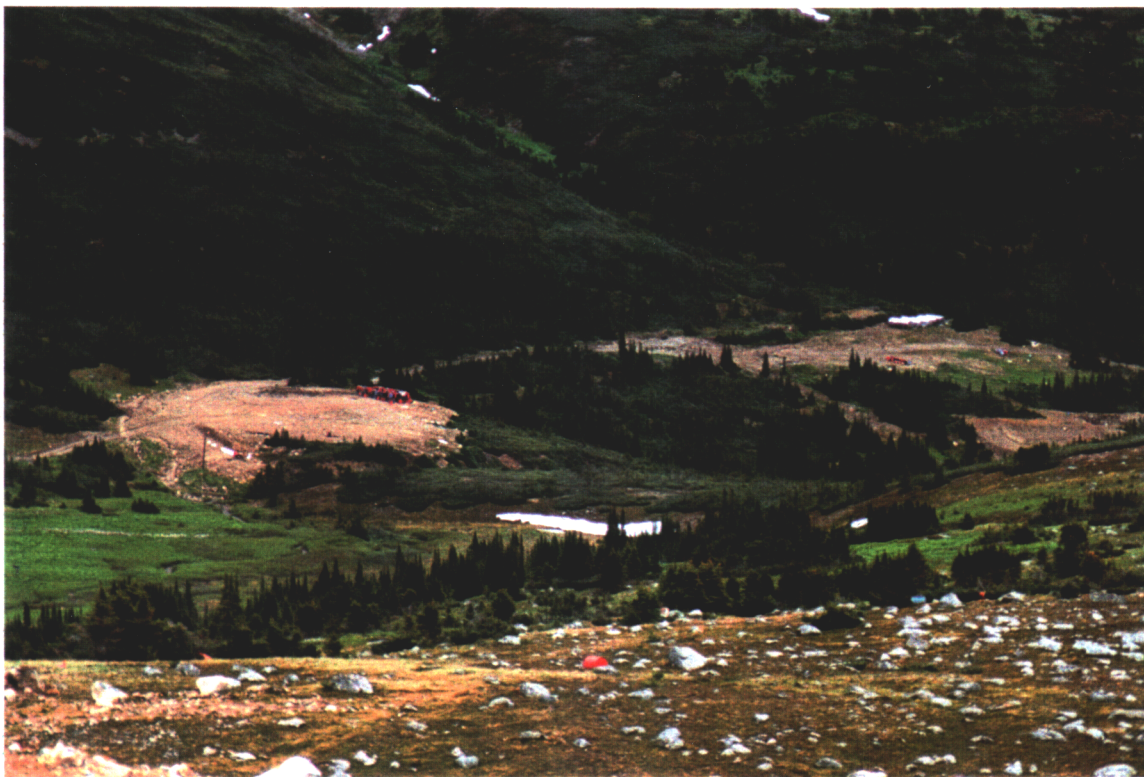
- 5 collapsing core sheds measuring 2.4x6.1m. Four core sheds are full and each contains 640 trays of core. One core shed is empty.
- 270 barrels of crushed ore stored on wooden pallets at two separate locations (240 barrels at one location and 30 barrels at another location).
- 21 empty barrels.
- one partially full barrel of oil. The remainder of the oil has leaked into the ground after the barrel was punctured from what appears to be a gunshot.
- a sewage lagoon constructed of the local silt and gravel. If fluids had been pumped into this lagoon, they have since leaked out.
- an excavated garbage pit adjacent to the sewage lagoon. The garbage pit contains small volumes of metal and wood waste.

3. CAMP LOCATION AND ORE STORAGE SITE

Ore Barrels - The 270 barrels of ore if left on-site are not expected to cause any additional site problems. Eventual deterioration will occur with rotting of the wooden pallets the barrels are stacked on, rusting of the barrels, and spillage of the ore product if the stored barrels upset. One option for clean-up of these barrels would involve;

- unstacking all barrels,
- hauling the barrels to the area where the bulk samples are stored,
- emptying all the barrels,
- crushing the barrels when the other empty barrels are crushed,
- loading all crushed barrels on trucks, and
- hauling all metal waste off-site.

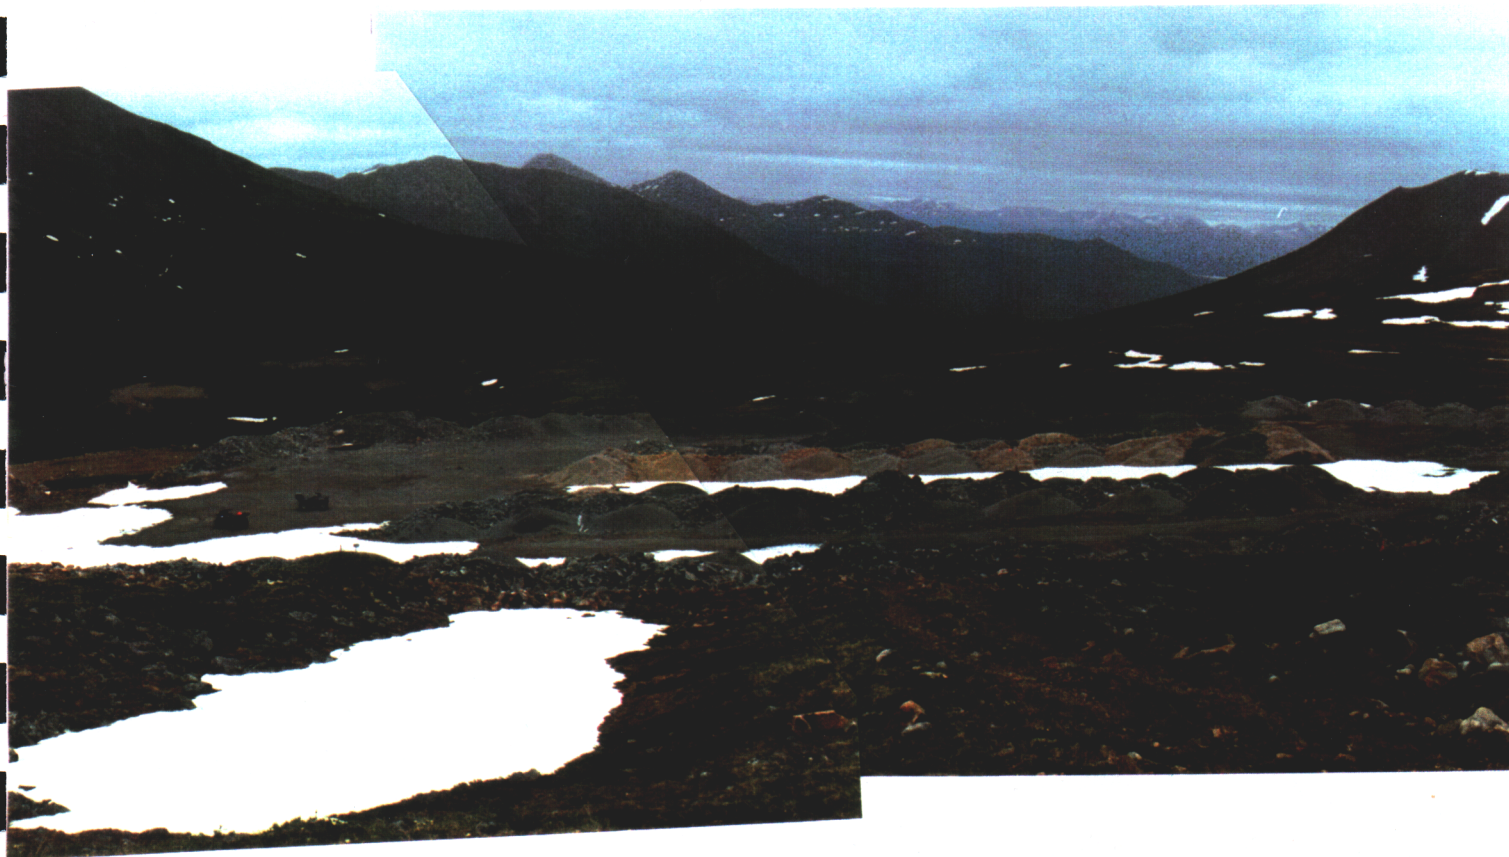
Sample Storage and Barrel Loading Area - The bulk sample storage area appears as a continuation of the adjoining waste rock pile with samples piled in four rows covering an area measuring approximately 40x60m in size. Adjoining this site is a loading platform with built-in rollers for handling barrels. The only potential salvage at this site is dismantling and removing the loading platform. This is a very **LOW** priority and should only be considered if a comprehensive clean-up program is undertaken. It is recommended that this site not be disturbed as the only impact on the environment appears to be visual.

4. BULK SAMPLE PILES

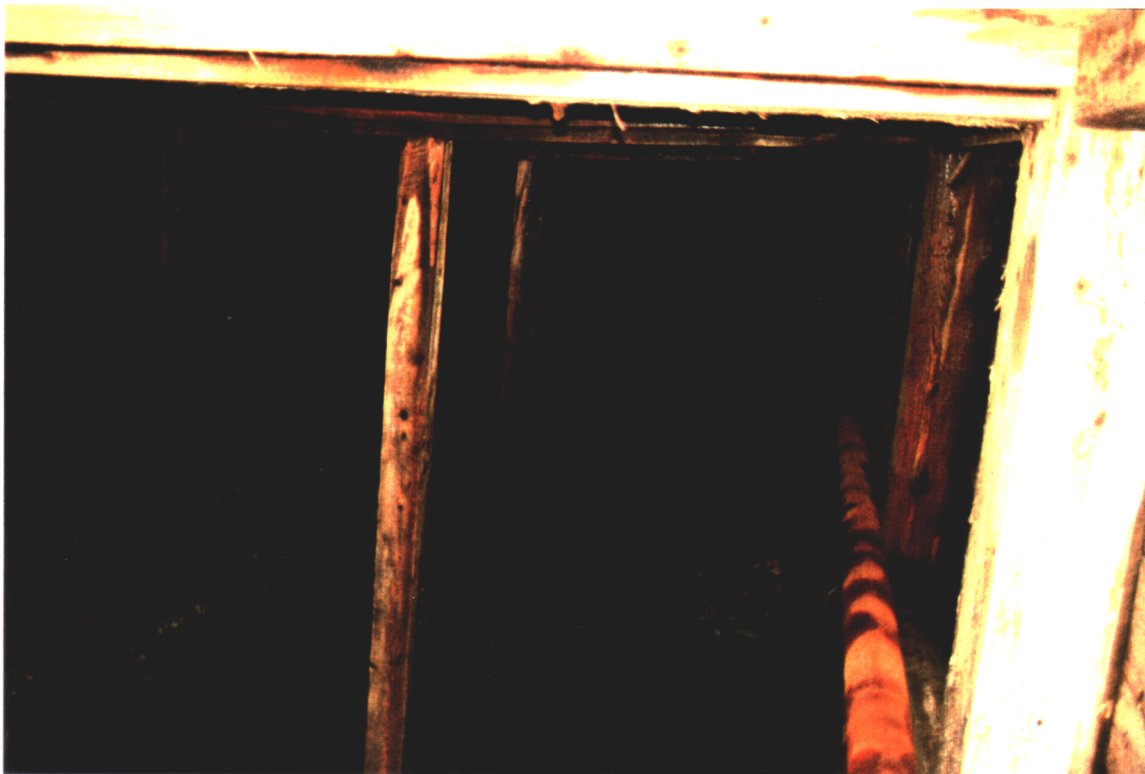
An exploration adit is situated near the base of the steep mountain slope. The entrance of the adit has been covered with a wire screen and a pile of rock has been dumped at the adit entrance to block any access. The wire screen is loosening from the weight of the seasonal snow pack and one corner of the adit is now accessible. Waste rock has been placed around the entrance to the adit and used as a working platform during the exploration phase. This waste rock covers an area approximately 50x100m. In excess of 100 bulk samples are also placed in four rows. Each row is two samples wide and measures approximately 10m wide and 60m long.

5. INTERIOR OF ADIT ENTRANCE

Adit - When the exploration site was closed the adit was properly sealed with a heavy wire mesh screen placed across the adit as well as waste rock being piled in front of the adit entrance. It was observed that the wire mesh was starting to be pulled down from the weight of the annual snow pack. Repairs should be made to this screen to ensure access to the adit cannot be gained easily.

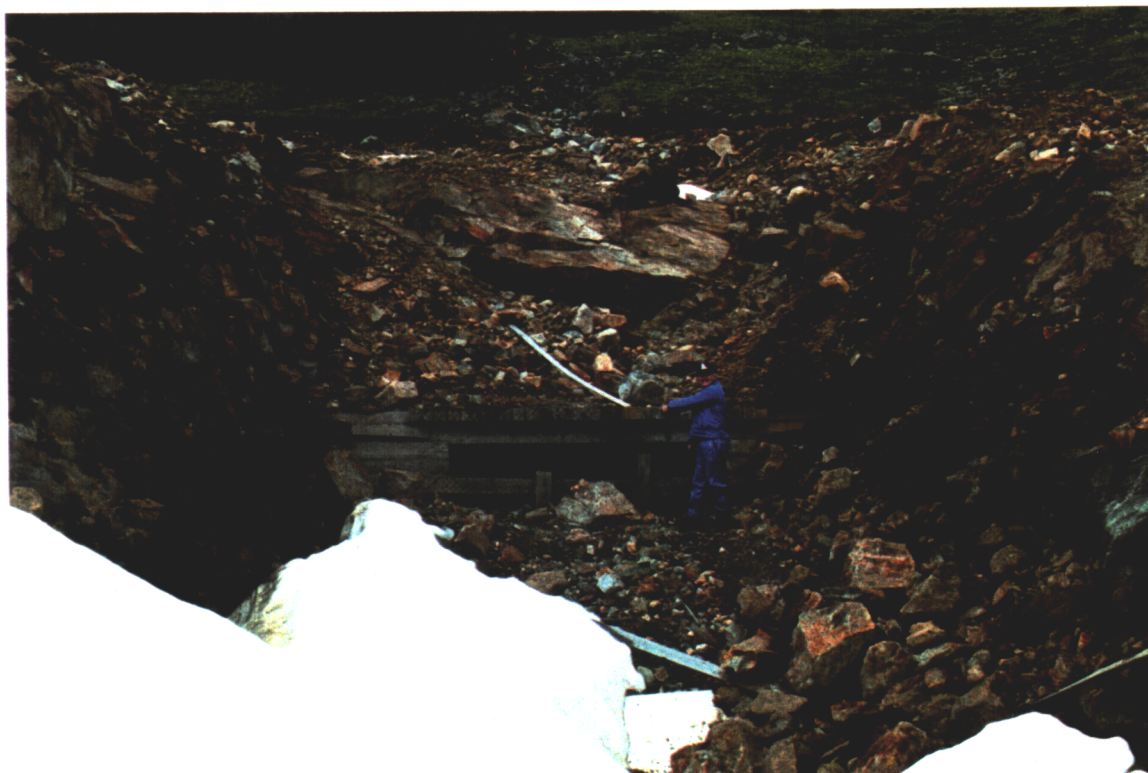
6. ADIT ENTRANCE

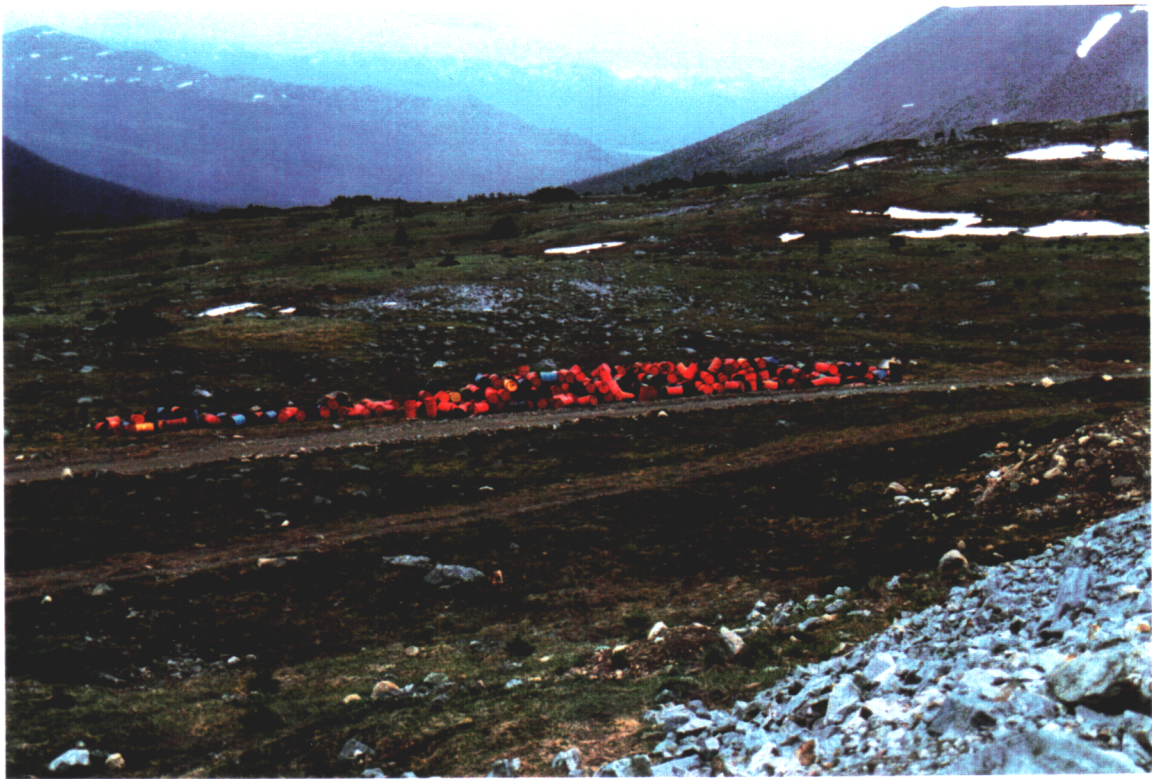
Below the adit between 200-300 empty barrels are randomly stockpiled in one large pile.

7. BARREL SITE

Barrel Storage Site - Between 200-300 empty barrels are piled below the adit and waste rock site and could be crushed and removed quite easily. If a metal waste recovery

program is in place, the removal of these barrels should be included in this program. Removal of these empty barrels is still considered a **LOW** priority because of the relative inertness of the metal.

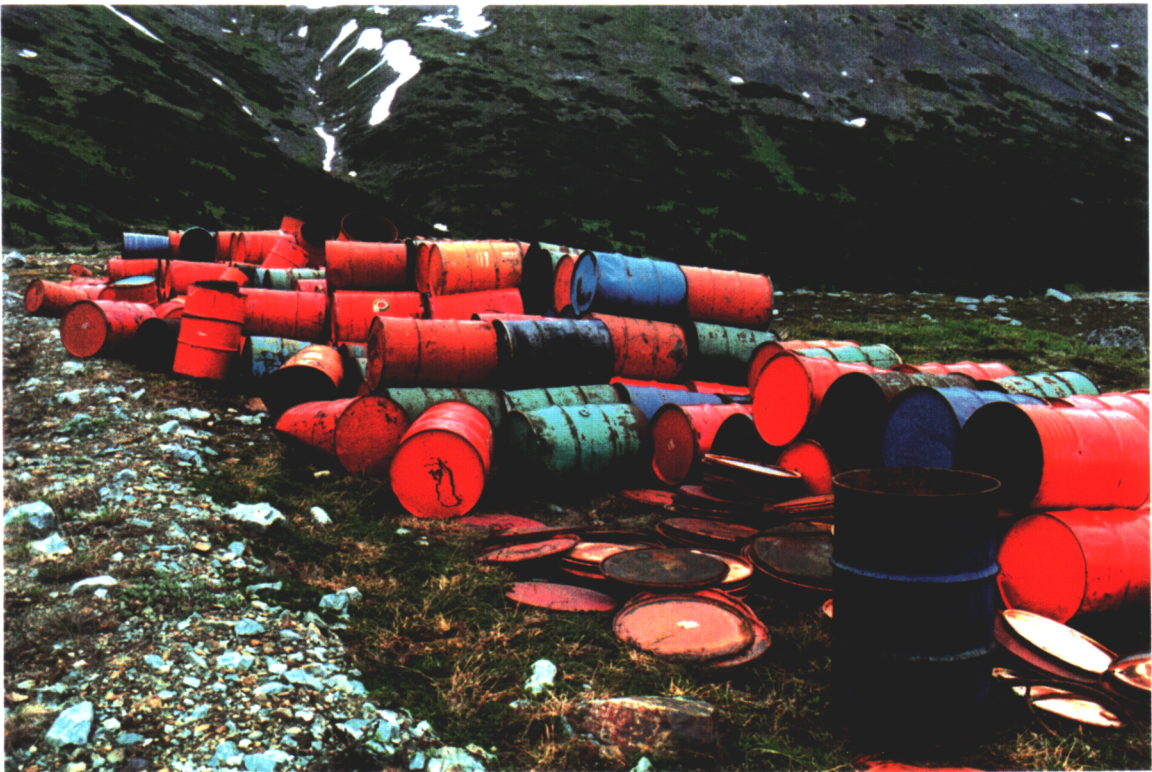
8. CLOSE-UP OF BARREL SITE

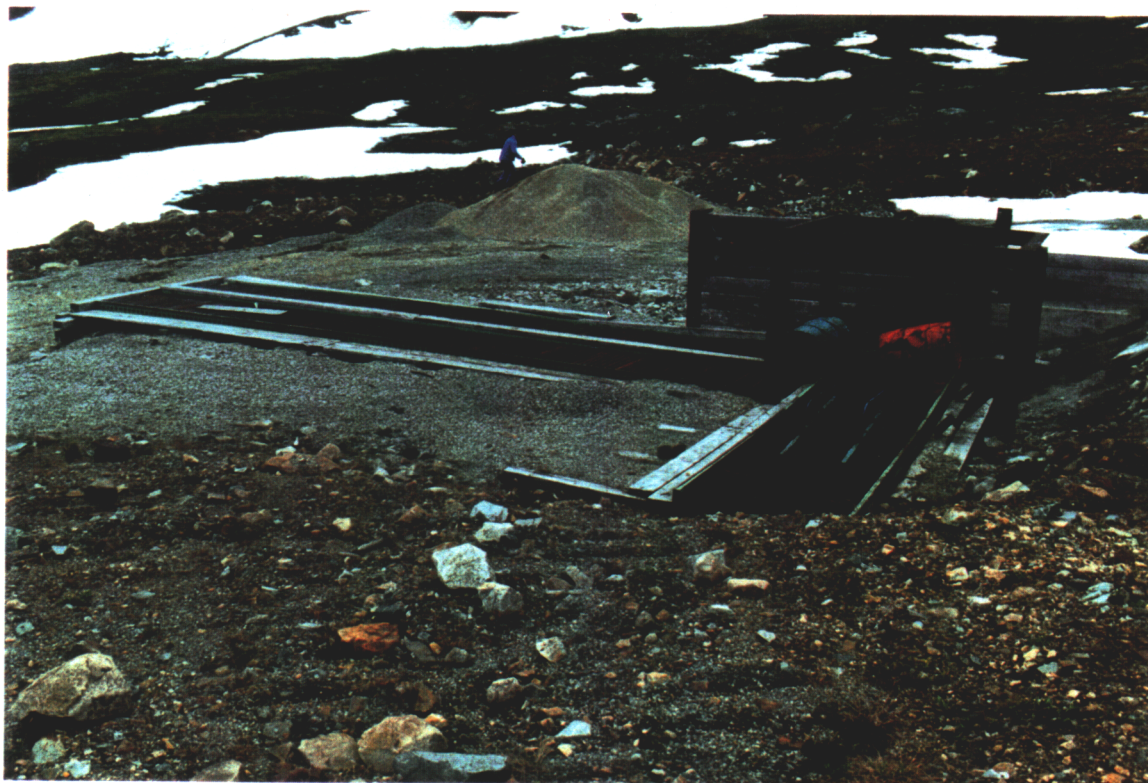
Adjacent to the bulk sample storage area is a loading platform with built-in rollers for handling barrels. This loading platform was used to load crushed ore samples into 204 litre barrels. The barrels were then loaded onto transport trucks and hauled from the site for additional refining and analyzing.

9. LOADING PLATFORM

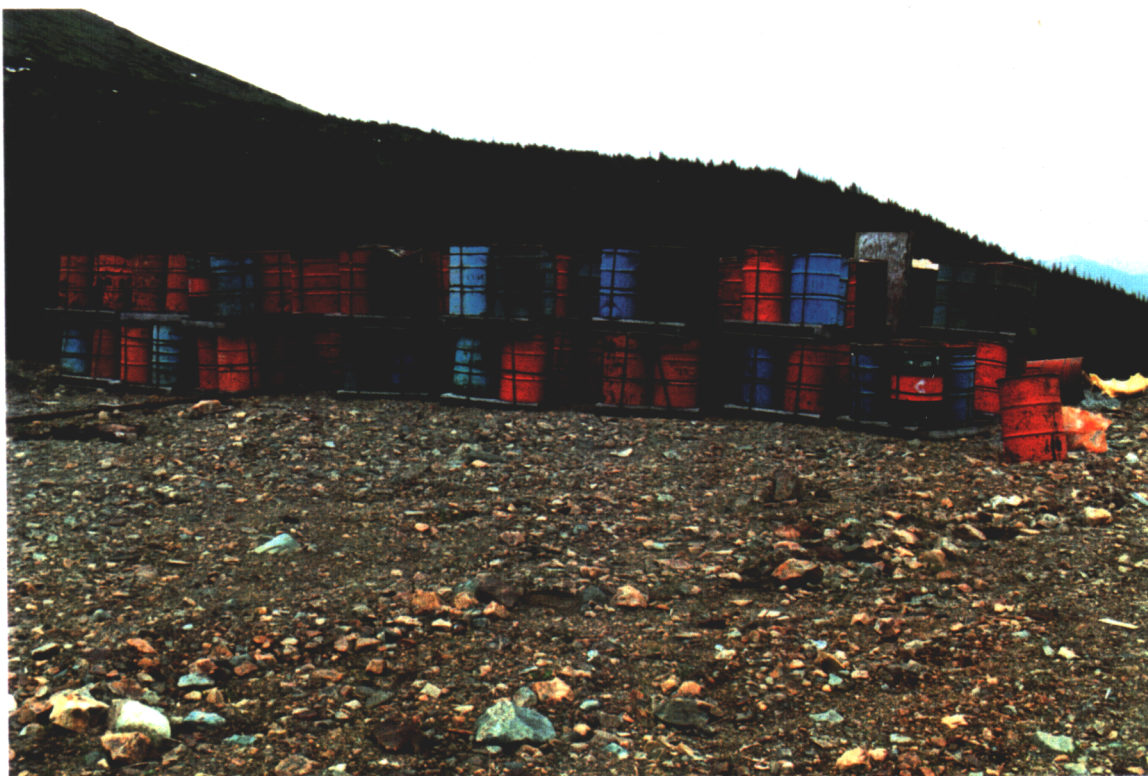
10. LOADED SAMPLE BARRELS

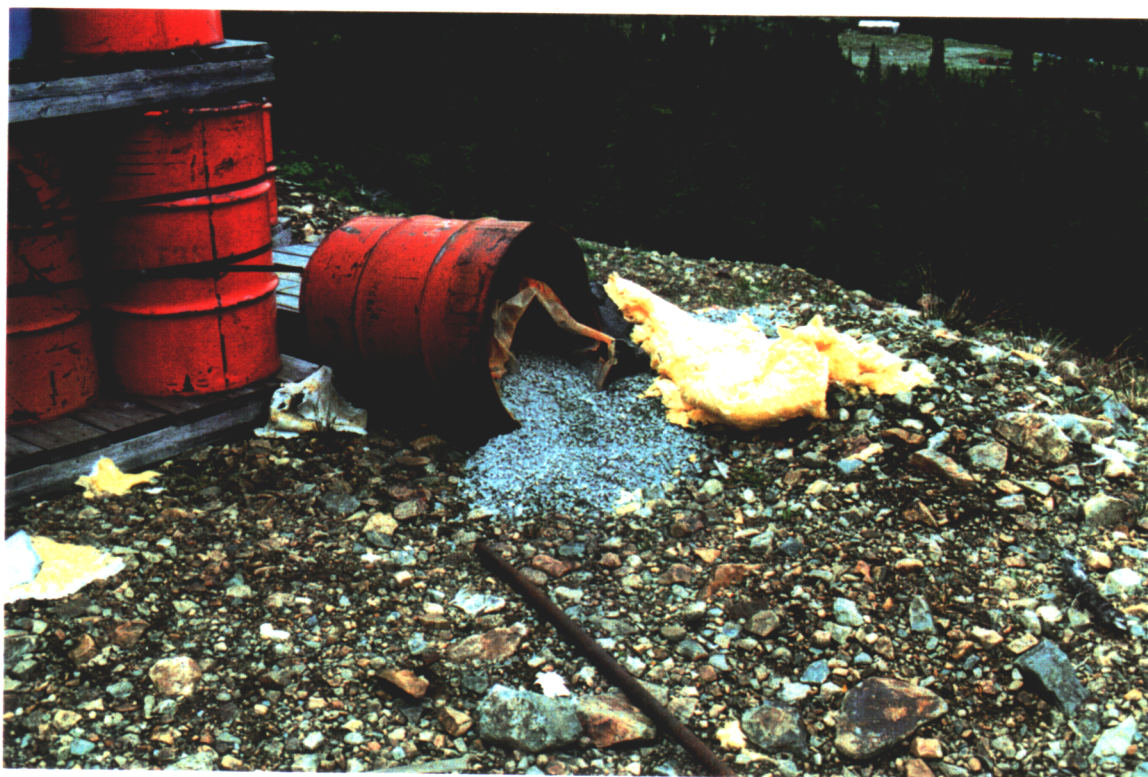
11. SPILLED SAMPLE

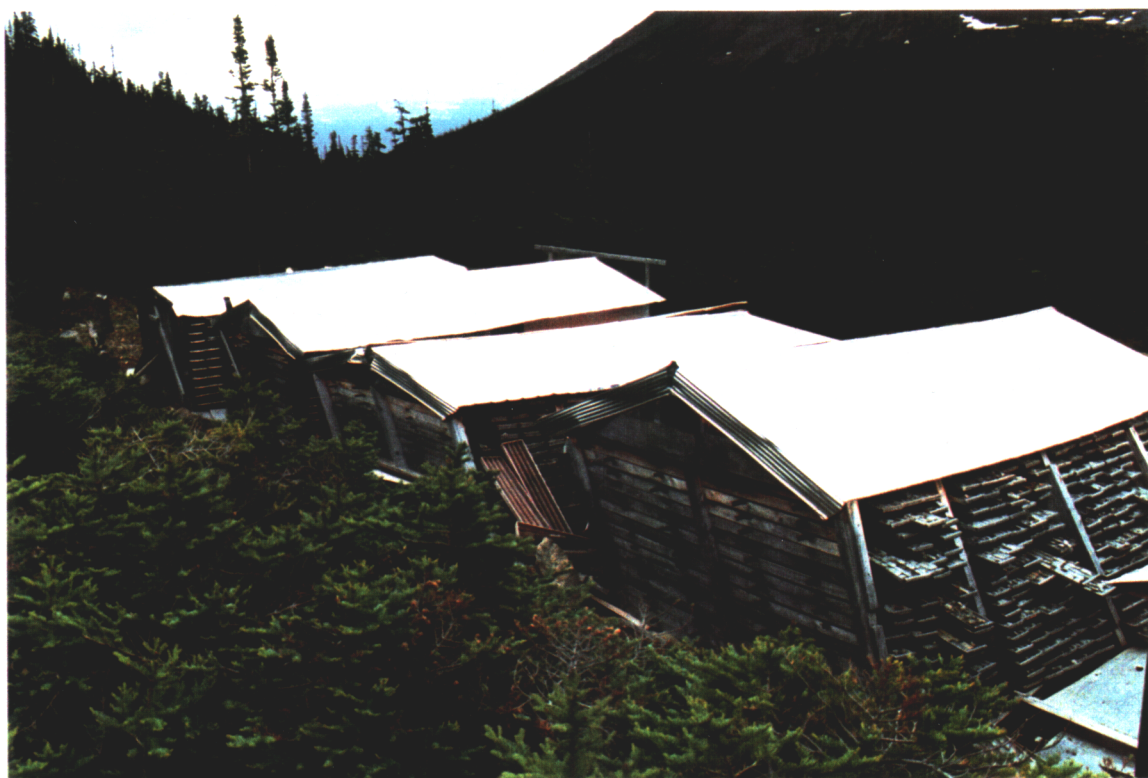
12. CORE STORAGE SHEDS

Core Sheds - An extensive inventory of core is stored in the collapsing core sheds. Proper clean-up of the core storage area would involve loading all core on trucks and hauling the core off site to a central storage facility. The collapsing sheds could then be piled and burned if all the metal core rack supports and metal roofs were removed. All metal could be removed at the same time other metal waste is being hauled from the site.

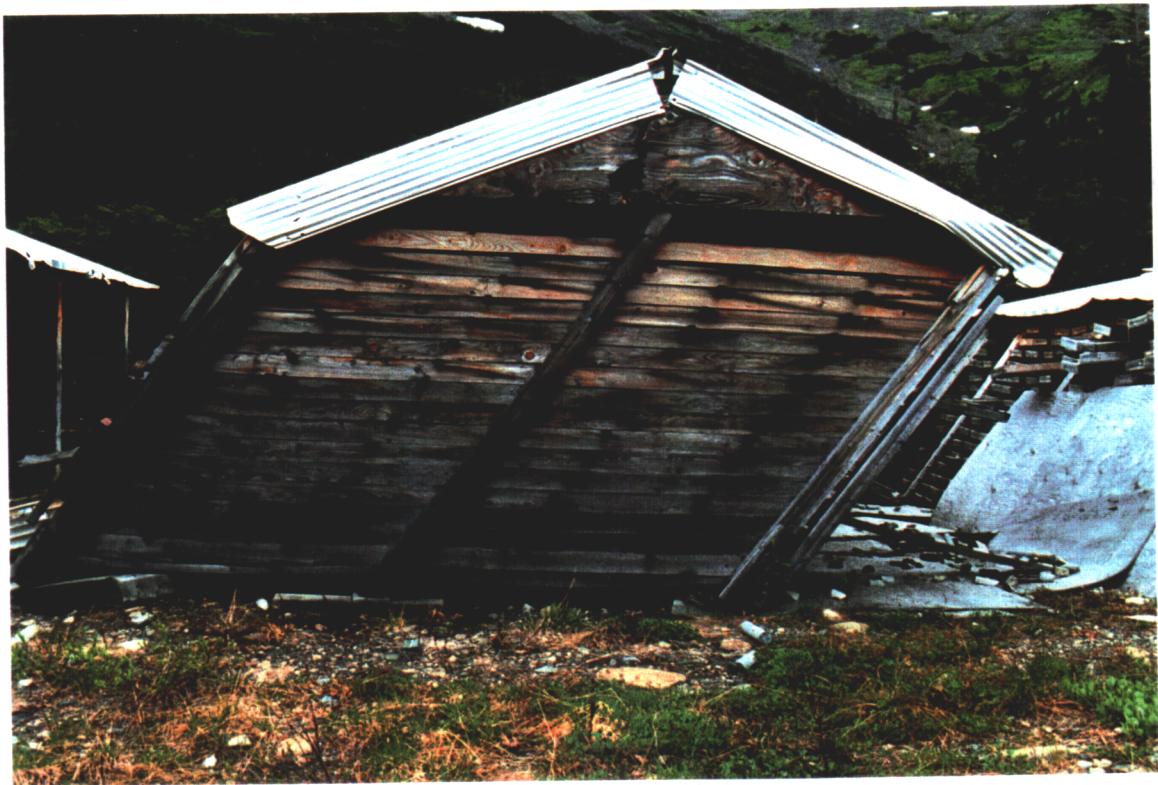
13. COLLAPSING CORE STORAGE SHED
