ASSESSMENT REPORT

105D-03-4

TALLY-HO

DIAND TECHNICAL SERVICES

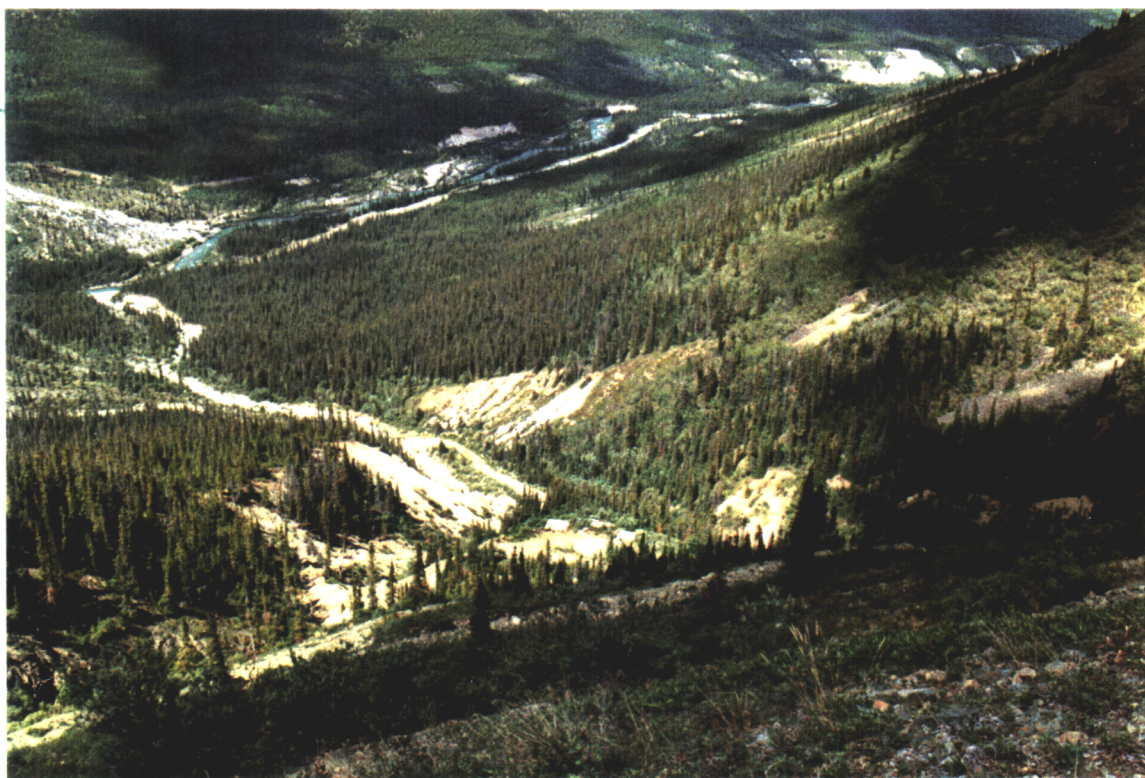
TALLY-HO CREEK AND EXPLORATION CAMP SITE (MIDDLE OF PHOTO)

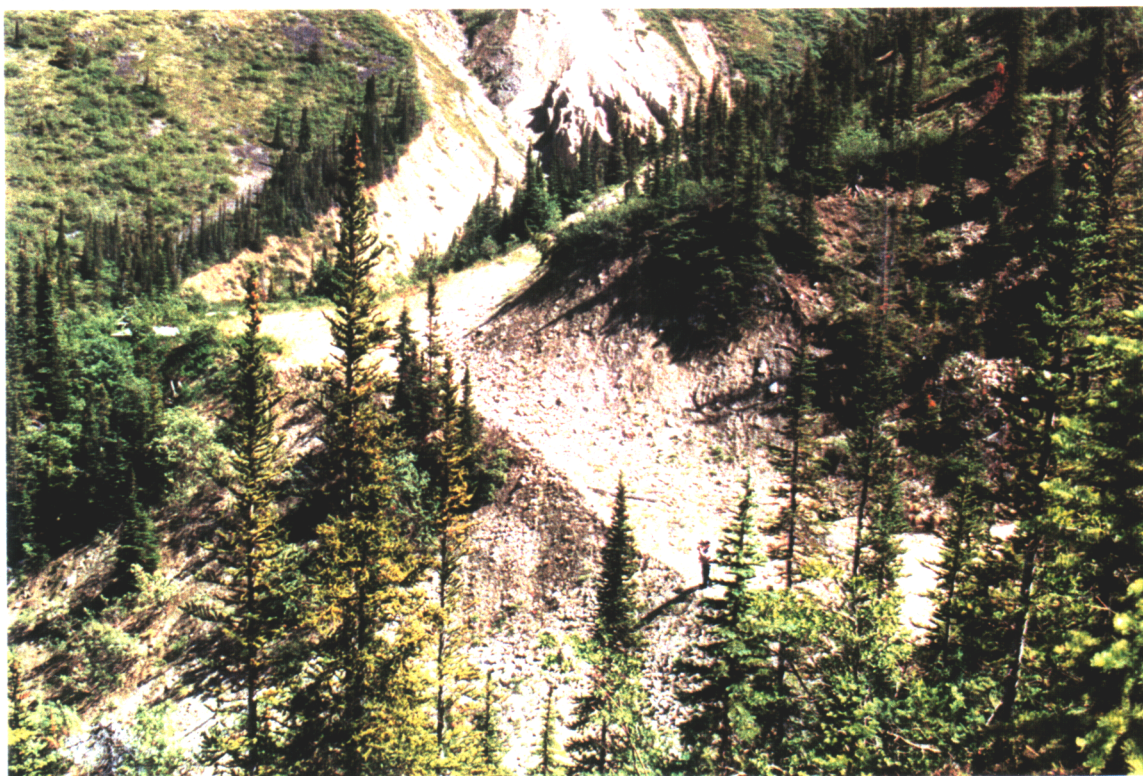
CAMP SITE LOCATION AND AREA NEAR LOWER ADIT

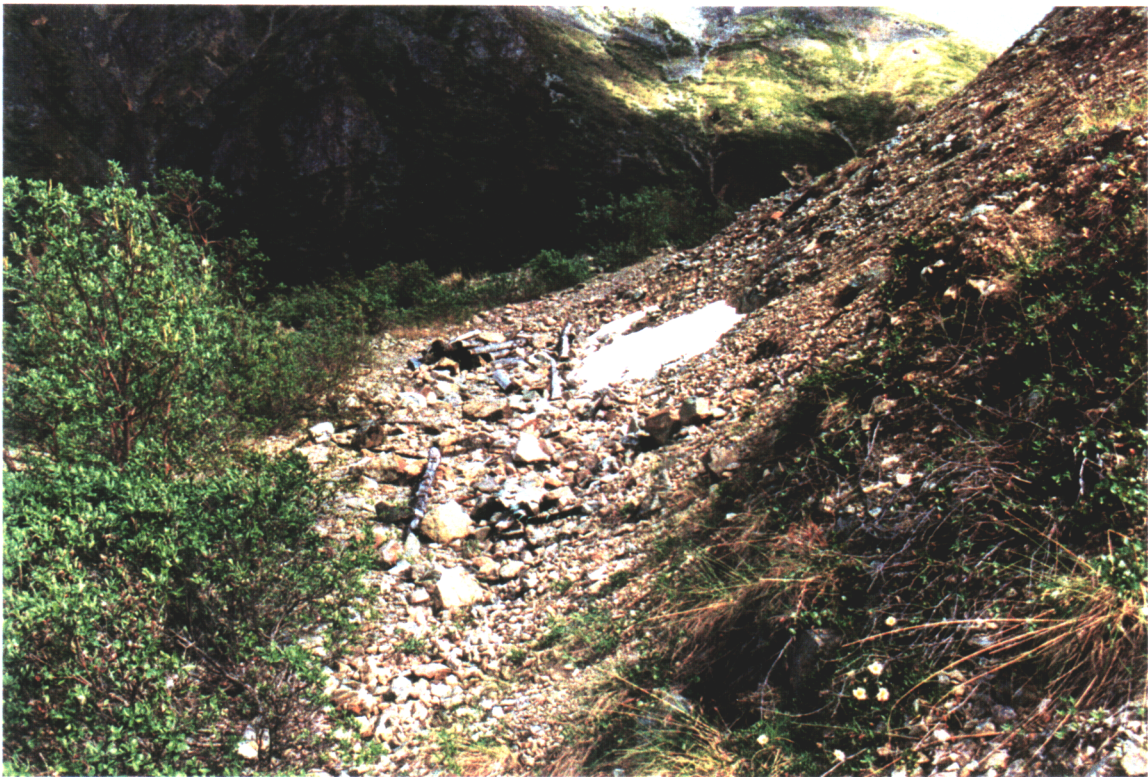
Over time the trails have been overgrown with the local vegetation encroaching from the sides, and any oversteepened cut slopes have usually ravelled, reestablishing the original slope angles in the area.

EXPLORATION TRAIL (NOTE REVEGETATION AND NATURAL SLOUGHING)

The exploration trails to the site are steep and narrow and constructed on coarse granular material. The area is dry with only some surface ravelling taking place. Revegetation on the road surface and "cut slopes" has started and in some cases is well advanced. Leaving the area to recover naturally appears to be working at this location. Reshaping the drill roads to completely blend in to the natural landscape would be very costly and disturb any natural recovery that has occurred in the area, and is not recommended.

Revegetating roads and drill sites is considered a **VERY LOW** priority for this area.

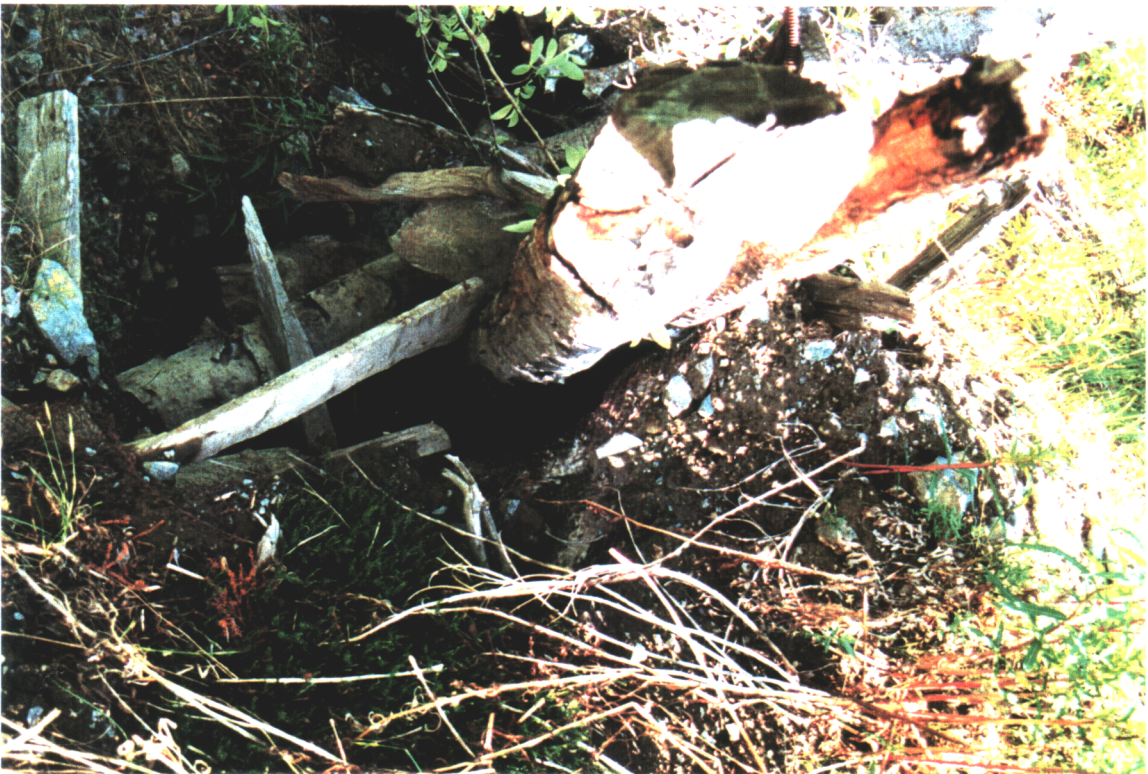
The lower adit, developed over 70 years ago, is collapsed and overgrown at the entrance. The lower adit is located on a steep slope whereas the upper adit could not be found. It appears that the upper adit has either collapsed or was sealed and is no longer visible from the surface.

ENTRANCE TO LOWER ADIT

Very little remains from the exploration activity at this site. The remnants of one collapsed adit is visible but the other adit could not be found. This other adit is either in another location or it has been sealed off. The area was inspected in some detail for this other adit and it appears to have been buried.

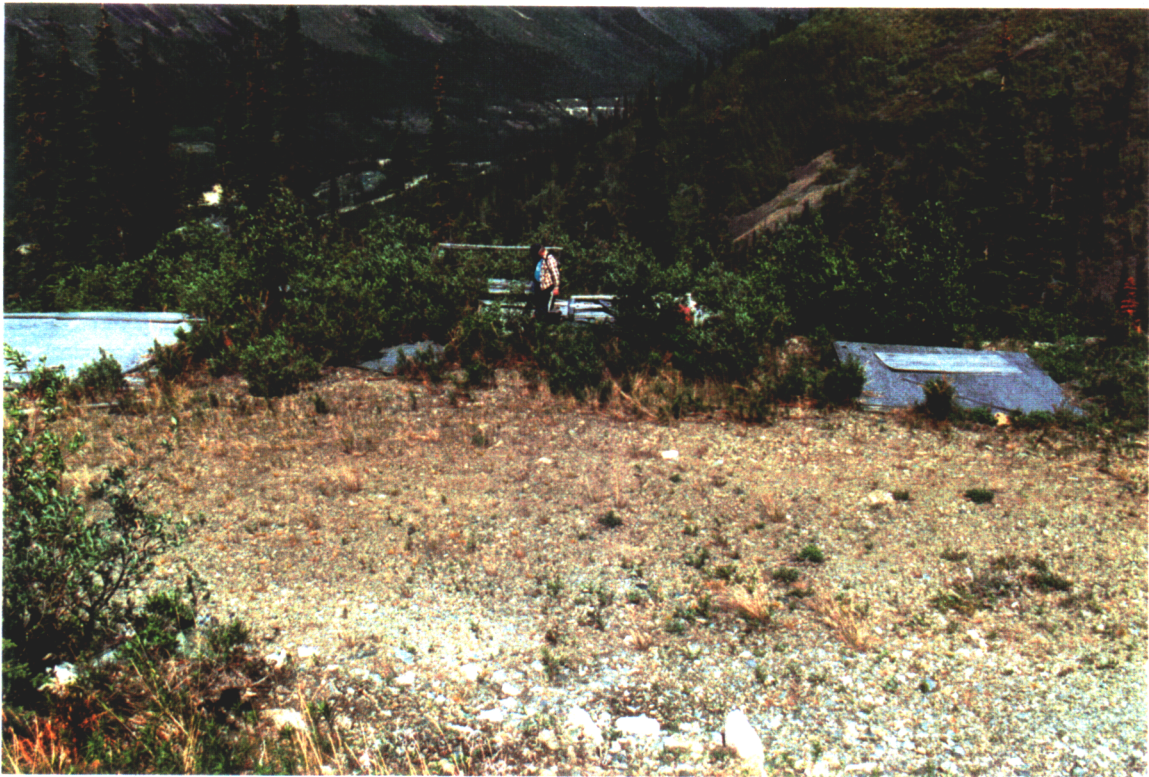
- 15 empty 204 litre fuel barrels,
- 2 plywood tent frame floors (3.7x4.9m), and
- poor trails to the exploration area.

TENT FRAME FLOORS

If a waste clean-up program is ongoing in the area, it is recommended that the 15 barrels be removed from the site. Recovery of these barrels will have to be completed using a helicopter as the site is not practically reached without upgrading the road for vehicular traffic. At the same time, the remaining wood waste could be piled and burned in an acceptable location. This work should be considered a **LOW** priority at this location.

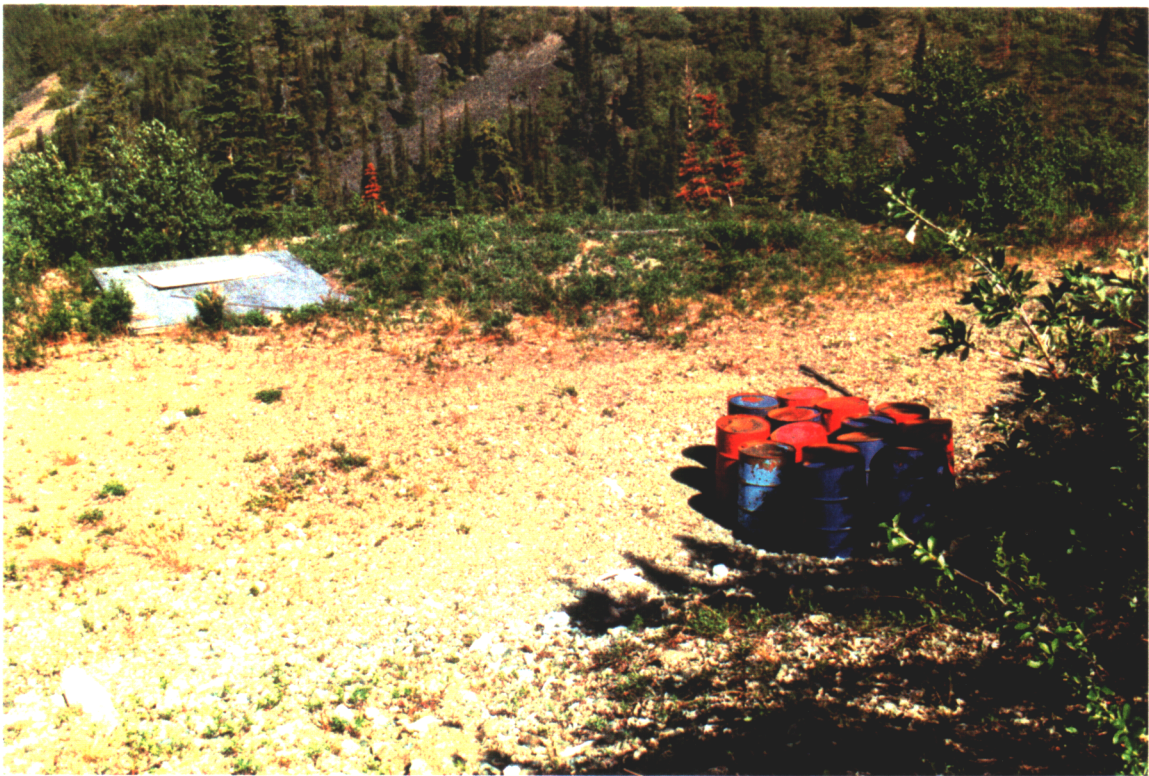
EMPTY FUEL BARRELS AT CAMP SITE

Clean-up of metal waste should be considered if an ongoing waste clean-up program is undertaken in the area. However, the remaining waste is considered to have a **low** level of impact on the environment.
