ASSESSMENT REPORT

105D-06-1

WHEATON MOUNTAIN

DIAND TECHNICAL SERVICES

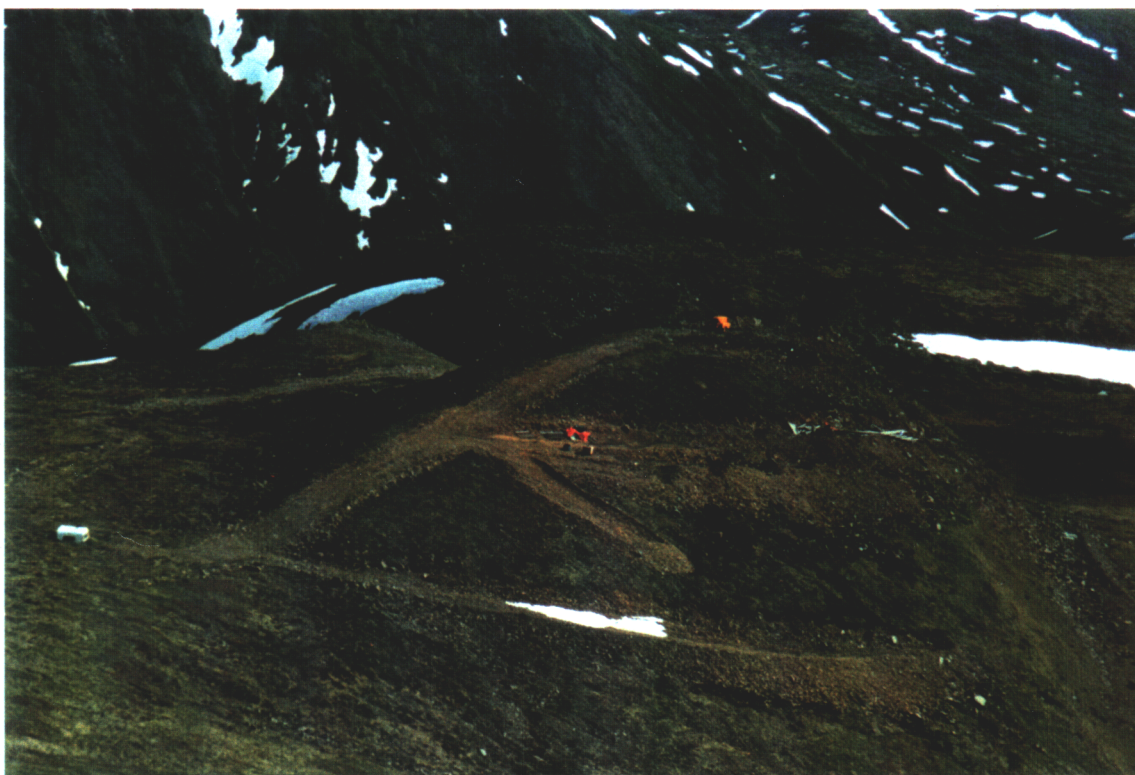
Disturbance of this site is limited to a relatively small area measuring approximately 100x200m in size. This disturbance observed at this site has been from levelling trails and preparing drill sites, and a minor amount of trenching. This surface disturbance has not caused any instability or erosion.

OVERVIEW OF SITE

Disturbance of this site was caused mainly from trenching and constructing trails to drill sites. This trail construction and trenching resulted in destroyed vegetation that has left surface scarring. However the amount of disturbance is very limited and it is recommended that this surface damage be left to recover naturally. Regrading any surface workings will only damage more ground, and revegetating this area is considered impractical in this remote area.

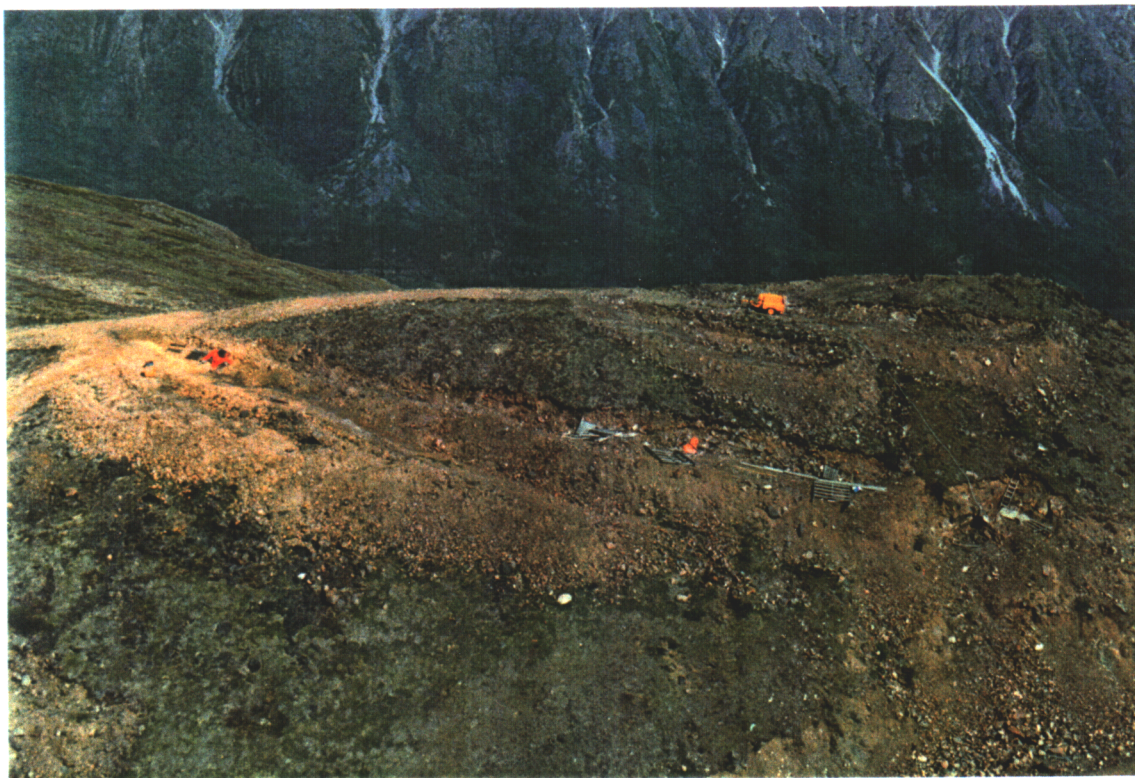
- 1 unlocked container filled with explosives measuring 915x610x610mm,
- 1 Ingersoll Rand compressor complete with drill and approximately 60m hose,
- 4 empty 205 litre barrels,
- wood decking/logs,
- camper top,
- approximately 8 litres of oil, and
- approximately 6 empty core boxes.

CLOSE-UP OF SITE

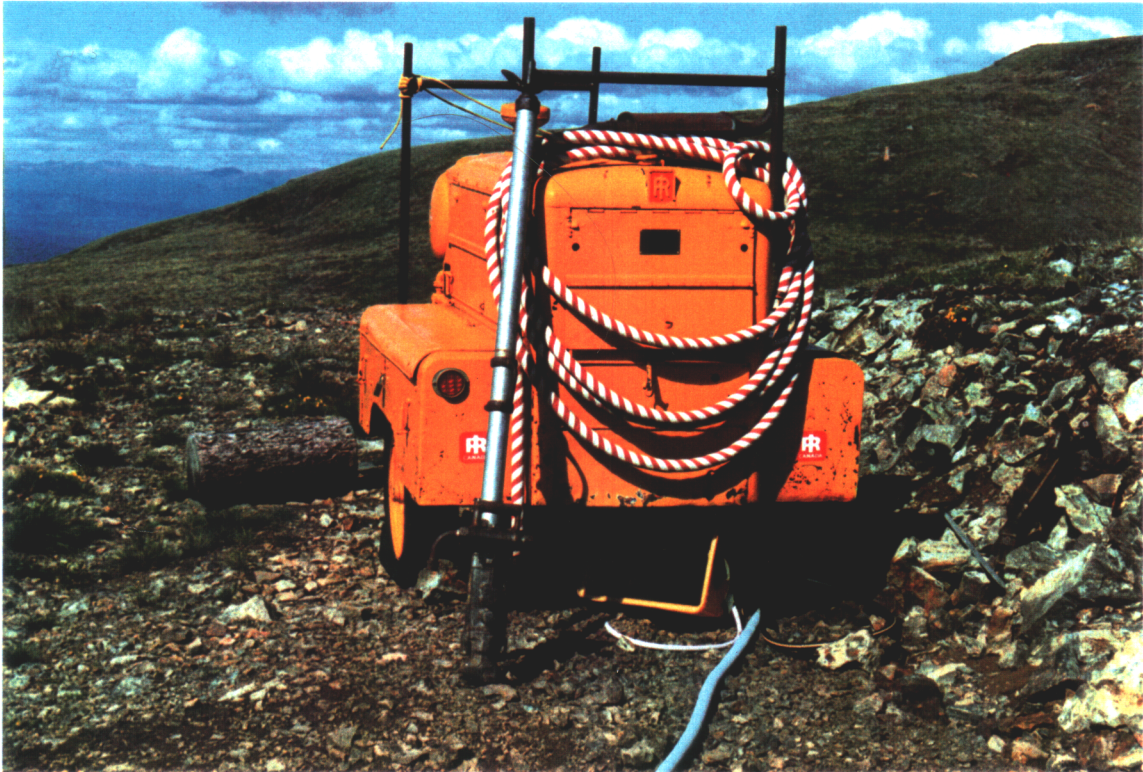
As noted, an air compressor, drill, associated hose, explosives, and various pieces of metal waste has been left at this site. From the historical records it appears that this equipment was last used in 1991. Since then little deterioration appears to have taken place.

INGERSOLL RAND COMPRESSOR AND DRILL

- remove or destroy the explosives,
- gather all barrels scattered across the area and remove them from the site,
- stockpile all wood timbers, posts and core boxes and dispose by burning,
- remove the compressor, drill, and associated hose from the site,
- remove the small container of oil from the site.

Removal of the equipment and waste from the site can either be completed from road access, if one can be confirmed, or by flying all material off the site. The compressor tires are flat and would need to be repaired if it was to be driven off site. If it is flown off site a medium lift helicopter would need to be used. This clean-up work is considered to be a **LOW** priority for environmental clean-up.

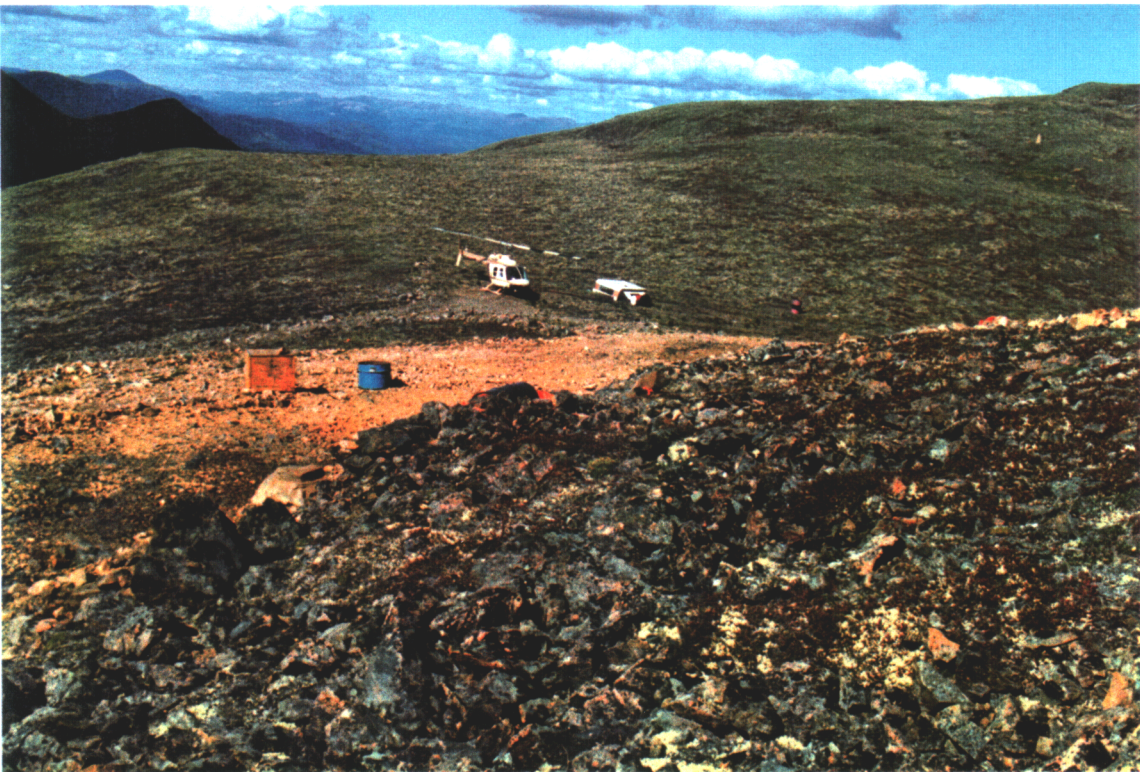
The bags of explosives are contained in an unsecured wooden box and are exposed to moisture. The explosives container does not clearly identify the contents and should be considered **EXTREMELY DANGEROUS**. These explosives should be disposed of immediately or stored in a properly secured explosives magazine.

The most significant concern at this site is one of public safety with the unsecured explosives that have been left. The explosives should be considered a **HIGH LEVEL OF RISK** and should be removed or disposed as soon as possible.

EXPLOSIVES MAGAZINE (YELLOW) AND CAMPER TOP (BESIDE HELICOPTER)

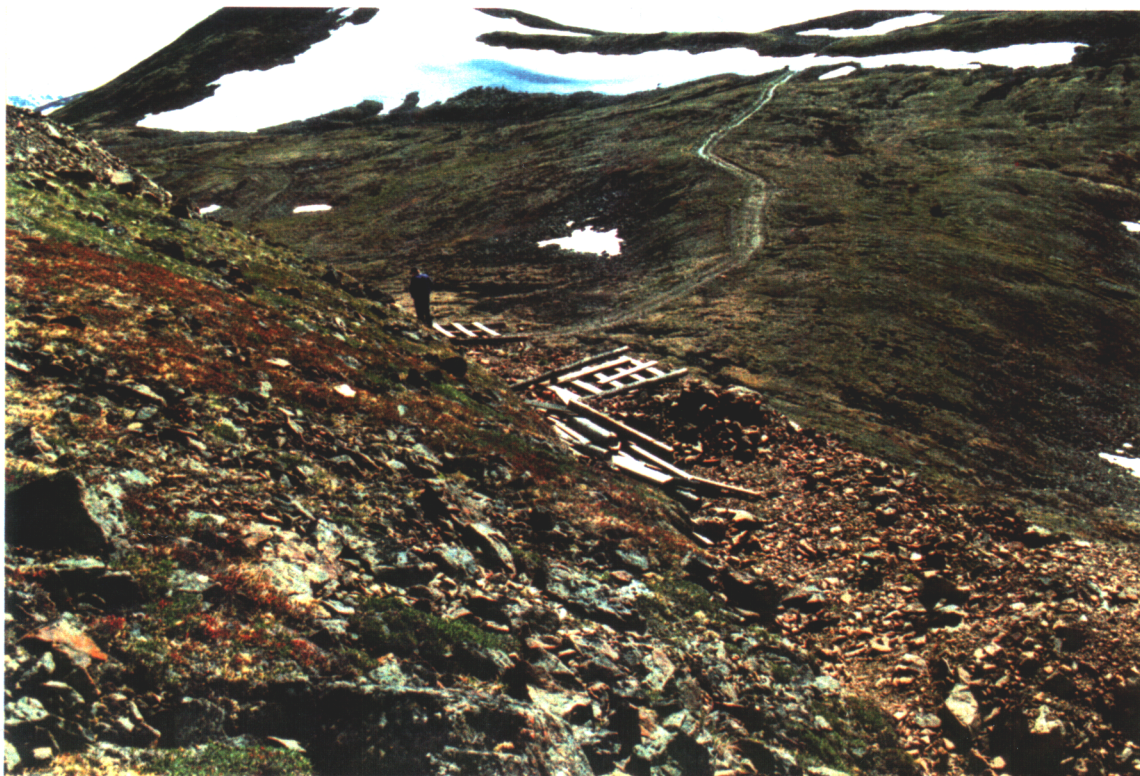
WOOD TIMBERS (FOREGROUND) AND ACCESS TRAIL TO SITE (BACKGROUND)
