**ASSESSMENT REPORT**

**105M-14-8**

**GAMBLER**

**DIAND TECHNICAL SERVICES**

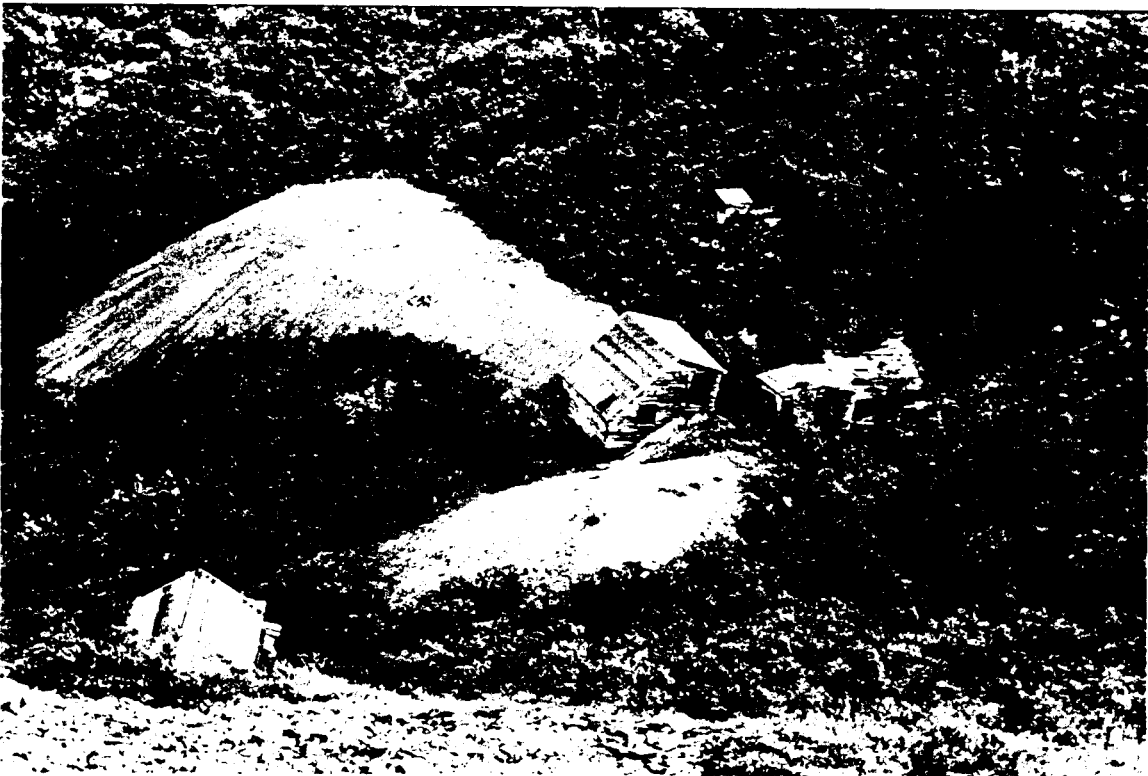
- a 6x9m wood frame, wood clad building used as a cookhouse. Metal bedframes were still in the building,
- a 7x7m empty one and one half story wood frame, wood clad building,
- a 6x10m empty wood frame, wood clad building
- remnants of a collapsed hand excavated adit, and

- a rock waste dump approximately 50m long and 40-50m wide was spilled downslope of the adit.

ADIT AND WASTE ROCK DUMP

Any environmental impact occurred at this site many years ago when the exploration work was ongoing. Since that time the site appears to have been recovering with vegetation growing over the site, with the exception of the waste rock piles which are still barren. Any buildings left on-site are also deteriorating and are beginning to collapse. The adit has collapsed at the entrance, and was difficult to find. This adit does not pose any safety hazard.
