ASSESSMENT REPORT

105O-02-1

SAMOVAR

DIAND TECHNICAL SERVICES

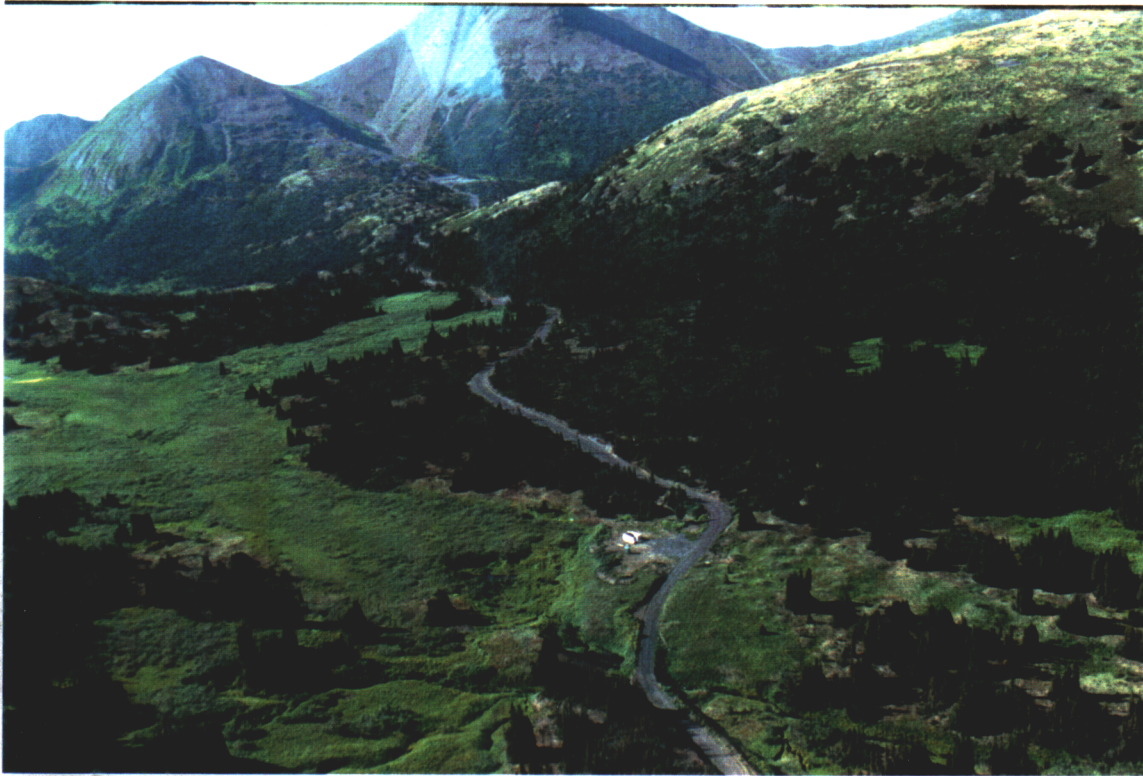
The predominant feature from the development is the road up the valley and the exploration trails on the steep mountain slope. The road to the site was well constructed with minimal disturbance to the surrounding terrain in the valley portion of the road. As the road rises up the mountain to the main exploration area significant mass wasting down the mountain slope has been caused by excavating material out of the mountainside. This method of exploration has buried much of the original vegetation. This disturbed material has also eroded downslope. No terrain instability was apparent at the time of inspection on 1993/07/27.

ACCESS ROAD AND EXPLORATION SITE ON MOUNTAIN (LEFT)

The main access road has been developed in the least damaging way, generally following the bottom of the valley leading to the site. Very little cutting or filling of the slopes resulted and no evidence of any slope instability or erosion was observed or expected. It is recommended that this road not be touched and revegetation left to occur naturally at this remote site.

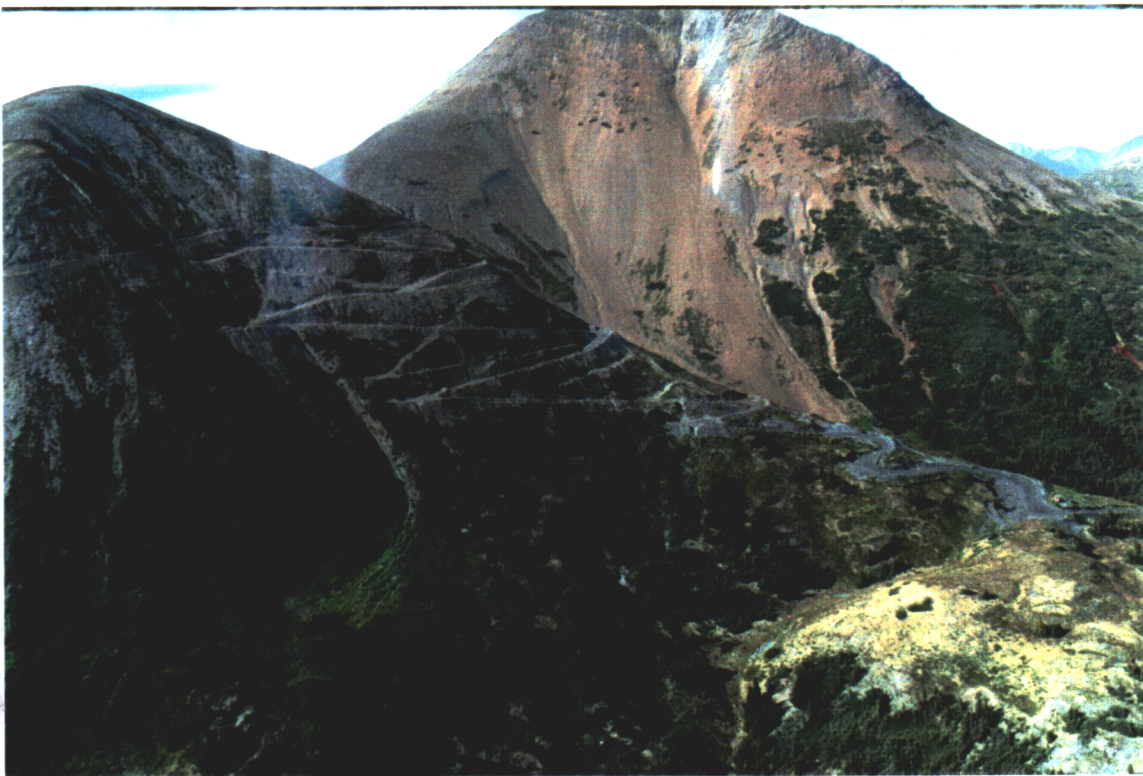
The most impact at this site has been caused by the exploration activity on the mountainside. This exploration activity has caused extensive damage to the vegetative cover as well as causing erosion of the excavated material that had been pushed downslope. Site remediation, if it was undertaken, would consist of reshaping the excavated mountainside. This would likely cause additional damage to vegetation and damage any new vegetation that had started to regrow on these excavated slopes. Because there appears to be little ongoing damage it is recommended that reshaping and revegetation techniques not be considered at this very remote, dry site.

EXPLORATION AREA

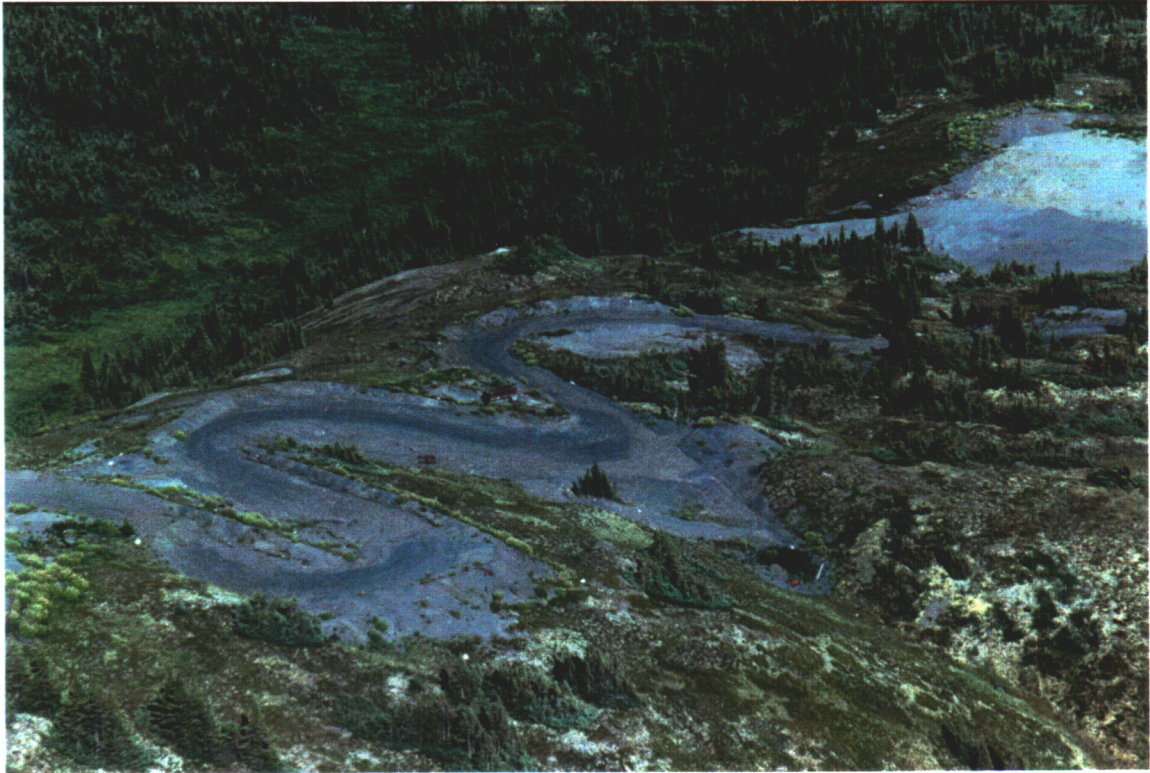
ROAD BETWEEN CAMP AND EXPLORATION AREA

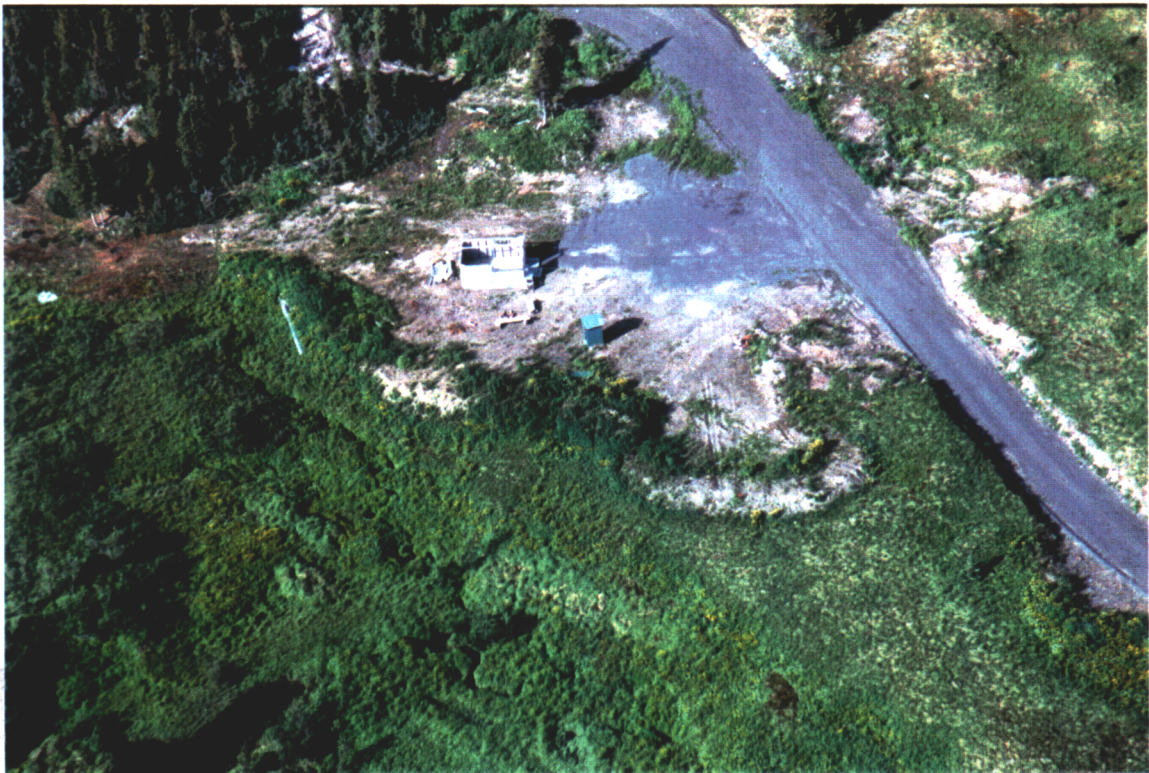
The only other site disturbance is from the remains of an exploration camp. An old wood frame building with plywood walls but no roof, two pieces of metal sheathing (each measuring 2x3m), and a plywood clad outhouse are the only remaining buildings on-site. Some scattered wood lumber appears to be the only other remnants from the exploration activity left around the camp site.

CAMP SITE

The only other remaining infrastructure impacting the environment at this site is the remaining building and wood waste. This material has a **VERY LOW** impact on the environment, with the major impact being visual. It is recommended that this material be removed from the site only if a clean-up program has been initiated in the area. The wood waste material, if it was disposed, should be piled and burned in an appropriate area.
