ASSESSMENT REPORT

115I-07-1

TINTA HILL

DIAND TECHNICAL SERVICES

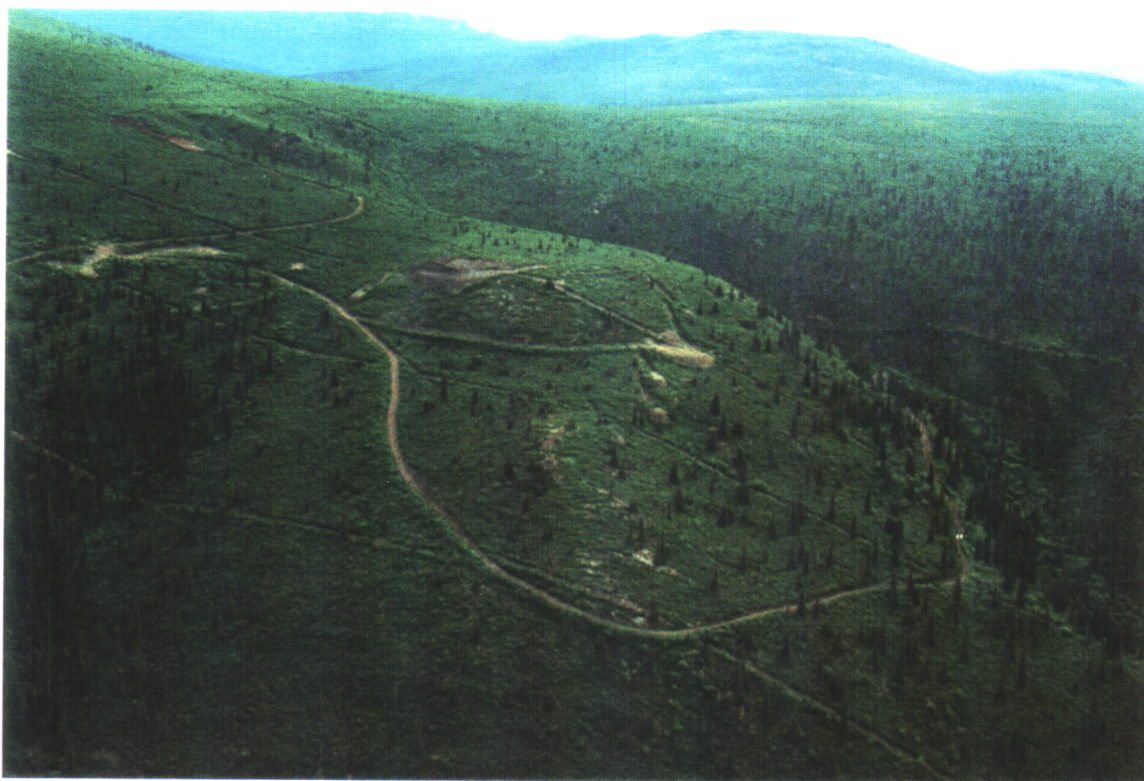
ROAD INTO TINTA HILL SITE

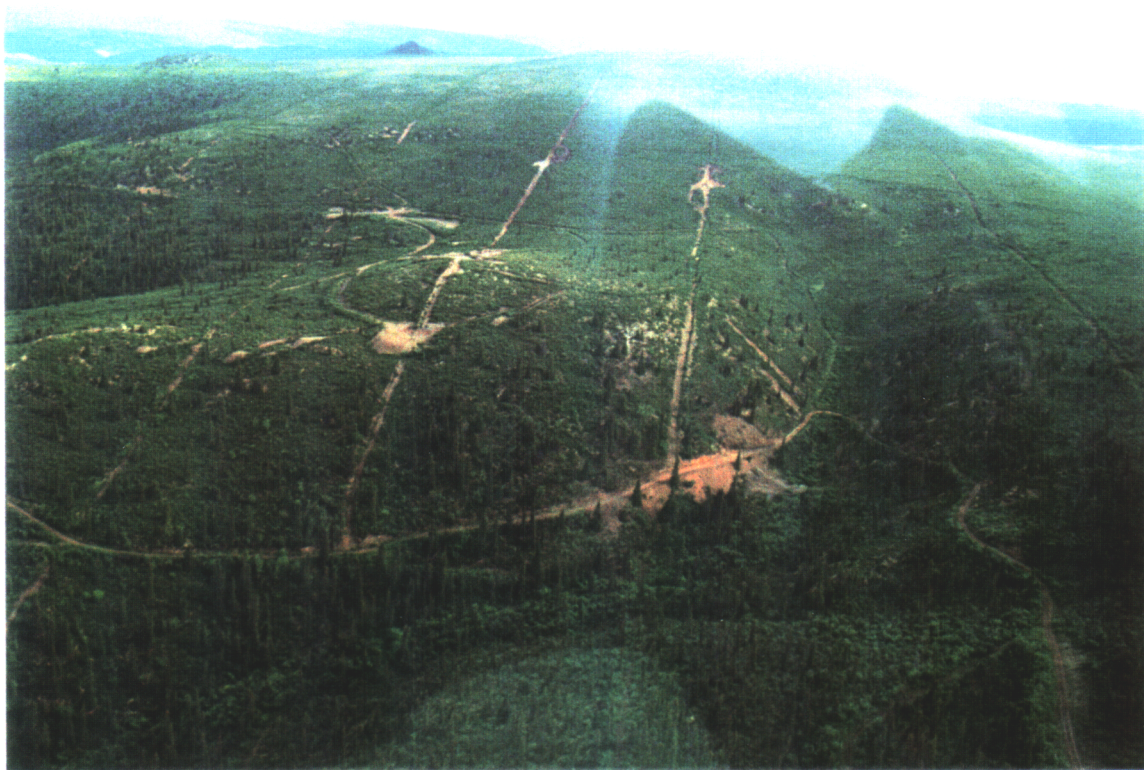
Site disturbance consists of an extensive gridwork of trenching covering several square kilometres. The site has been developed with roads crossing the exploration area and a gridwork of exploration trenching to a depth of up to 3m. The vegetation has been removed wherever road or trenching operations took place. Vegetation is well established over the older parts of the site.

EXPLORATION AREA

Attempting to revegetate the roads and exploration areas would be very difficult. The disturbed areas will eventually revegetate themselves from the local vegetation encroaching into the disturbed areas as is occurring on the older parts of the site. This revegetation process is likely the only practical solution in an area that is remote with a harsh climate.

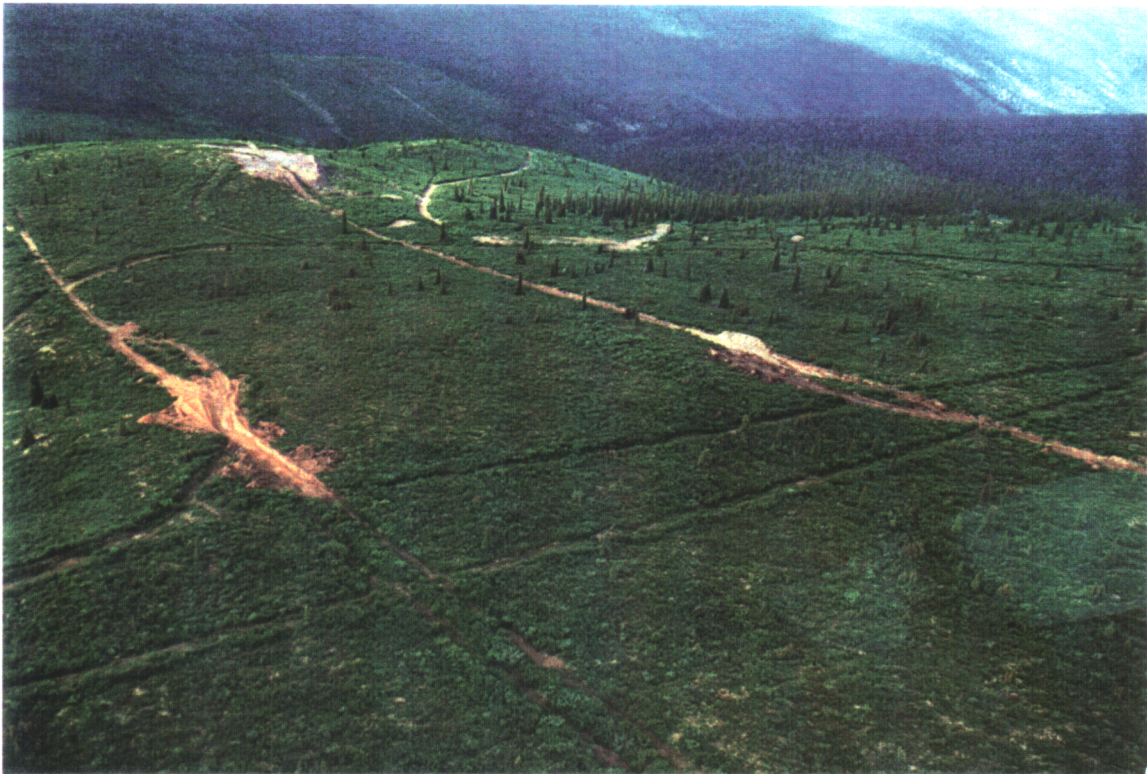
OLD AND NEWER EXPLORATION TRAILS

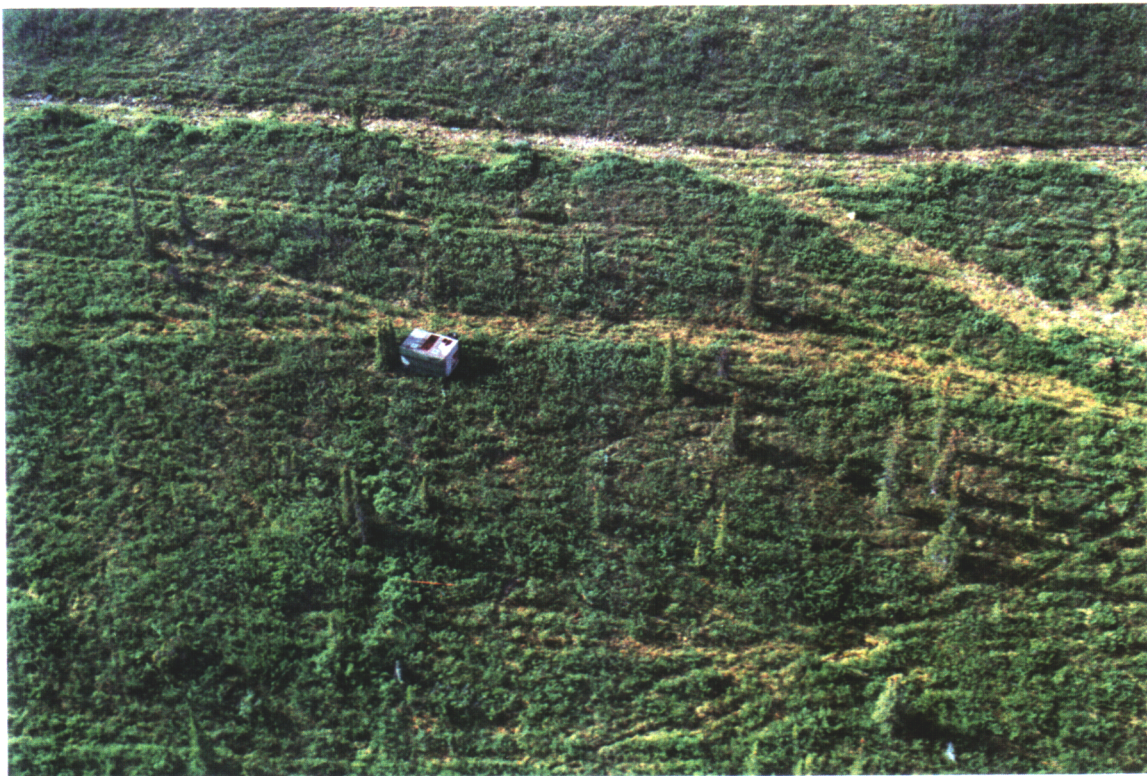
The only remaining infrastructure spotted at the site was one very old trailer.

TRAIL ABANDONED ON-SITE

The old trailer left on-site is not causing any continuing environmental damage and is considered to be a **LOW** priority for clean-up. It is recommended that this trailer be removed only if a general clean-up program is initiated in this area.
