**ASSESSMENT REPORT**

**106C-05-2**

**VERA**

**DIAND TECHNICAL SERVICES**

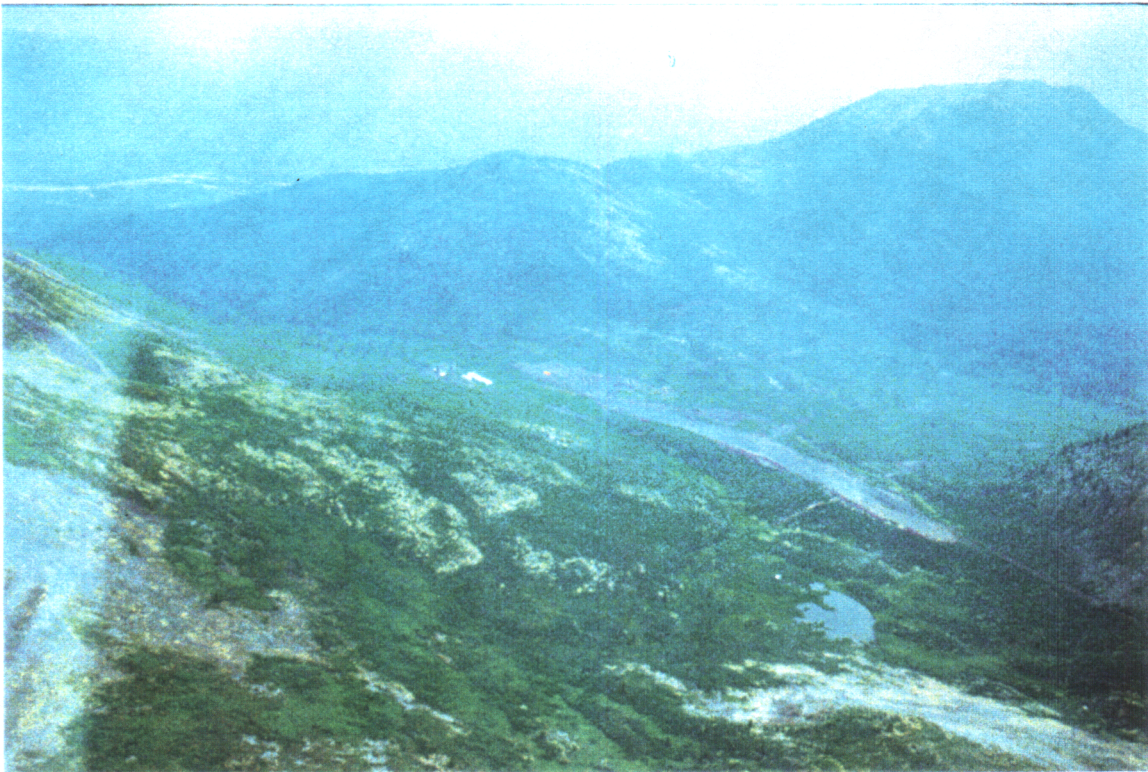
VIEW OF AIRSTRIP, CAMP SITE, AND SURROUNDING TERRAIN

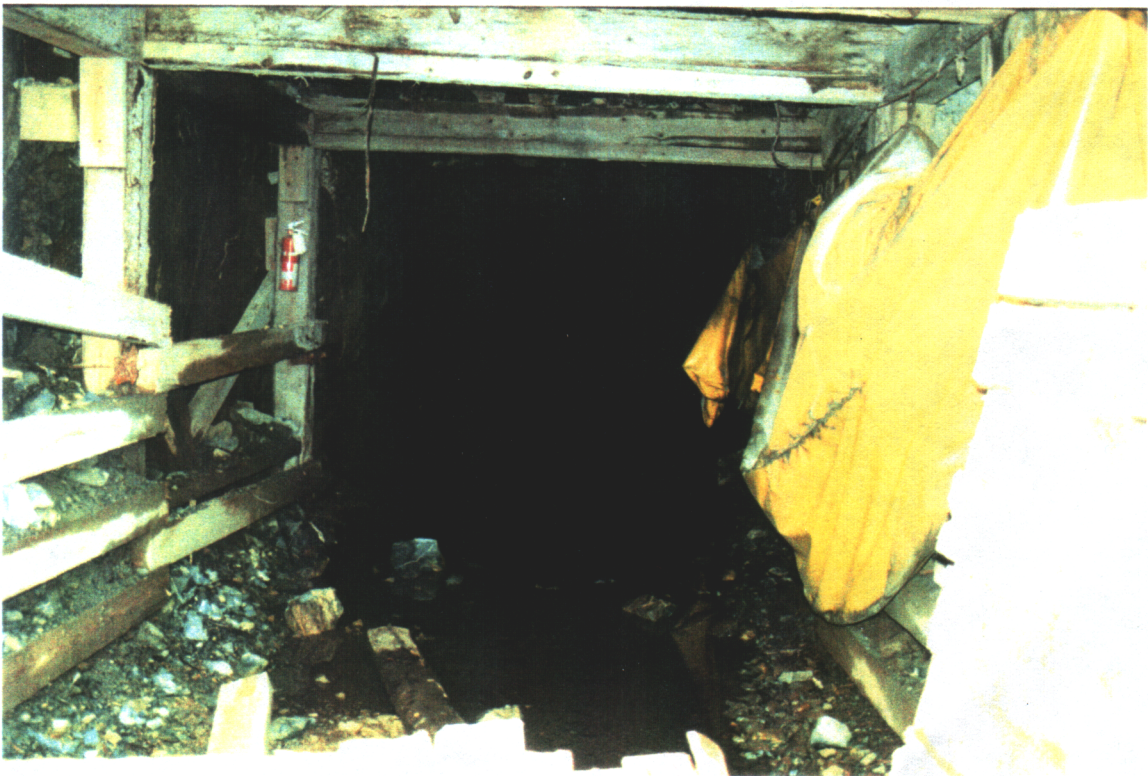
In addition to this list of material piping extends into the open adit.

INTERIOR OF OPEN ADIT

The adit has been left open and is accessible. Some seepage continues to exit the adit. It is recommended that the adit be properly sealed to prevent anyone from entering the adit. Because the site is so remote this work is not considered a high priority, although leaving it open does leave a public safety hazard. If it is sealed the seepage should be allowed to continue.

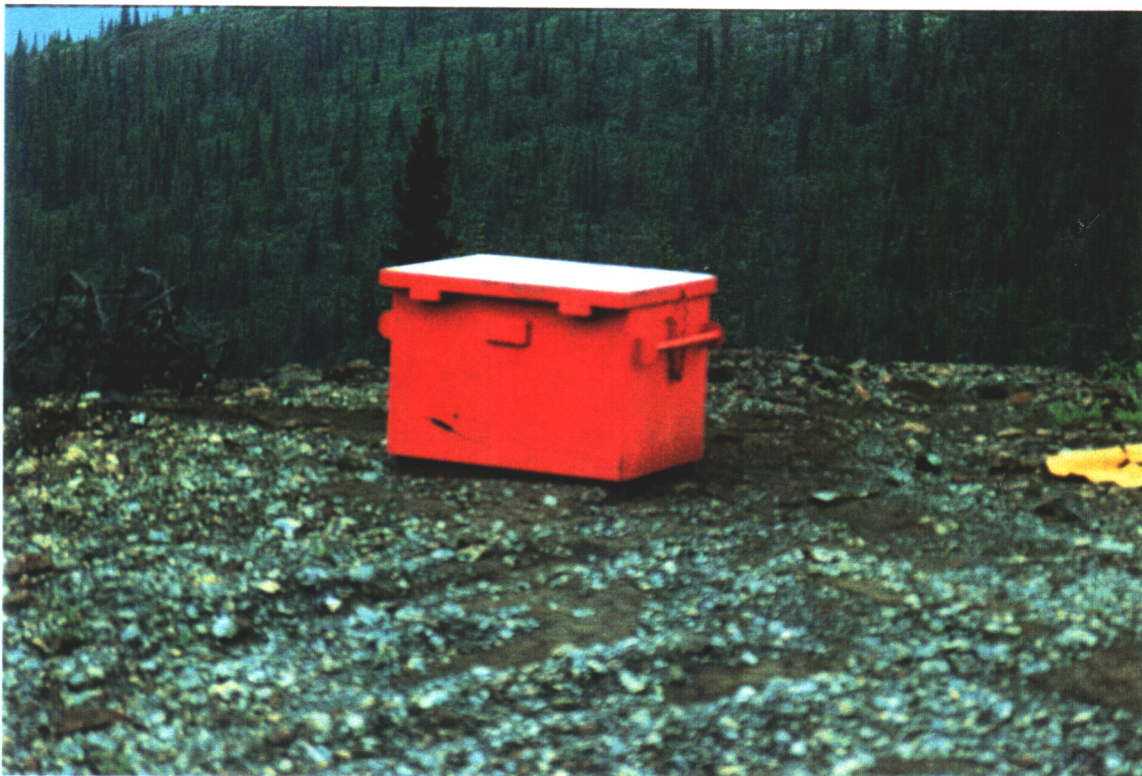
EXPLOSIVES MAGAZINE

The contents of the explosives box should be confirmed with the owners. Once the contents of the explosives magazine is confirmed an appropriate plan to remove or store any explosives can then be made. This should be considered a **HIGH** priority.

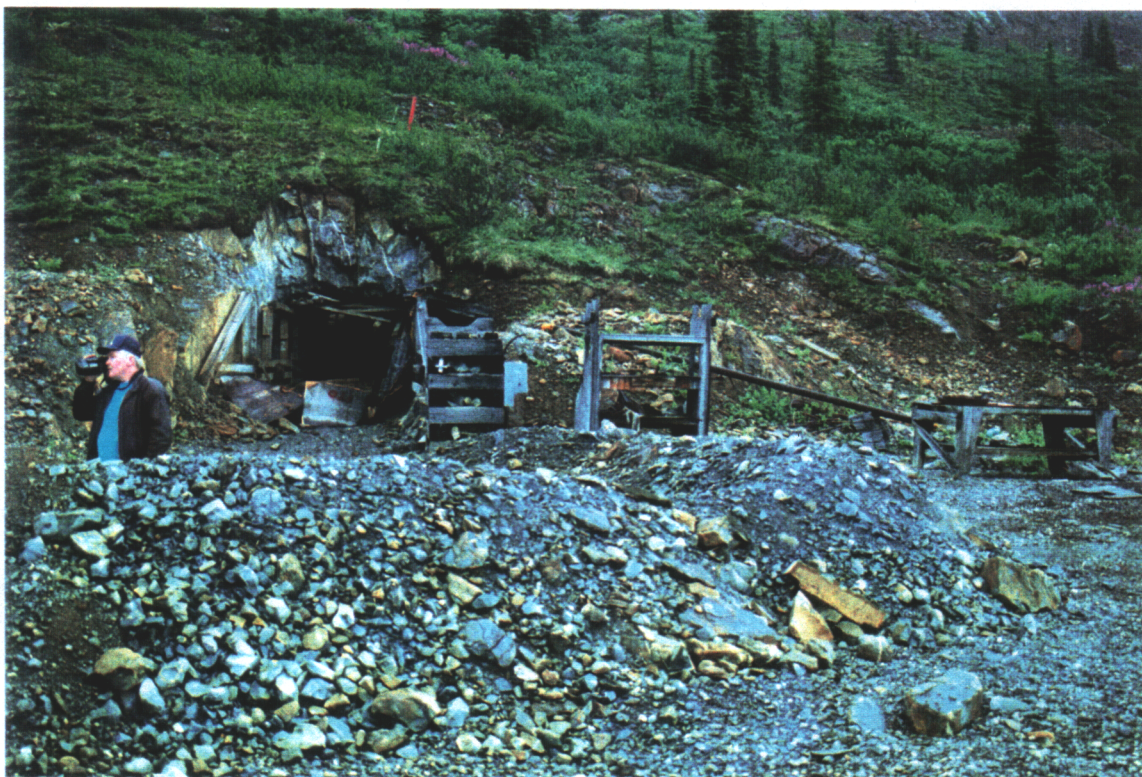
WASTE PILES AND OPEN ADIT

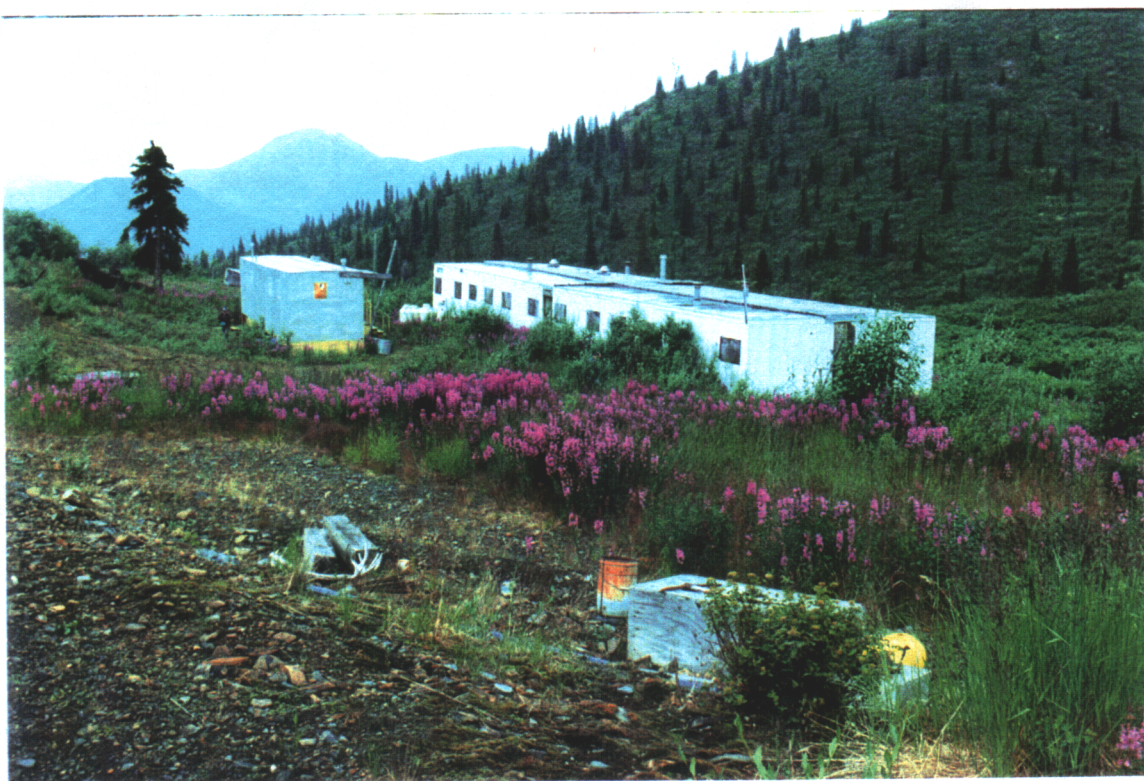
CAMP SITE

The trailers are locked and inaccessible. All buildings are considered a **LOW** environmental hazard. These buildings are deteriorating and will quickly lose any residual value they may still have. Removal of these trailers will be quite costly and it is likely not economically sensible to remove them. However, if a general clean-up program is undertaken for the area then these trailers should be removed if possible.

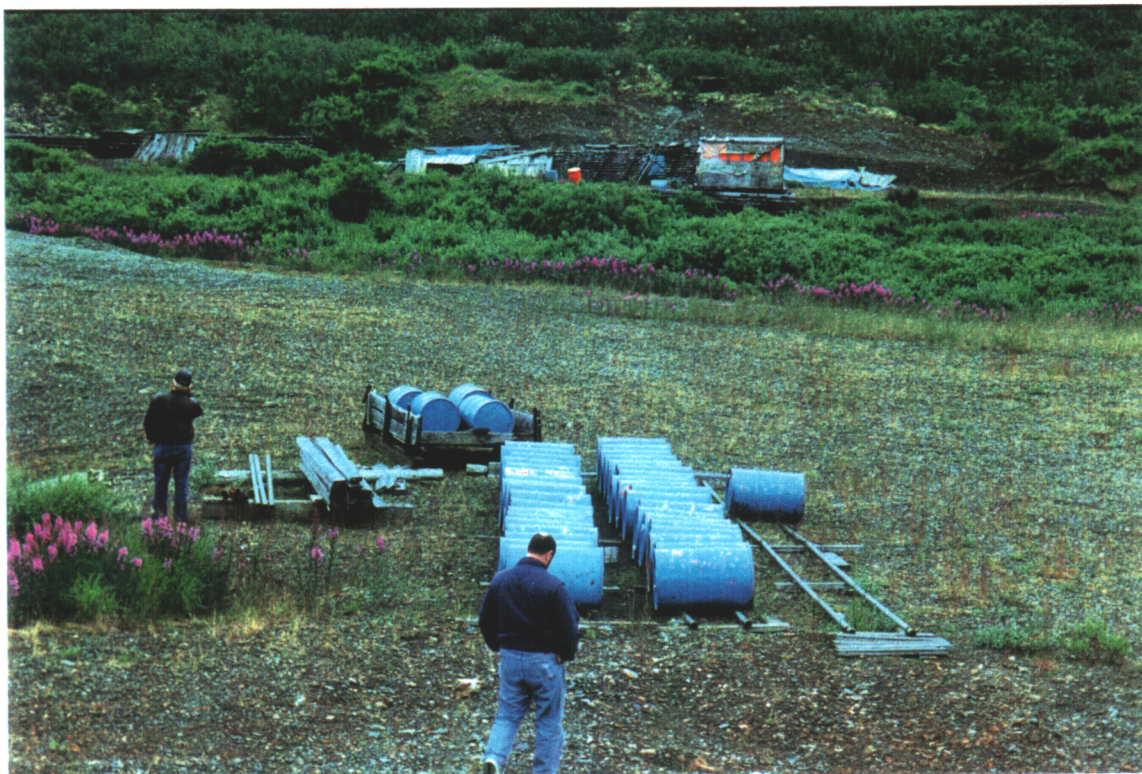
FUEL BARRELS ON AIRSTRIP AND CORE STORAGE AT TOP OF PHOTO

The **HIGHEST** environmental risk at this site appears to be the remaining hydrocarbon products, propane tanks, and acetylene tanks that have been left at the site. The hydrocarbon products could spill and damage the surrounding environment and the propane and acetylene tanks could be dangerous if any contents remain in the tanks. These tanks and hydrocarbon products should be removed as soon as possible and be considered a **HIGH** priority.

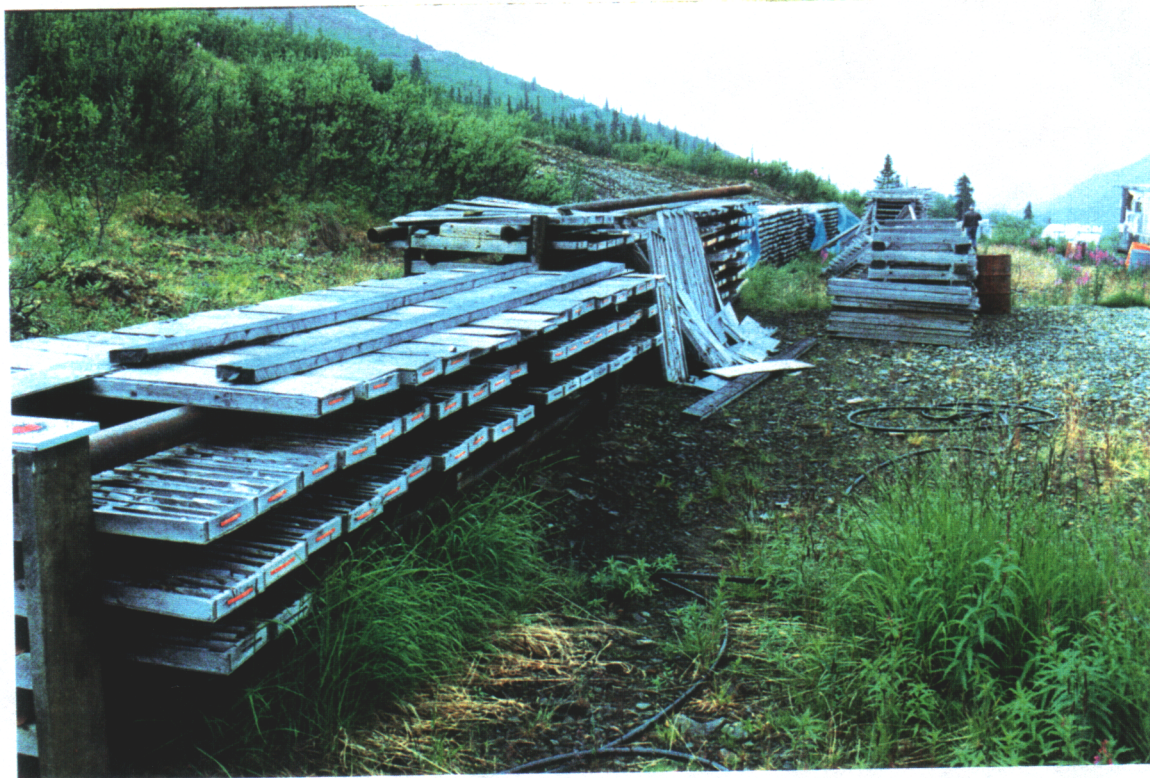
A large amount of core has been left piled at the site but exposed to the elements. The core racks are collapsing with core starting to spill. If this core has any value it would need to be properly stored to maintain the value. An assessment by qualified geologists would need to be completed to determine the value of this core. This core does not appear to have any detrimental long term impact on the environment and is considered a **LOW** priority for clean-up.

CORE STORAGE

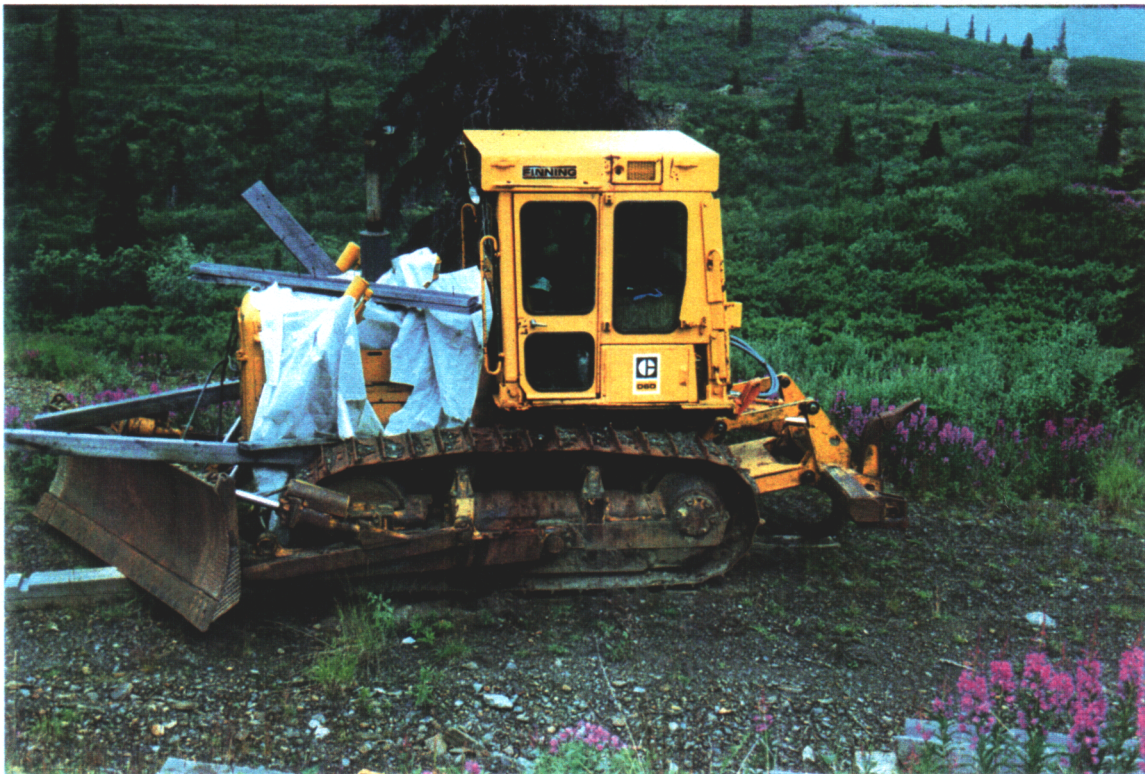
D6 CATERPILLAR DOZER

A large amount of equipment has also been left behind at this site, some of which appears to have significant residual value. The most valuable equipment left behind appears to be the D6 Caterpillar dozer, generators, welders, etc. This equipment will deteriorate and lose any of its value in the very near future. Because the site is so remote, removal of the remaining equipment will be costly. The remaining material appears to have a relatively **LOW** impact on the environment of this very remote site and should be removed only if a general clean-up program is initiated in the area.

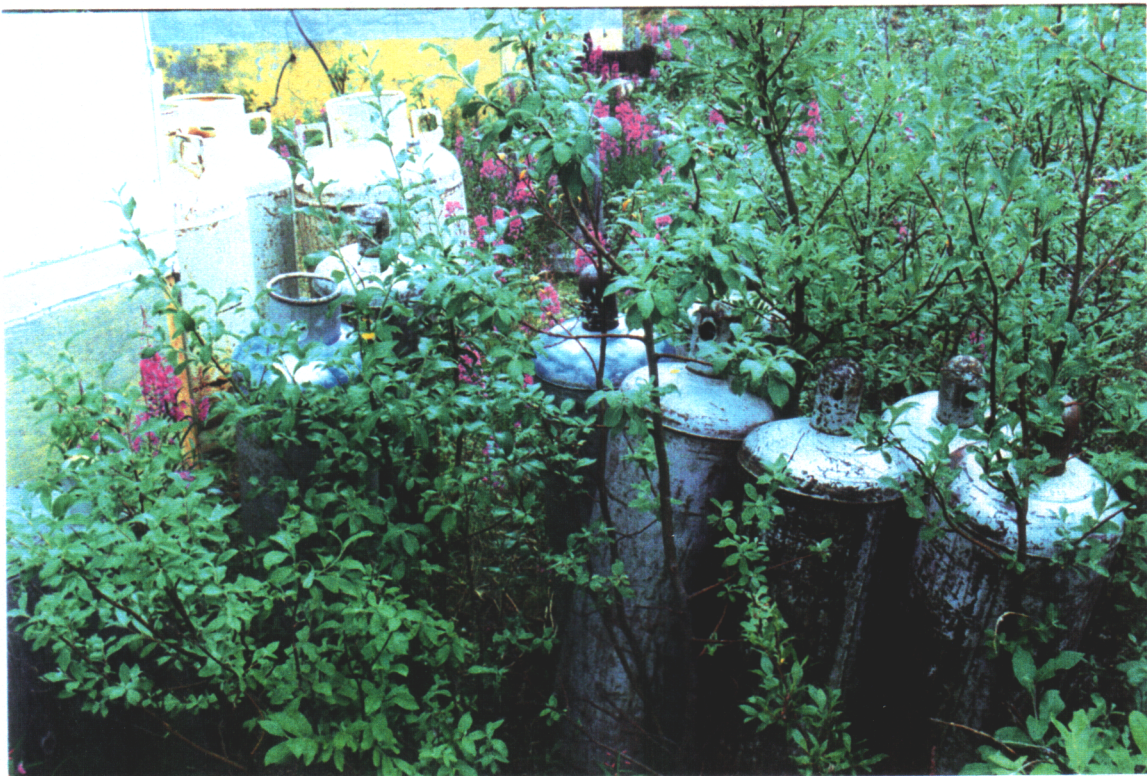
PROPANE TANKS
