**PHASE II ENVIRONMENTAL ASSESSMENT
OF THE
BECKER COCHRAN
ABANDONED MINE SITE**

**Action on Waste Program
Indian and Northern Affairs Canada**

**Environmental Services
Public Works and Government Services Canada**

March 1997

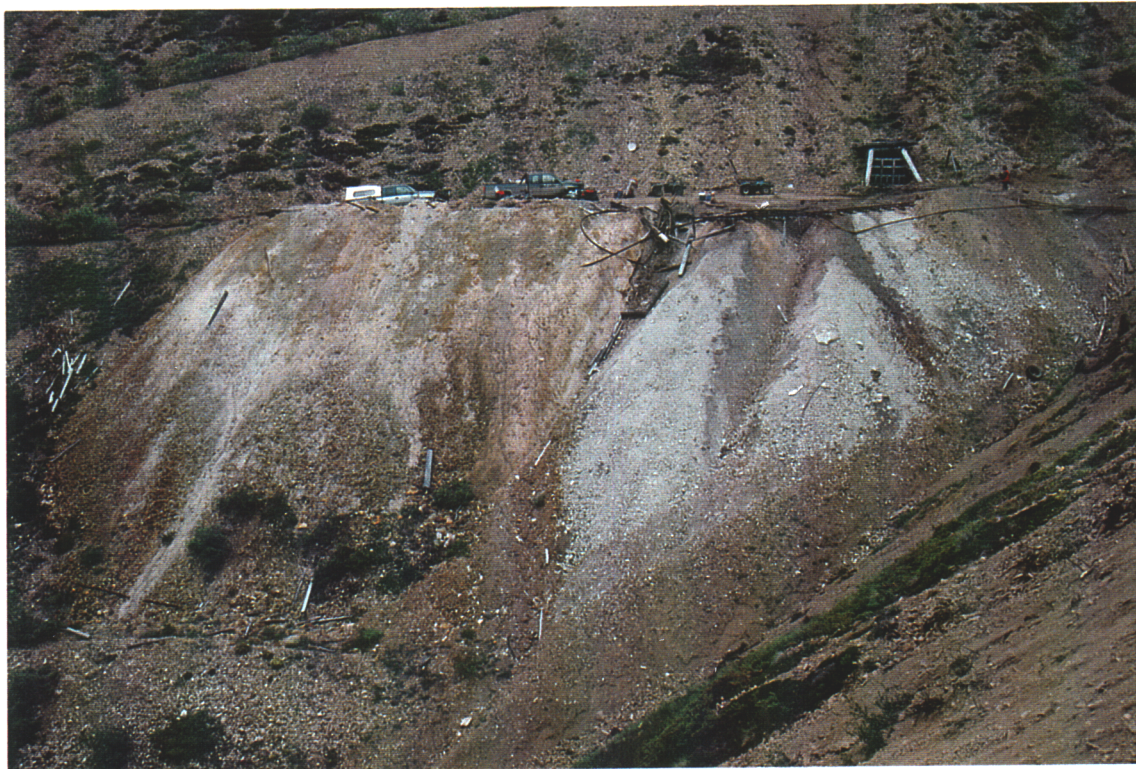
Photo # 1 - Waste Rock, Below Lower Adit

Approximately 20% of the surface area of the waste rock piles is stained reddish from secondary iron minerals and 12% is composed of yellow/green coloured clay from the mineralized shear zones. It is estimated that there is between 3000 and 4000 tonnes of mineralized waste rock at the Becker Cochran site, assuming that the proportion of mineralized to unmineralized waste rock on the surface is representative of the total waste rock pile. The distribution of mineralization in the waste rock piles is shown on a site map, Drawing 2.

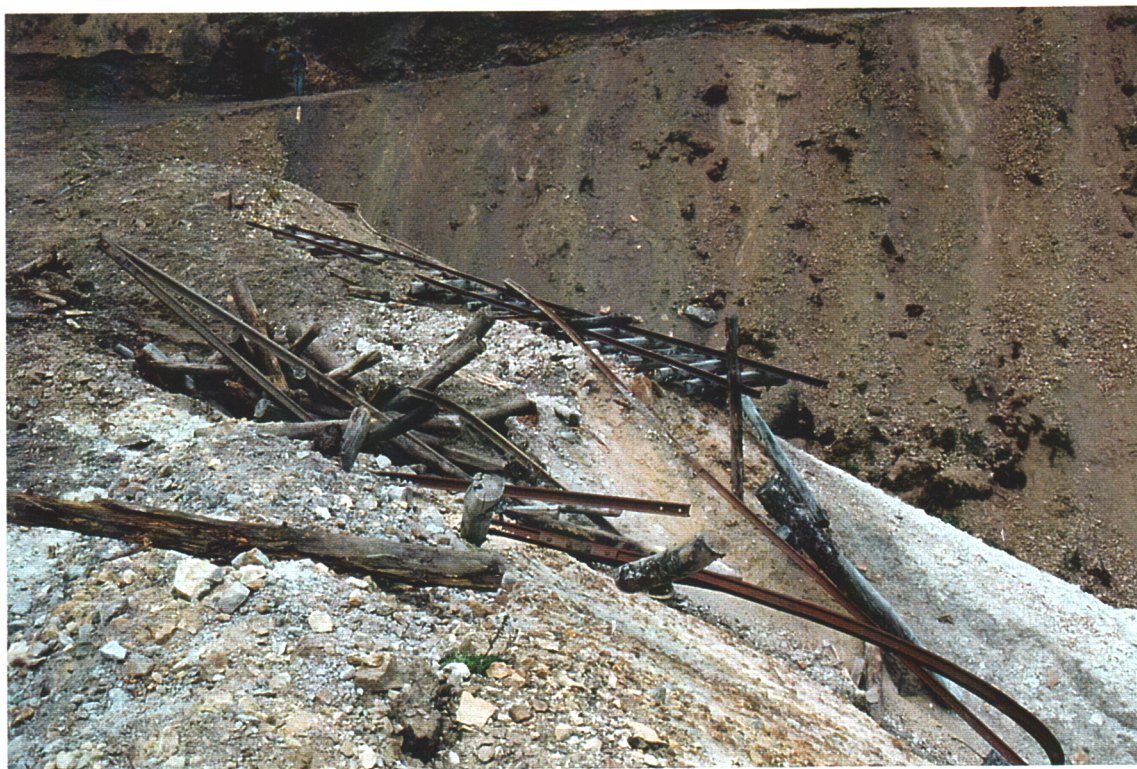
Photo # 2 - Track and Debris

The rails and trestles in front of the lower adit are physically unstable and pose a health and safety hazard to humans visiting the site.

It is recommended that all rails and trestles be demolished and buried on site for health and safety reasons. This can be accomplished using locally available resources and labour and can be buried on-site together with other site debris. Burial can occur by covering waste material with surrounding rock and soil on a clearing adjacent to a rock slope.

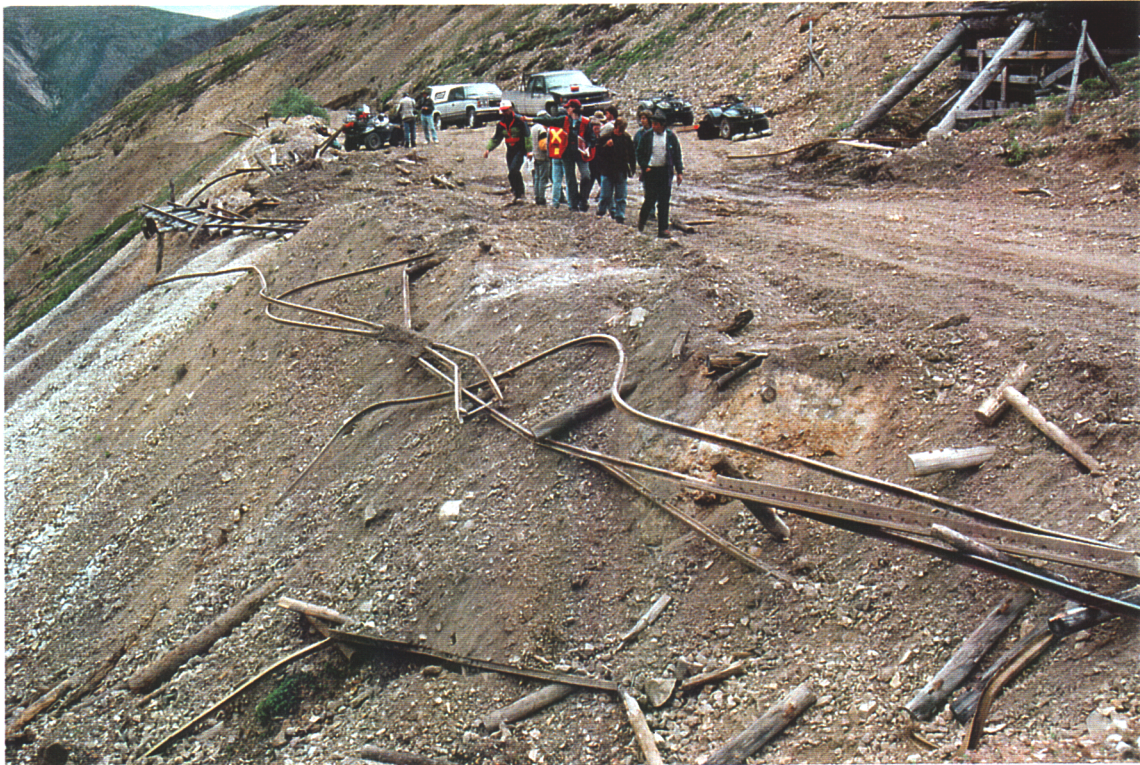
Photo # 3 - Miscellaneous Pipe, Rails and Debris

Waste Material	Number/ Volume	Location	Comments
2000 litre fuel tank	1	50 m northwest of site in prominent gully	empty with large hole, no staining
205 litre barrel	9	scattered down 500m in northwest gully	empty, no staining
timbers	<10 m ³	scattered around site and in northwest gully	non-preserved, burnable
small cans and metal scraps	<2 m ³	scattered around site and in northwest gully	non-burnable and rusted

It is recommended that site debris be collected and buried on-site for aesthetic reasons. The 2000 litre tank, 9 barrels, structural timbers, and miscellaneous metal debris, surrounding the site can be collected using locally available labour and resources.

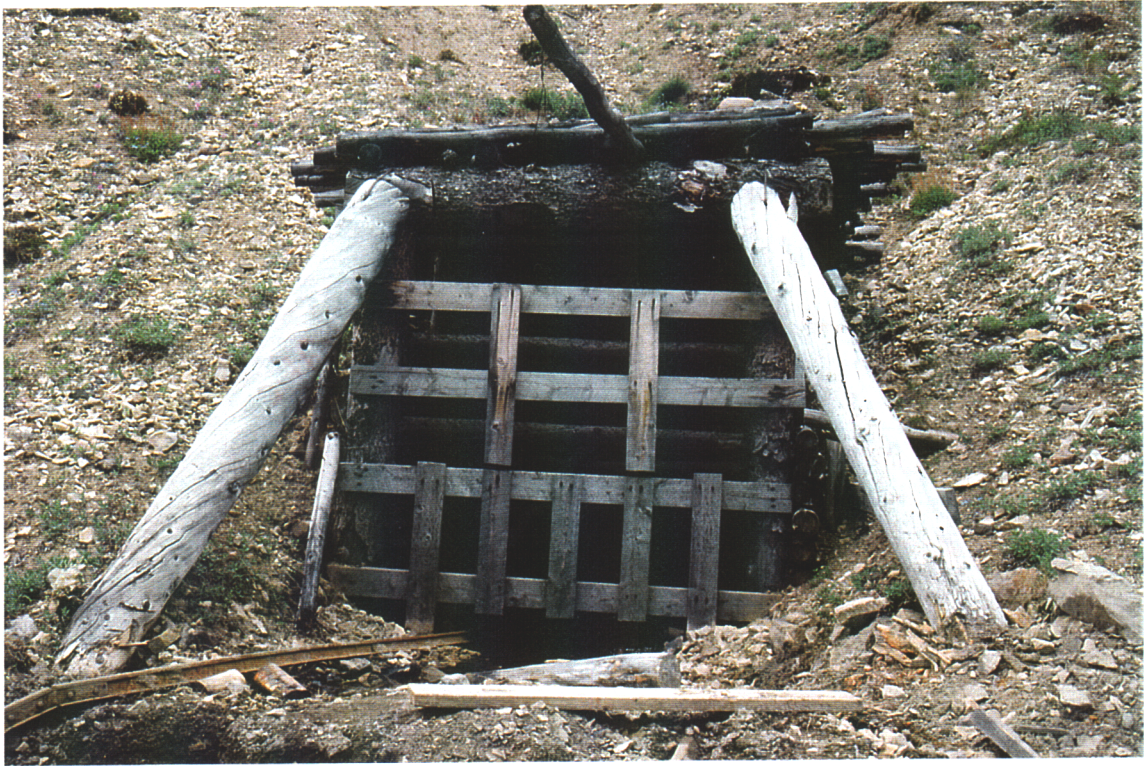
Photo # 5 - Lower Adit - A 1

Adit	Location	Drift Length	Condition
A1	lower site, 1557 elev.	137 meters	unstable condition, timber structure rotting, 2x6 cladding partially blocking entrance
A2	upper site, 1603 elev.	41 meters	unstable condition, drift collapsed 5m from opening
A3	upper site, 1603 elev.	158 meters	unstable condition, adit opening is collapsed and covered by surrounding material and structural timbers

All the three openings are in unstable condition and are not adequately secured from public and wildlife access. One of the upper adits (A3), had previously collapsed and remains unstable. The second upper adit (A2), has partially collapsed and the access is blocked by rotting timbers. The third adit (A1), is also partially blocked by rotting wood and is in an unstable condition as a result of slumping of loose rocks and soils surrounding the opening.

It is recommended that all three mine openings be secured from human and animal access for health and safety reasons. Since site access is good, adits should be covered with surrounding rock and soil using readily available equipment. Timbers should be removed and buried along with other site debris. Should the mine need to be reopened, access to workings is achievable with heavy equipment.
