PHASE II ENVIRONMENTAL ASSESSMENT OF THE CALEY ABANDONED MINE SITE

**Action on Waste Program
Indian and Northern Affairs Canada**

**Environmental Services
Public Works and Government Services Canada**

March 1997

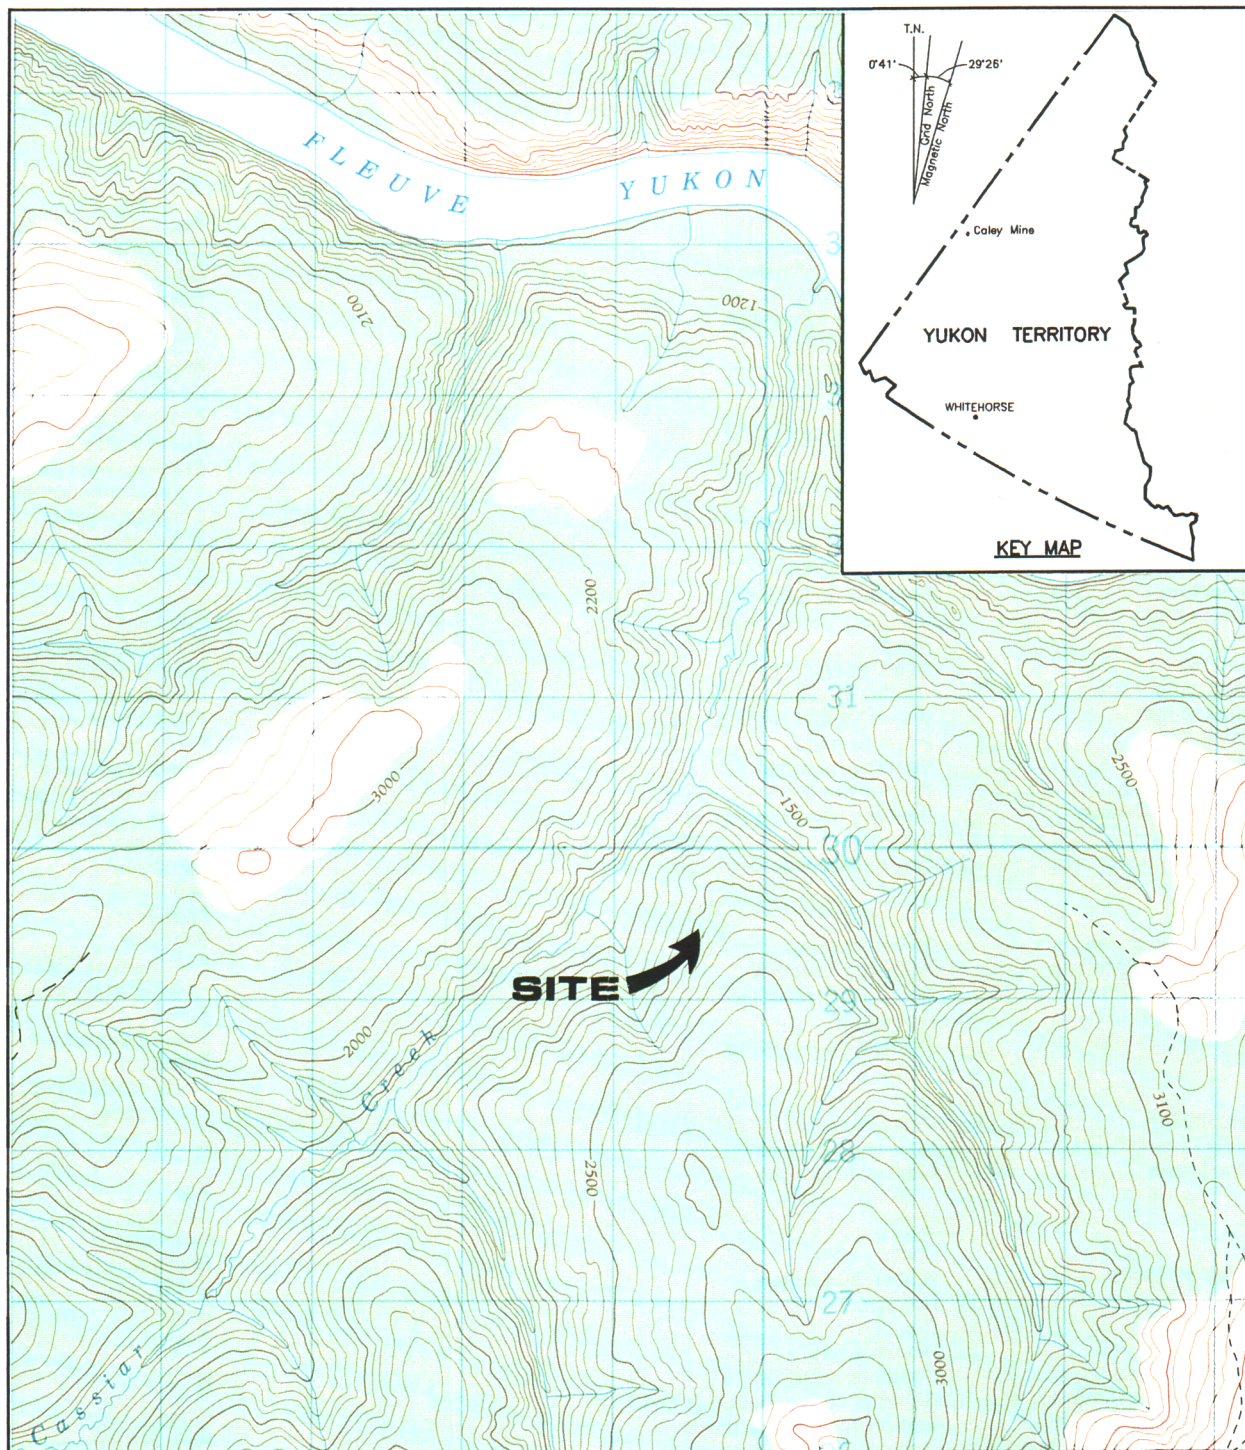
**Figure 1. Location of Caley Mine - 1:50,000, NTS-116 C/8
[Energy Mines and Resources Canada: 1991]**

Both the site and regional drainage are to the northwest draining 500 metres into Cassier Creek and subsequently 3500 metres into the Yukon River (see Figure 1).

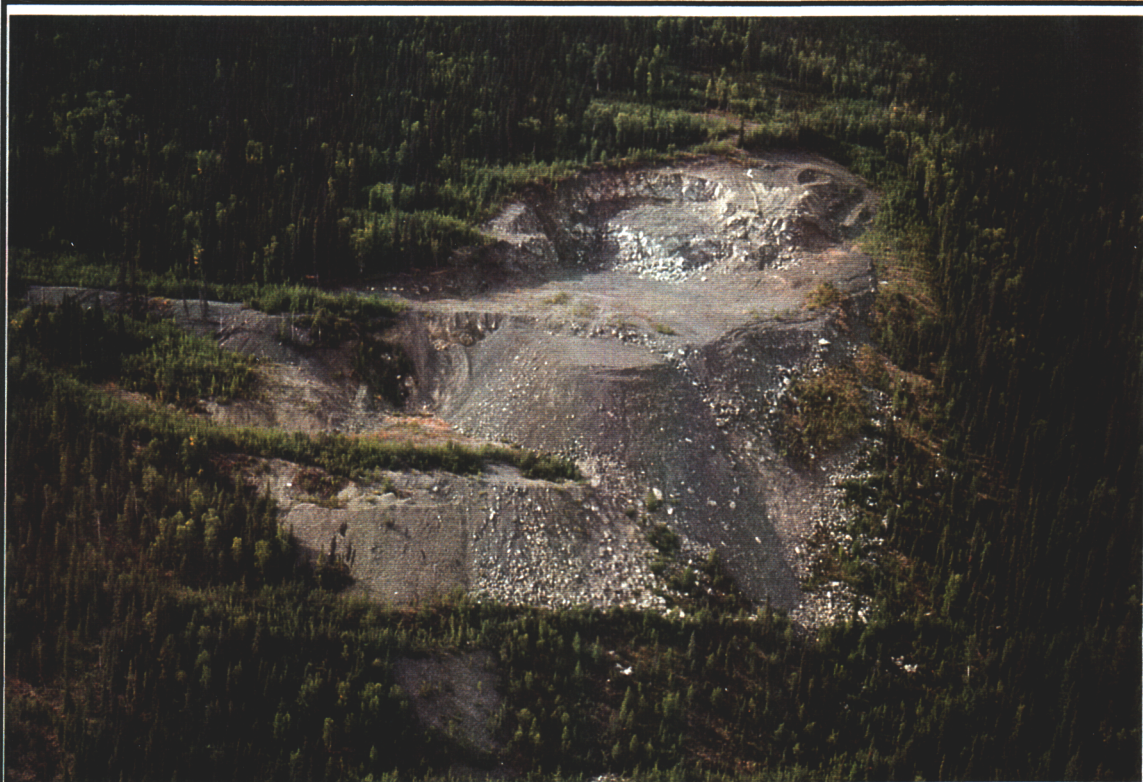
Photo 1: Overview of Caley Mine from the east

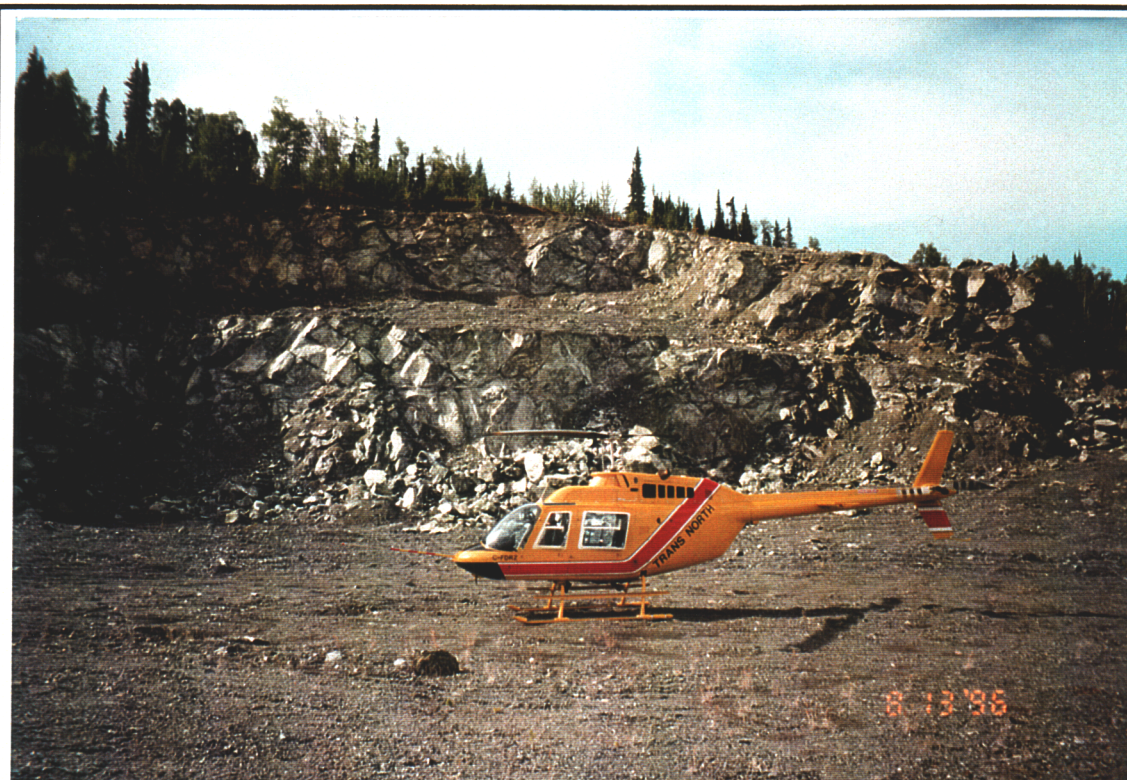
Photo 2: View of main excavated terrace

The exploration site consists of an open cut into the hillside. The slope and rocks are stable. There are no mine openings.

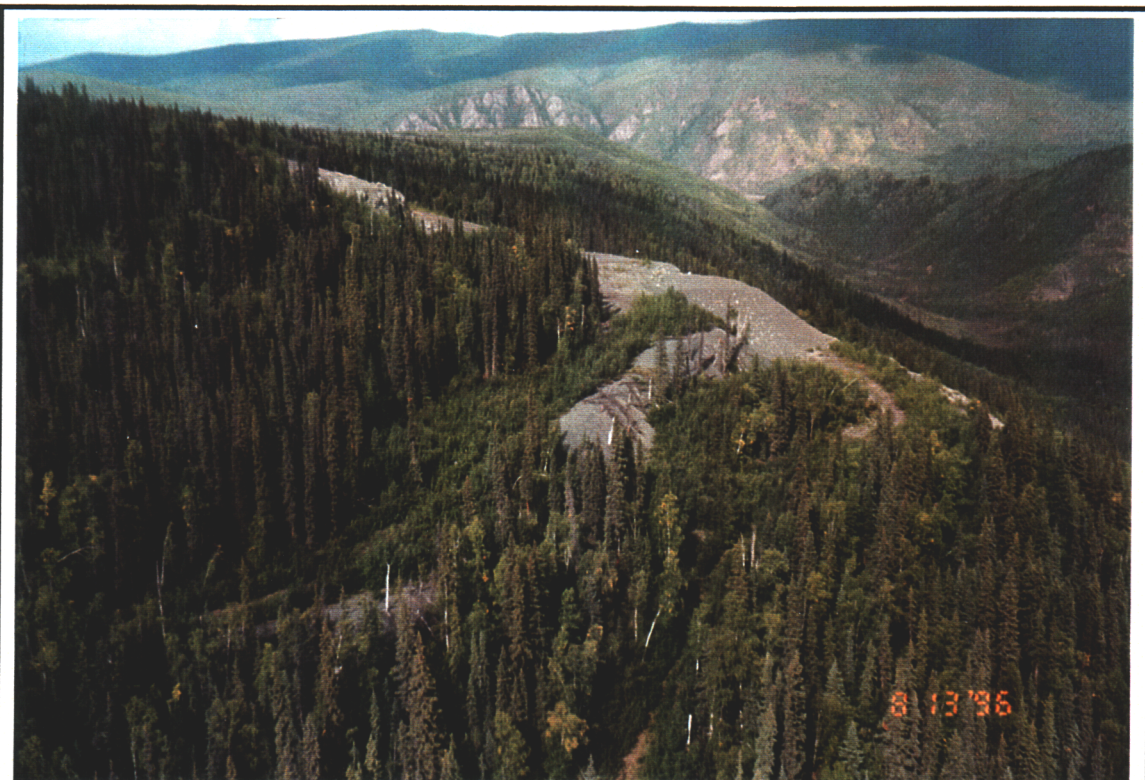
Photo 3: View of overgrown access road to site from south

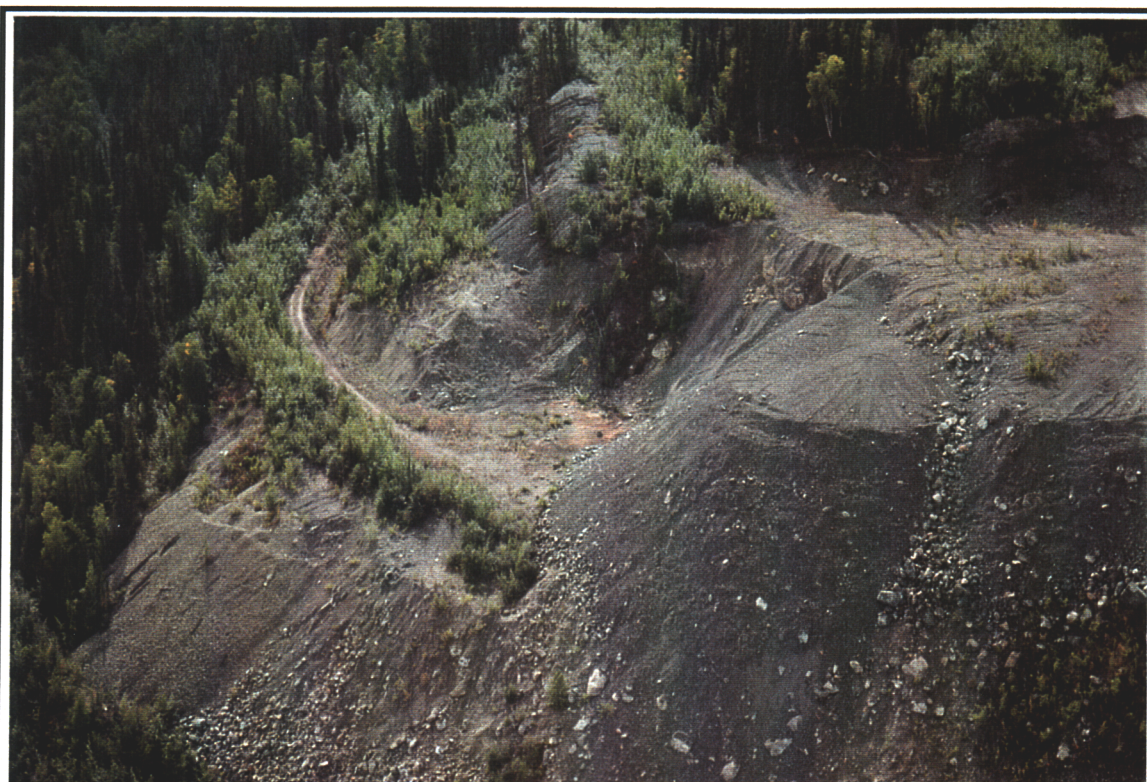
Approximately 230,000 tonnes of waste rock was deposited at the site as a result of the open cut operation. This material was composed primarily of asbestos and serpentine. The adits were not identified on site and it is assumed that these were consumed in 1978 when the site was mined and the open cut was formed.

Because of the homogeneity of the serpentinite, only one test pit was dug and one rock sample collected. The sample (CLWR/P1/1) was composed almost exclusively of asbestos fibres. This sample was submitted for Acid Base Accounting (ABA) tests and determination of metals by Inductively Coupled Plasma - Atomic Emission Spectrophotometry (ICP-AES).

Results of these analyses are presented in Table 2. The laboratory pH (9.0) was higher than that measured in the field (7.4) but both indicated that the waste was not currently generating acid. The material had a total sulphur concentration of 0.02% and an NP/AP of 705, indicating that it is acid consuming.

The waste contained significant concentrations of arsenic (52 mg/L), chromium (229 mg/L), cobalt (89 mg/L), mercury (0.64 mg/L) and nickel (1930 mg/L).

Photo 4: Waste rock (note discoloration at base of pile)

Since there are no concerns at this site, no action is required.

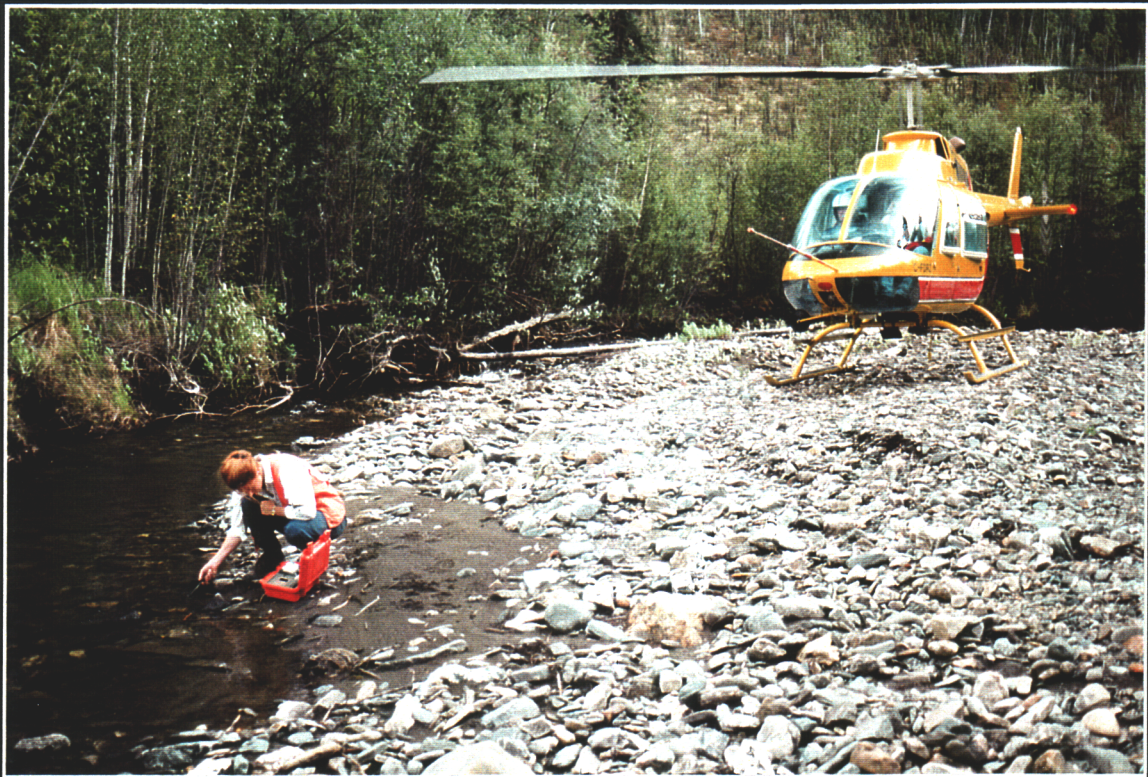
To identify possible contribution of metals by the Caley exploration site, two water samples were collected on Cassiar Creek, one upstream from the Caley deposit (CLWQ/STR1/1) and one at the mouth of the creek where it empties into the Yukon River (CLWQ/STR1/2). The downstream sample was collected approximately 2 kilometres from the site due to access constraints.

Photo 5: Upstream water quality sample location

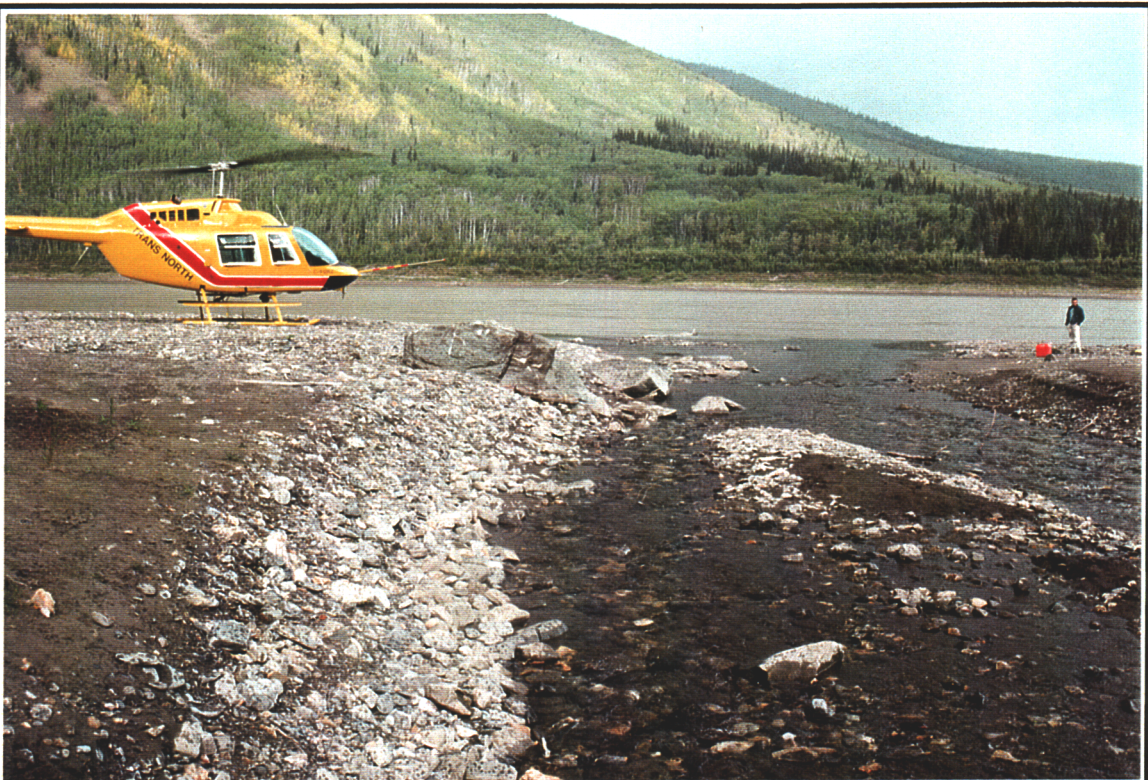
Photo 6: Downstream water quality sample location
