P118401

**PHASE II ENVIRONMENTAL ASSESSMENT
OF THE
COBALT ABANDONED MINE SITE**

**STEFFEN ROBERTSON AND KIRSTEN (CANADA) INC.
Suite 800, 580 Hornby Street
Vancouver, BC V6C 3B6
Tel: (604) 681-4196 • Fax: (604) 687-5532**

FEBRUARY, 1997

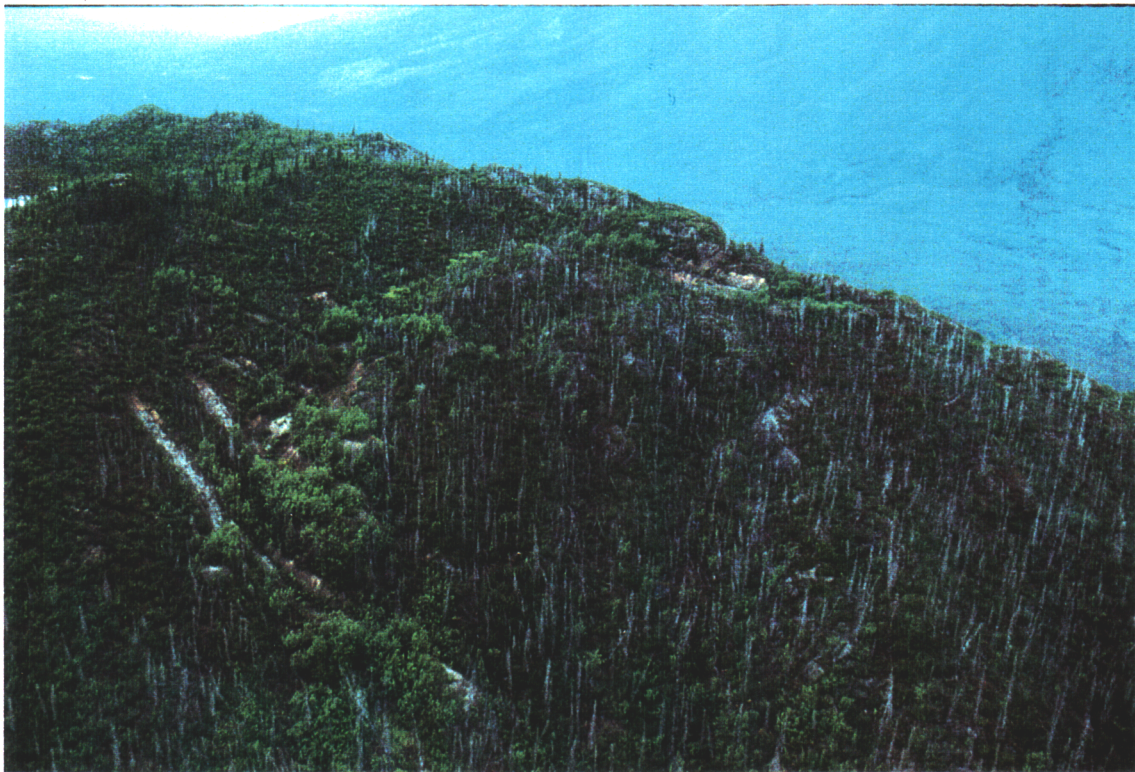
The Cobalt mine site occurs within the Yukon Plateau North ecoregion. Vegetation at 1000 metres above sea level on the terraced slopes in the Gustavus Range is typical of warmer Western Boreal areas. Black spruce white spruce, alpine fir, and willows are abundant; aspen poplar, balsam poplar, white birch, and alder are less common (GSC Memoir 364, p.4). The Cobalt site appears to have typical vegetation for the area, based on photographs provided by DIAND (1994). The area has been burnt, probably sometime in the last 20 years given the height of the new growth (DIAND, 1994, Photos 1 and 2).

Photo 1: Cobalt abandoned exploration site, in an old burn area. Looking south. (Photo reproduced, with permission, from DIAND, 1994)

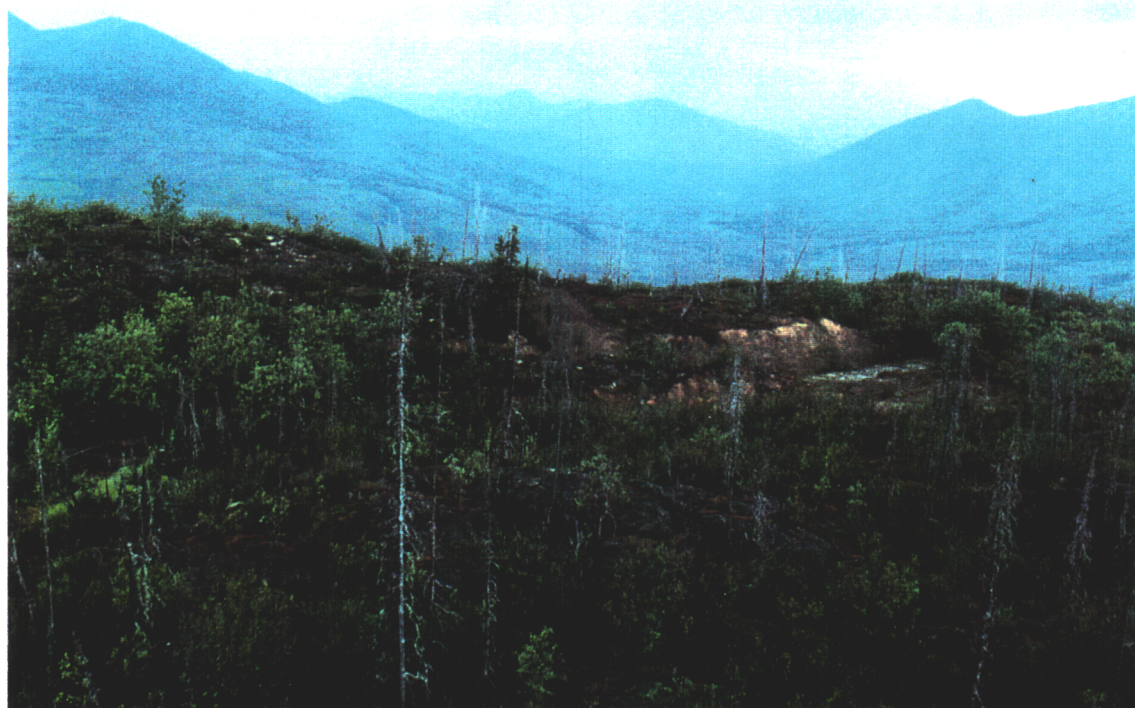
Photo 2: Trench at Cobalt. Adit is in the centre of the photo, at the upper left side of the trench. Looking west. (Photo reproduced, with permission, from DIAND, 1994).

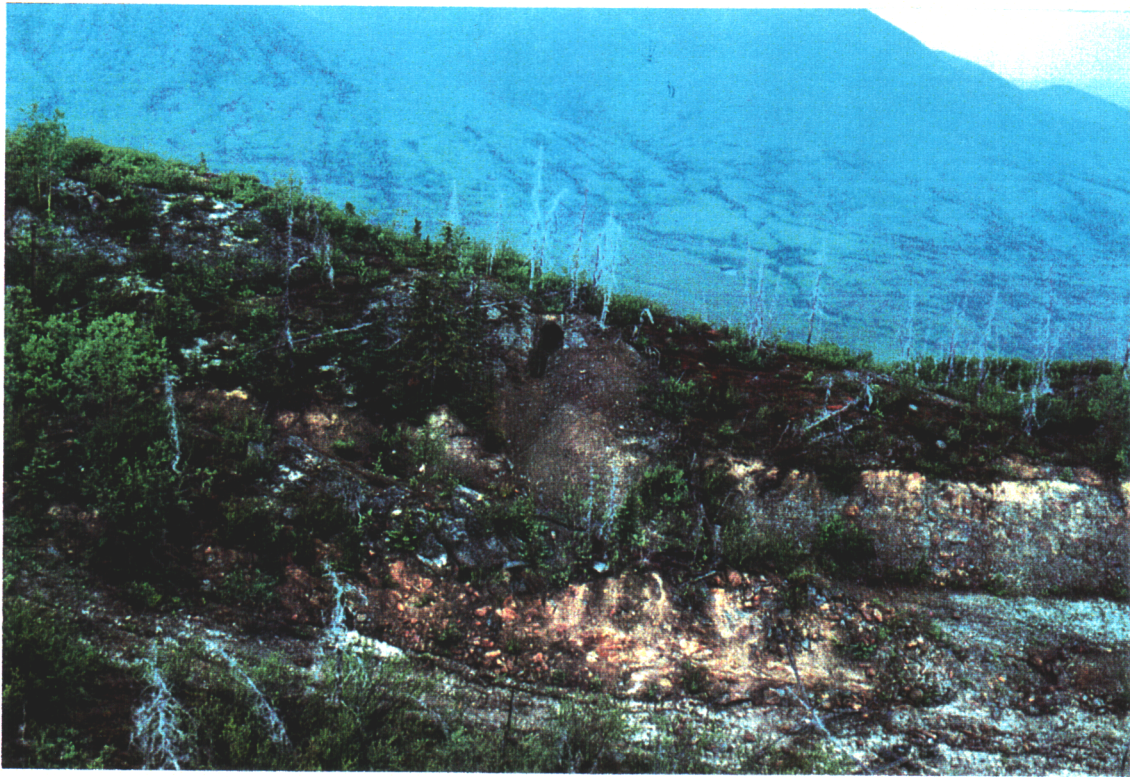
A small pile of waste rock is located above the trenching and on the west side of the adit (Photos 3 and 4). The volume of waste rock produced from the underground exploration program is in the order of 300 tonnes. The assumptions made to derive this estimate are:

The trenching and the adit have exposed iron stained rocks (GSC Memoir 357, p. 61). The mineral occurrence contains the occasional erratic 5 to 8 cm wide veinlets of galena,

which is a potential source of metal leachate, and the waste rock on site contains pieces with massive galena (GSC Memoir 357, p.61). The volume of waste present at the site is very small, as is the overall extent of disturbance by trenching.

An adit, 12.2 metres long, is located at the southeast end of the trenching (Photos 3 and 4). It is open and the ground conditions around the entrance appear stable. The total area disturbed by trenching is probably 125 metres by 50 metres (DIAND, 1994, GSC Memoir 357, p.61).

Photo 3: Adit and waste rock or 'upper dump', above trenching that shows iron staining. Looking southwest. (Photo reproduced, with permission, from DIAND, 1994)

The open adit, as it was photographed in 1993, appears to be narrow and in solid rock. Due to the short length of the underground workings and the remote location of the site no mitigation measures are recommended at this time. However, if access to the area is improved in the future consideration should be given to sealing the adit to prevent entry.

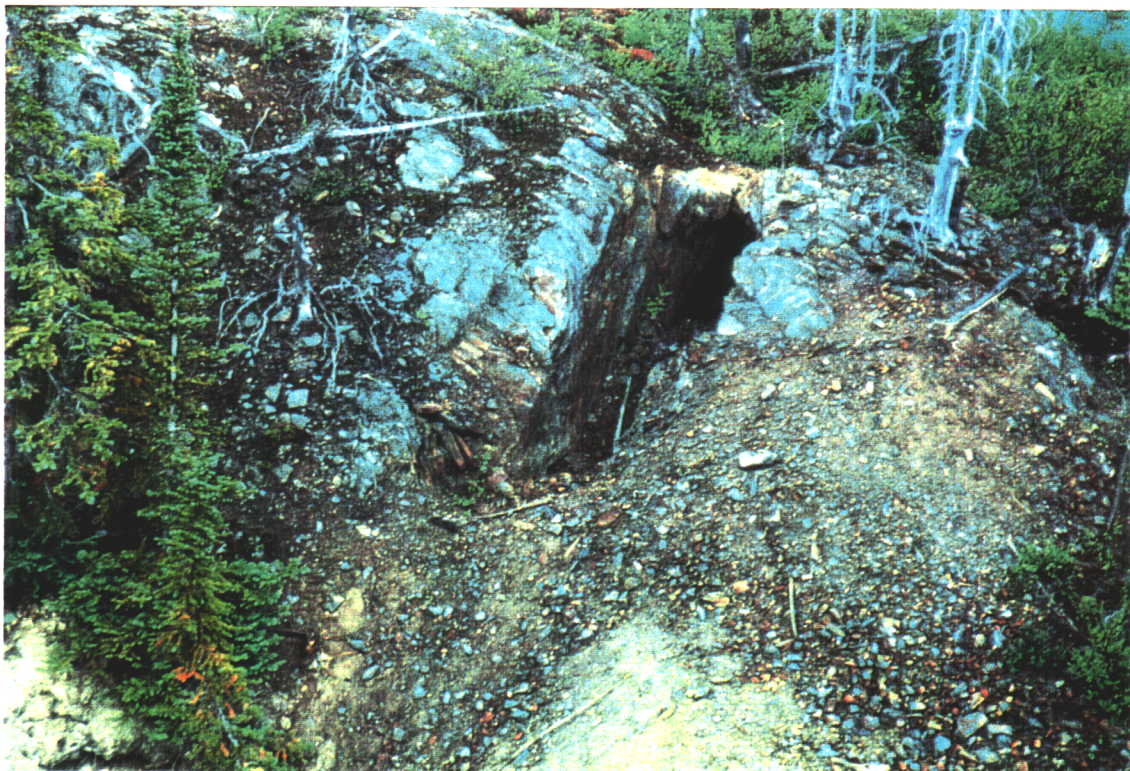
Photo 4: Adit and oxidized waste rock pile. Looking south. (Photo reproduced, with permission, from DIAND, 1994)
