**PHASE II ENVIRONMENTAL ASSESSMENT
OF THE
CONNAUGHT
ABANDONED MINE SITE**

**Action on Waste Program
Indian and Northern Affairs Canada**

**Environmental Services
Public Works and Government Services Canada**

March 1997

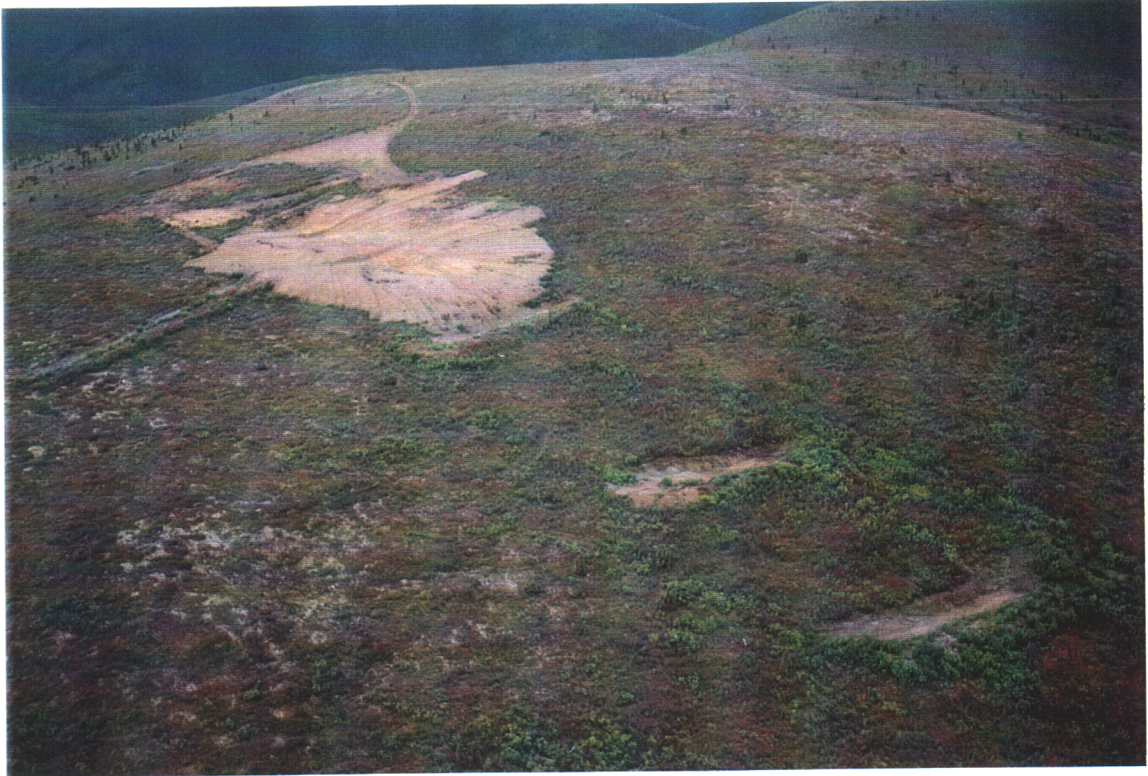
Photo # 1 - Overview of Connaught Mine from Air

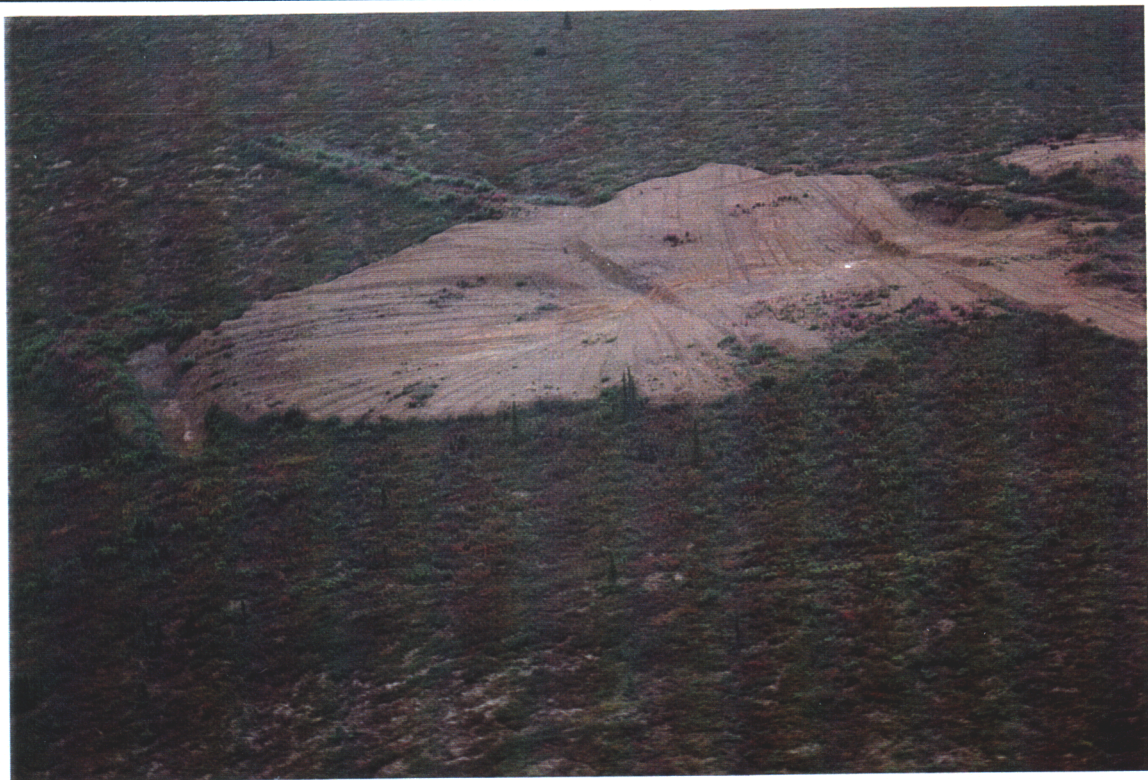
There is no waste rock at the site. Activity has been limited to bulldozed trenches and flat-lying scars, and any mining conducted has been by hand-cobbling (high-grading). The trenches and the berms created by trenching are fairly well vegetated, and, therefore, were not sampled. The scar is a more recent disturbance, however, and two grab rock samples were collected in that area: a composite sample across the largest vein and a sample of the altered metamorphic rocks located west of the vein.

Photo # 2 - Overview of Surface Stripped Area

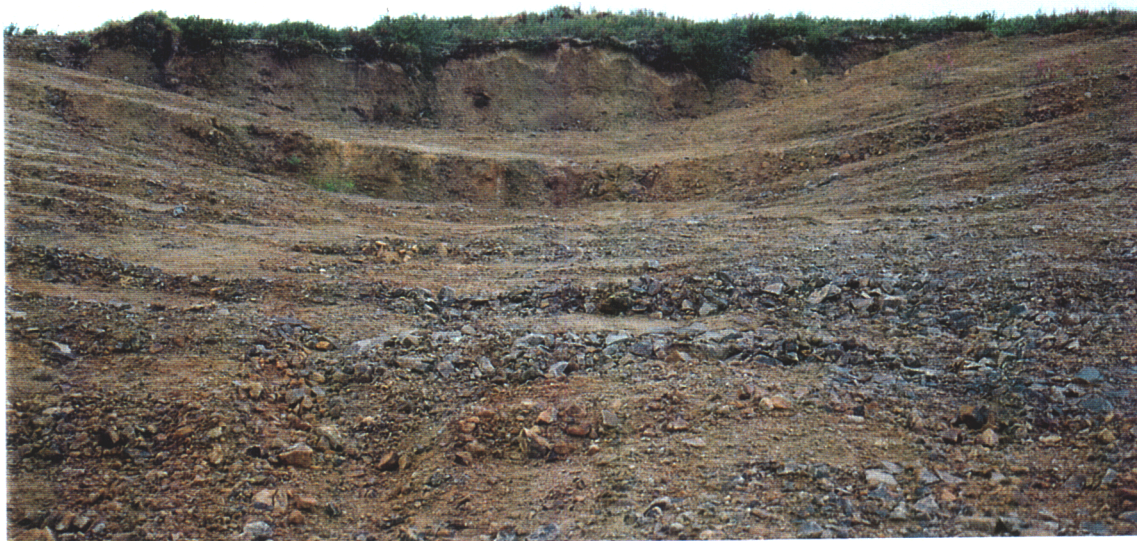
Photo # 3 - View from Centre of Stripped Area looking West

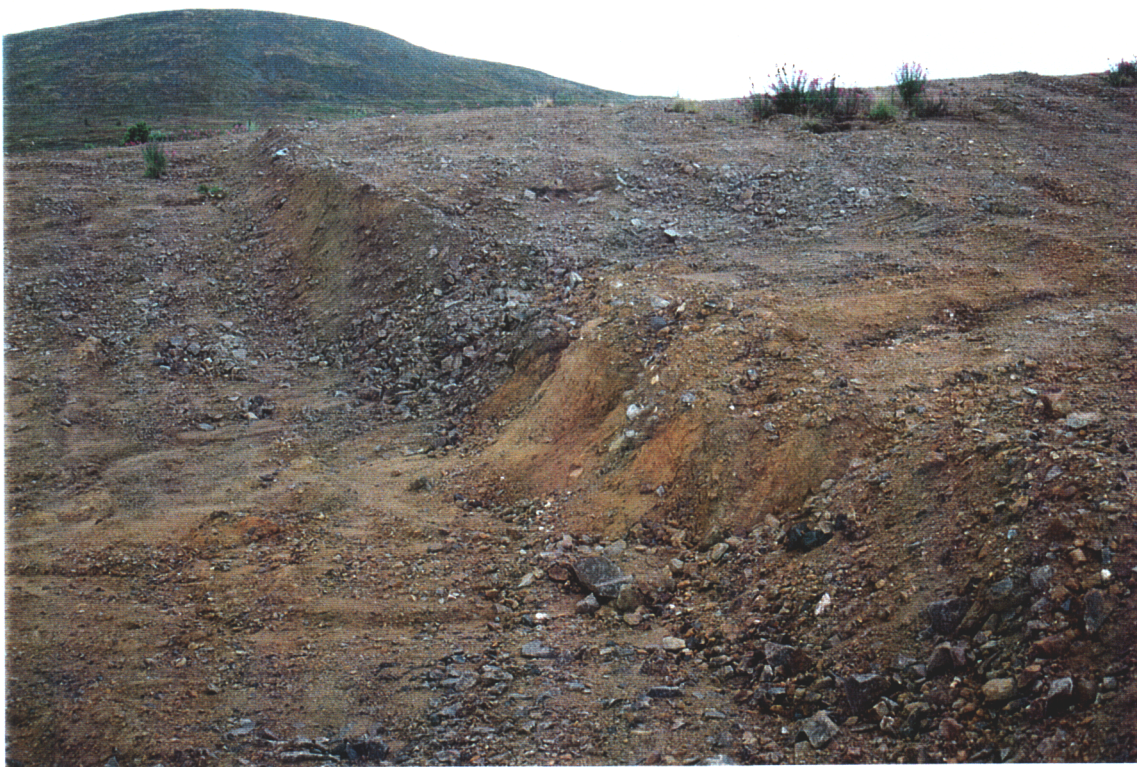
Photo # 4 - North-South Ridge within Stripped Area

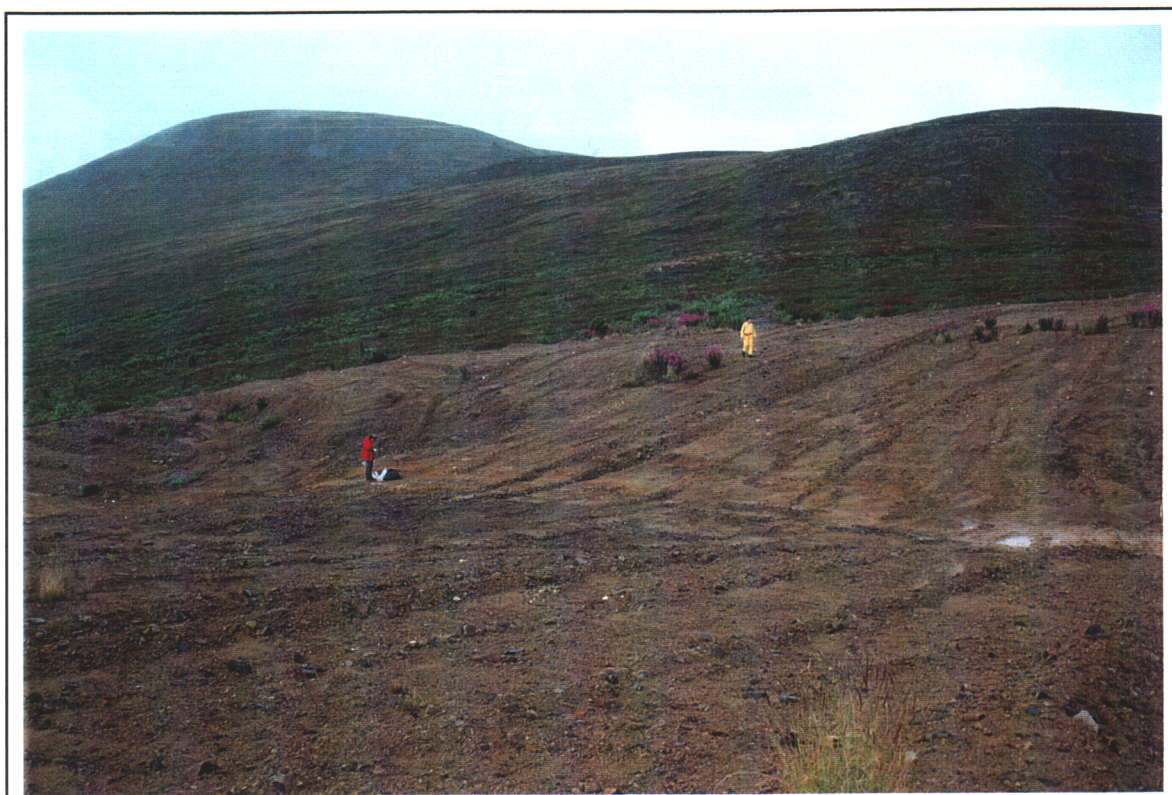
Sample ID	Sample Location and Description	Discussion of Results
CNWR/P1/1	Grab sample across large quartz-galena vein	Potentially acid generating (NP/AP=0.12); high As, Cu, Pb, Zn.
CNWR/P2/1	Grab sample west side of the trench in altered biotite granite.	Potentially acid generating (NP/AP=1.14); high As, Cu, Pb, Zn.

Laboratory paste pH values for the two samples were 5.4 and 5.7, indicating that the rock is slightly acid generating. However, paste conductivity measurements below 60 $\mu\text{S}/\text{cm}$ indicate that the lack of oxidation products stored in the rock. The exposed rock has the potential to generate acid (NP/AP = 0.12 and 1.14) but the total sulphur concentrations are low (0.52% and 0.14%).

The rock samples contain high concentrations of arsenic, copper, lead, and zinc, with lesser concentrations of molybdenum.

Photo # 5 - Location of Waste Rock Sample CNWR/P1/1

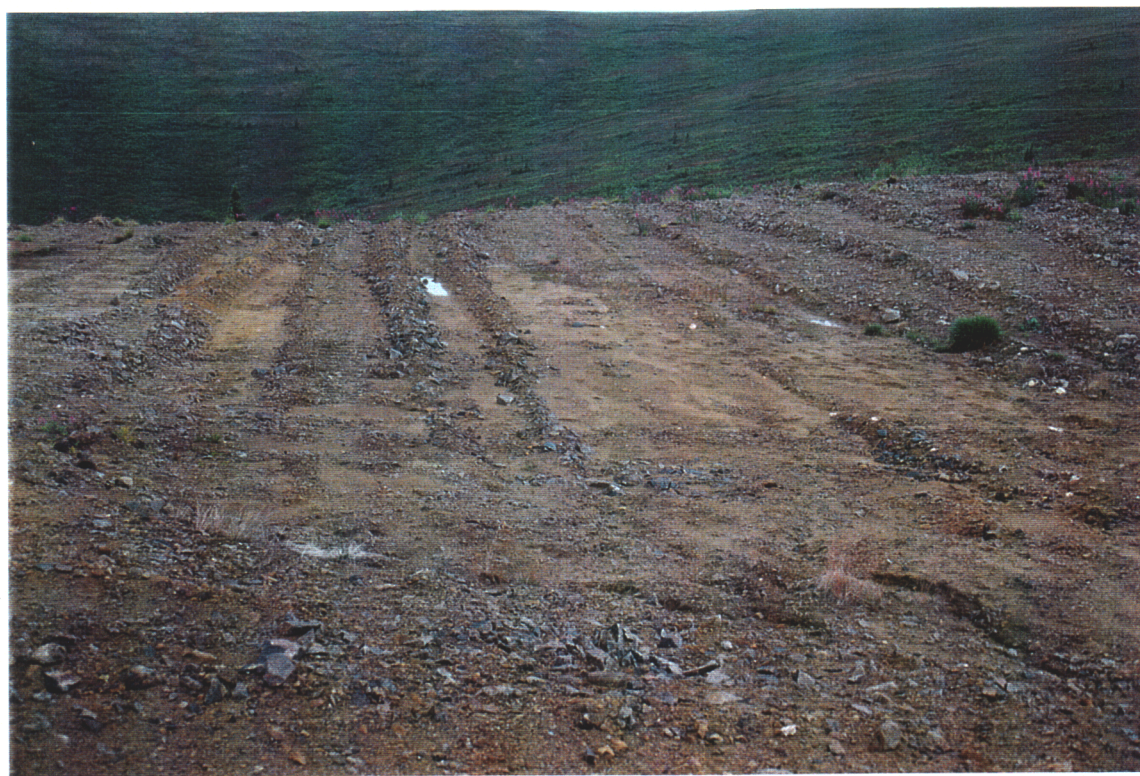
Photo # 6 - View of Stripped Area looking East
