**PHASE II ENVIRONMENTAL ASSESSMENT
OF THE
HART
ABANDONED MINE SITE**

**PHASE II
ENVIRONMENTAL ASSESSMENT
of the
HART MINE SITE**

EXECUTIVE SUMMARY

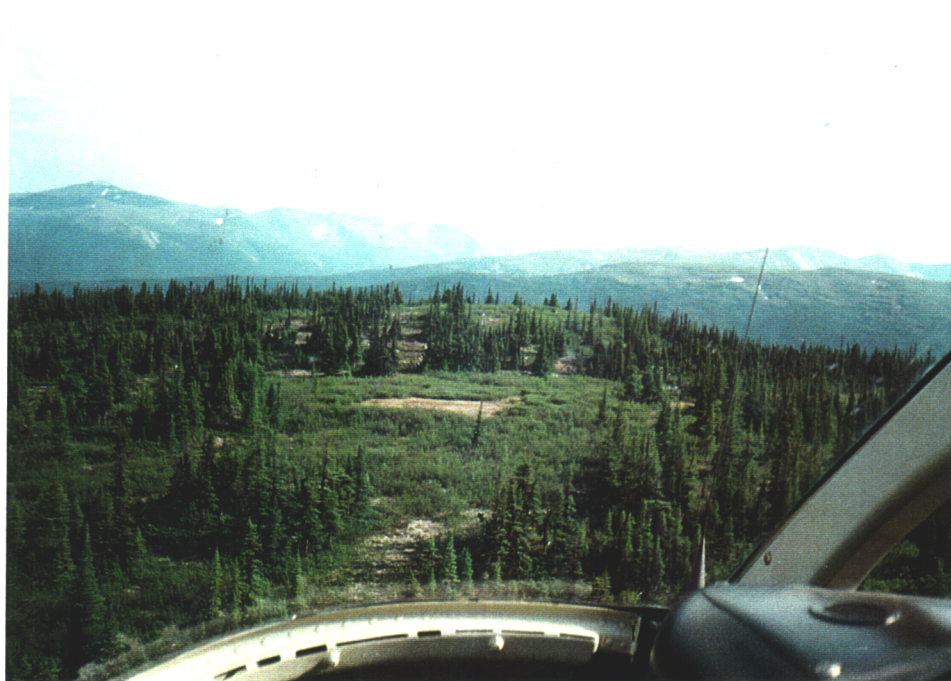
The Hart mine site is located at 60°19'20"N, 130°40'30"W, approximately 28 km west Rancheria, YT. and 2.75 km east southeast of the Silver Hart minesite on a relatively level plateau area at an elevation of 1400 m (See Photo 1). No adits were identified in the previous report and this condition was confirmed during this site visit.

Photo 1 View of Hart mine site looking south.

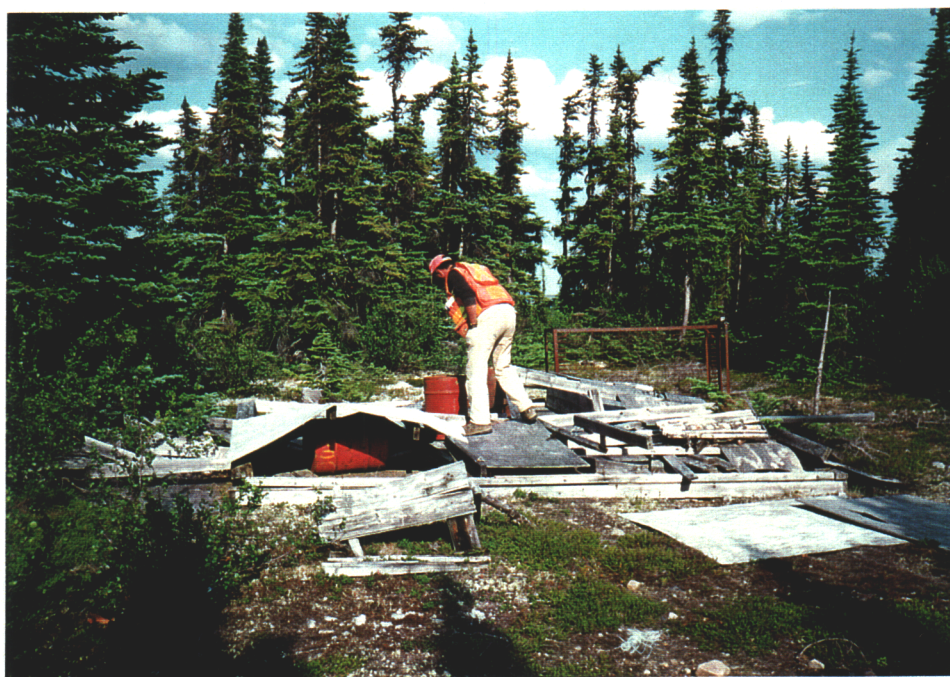
The Hart mine site consists of a small centralized area with two collapsed wood structures situated side by side as well a core storage structure situated at the west end of the site (See Photo 2). The only remaining infrastructure on site is deteriorating canvas and metal stove parts (See Photo 4).

Photo 2. Remains of wood frame buildings in camp area with empty metal drums and assorted metal waste (background).

Gather up remaining wood waste on site and burn in an open area.

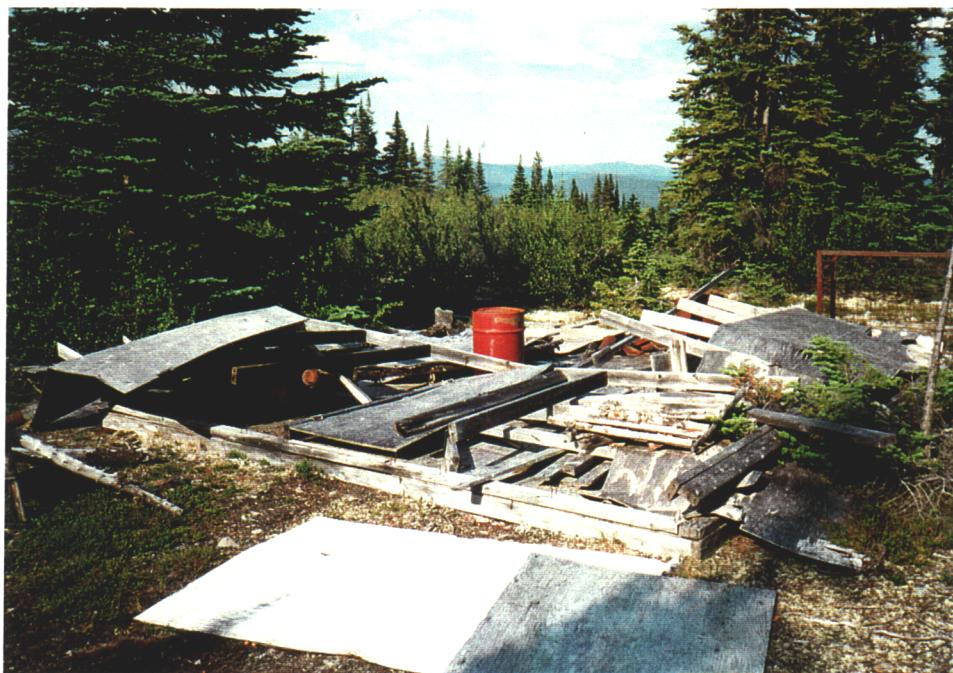
The major portion of hazardous materials remaining on site consisted of one 150 litre metal barrel (red) marked Jet B aviation fuel. No landfills or waste areas were observed on site during the visit. (see Photo 3).

Photo 3. Further detail of derelict structures with 150 litre barrel of Jet B fuel (centre).

Using applicable federal and territorial criteria as well as northern mine reclamation guidelines, recommendations are to flare off aviation fuel on site, crush and bury barrels and miscellaneous metal waste on site, and demolish and burn wooden structures and combustible waste on site.

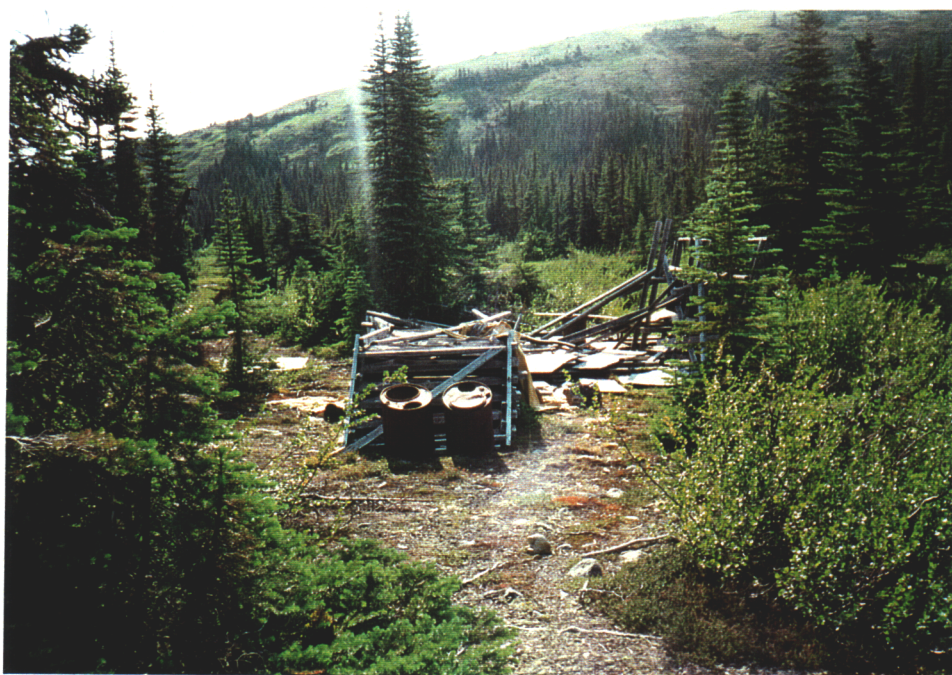
Photo 4. Barrels and wood core storage structure at western edge of site. Note old metal "airtight" stoves.
