# Assessment of Abandoned Yukon Mine Sites

## Hayes #85

Prepared for  
Public Works and Government  
Services Canada

February 1997  
GV206.01

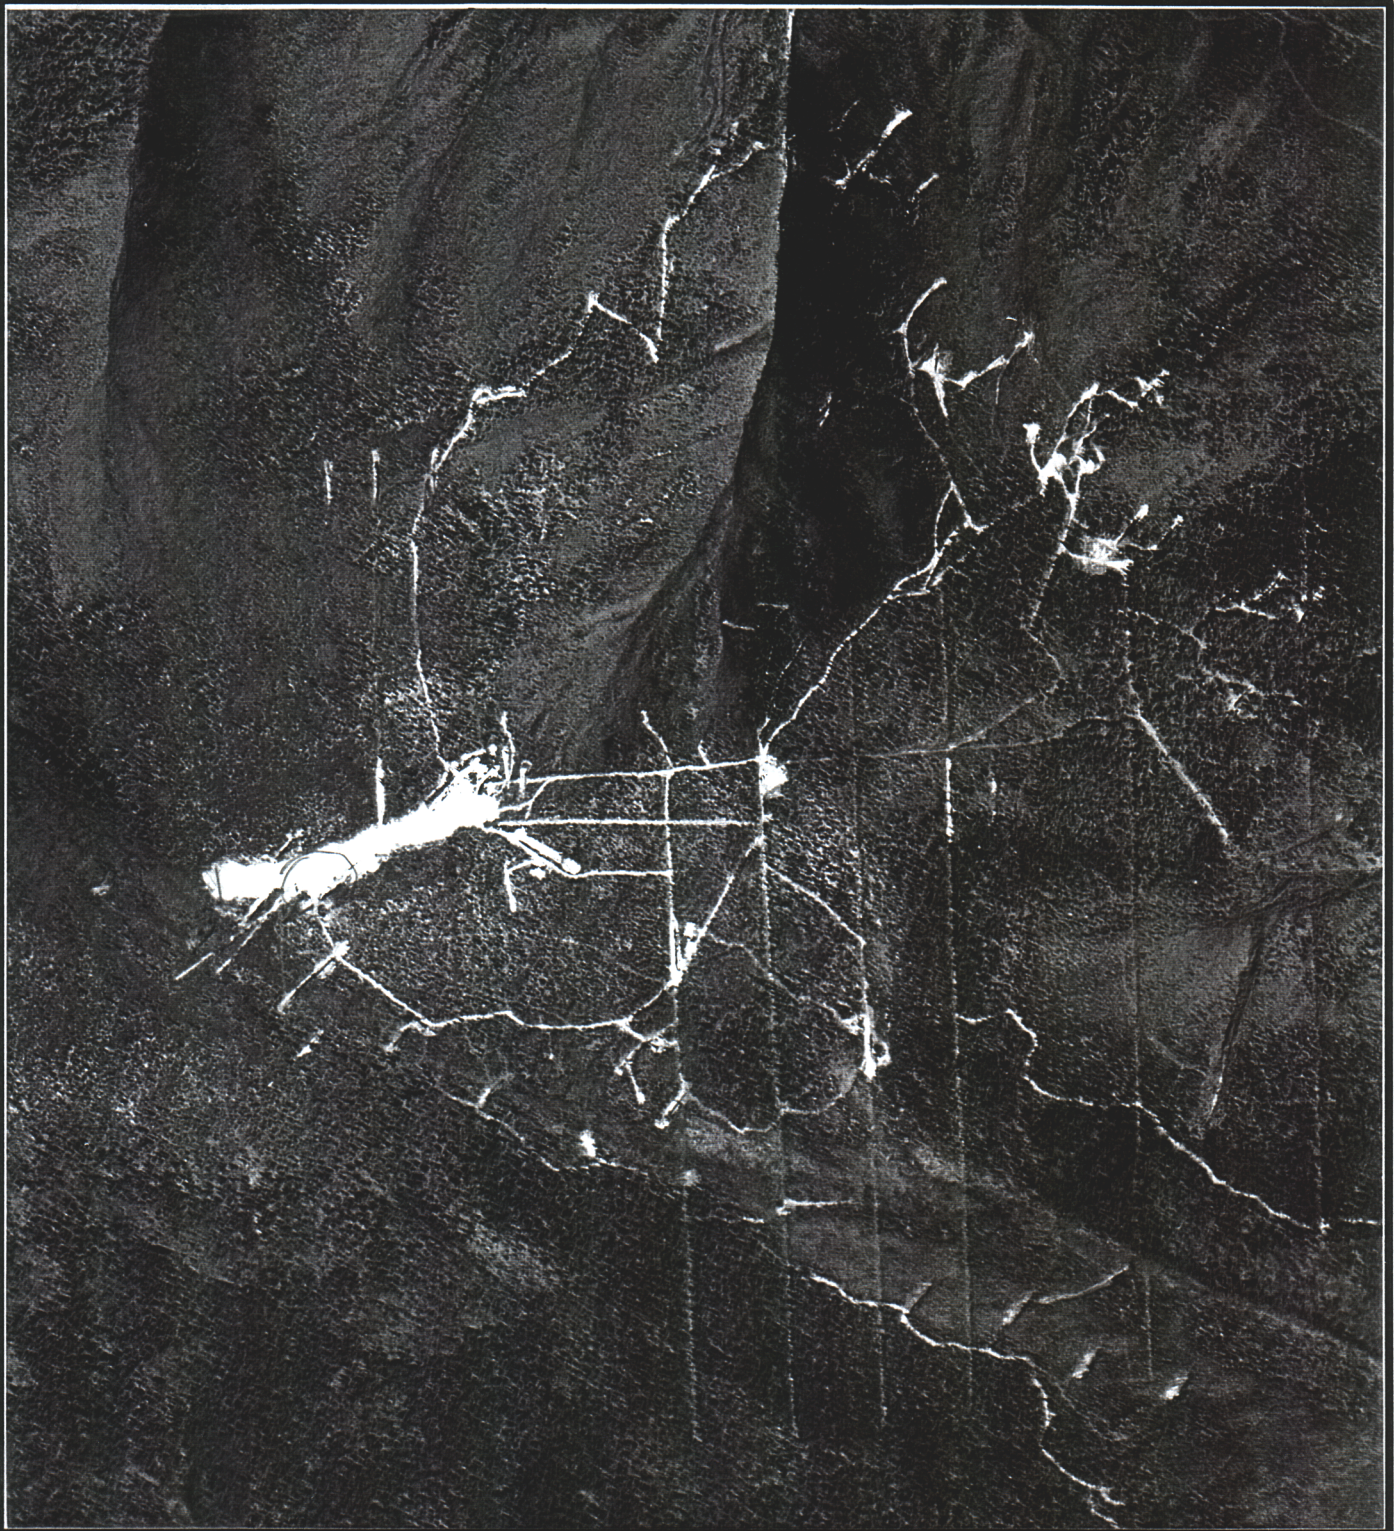
Figure 1.3

Roads, trails and exploration workings are shown in the airphoto presented as Figure 1.3.

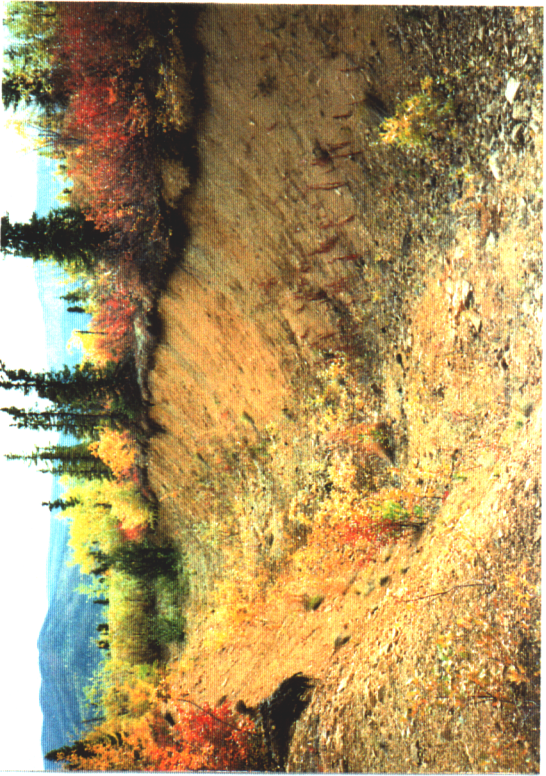
1

The site is covered by sparse vegetation at the top of the eroded ridge to moderate vegetation coverage in more protected areas at lower elevations. The vegetation is comprised predominantly of alder, black spruce and moss. Trails on-site, that are easily identified on the airphoto (Figure 1.3) dated 1968, are now moderately overgrown. Minor vegetation is being re-established in trenches and excavations (Photo 1, Appendix A). The site (other than the eroded peak) is mantled by a very thin layer of topsoil (10 cm) that is underlain by granular rocky material with no organic content; therefore, disturbed areas require a long period of time to re-establish vegetation. The thin layer of topsoil is evident at the top of the trench shown in Photo 1.

- Photo 1: Photo of typical trench, note the slow vegetation growth in the trench and the thin layer of topsoil present at the top of the trench.
- Photo 2: Camp site, airstrip and Hayes creek as seen from the air.
- Photo 3: Camp building.
- Photo 4: Inside camp building.
- Photo 5: Bunkhouse No. 1.
- Photo 6: Bunkhouse No. 2.
- Photo 7: Wood platform.
- Photo 8: Wood shack.
- Photo 9: Debris and cores 350 m east of airstrip.
- Photo 10: Debris, cores and equipment north of bunkhouse No. 1.
- Photo 11: Drums and campsite, pictures taken from edge of airstrip.

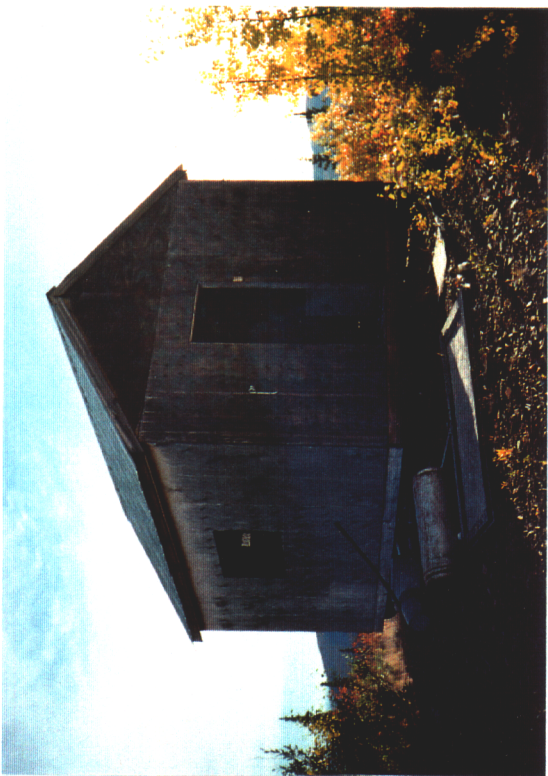
3

The camp building (Photos 3, Appendix A) is of wood construction with a tin roof. The building is 4.9 x 3.65 m in area and does not have any insulation. The building was full of debris (Photo 4, Appendix A) comprising a freezer, camp supplies, tent tarps, tools, kitchen supplies, table, chairs, books and other non-hazardous debris. It appears as though the camp supplies and equipment were stored in this building with the expectation that they would be recovered or used at a later date.

**Buildings** - several building on-site are in various states of deterioration. The camp building is standing and in fair condition. The other buildings do not pose an immediate health and safety hazard. The floor boards on the buildings are slightly deteriorating and in the future may pose a health and safety hazard to people walking on the floors. To prevent a future health and safety issue and to improve the site appearance, all structures should be levelled and non-hazardous and combustible materials burnt in an approved location on-site. Non-hazardous and non-combustible material should be landfilled on site.

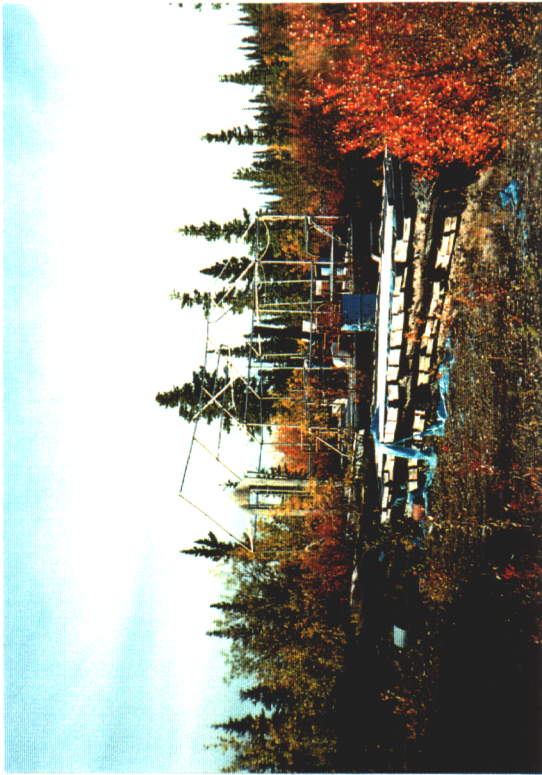
5

A bunkhouse comprised of a wood platform and metal frame (Photo 5, Appendix A) is located approximately 15 m west of the camp building. This bunkhouse is 4.75 x 4.15 m in area and three metal bunks are present on the wood platform.
