FINAL REPORT

SITE ASSESSMENT REPORT
WERNECKE CAMP
KENO HILL, YUKON

PUBLIC WORKS & GOVERNMENT SERVICES

Job No. 20749-013-310
March 27, 1997

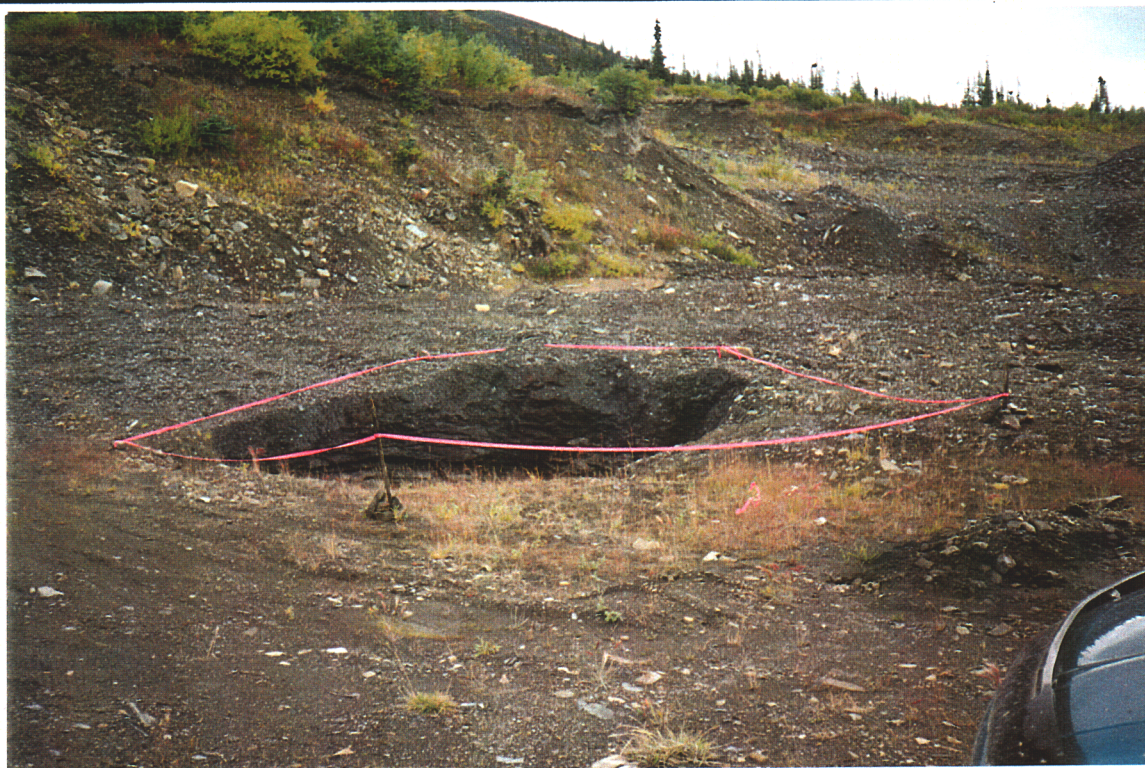
PHOTO 1

The surface exploration and trenching covers an area at least 800 x 600 m with an open pit situated in the centre of the site. An open hole, measuring 5 x 3 m was noted to the southeast of the main pit and is interpreted to have been caving of old underground workings. The open hole, flagged by NDM staff at the time of the site visit, is shown in Photograph #1.

View of collapsed ground at centre of camp.

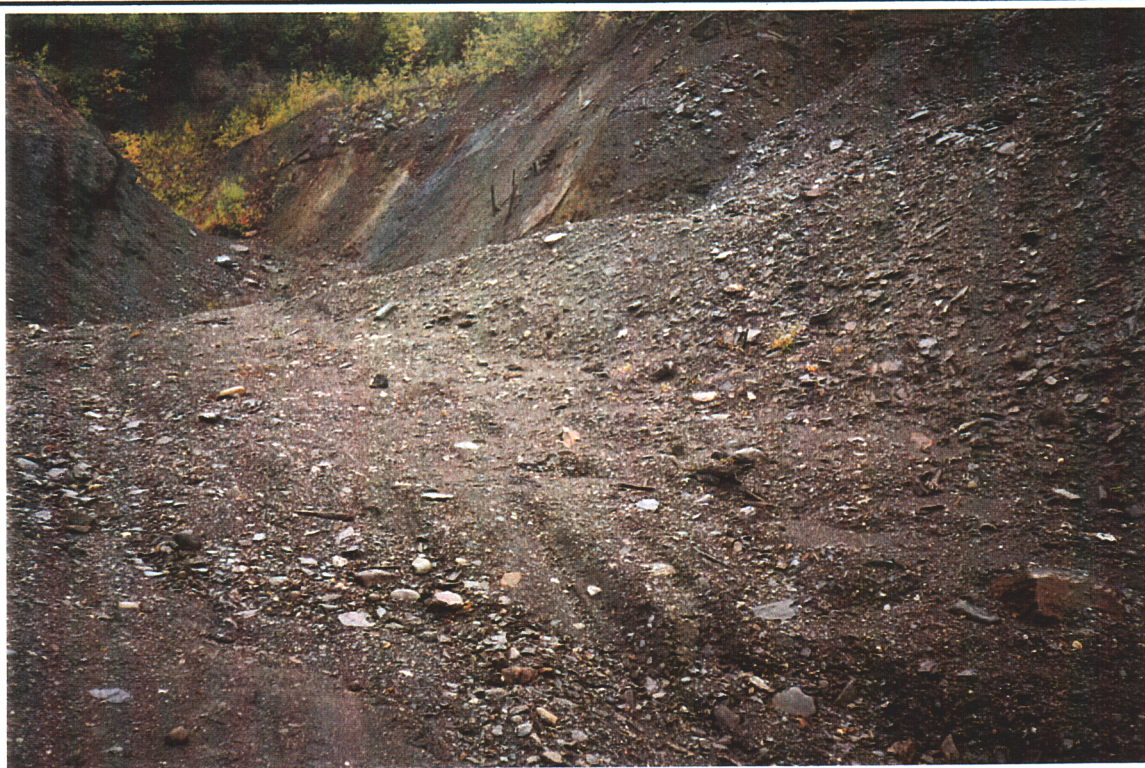
PHOTO 2

At the time of the site visit, visual observations were made as to the condition of the waste rock piles, characterization of rock type, visible presence of carbonate/sulphides, visible evidence of acid generation, etc. No visible evidence of acid generation was noted at the time of the site visit. Several views of the onsite waste rock piles are presented in Photographs #2, #4, and #8.

Waste rock piles at centre of camp.

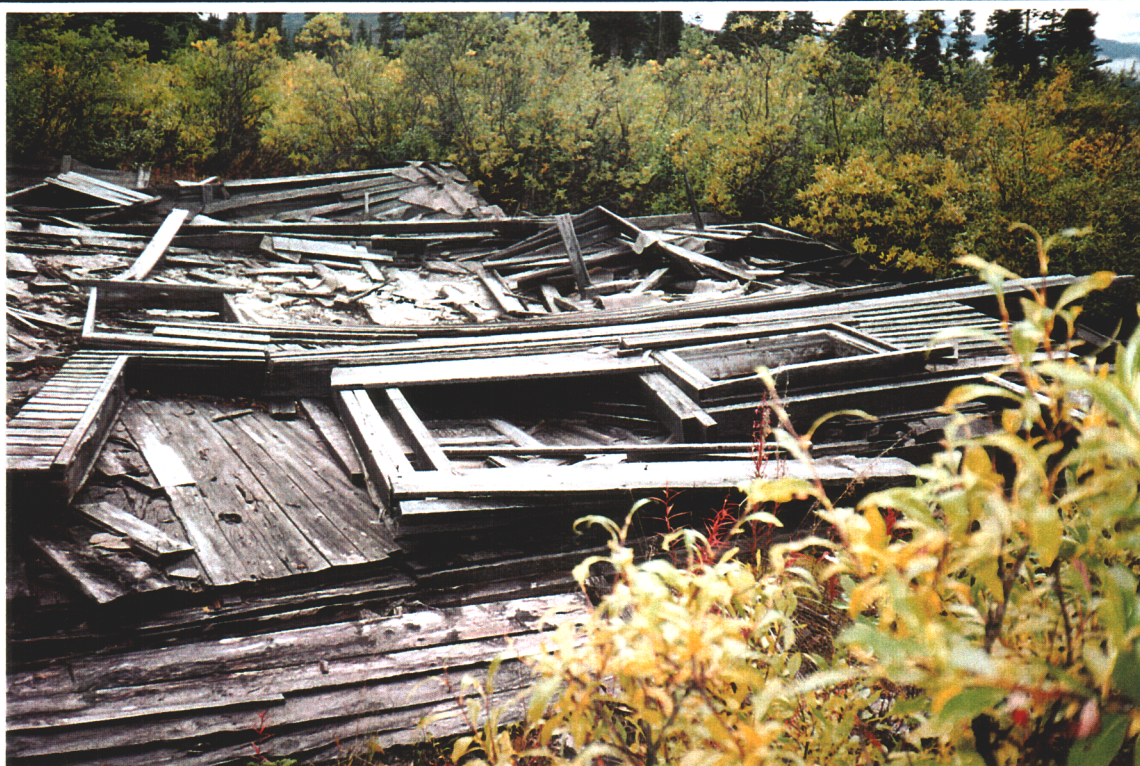
PHOTO 3

Other than the outhouse, which is a more recent construction, the buildings have been vandalized and are close to a state of collapse. The wooden structures were built on wood crib foundations. The wood and timber on site does not appear to have been treated using chemicals. Photographs of some onsite collapsed building structures are presented in Photographs #3 and #4.

Collapsed building structure.

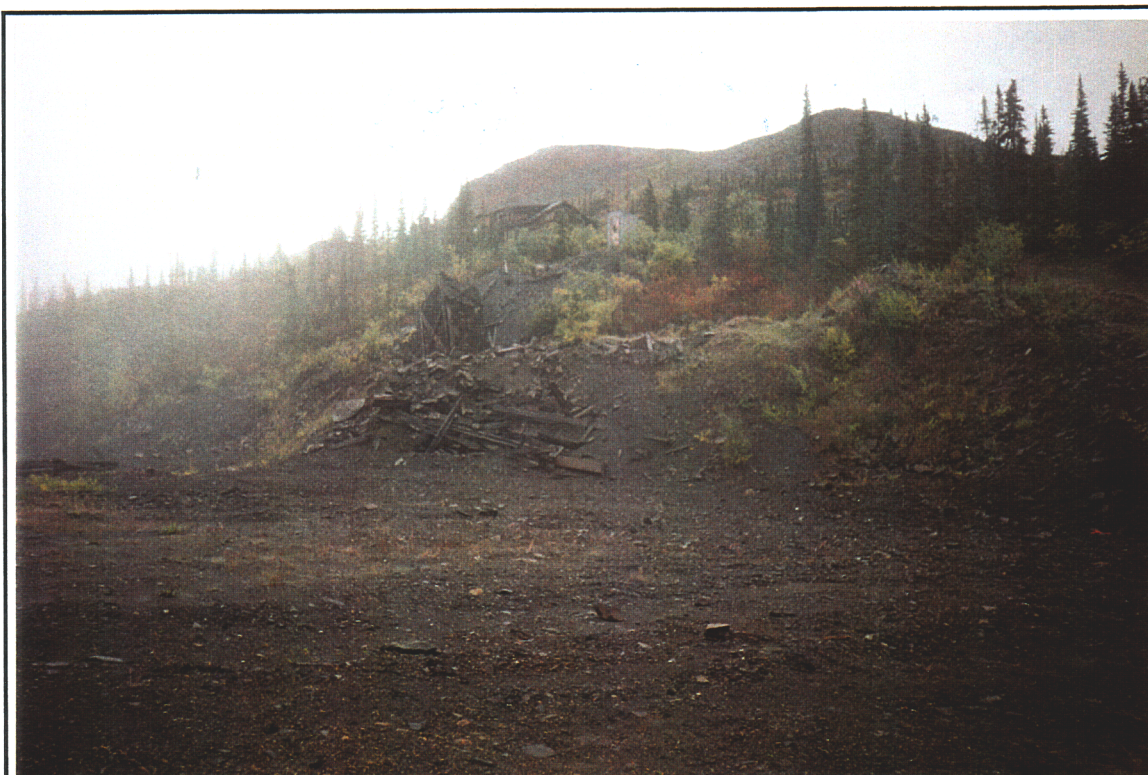
PHOTO 4

Collapsed mine workings and building structure at centre of camp.

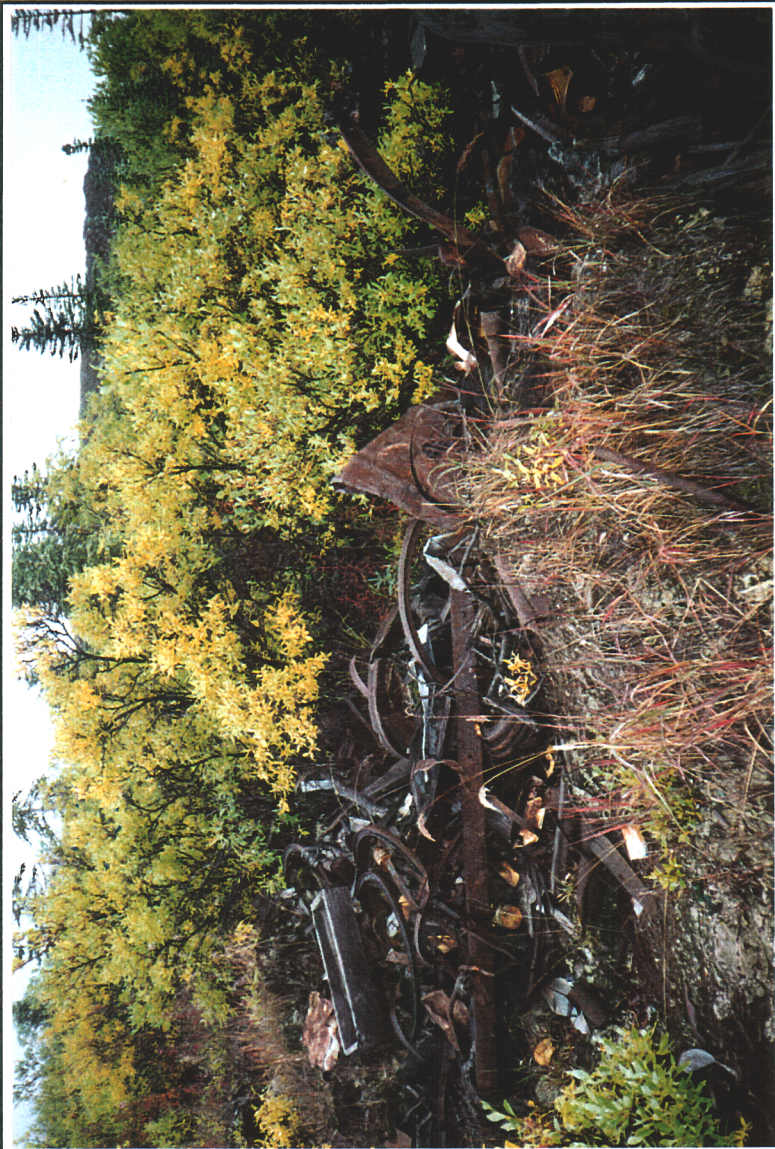
PHOTO 6

A waste dump area was observed down gradient of the camp area on the west side of a northwest-trending access road to the site. Empty drums, scrap metal and other non-hazardous debris were dumped on the vegetated slope. The surface area appeared darkened and stained. One soil sample (WS4) was collected from this area and submitted for total

Scrap metal and waste dump down gradient of camp.

Non-hazardous scrap material identified at the waste dump can be left on-site as is, consolidated, or buried under waste rock. A review of the site by a cultural resources expert and further discussions with the local tourism board may be advisable to identify the site's historical value. It is recommended that the extensive piles of waste rock be used to fill in the trenches and as burial cover for incinerated materials.

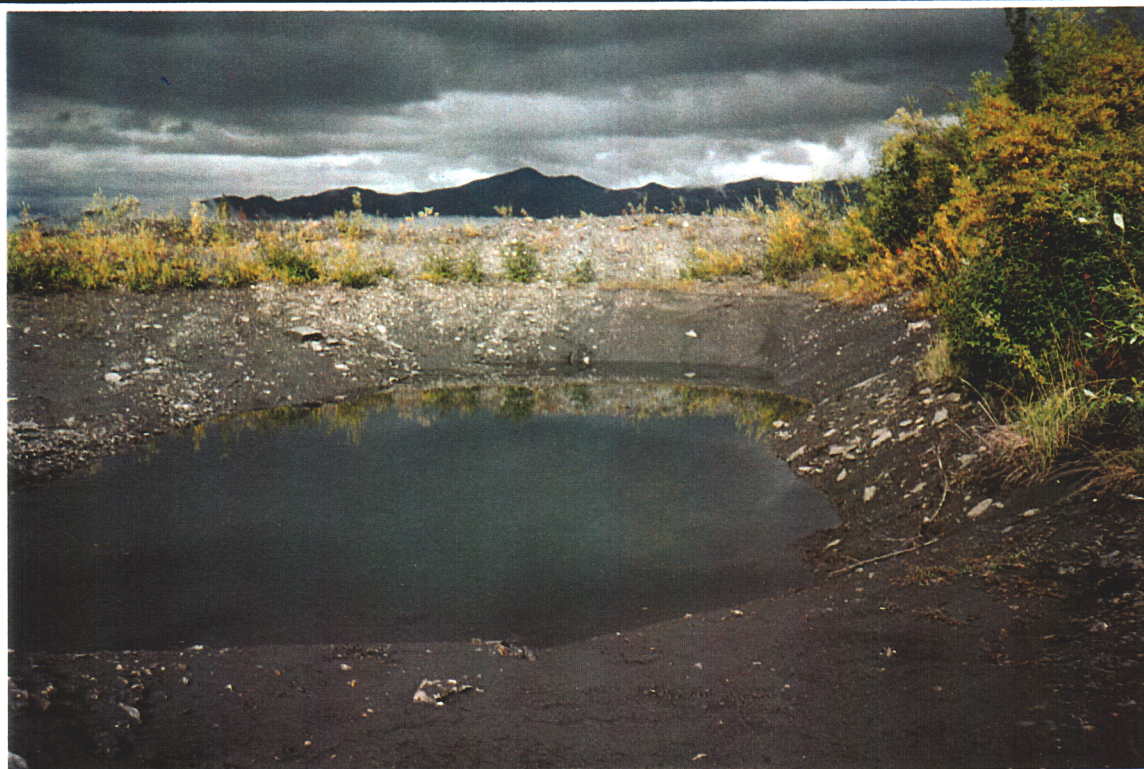
PHOTO 7

A small pond of water was noted in the most northern trench and appeared to contain seasonal surface water runoff produced by precipitation. No stream or seeps were observed at the site.

View of surface water in trench at north end of camp.

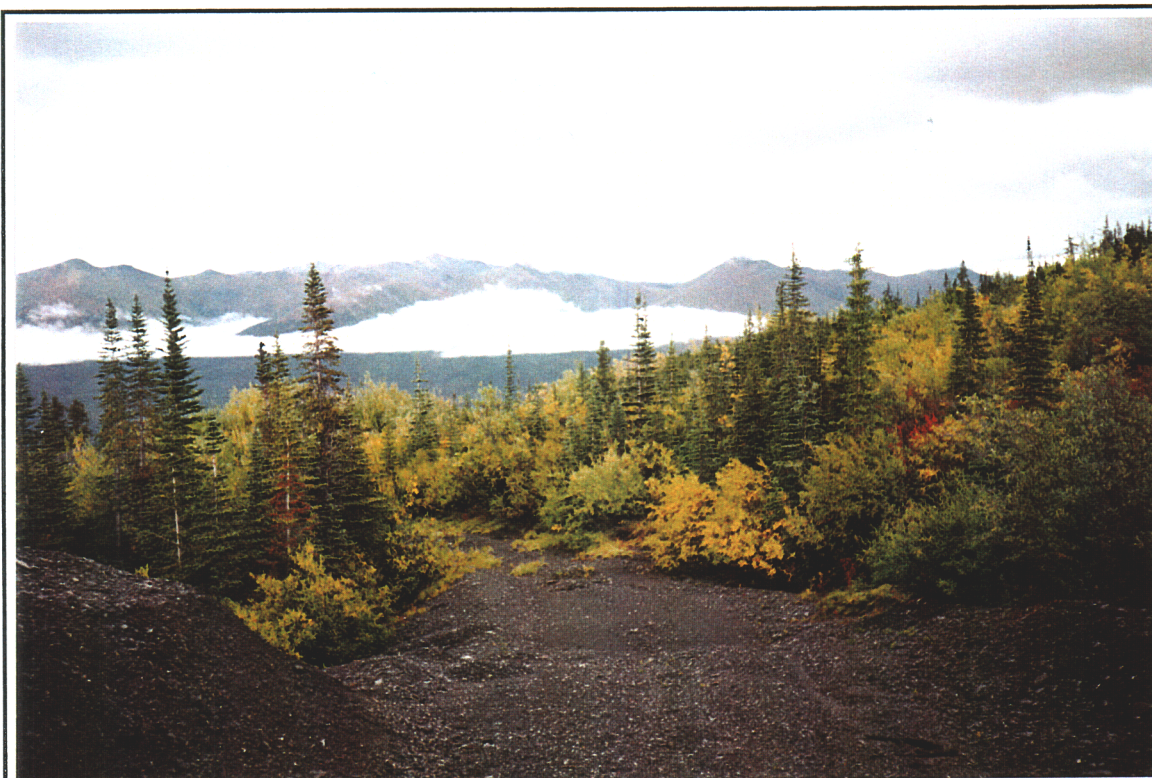
PHOTO 8

View of waste rock at north end of camp.
