PHASE II ENVIRONMENTAL ASSESSMENT OF THE LOGTUNG ABANDONED MINE SITE

Action on Waste Program
Indian and Northern Affairs Canada

February 1997

**PHASE II
ENVIRONMENTAL ASSESSMENT
of the
LOGTUNG MINE SITE**

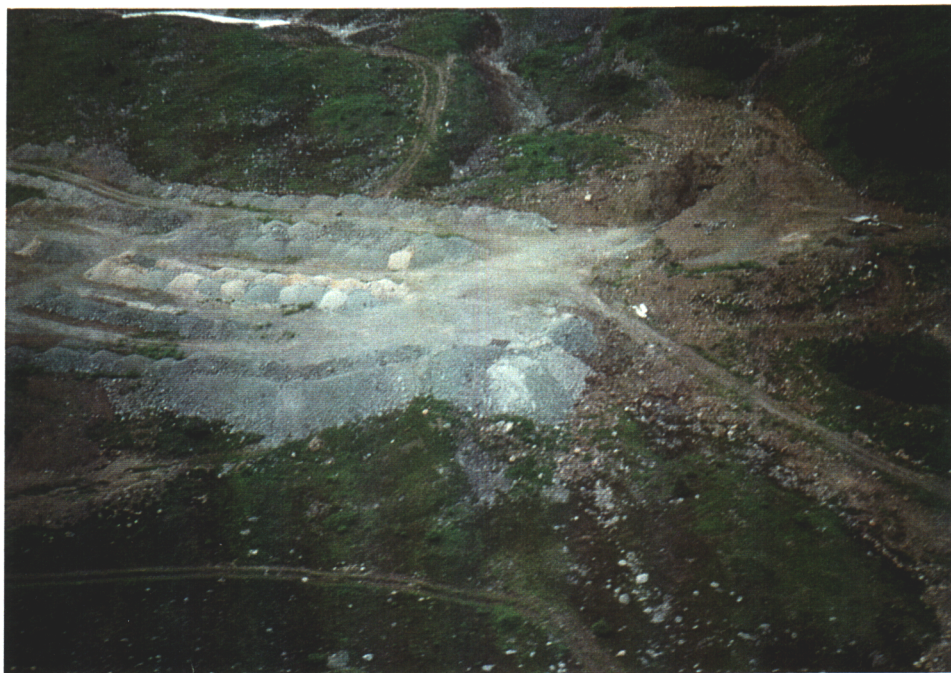
Photo 1. Aerial view of upper exploration area looking west. Note multitude of ore piles at left and adit entrance at upper right.

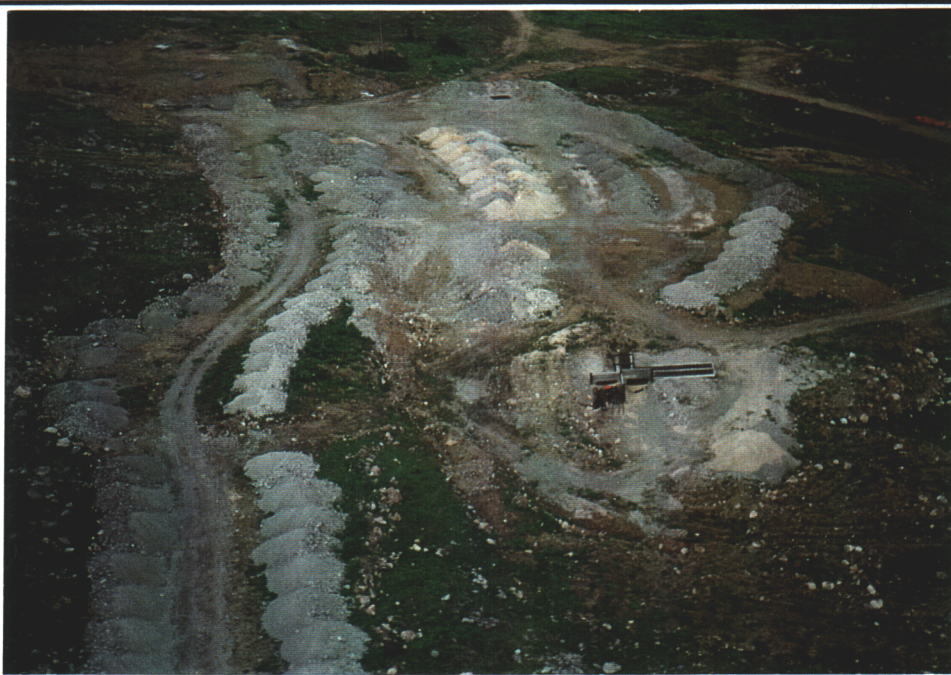
Photo 2. Aerial view of upper exploration area looking east. Note ore sample handling area (foreground), adit area (upper left) and access road to camp area at right.

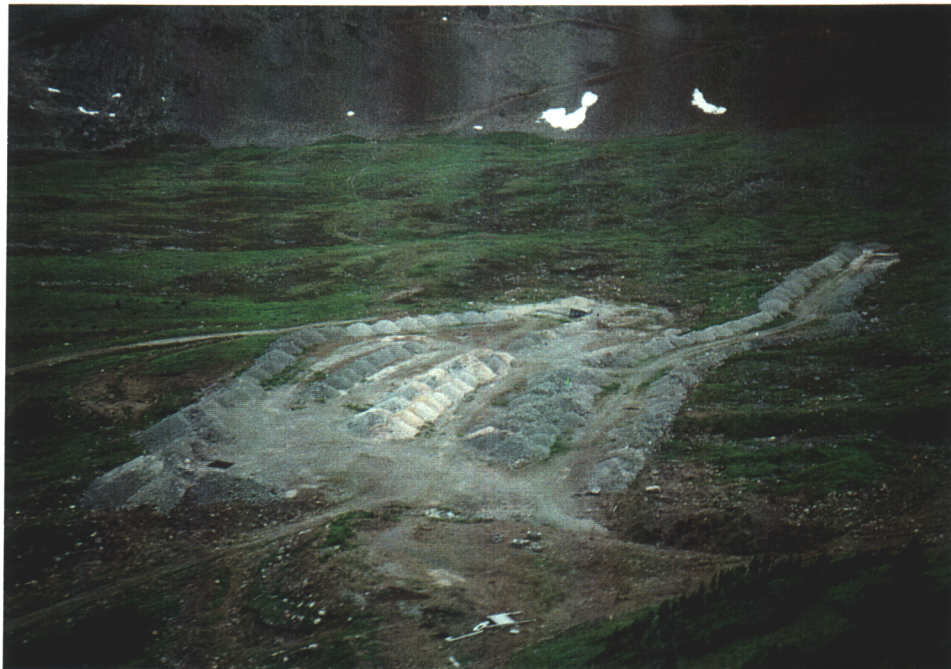
Photo 3. Aerial view of upper exploration area from north with adit at lower right and waste rock piles in background.

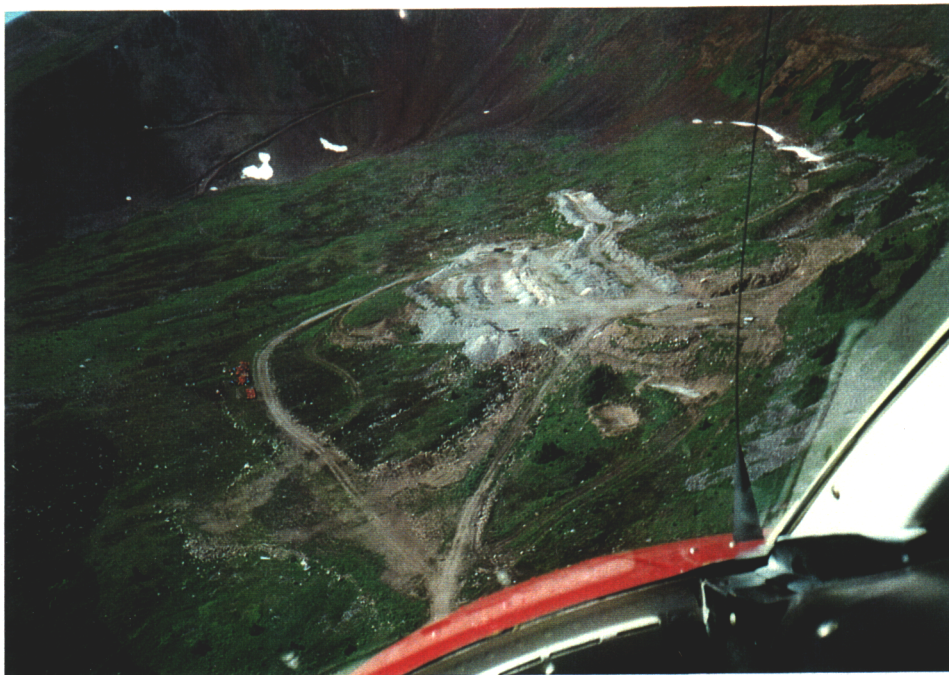
A barrel storage area camp lies approximately 800 m south of the adit area at 1625 m level (see **Photo 4**). Another barrel storage area lies across from core storage shacks located a further 300 m down the access road, south of the main site (see **Photos 13 & 14**). A level excavated area (presumably the site of the camp) a settling pond and four partially collapsed, covered core sheds are located 750 m southeast of the portal site (see **Photo 11**). A 15 km all weather road exists into the site from the Alaska Highway to the south. Approximately 3.5 km of road have been constructed on the Yukon side of the Yukon-B.C. border.

Photo 4. Aerial view of upper exploration area from east with access road to camp area at left. Note barrels by side of access road(left) and adit at right.

All metal from the upper level loading platform should be removed and buried on site. Remaining wood timbers from the platform should be combined with timbers in front of adit and burned on site. Empty waste rock from all barrels and spread over large expanse of existing waste rock piles at upper level and bury barrels under waste rock piles.

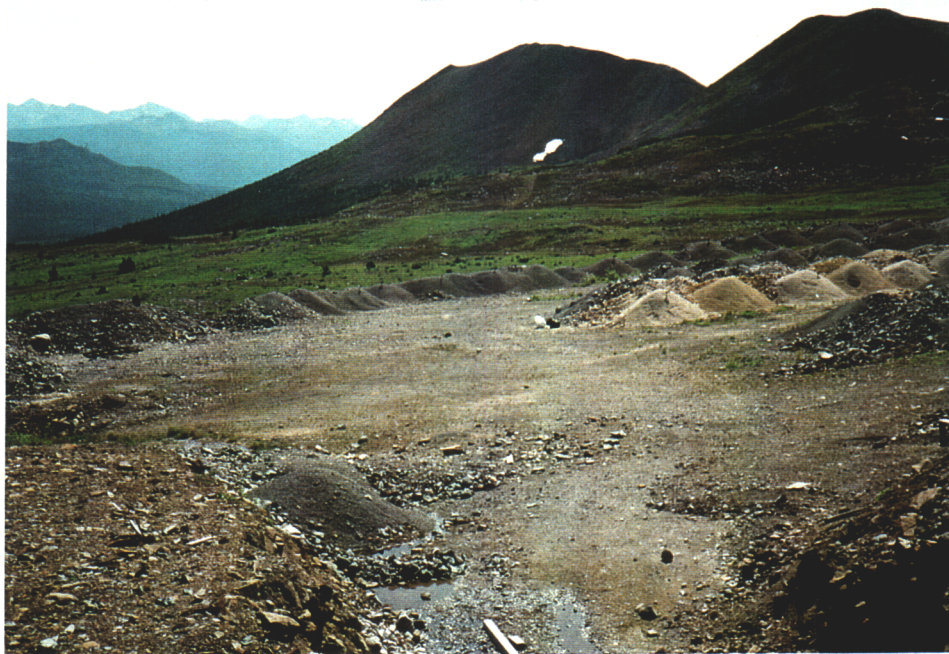
The underground workings at the Logtung mine site produce a small flow of mine water which seeps through rubble blocking the portal and then over the surface of the waste rock. The flow was not traced beyond the waste rock pad area however it does not access West Logjam Creek directly which is 0.4 kilometres to the south. No groundwater seeps were observed in the area of the rock dumps on the Logtung property.

Photo 5. View from adit area of waste rock piles looking southwest. Note mine seepage which was the site of LT-WQ-A1.

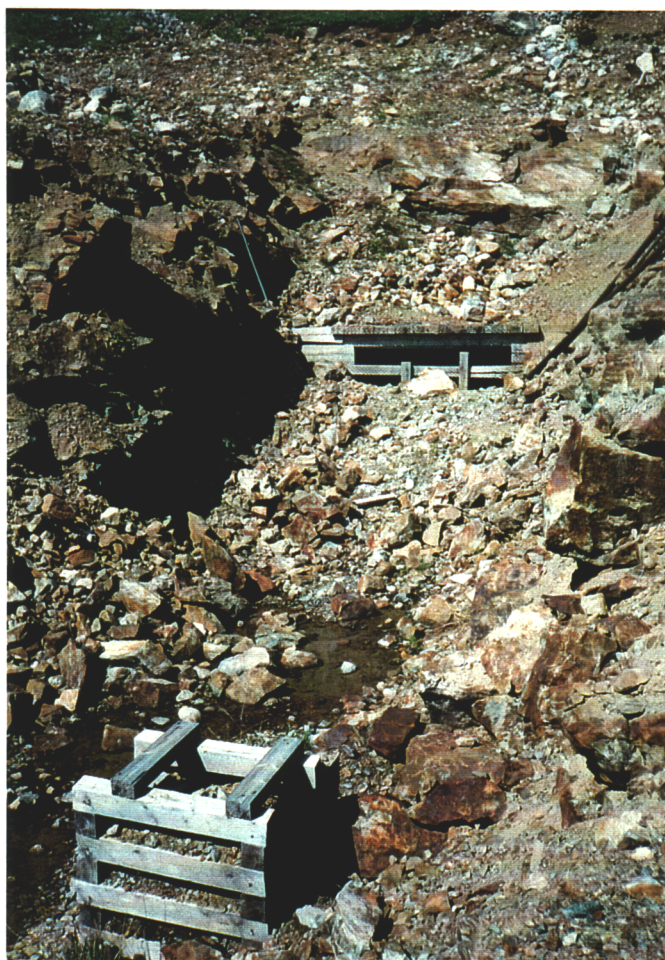
The Logtung deposit was explored by a single decline commencing from the portal at UTM coordinates 356800 metres North and 6654680 metres East at an elevation of 1510 metres. The decline is collared at azimuth 325°. The portal area has been partially backfilled with broken rock and rubble, leaving less than 0.5 metres of the timbered portal is exposed. The adit has been closed off with timbers and chainlink fencing. No repair has been done to the sagging fencing (noted in the 1993 site assessment by DIAND Technical Services), but the portal is otherwise in sound condition (see Photo 6).

Adit	Location	Drift Length	Condition
A1	1510 m elev.	undetermined, no access	- wood timbers in crib fashion covering adit entrance; 0.3 m X 0.9 m max. opening; timbers in fair condition; waste rock piled in front to within 1.5 m of adit roof

Photo 6. View from south of seepage from adit. Note collapsed conditions surrounding adit entrance.

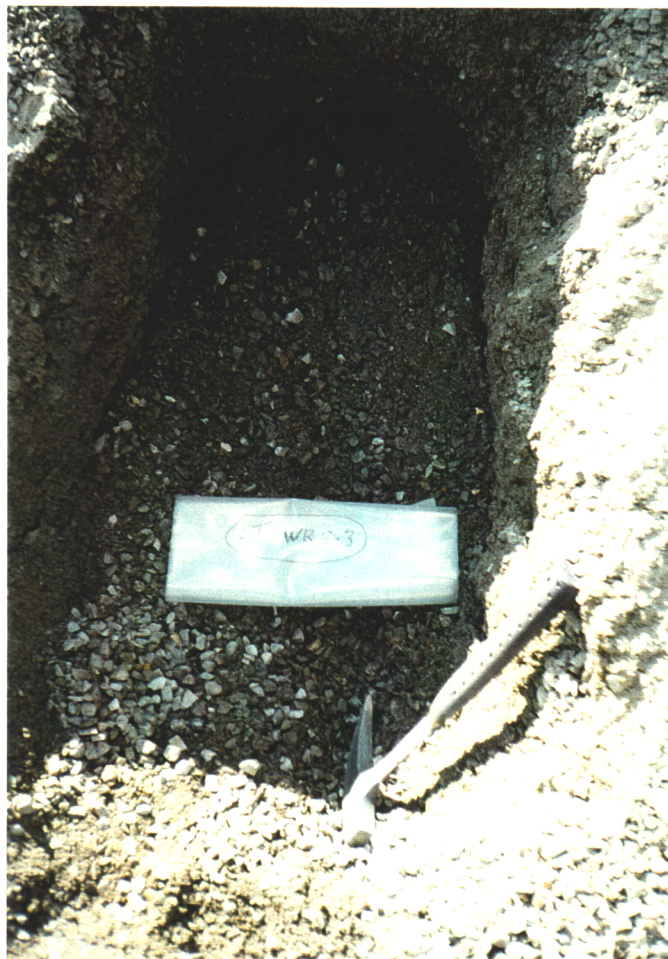
Photo 7. Detail of test pit LT-WR-R3 taken from crushed reject ore pile material stockpiled on site.

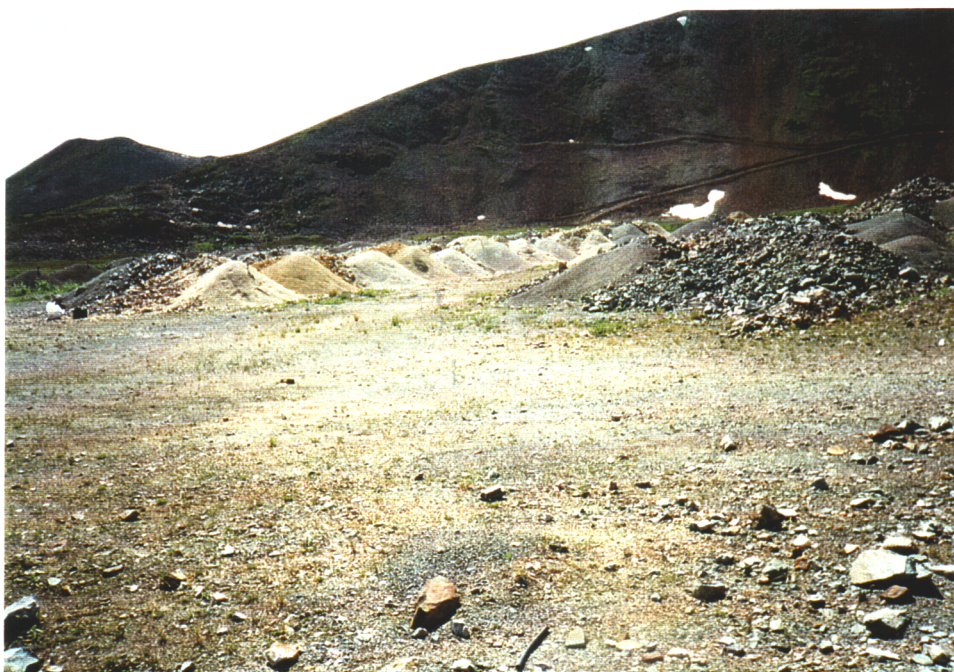
Ore material was stockpiled on a per mining round basis west of the portal area resulting in 116 individual piles of approximately 8 m³ of ore material totalling approximately 960 m³. Each ore pile has been split and is now a composite of 2/3 coarse rejects and 1/3 minus 10 mm crushed sample material. A total of 29 of the 116 ore piles are composed of quartz porphyry material with vein fracture coatings with 1% molybdenum and 2% pyrite (96 m³ crushed, 144 m³ coarse rejects).

Photo 8. Ore piles (2 m X 4 m) extending westward containing 50% crushed rock (sorted to 1 cm diameter) and 50% muck sorted by round.

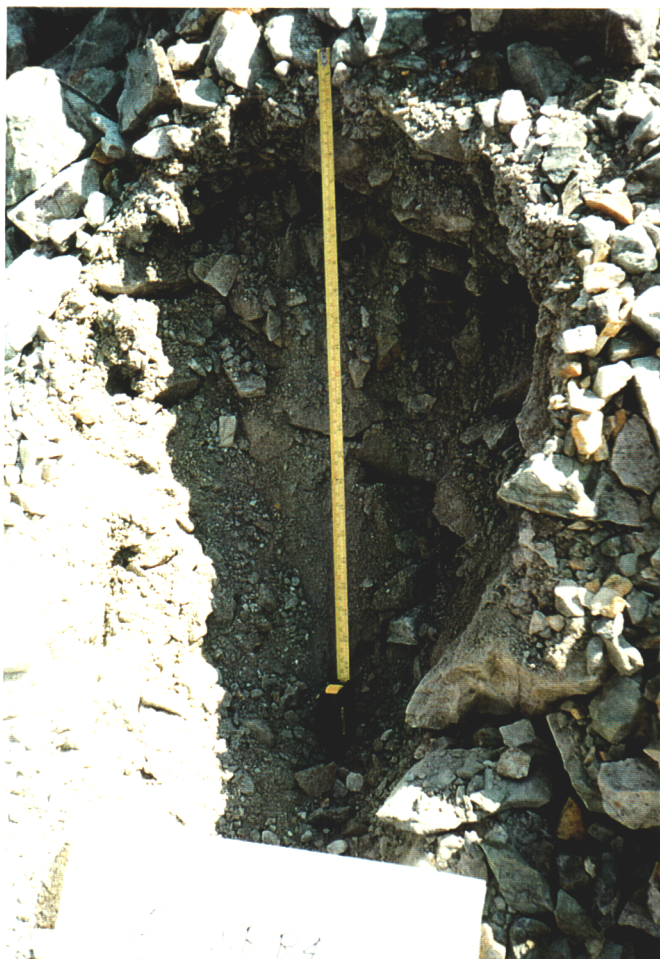
Photo 9. Detail of test pit LT-WR-R4 taken from muck portion of crushed reject ore pile material stockpiled on site.

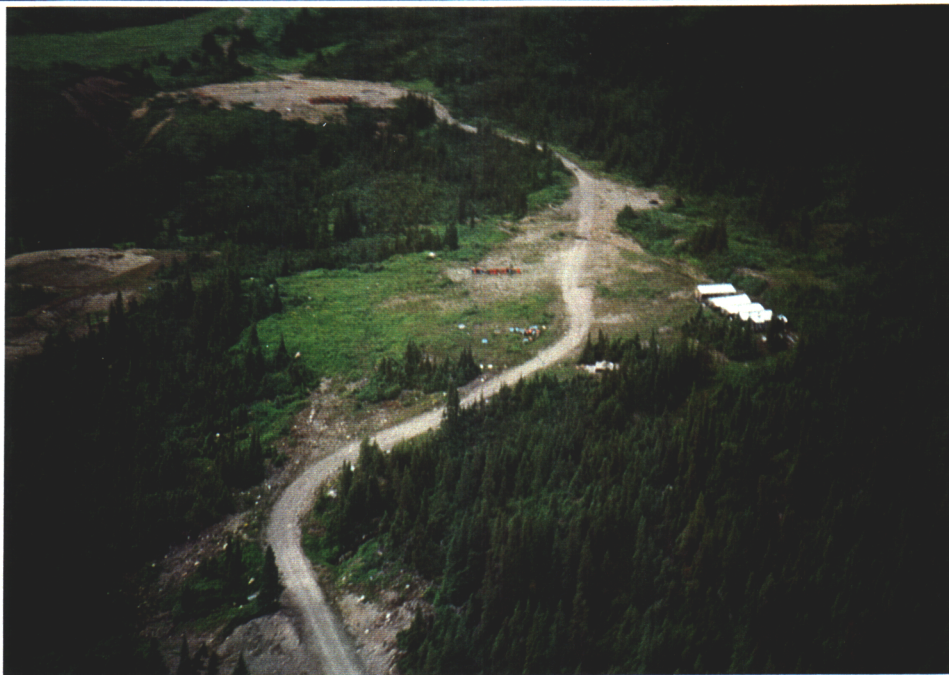
Photo 11. Aerial view (looking north) of lower camp area with collapsing core sheds (centre right), as well as barrel storage areas along access road.

Brace sheds in place remove core boxes and brace with angle iron. Remove core boxes from 2 core sheds (in fair condition) at lower site. Burn remaining sheds on site.

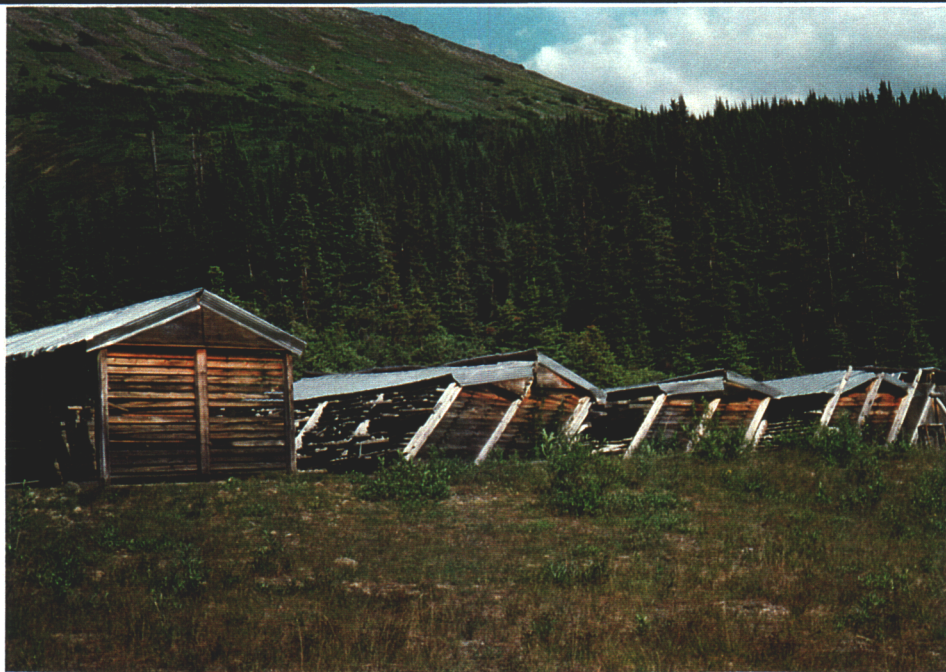
The primary concern at the Logtung mine site is the health and safety of humans and wildlife from collapsing core sortation sheds at the lower elevations as well as unsecured adit openings at the upper exploration area. Risks relating to mine safety are low, although in the future the wooden portal will rot and begin to collapse, requiring backfilling with coarse rock. This can be easily done considering the shallow topography of the site.

Photo12. Collapsing wood frame core sheds at lower camp level. Shed at left is only partially filled with core while other sheds have had core placed on upper racks.

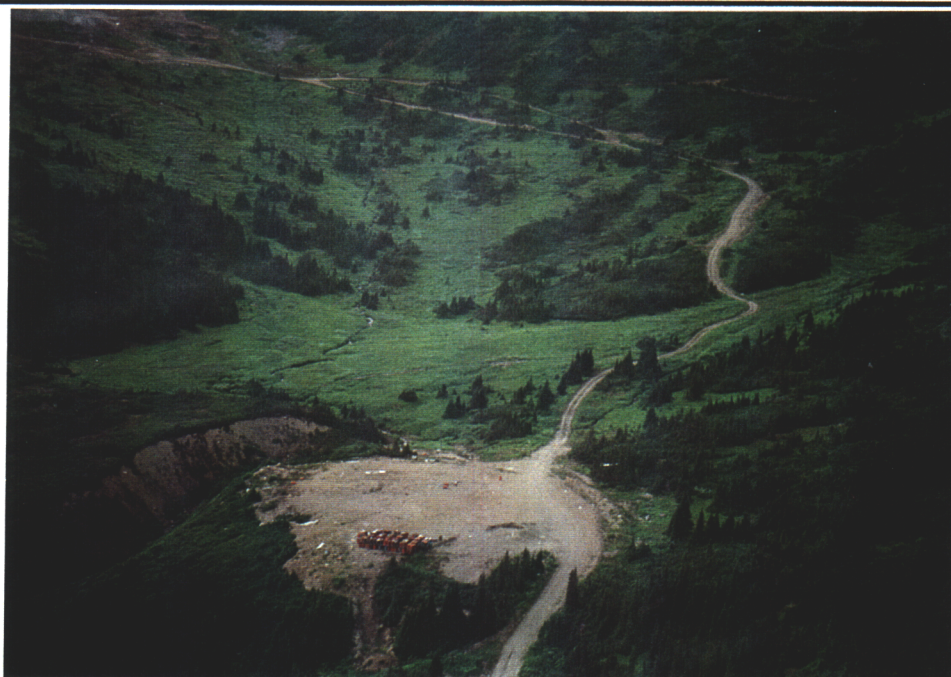
Photo 13. Aerial view of lower camp area showing ore barrel storage area between exploration area and camp with West Logjam Creek at left..

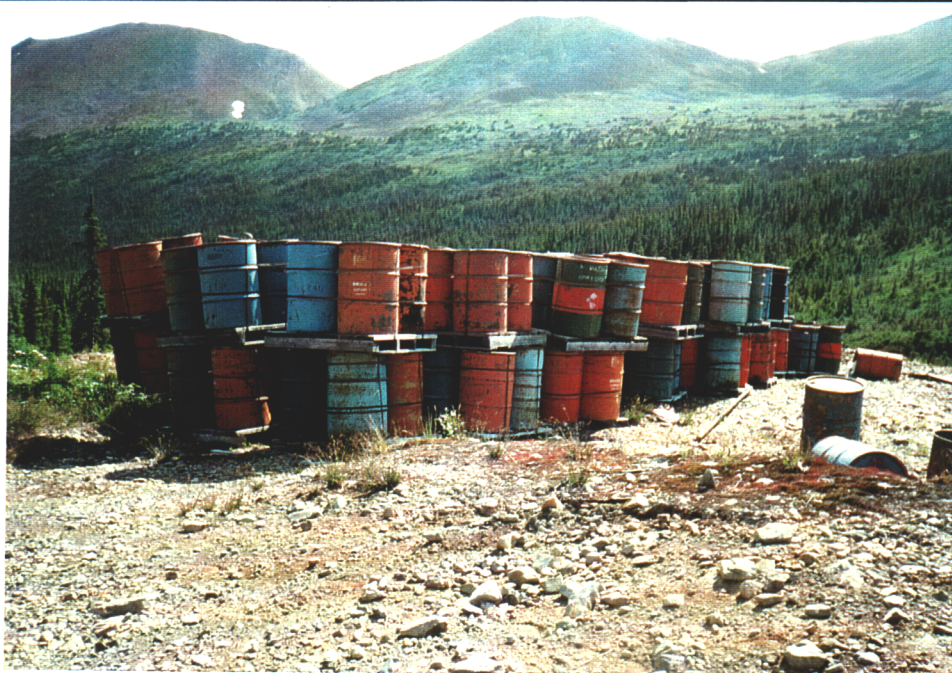
Photo 14. Detail of ore barrel storage area (total of 258 barrels on wood skids). Most barrels in this area were in good condition and contained graded ore sample material.

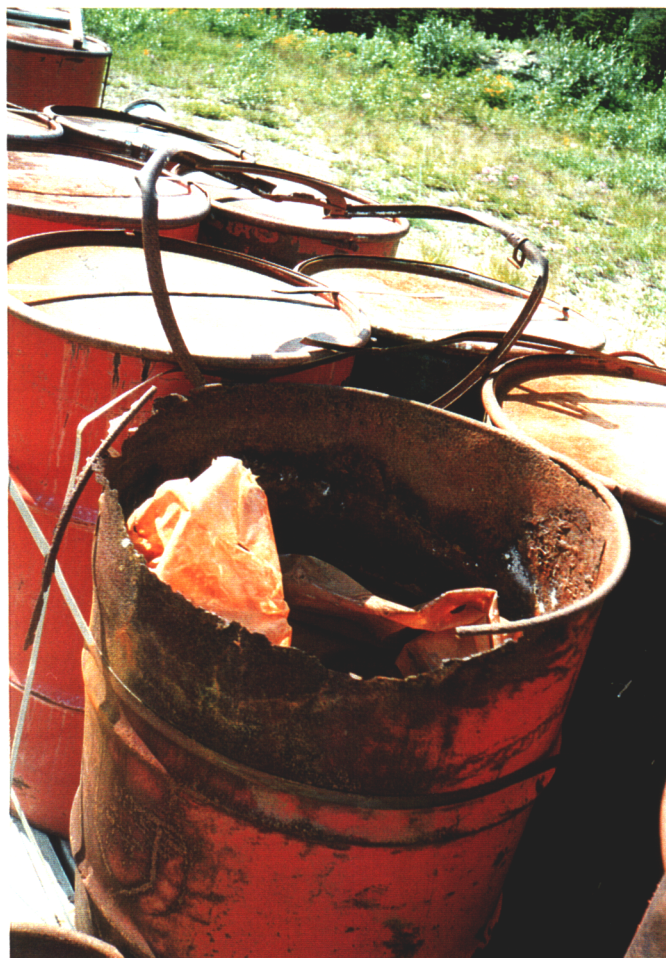
Photo 15. Detail of smaller ore barrel storage area opposite core storage sheds.

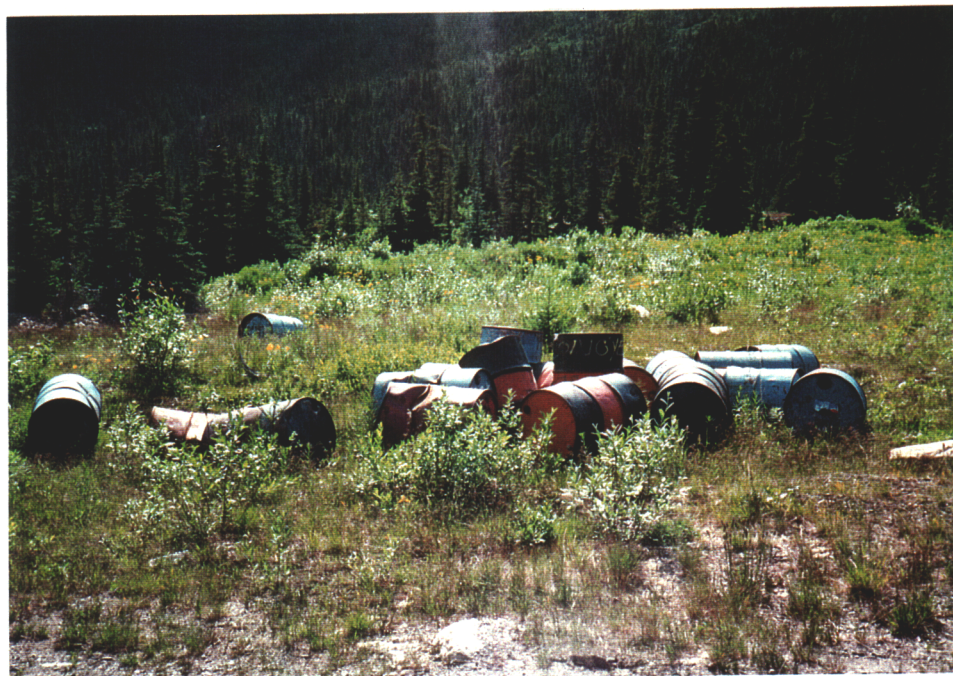
Photo 16. Random empty 205 litre barrels scattered by access road between camp area and exploration area.
