Phase III ENVIRONMENTAL ASSESSMENT

PESO MINE SITE

Interim Report

Environmental Services
Public Works and Government Services Canada

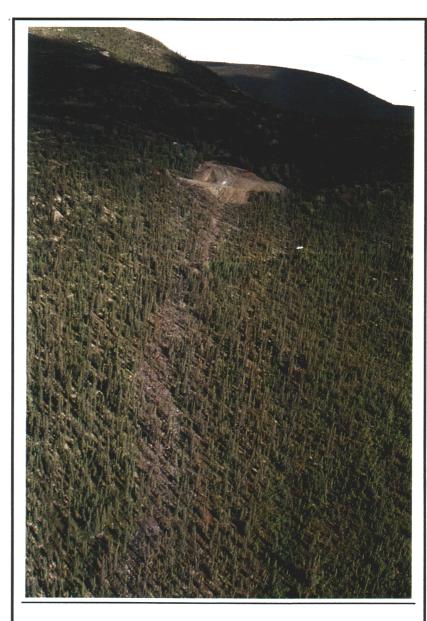
Photo 1. Peso mine waste rock dump. Note trail of distressed vegetation leading from waste rock.

Recommendation 1. Prevent further leaching and transport of metals from waste rock by constructing a containment and isolation or migration control system. If a geomembrane cover with rock anchor is planned, conduct a geological assessment to identify a suitable source and volume of non-acid generating anchor rock.

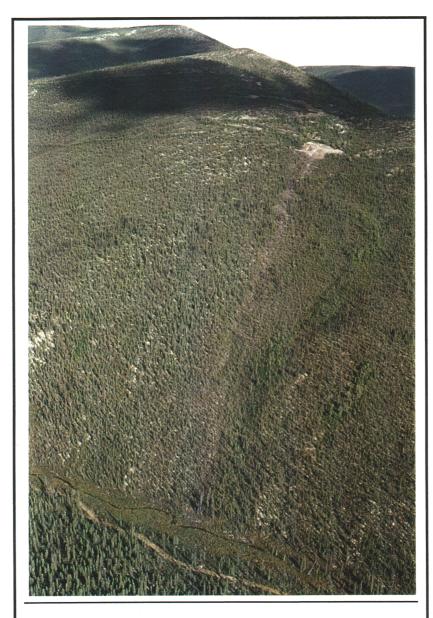
At the Peso site, additional mapping was conducted around Adit 1 (Figure 4). The most significant observation was that the vegetation stress that was noted below the waste rock piles at Adit 1 during the 1996 visit, continues down slope for at least 200 m, and possibly to the stream below.

Photo 2. Aerial view of distressed vegetation seen as a greyish line between the waste rock and Secret Creek channel.

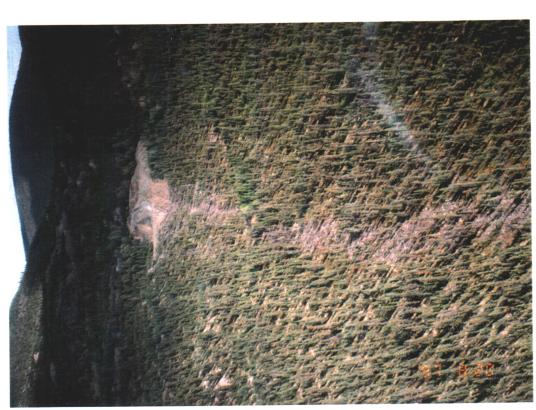
Photo #PE2: Looking north at top of lower bench slope . Note schistose rock, relatively fine grained. Note stressed vegetation.

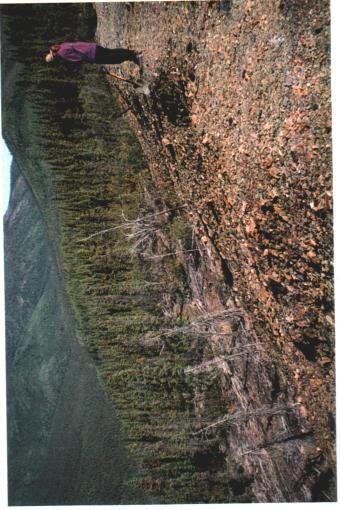
There was no evidence of slope failures throughout the waste rock mass with the exception of some minor slumping at the south edge of the waste rock pile. It does not appear that the existing depositional structure of the waste rock pile is prone to slope failures within the waste rock mass itself. The natural ground surface surrounding the waste rock pile consisted of a west facing slope with an angle of approximately 22° to 23°. The area was well vegetated with semi-mature to mature spruce trees and the near surface soil profile consisted of a thin veneer (0.05-0.08 m) of organics underlain by dense glacial till soil, a heterogeneous mixture of silt, sand, and gravel. Sample Peso 4 was retrieved from the native soil material and analysed for grain size and moisture content. As seen in Appendix C, sample Peso 4 consisted of a silty sand, some gravel with a moisture content of 11%.

Photo #PE1: Looking east at waste rock pile near adit and stressed vegetation along slope. Note benched tailings.

- 2. If it is the intention to remediate this site for ARD considerations, it is recommended to perform the necessary measures to develop a containment and isolation approach as previously discussed. This would include conducting an initial geological assessment to identify a suitable rock borrow source, performing the design and developing construction specifications for the remediation system, and engaging in the actual construction.

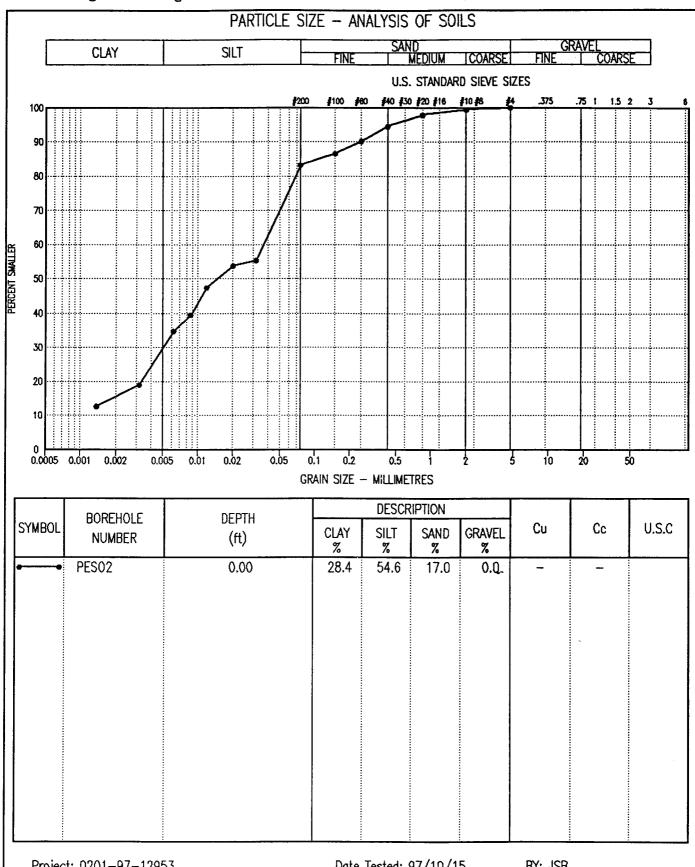
Project: 0201-97-12953

Tested in accordance with ASTM D422 unless otherwise noted.

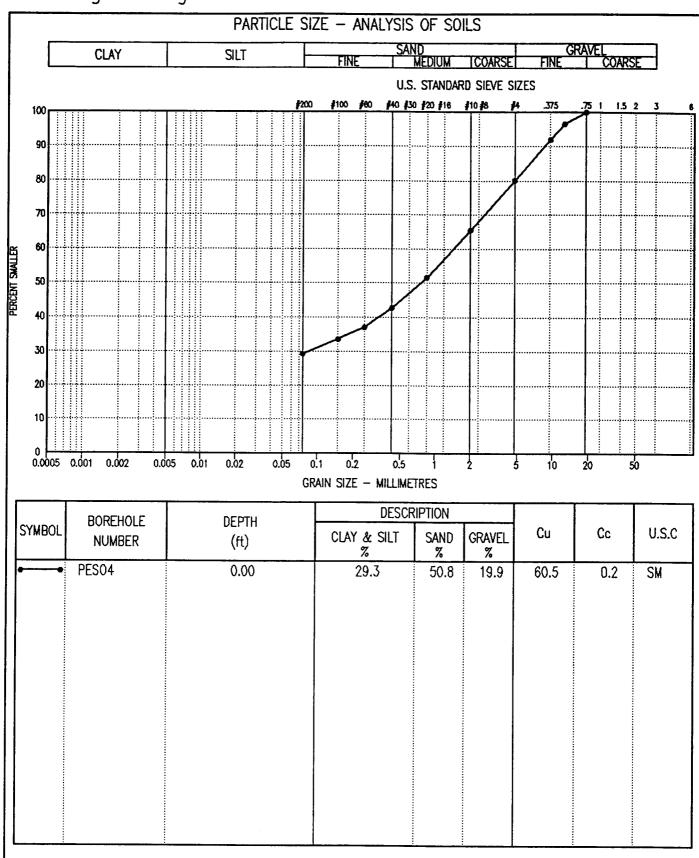
Project: 0201-97-12953

Tested in accordance with ASTM D422 unless otherwise noted.
